Confidential Inspection Report
PV Peninsula Real Estate, LLC
27538 Eastvale Road
Palos Verdes Peninsula, CA 90274

Prepared for: PV Peninsula Real Estate,LLC
Prepared By: Mike Howson
Alliance Inspections

22 April 16.

,
27538 Eastvale Rd
Palos Verdes, CA 90274.

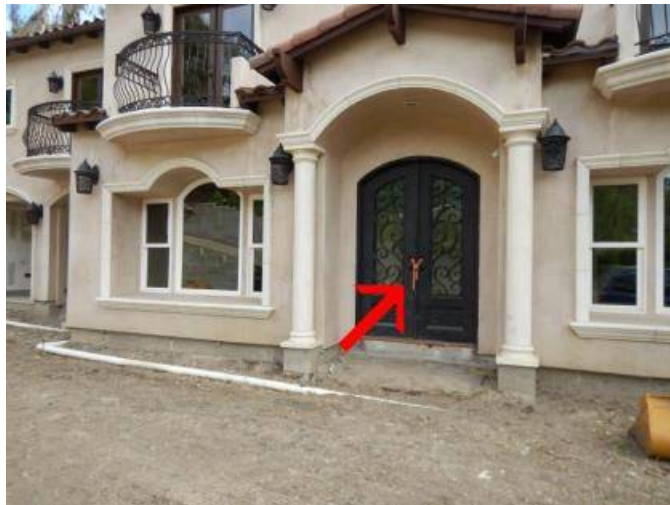
ENTRY DOOR:

Attention Needed- Hardware is missing on doors.

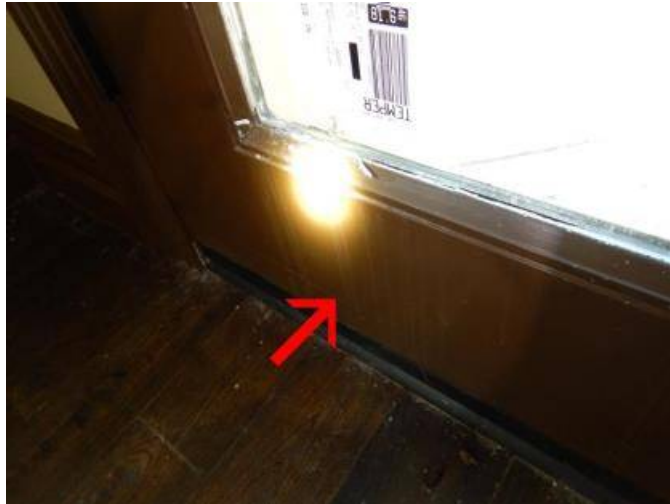
OTHER EXIT DOORS:

Attention Needed- Doors in the main house, to balconies appear to have leaked. Moisture trails are seen on doors, below the glass window in most cases.

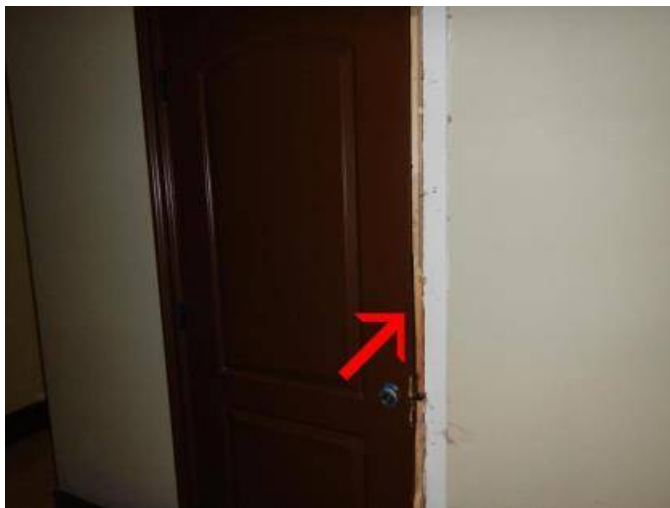
INTERIOR DOORS:

Attention Needed- Doors are missing or have missing hardware in places. Door in first floor hall is sealed off with screws and this door could not be opened using normal means.

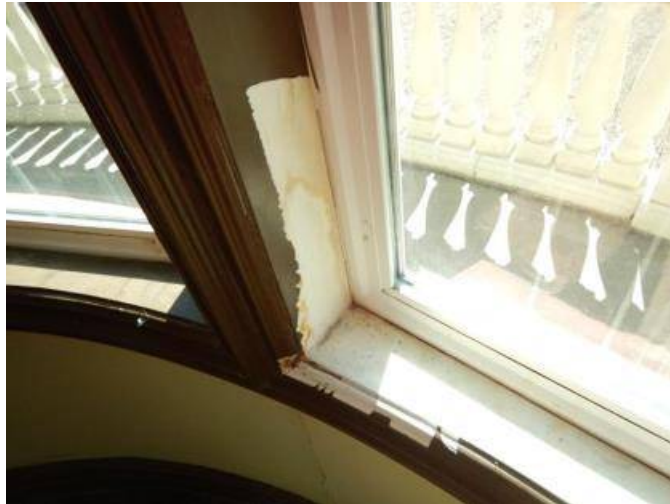
Attention Needed- Alcove in the breakfast room has leaked from the windows and walls overlooking back balcony.

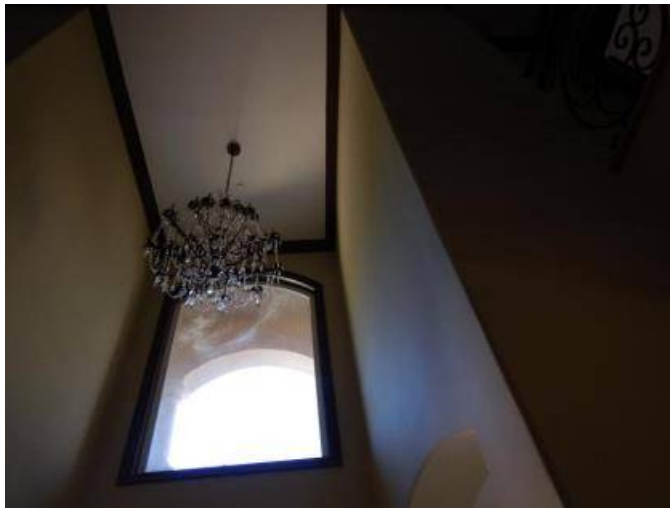
LIVING ROOM:

Attention Needed- Rooms have unfinished wall patches such as above the entry door, living room walls.

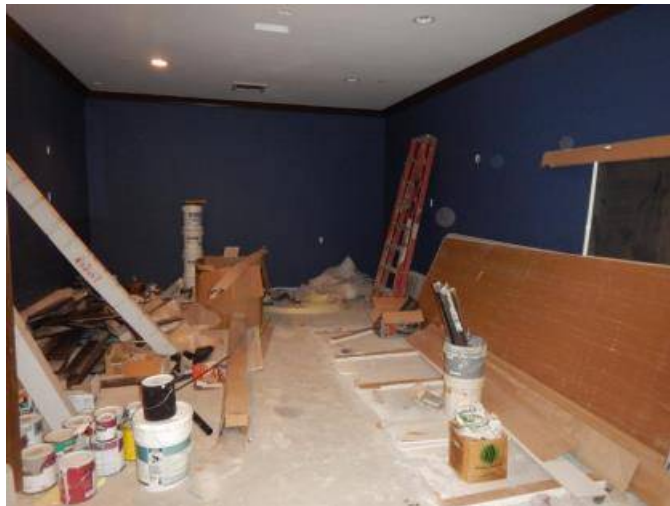
DEN:

There is a media room which is mostly occluded with construction materials and therefore not fully viewed.

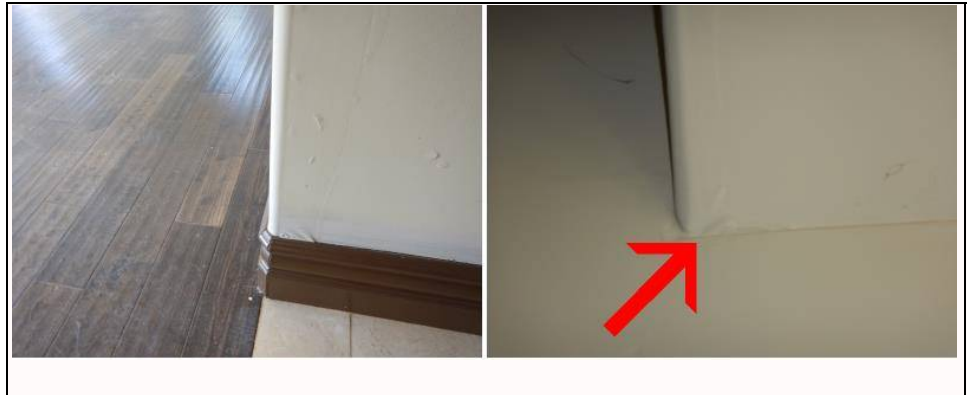
HALL:

Unsatisfactory- The hall has moisture bubbles in the paint in the entry to the back room (family room). There has been a moisture leak from some source in this area.

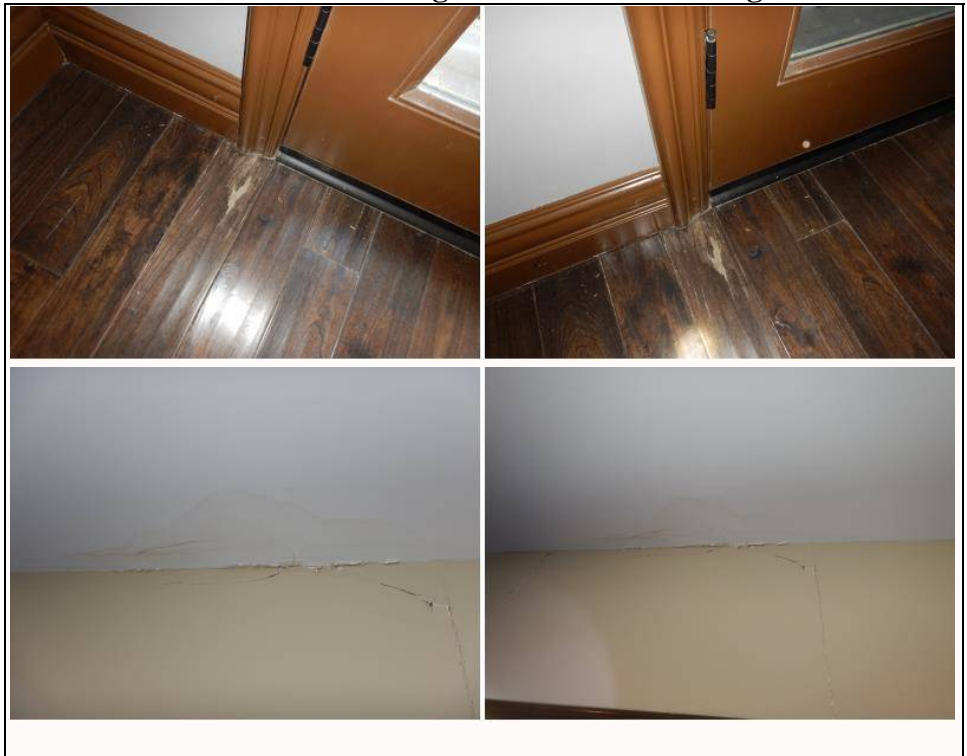
BEDROOM 2:

Attention Needed- Front left bedroom has moisture damage from the balcony door, which appears to have leaked.

Attention Needed- Bridge to the next house has moisture damages and cracks in ceiling and wall.

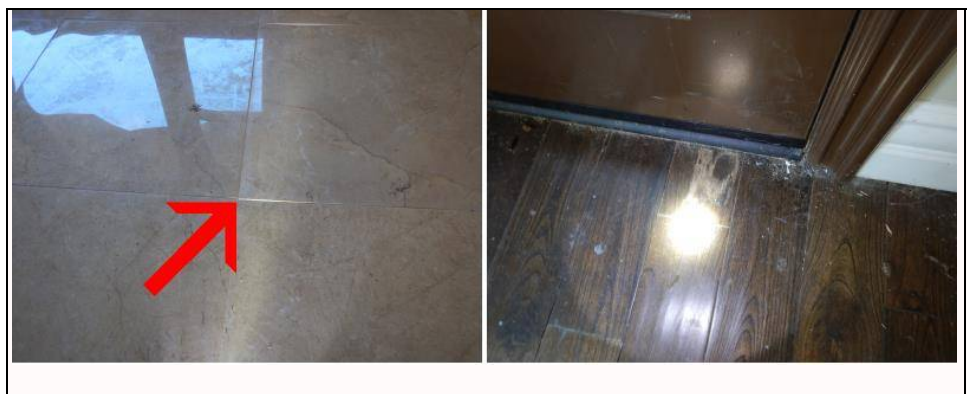
Attention Needed- Tile have raised corners in some places such as hall and living room.

Floors have moisture damages in areas noted such as kitchen area alcove, upstairs floor adjacent to balcony door.

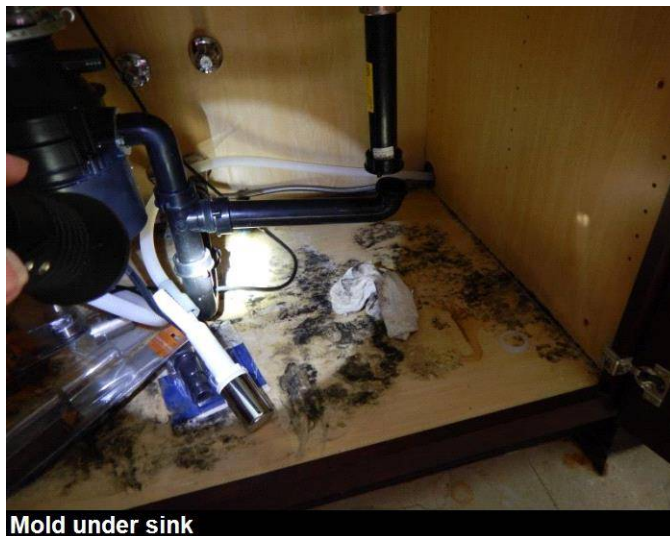
Mold under sink

Attention Needed- Mold stains and strong odor are noted under the kitchen sink as from moisture related stains.

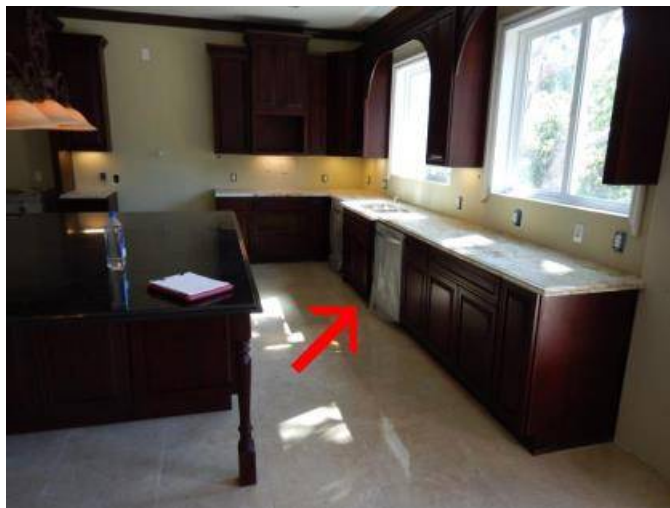
DISHWASHER:

Attention Needed- Dishwashers exist but are not fully installed and were not tested.

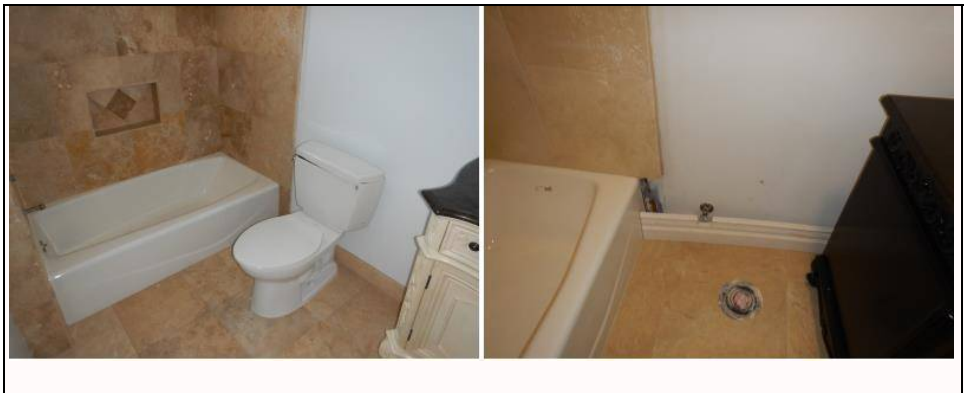
None of the bathrooms are fully operational at this time such having missing toilet supply connections, missing sinks or other fixtures.

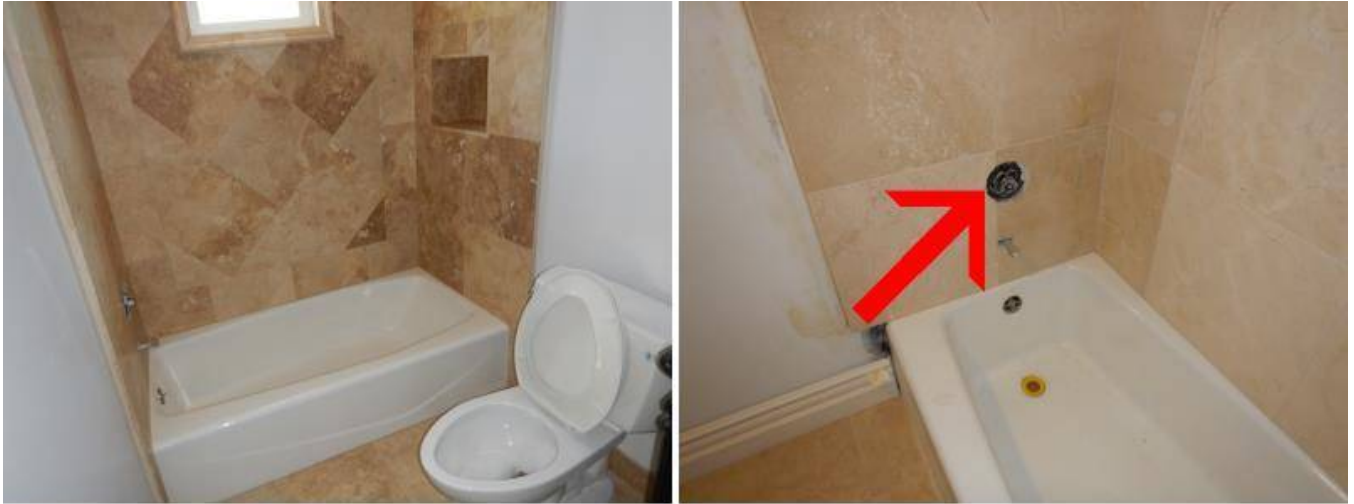
TUB:

Satisfactory overall. Faucets are missing however and these were not tested.

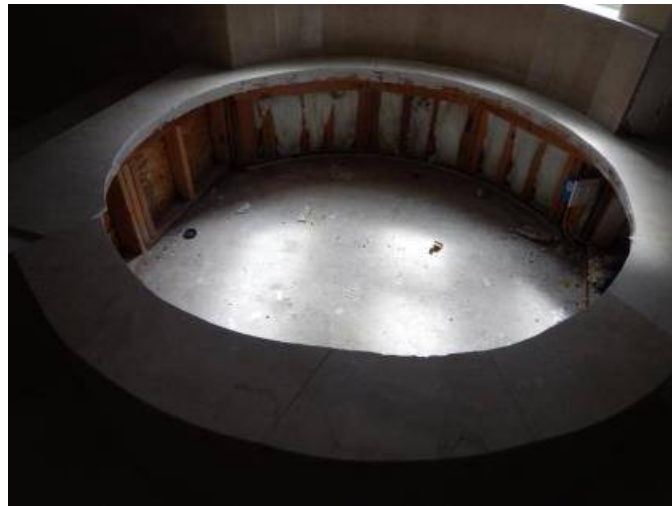
JET TUB:

Tub not installed in master bathroom.

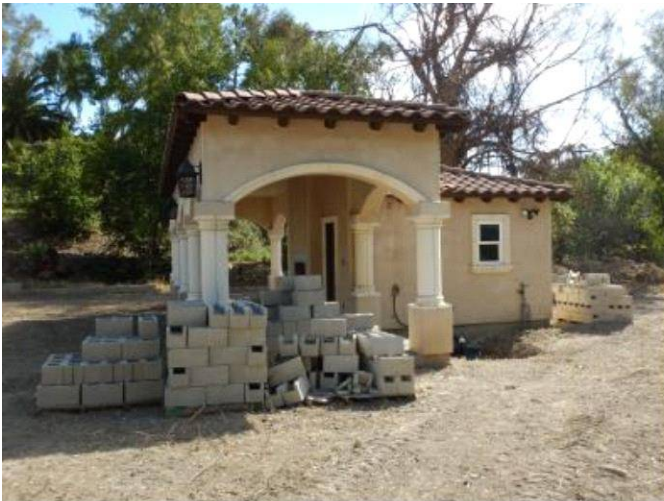
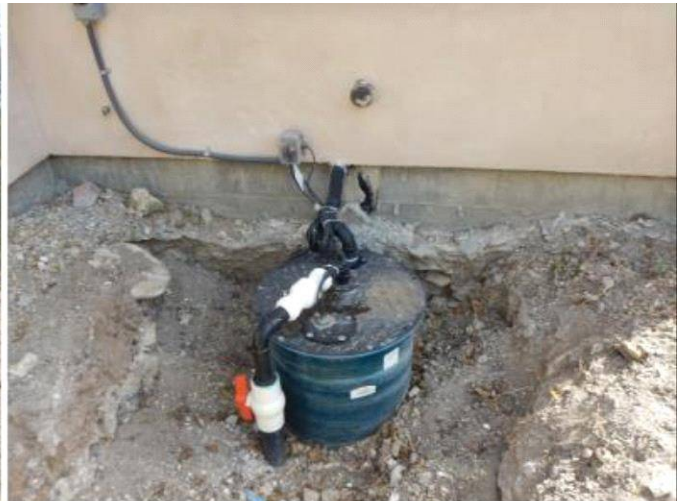
Pool house appears to have a sewage pump

Yes, there is a pump installed at the back pool house. This system was not tested.

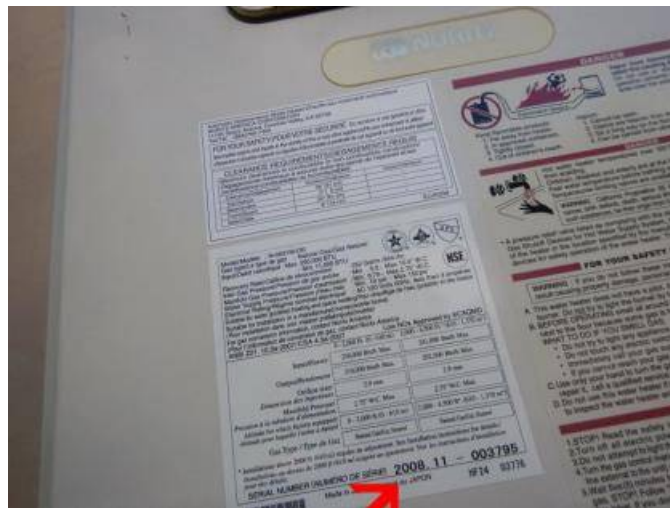
AGE:

These appear to be new systems.

The serial number on the Main house, however, shows that it is a 2008 system, serial number dates are typical.

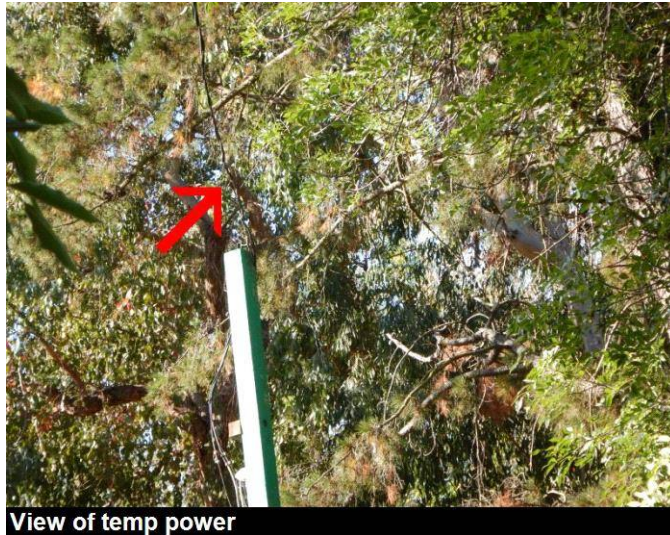
View of temp power

Temporary overhead power in installed.

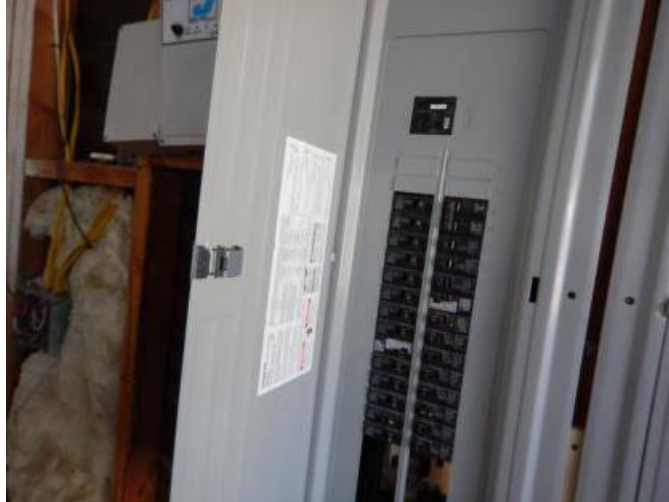
LEGEND:

The breakers are not marked as to the rooms, areas, or appliances controlled. It is recommended that they be noted as soon as possible.

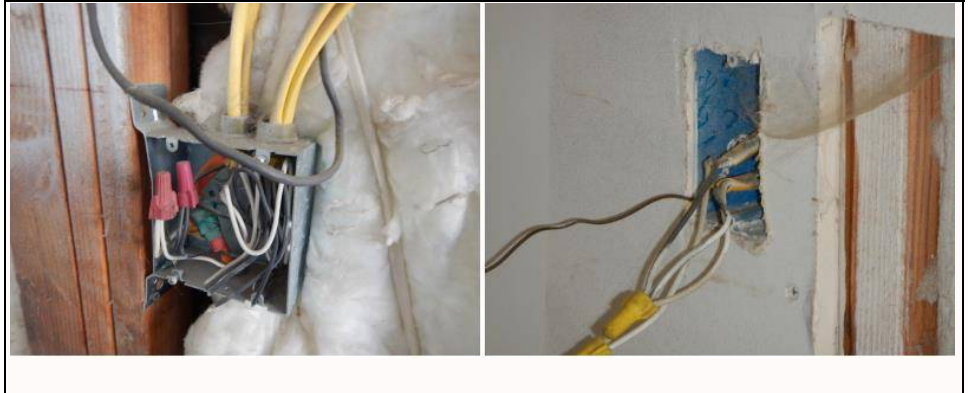
Attention Needed- There is exposed wiring in places such as garages, ceilings in rooms where a fixture is not yet installed.

All exposed wiring should be safely covered or terminated.

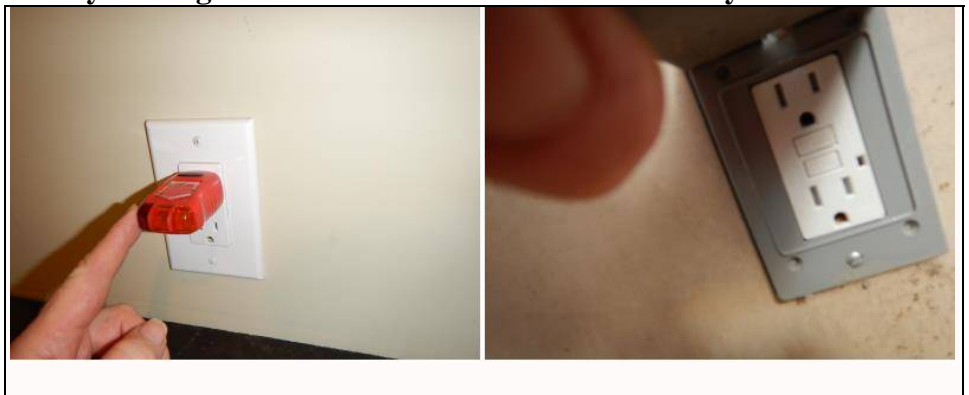
There are , however some outlets not yet energized such as some exterior and balcony outlets.

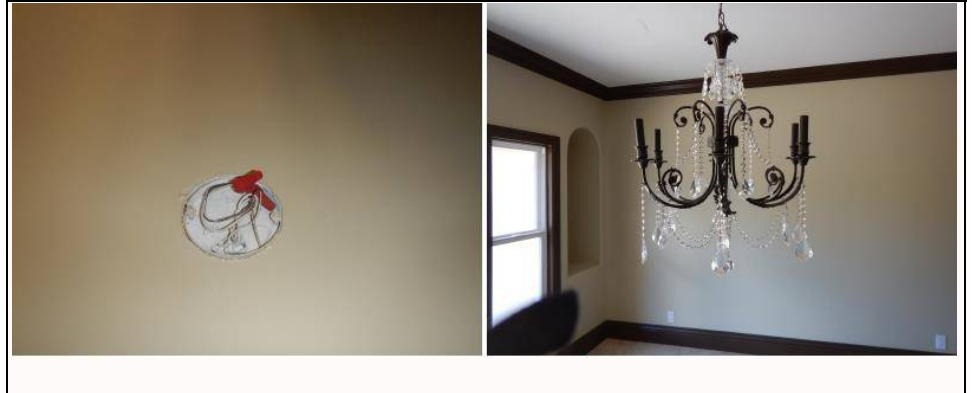
Attention Needed- Some fixtures are not yet installed or did not respond to the switch such as chandeliers in houses.

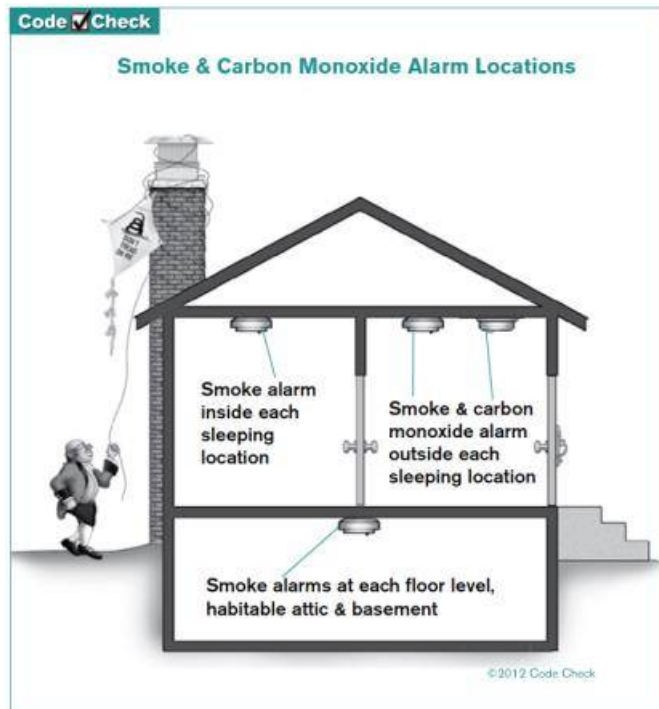
SMOKE DETECTORS:

Smoke detectors are chirping in some places as from low batteries.

Smoke and CO detectors need to be installed in all appropriate places. See code illustration.

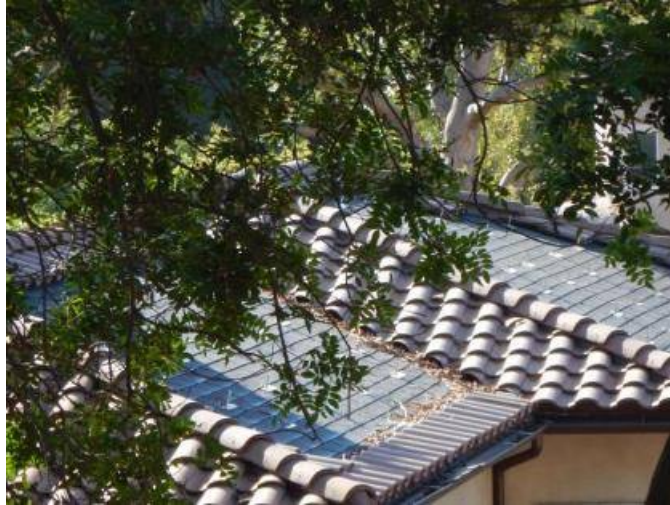
Attention Needed - The roof is not completely finished in places as the main house.

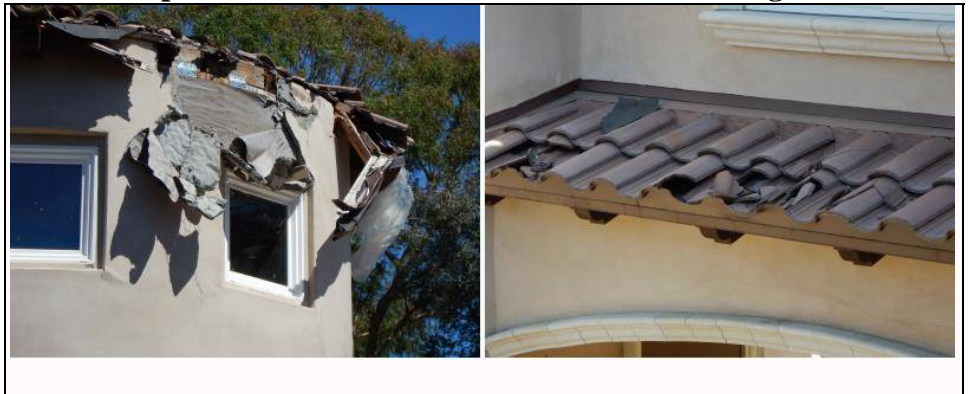
Attention Needed - Damaged tile is seen in places as the left side tower where tree damage occurred.

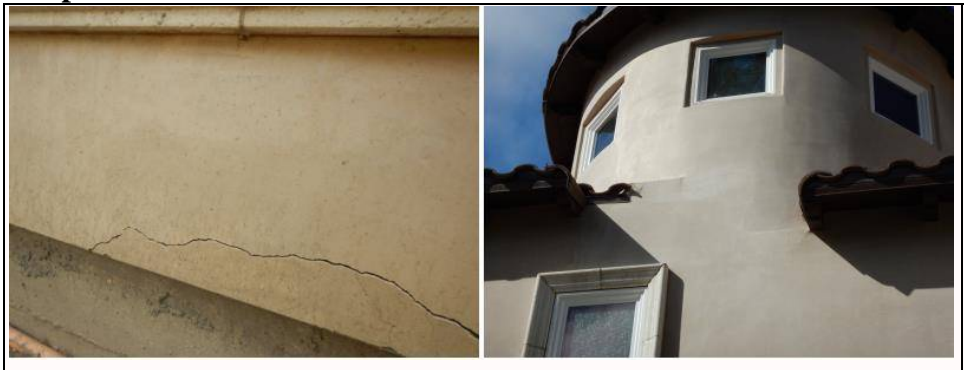
Attention Needed - Stucco cracks and damages are seen. The front house right corner are most severe. Repairs are needed by an expert.

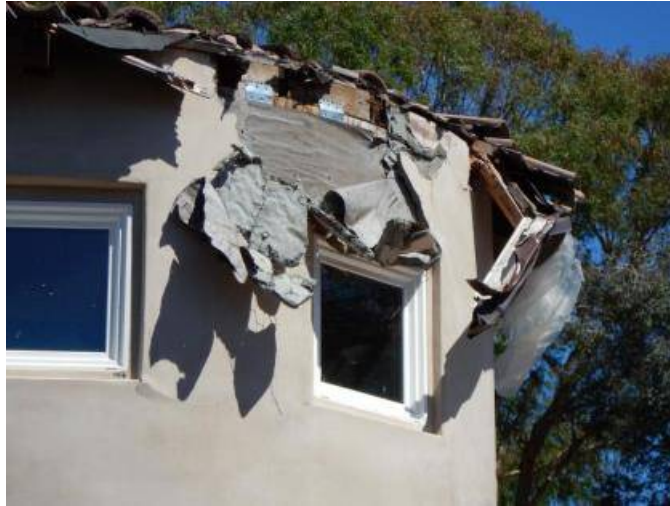
TRIM CONDITION:

Damaged area of tower already noted above , where evidently, a neighbors tree fell on the house.

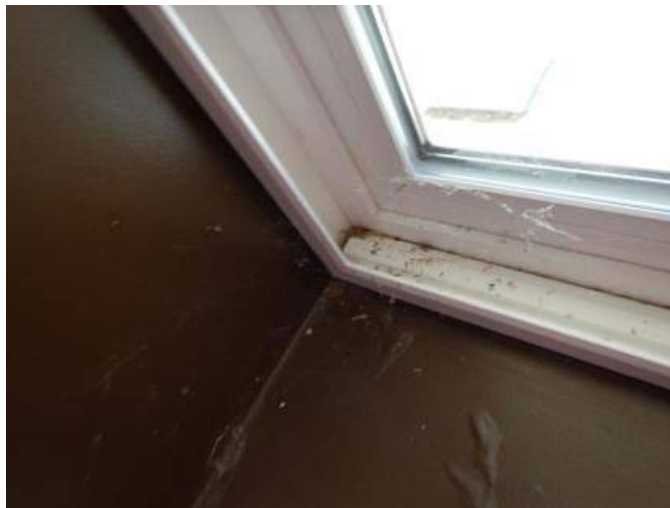
Attention Needed - Moisture intrusion from windows noted at kitchen/Breakfast room alcove, bridge area to front house.

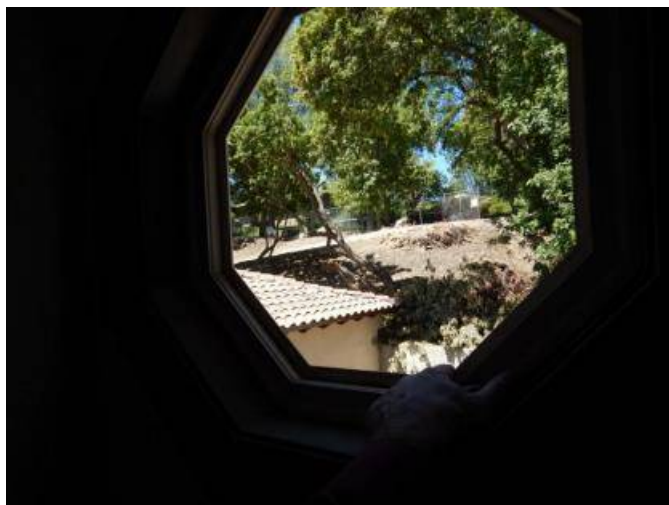
Unsatisfactory- Front house has missing glass from round windows at front face and master bed closet.

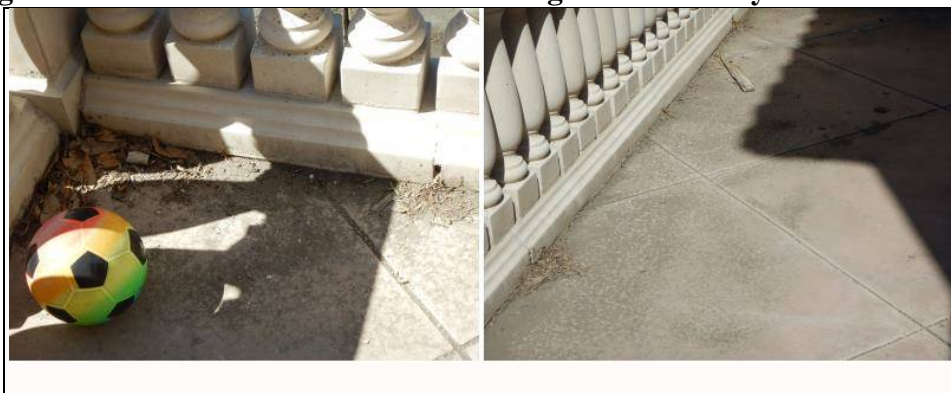
Attention Needed -Poor drainage is seen on balconies such as kitchen right side balcony.

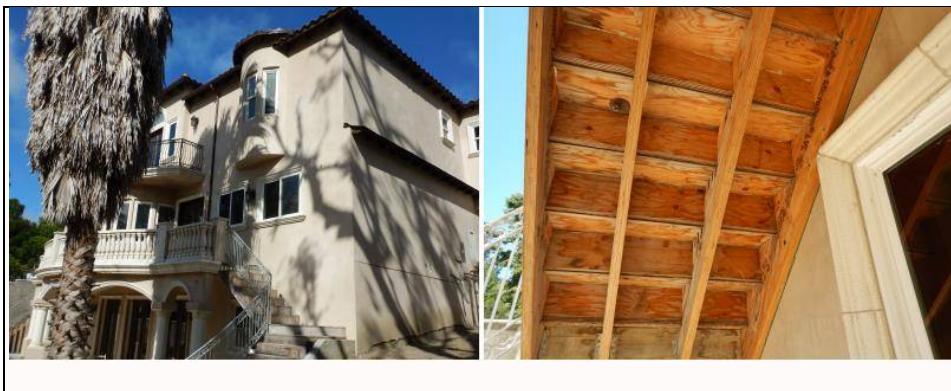
EXTERIOR STAIRS:

Attention Needed - Back of house stairs are not finished and have moisture stains on wood framing. Some may need repair or replacement if rotted.

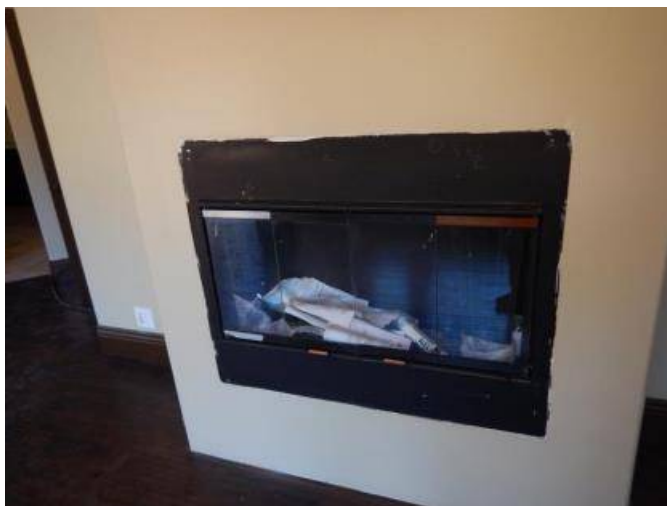
Attention Needed - Fireplaces are not yet operational. They need to be completed and then tested by an expert.

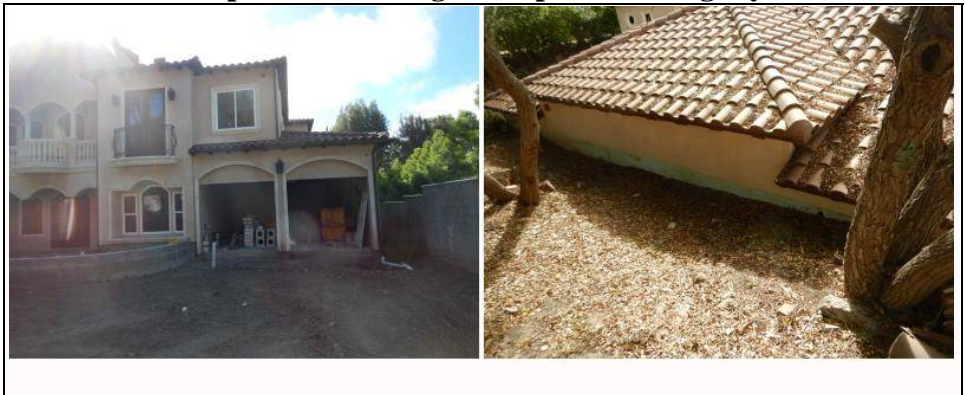
Attention Needed - The drainage around the foundation should slope away from the foundation at a rate of 1/2 inch per foot for 6 feet away from the foundation. Portions of the ground around the perimeter do not meet this minimum standard.

Back of garage, drainage needs to be installed.

The un-paved yard in front of the house has not yet had drainage measures installed such as area drains. Work around the house needs to be completed including a complete drainage system.

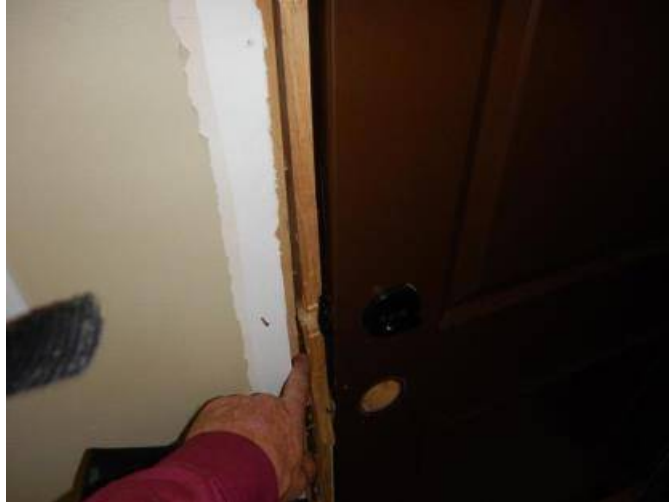
ENTRY DOOR:

Attention Needed - Front house door frame is damaged as from forced access and door is not sealed up with lumber.

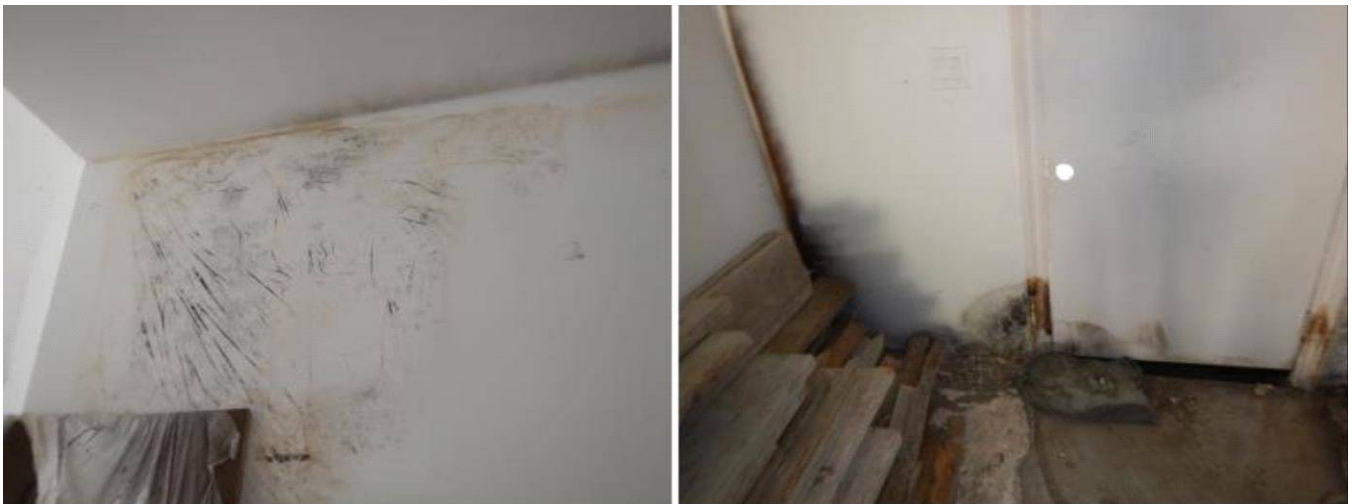
View of mold stains in garage

Attention Needed- Main house has mold on walls and ceiling at the back. Moisture intrusion from correct source needs to be isolated and repairs done.

Black stains noted in areas that appear to be moisture related. These stains should have further evaluation by qualified environmental agency. Also recommend that this company go through the dwelling in its entirety to ensure there are no other affected areas.

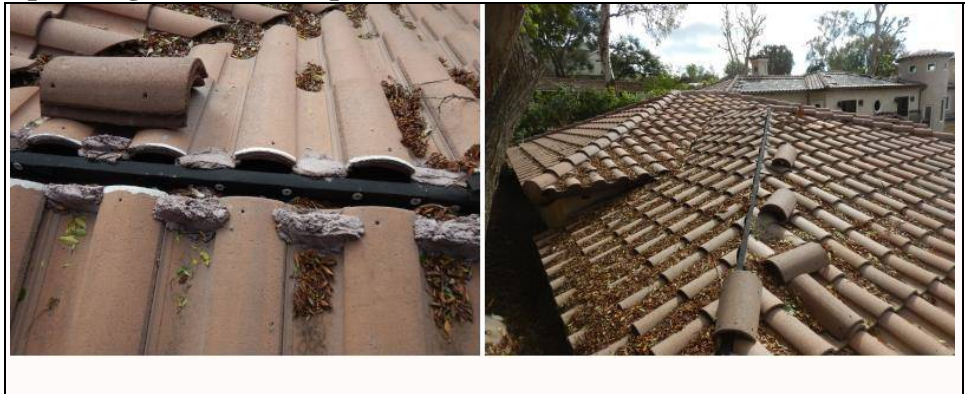
Garage roof needs completion. Open ridge is seen on top.

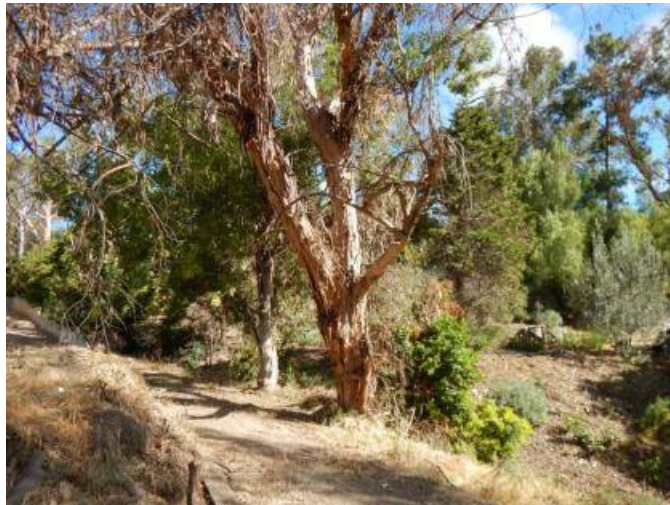
TREES:

Attention Needed- Back left side has a tree which appears dead.

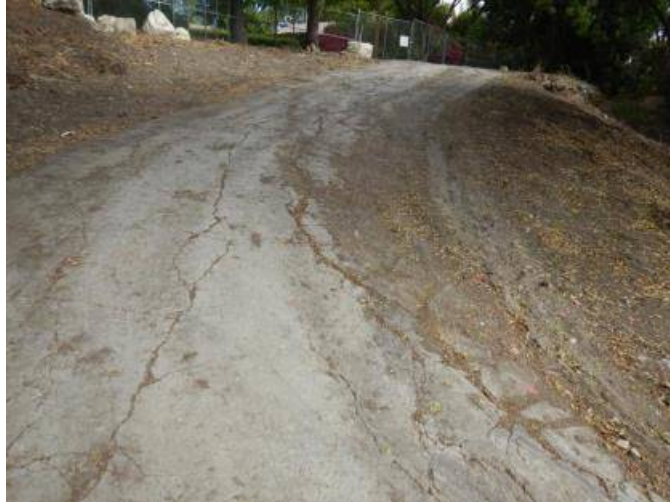
Attention Needed - Driveway in not yet completed .

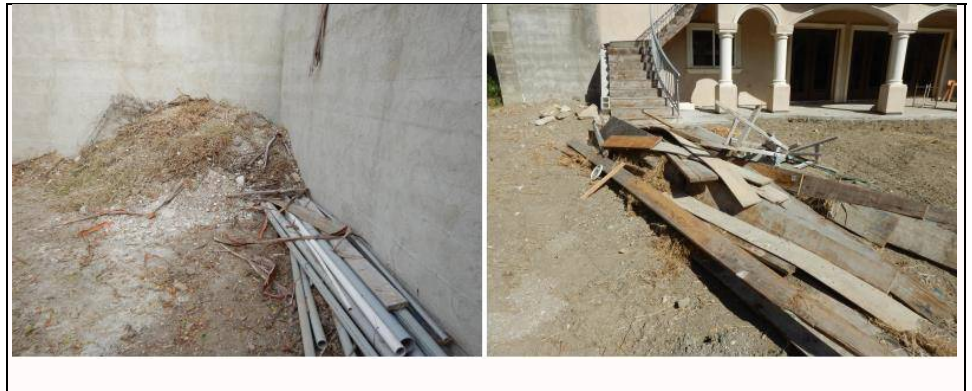
Attention Needed - Yard has piles of debris in corners and in piles . This will need to be hauled away or cleaned up.

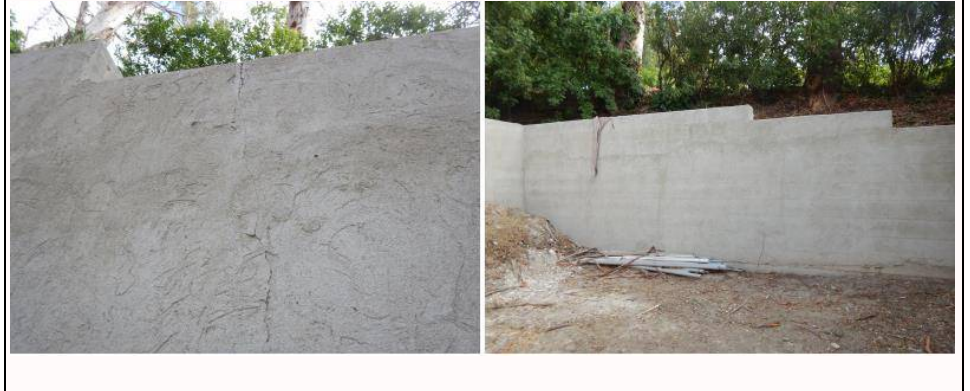
Attention Needed - There are walls and retaining walls around the property. Some have cracks. These may need repair or sealing.

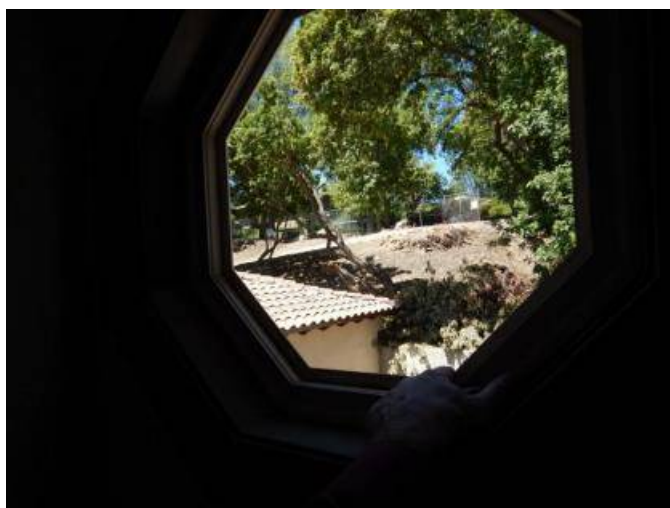
Attention Needed- Open windows with no glass were found in front wall and bedroom closet.

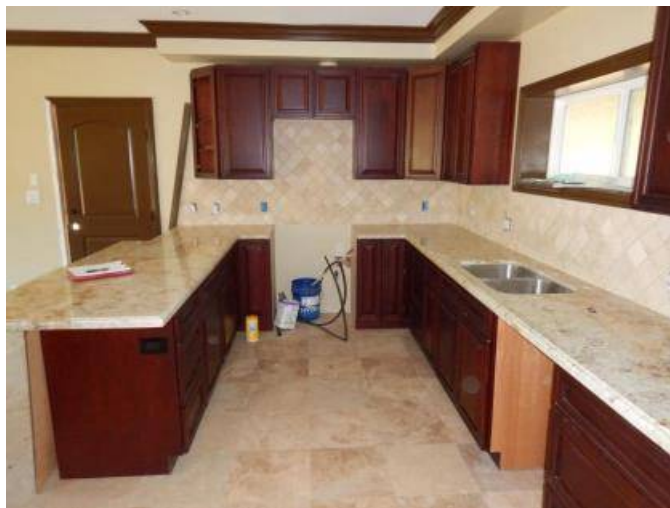
Attention Needed- Kitchen appliances and plumbing are not yet operational.

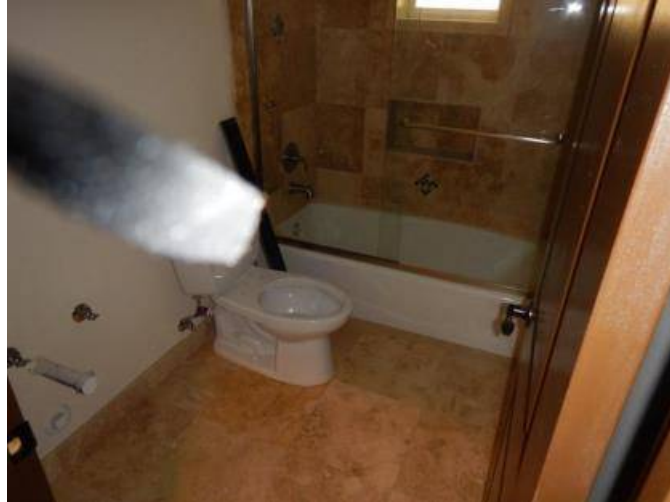
Attention Needed- Downstairs bathroom is not completely installed such as no sink.

Attention Needed- Upstairs bathroom has missing door.

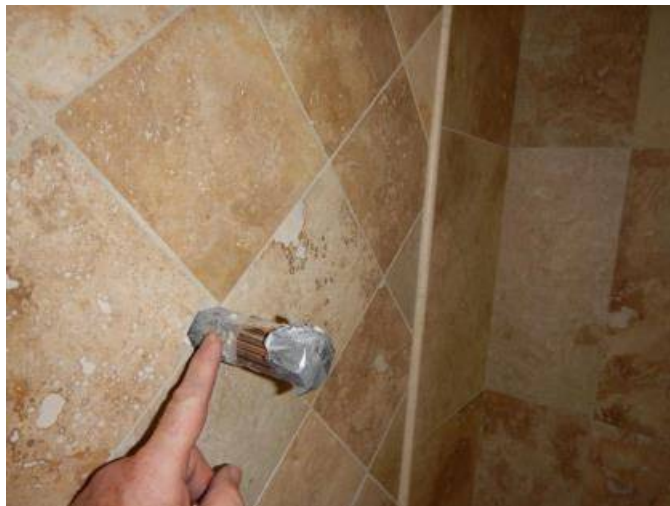
Attention Needed- Upstairs hall bathroom has missing shower components.
