**Exclusive Property Inspection Report Prepared For  
Jonathan & Kristin Mead**

Property Address: 2113 Gates Ave. Redondo Beach CA.

Inspection Date: 3/9/2021

Inspector: Ron Schloderer

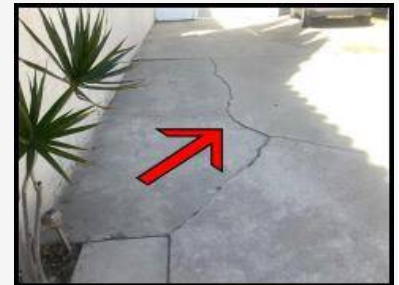
- Significant crack damage is visible at multiple locations which is causing the surface to be uneven. The condition poses a trip hazard. We recommend correction using appropriate methods.

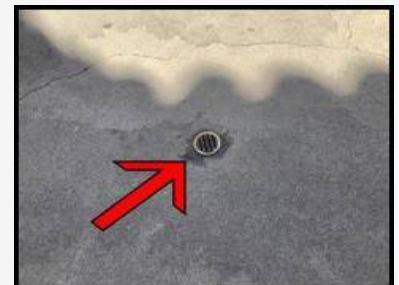
- A sub surface drainage system is installed. Determining the condition of the underground drains and location of the drain terminations is beyond the scope of this inspection, therefore not inspected. We recommend consulting with the seller to confirm the location of drain terminations and any history of drain stoppage.

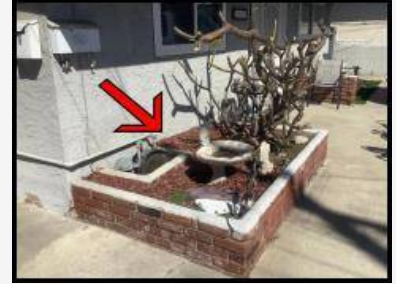
- A 2" air gap is not provided between the exterior wall and built up planter adjacent the front of the building. Moisture can become trapped between the wall and planter resulting in damage to the building. We recommend correction using appropriate methods. Determining if any damage exists within the walls is beyond the scope of this inspection due to inaccessibility.

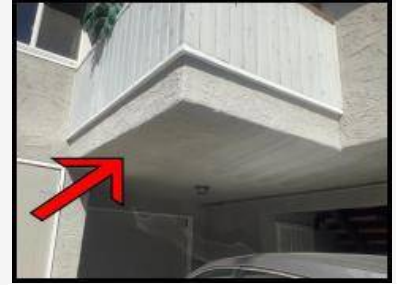
- The underside of the balcony decks are enclosed. A means to ventilate and / or drain the enclosed space is absent. Lack of ventilation can cause adverse moisture related conditions within the concealed space. Current construction standards require the enclosed areas to be ventilated both to prevent condensation and to allow any leakage to drain out. Determining the condition of the concealed areas is beyond the scope of this inspection due to inaccessibility. We recommend correction using appropriate methods. We also recommend further evaluation / cost estimate for corrections by a state licensed contractor qualified to perform work on these systems / components.

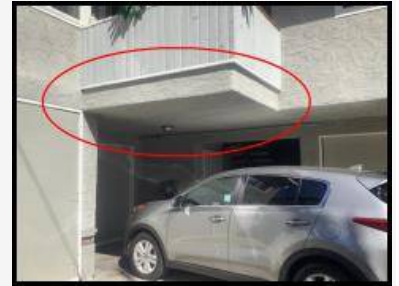
- The structural support of the cantilever is suspect. Structural engineering is beyond the scope of this inspection. We recommend further evaluation by a qualified state licensed structural engineer to determine if any adverse structural conditions exist.

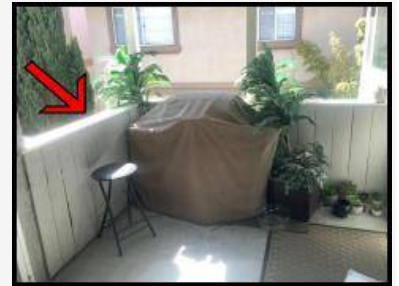
- The guard railing system is outdated by today's standards as the height at the landing is lower than 42". Upgrading the guard railing to current construction standards should be considered and is recommended for safety enhancement.

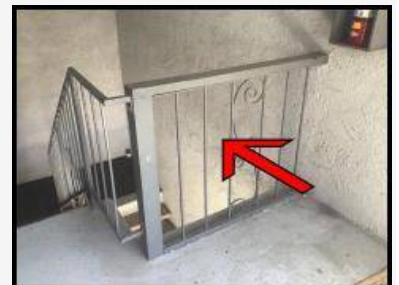
- The guard railing system is outdated by today's standards as the openings between the balusters are too wide (opening width should prevent a 4" sphere from passing through) and the height at the landings is lower than 42". Upgrading the guard railing to current construction standards should be considered and is recommended for safety enhancement.

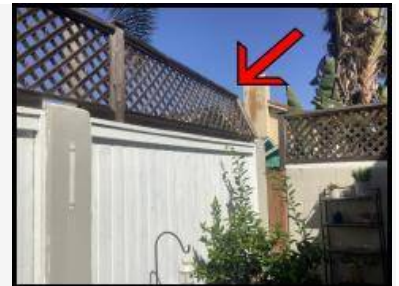
- Loose lattice is visible at the rear fence. We recommend correction using appropriate methods.

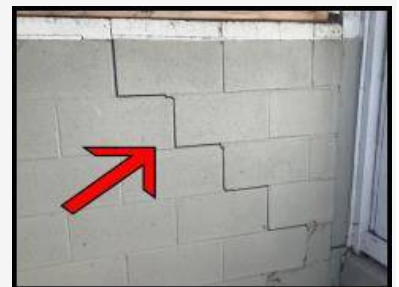
- Stairstep crack damage is visible to the grout at multiple locations. The condition can cause the blocks to loosen. We recommend correction using appropriate methods.

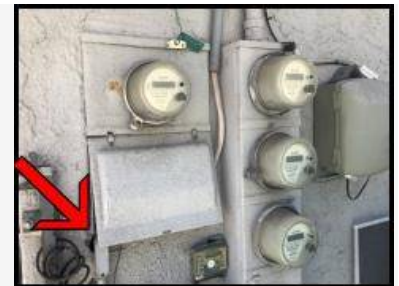
- Pipe / conduit / wire penetrations are not sealed to prevent moisture intrusion into the building. We recommend correction using appropriate methods.

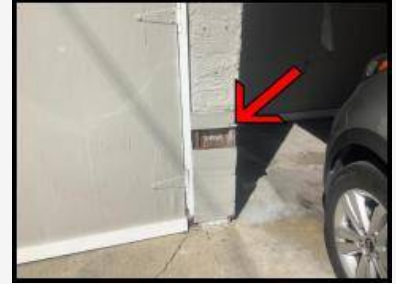
- Siding is broken out adjacent the rear garage. The condition is conducive to moisture intrusion and subsequent damage. We recommend correction using appropriate methods.

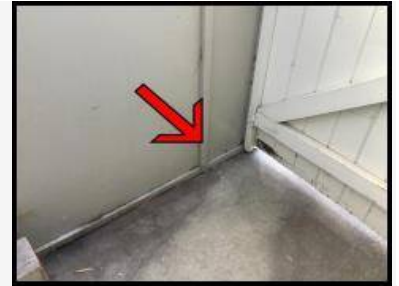
- Moisture related damage is visible to the siding at the rear garage. The damage is likely caused by the siding resting on the walkway surface. We recommend correcting the cause of the damage and repairing the wood using appropriate methods. We also recommend further evaluation by a qualified state licensed Structural Pest Control Operator to determine if any wood destroying organism conditions exist.

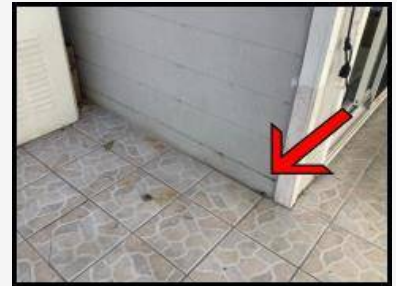
- Moisture related damage is visible to the siding at the rear laundry structure. The damage is likely caused by the siding resting on the patio surface. We recommend correcting the cause of the damage and repairing the wood using appropriate methods. We also recommend further evaluation by a qualified state licensed Structural Pest Control Operator to determine if any wood destroying organism conditions exist.

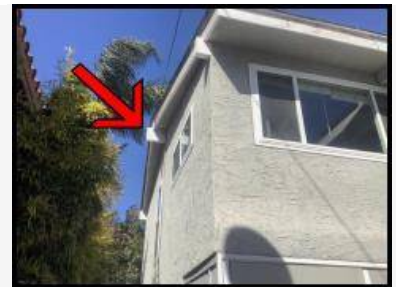
- Cap flashing is absent on the exposed beam ends that project past the roof line, therefore the wood is subject to moisture related damage. We recommend correction using appropriate methods.

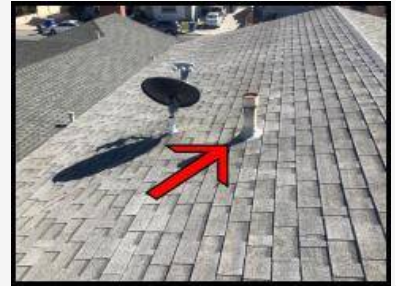
- The existing flashings were not reinstalled to the last layer of the multi layer roof, therefore do not lap correctly with the top layer of shingles. The condition is conducive to moisture intrusion and subsequent damage. Flashings and underlayment should be reinstalled to prevent moisture intrusion when a new roof material is installed over an existing roof material. We recommend correction using appropriate methods.

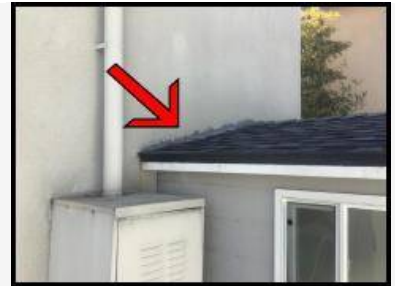
- Step & counter flashing is absent at the rear laundry structure roof to wall interface. The condition is conducive to moisture intrusion and subsequent damage. We recommend correction using appropriate methods.

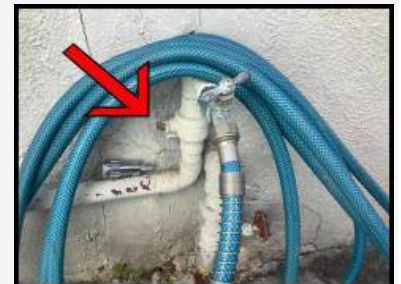
- The handle is absent from the main shut off valve. Replacement is recommended.

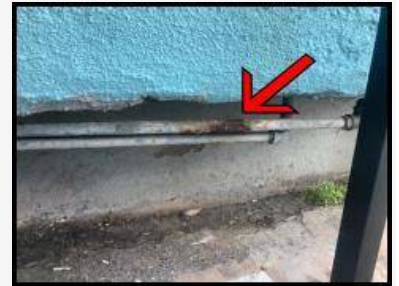
- Midline corrosion caused by pinhole leakage is visible on galvanized piping at the front unit. Replacement of any damaged piping is recommended.

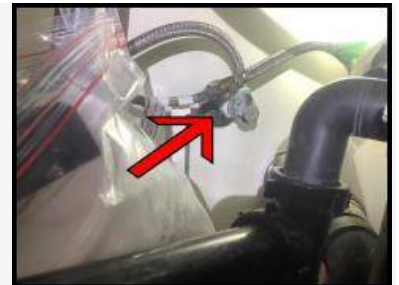
- Corrosion related damage caused by leakage is visible to multiple angle stop valves which are located below the sinks. We recommend replacing any damaged angle stop valves.

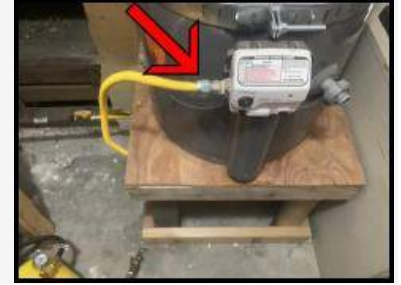
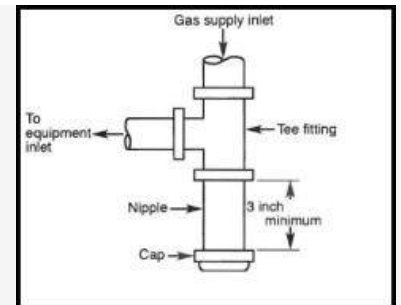
- There is no sediment trap at the gas line supplying the water heater. The purpose of a sediment trap is to catch potential debris that could clog and block an automatic gas valve in the open position, preventing the appliance from shutting off. A gas valve blocked in the open position poses a fire ignition hazard. We recommend correction using appropriate methods. Refer to the water heater manufacturers installation manual for gas piping installation instructions.

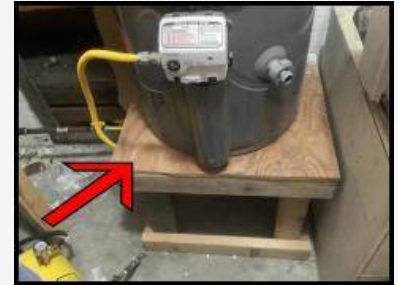
- A catch pan & drain system is absent. Lack of an appropriate catch pan system can cause damage to the platform and surrounding area in the event of leakage. Installation of an appropriate catch pan & drain system is recommended.

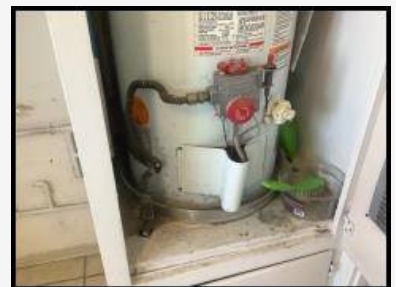
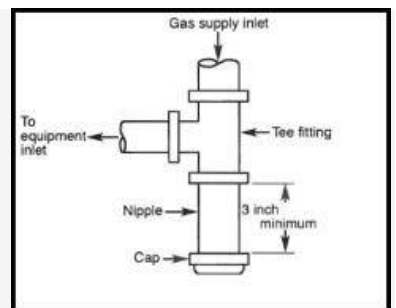
- There is no sediment trap at the gas line supplying the water heater. The purpose of a sediment trap is to catch potential debris that could clog and block an automatic gas valve in the open position, preventing the appliance from shutting off. A gas valve blocked in the open position poses a fire ignition hazard. We recommend correction using appropriate methods. Refer to the water heater manufacturers installation manual for gas piping installation instructions.

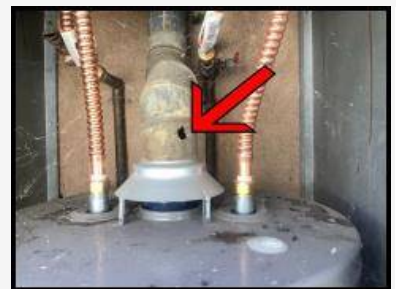
- A hole is visible in the vent connector pipe. The condition can cause spillage of hazardous exhaust gases, therefore a carbon monoxide poisoning hazard exists. Replacement of any damaged vent piping is recommended.

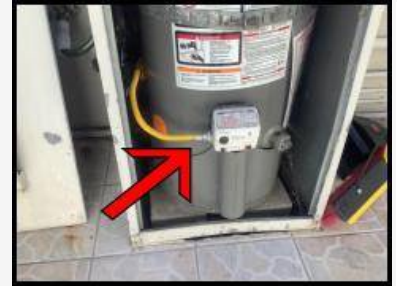
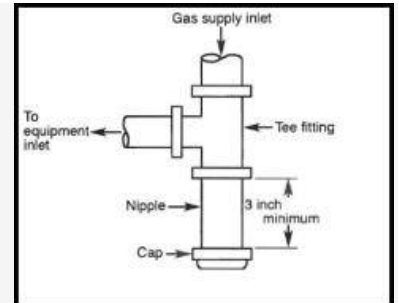
- There is no sediment trap at the gas line supplying the water heater. The purpose of a sediment trap is to catch potential debris that could clog and block an automatic gas valve in the open position, preventing the appliance from shutting off. A gas valve blocked in the open position poses a fire ignition hazard. We recommend correction using appropriate methods. Refer to the water heater manufacturers installation manual for gas piping installation instructions.

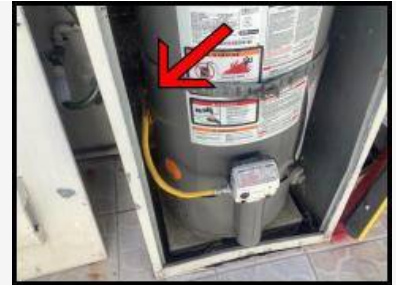
- The tank touches the gas piping. The condition is conducive to pipe damage and subsequent gas leakage. We recommend correction using appropriate methods.

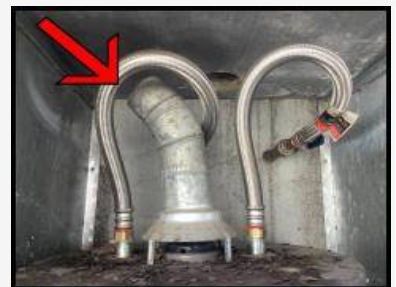
- The vent connector is separated from the vent pipe, therefore exhausts within the enclosure. A carbon monoxide poisoning hazard exists as a result. We recommend correction using appropriate methods.

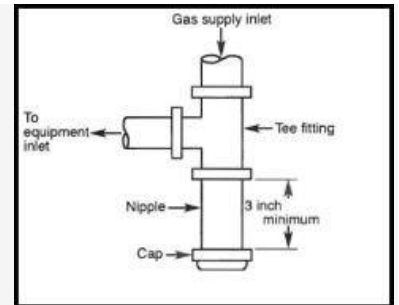
- There is no sediment trap at the gas line supplying the water heater. The purpose of a sediment trap is to catch potential debris that could clog and block an automatic gas valve in the open position, preventing the appliance from shutting off. A gas valve blocked in the open position poses a fire ignition hazard. We recommend correction using appropriate methods. Refer to the water heater manufacturers installation manual for gas piping installation instructions.

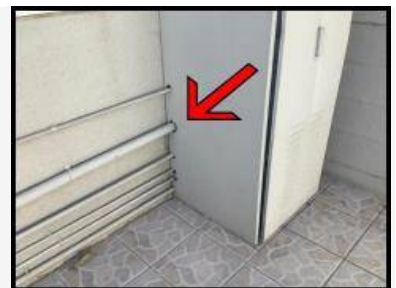
- Openings around pipes are visible in the enclosure walls. The condition is conducive to moisture intrusion and subsequent damage. We recommend correction using appropriate methods.

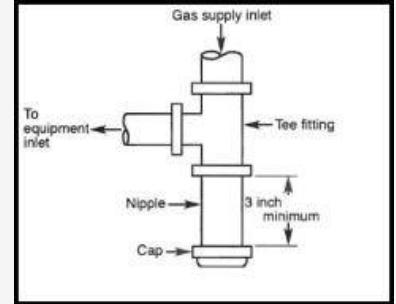
- There is no sediment trap at the gas line supplying the heater. The purpose of a sediment trap is to catch potential debris that could clog and block an automatic gas valve in the open position, preventing the appliance from shutting off. A gas valve blocked in the open position poses a fire ignition hazard. We recommend correction using appropriate methods. Refer to the heater manufacturers installation manual for gas piping installation instructions.

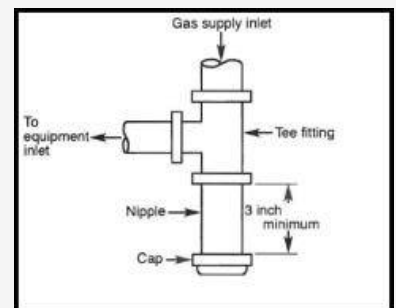
- There is no sediment trap at the gas line supplying the heater. The purpose of a sediment trap is to catch potential debris that could clog and block an automatic gas valve in the open position, preventing the appliance from shutting off. A gas valve blocked in the open position poses a fire ignition hazard. We recommend correction using appropriate methods. Refer to the heater manufacturers installation manual for gas piping installation instructions.

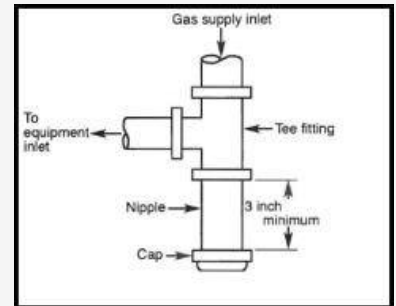
- There is no sediment trap at the gas line supplying the heater. The purpose of a sediment trap is to catch potential debris that could clog and block an automatic gas valve in the open position, preventing the appliance from shutting off. A gas valve blocked in the open position poses a fire ignition hazard. We recommend correction using appropriate methods. Refer to the heater manufacturers installation manual for gas piping installation instructions.

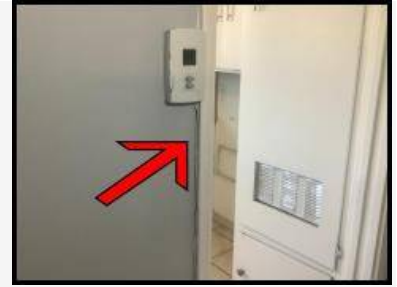
- Exposed thermostat wires subject to damage are visible on the interior wall. We recommend correction using appropriate methods.

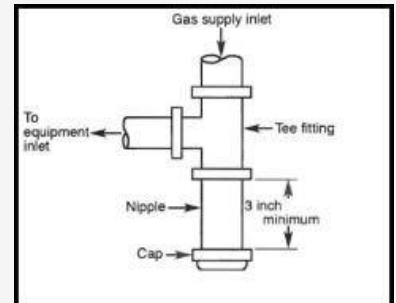
- There is no sediment trap at the gas line supplying the heater. The purpose of a sediment trap is to catch potential debris that could clog and block an automatic gas valve in the open position, preventing the appliance from shutting off. A gas valve blocked in the open position poses a fire ignition hazard. We recommend correction using appropriate methods. Refer to the heater manufacturers installation manual for gas piping installation instructions.

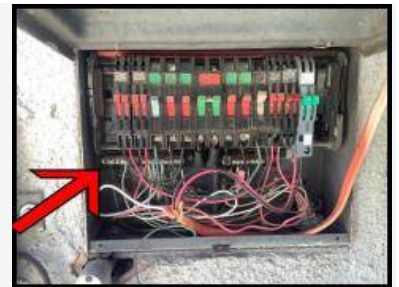
- The dead front cover is absent. The condition exposes energized components within the panel, therefore an electrical shock hazard exists. We recommend correction using appropriate methods.

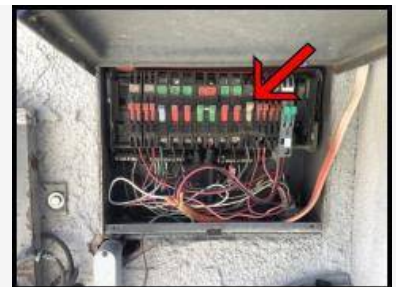
- There is a 40 amp single pole circuit breaker with amperage too large for the gauge of the wire attached. Overheating of the wiring can occur as a result, therefore a fire ignition hazard exists. We recommend correction using appropriate methods.

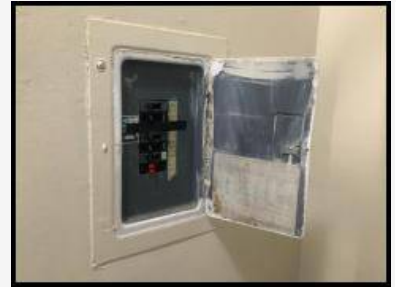
- The panel is manufactured by Zinsco. The clip to bus style of circuit breaker is conducive to failure at the point of contact. Hazards may be present in the electrical panel which could result in overheating, fire, or inability to turn off the electrical power in the home. The inspector does not remove the circuit breakers and does not perform any other disassembly of the electrical panel components, therefore visual inspection may not identify significant damage or other failures that may be present. Also, the panel components may be near / at the end of their service life due to age. Replacement with a panel meeting current construction standards should be considered for safety enhancement. We recommend further evaluation of this system / cost estimate for corrections by a qualified state licensed electrical contractor.

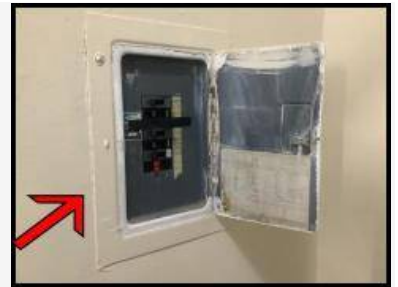
- The dead front cover is bonded to the interior wall with paint. For the safety of the inspector and to prevent damaging the interior wall, the inspector did not remove the dead front cover. The components within the panel were not inspected. Further evaluation by a qualified state licensed electrical contractor is recommended.

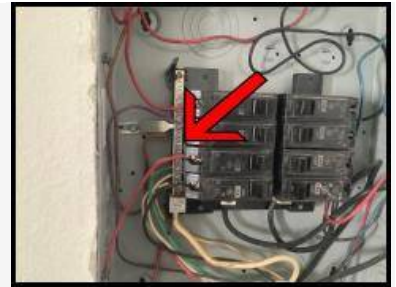
- The equipment grounding conductors terminate on the neutral terminal bar which is an improper installation. The neutral bar places continuous voltage on the equipment grounding conductors as a result, therefore an electrical shock hazard exists. Equipment grounding conductors at sub panels should terminate on a separate ground terminal bar to provide a safe grounding path. We recommend correction using appropriate methods.

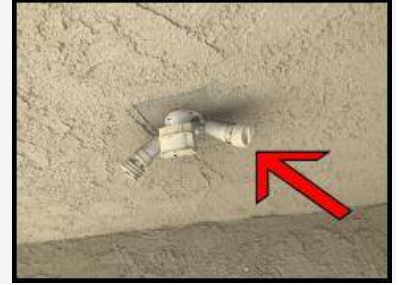
- CFL bulbs are installed in multiple exterior fixtures. The bulbs are an improper type for the location. The condition poses a risk of fire hazard per the warning label on the bulbs. Replacement with appropriate bulbs rated for the location is recommended.

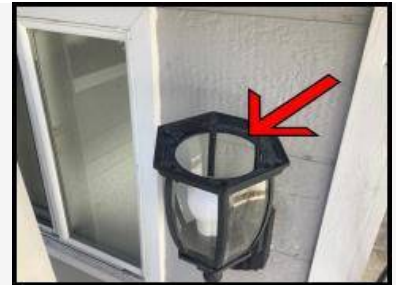
- The protection lid is absent from the rear laundry exterior fixture. We recommend correction using appropriate methods.

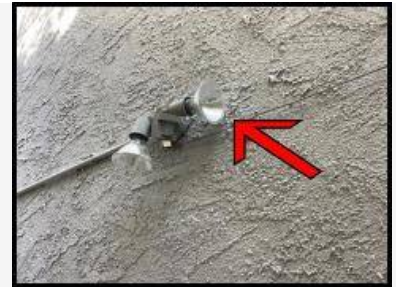
- Damage is visible to multiple bulbs at the exterior fixtures. Replacement is recommended.

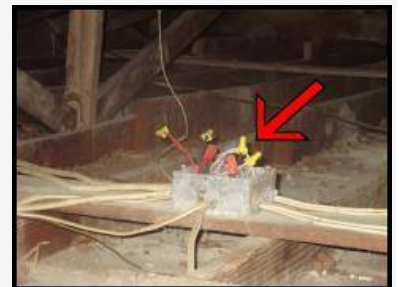
- Protection covers are absent from multiple junction boxes in the attic. The condition poses an electrical shock hazard due to exposure of the wiring within. We recommend correction using appropriate methods. Calculating the wire fill in the boxes is beyond the scope of this inspection.

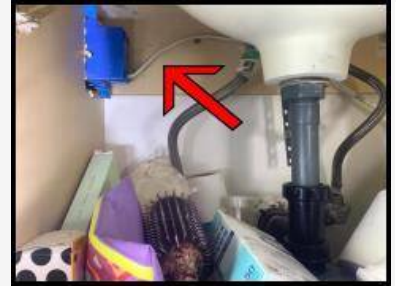
- Exposed wiring subject to damage is visible within the front unit master bathroom sink base cabinet. We recommend correction using appropriate methods.

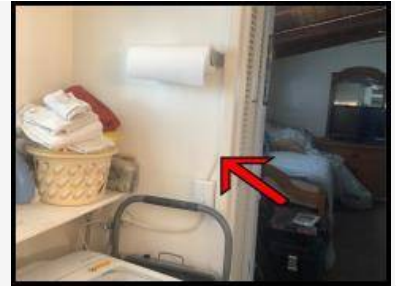
- Exposed wiring subject to damage is visible at the front unit laundry area. We recommend correction using appropriate methods.

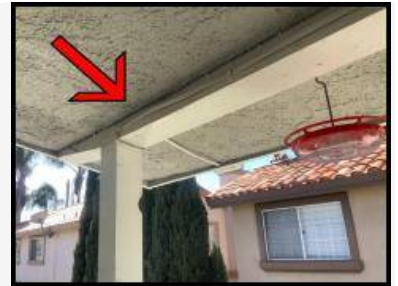
- Exposed wiring subject to damage is visible at unit A exterior. We recommend correction using appropriate methods.

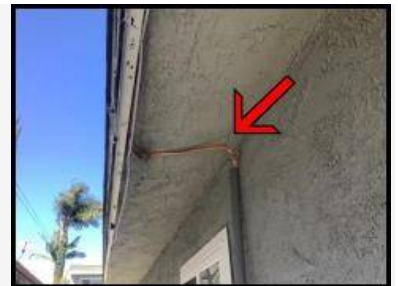
- Exposed wiring subject to damage is visible at the front unit roof eaves. We recommend correction using appropriate methods.
