Inspection Report

This inspection performed in accordance with current "Standards of Practice" of the California Real Estate Inspection Association.

Report Date: 7/19/2016

Inspection location: 3445 Gilbert Cayucos, CA 93430

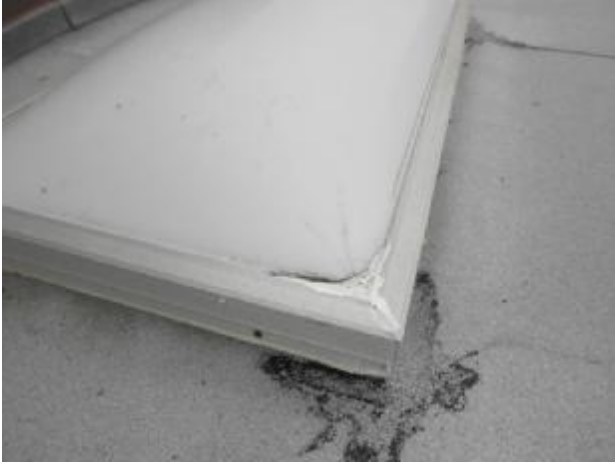
#R6

2.) The skylight dome above the enclosed deck is cracked and needs to be replaced.

Cracks in the skylight dome.

2.) **The skylight dome above the enclosed deck is cracked and needs to be replaced. (The skylight has been completely replaced)**

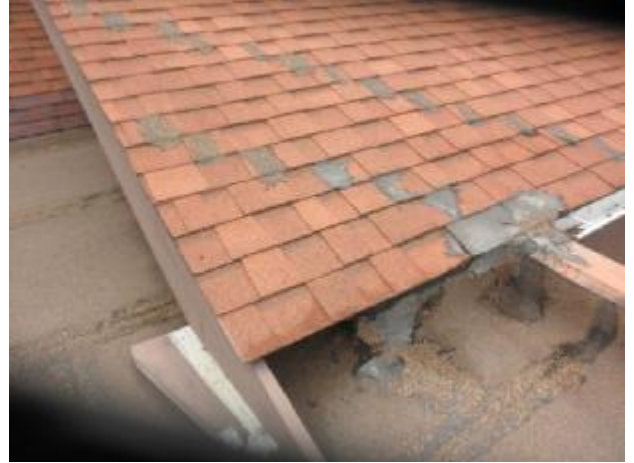
#R7

Amateur patching on the roof.

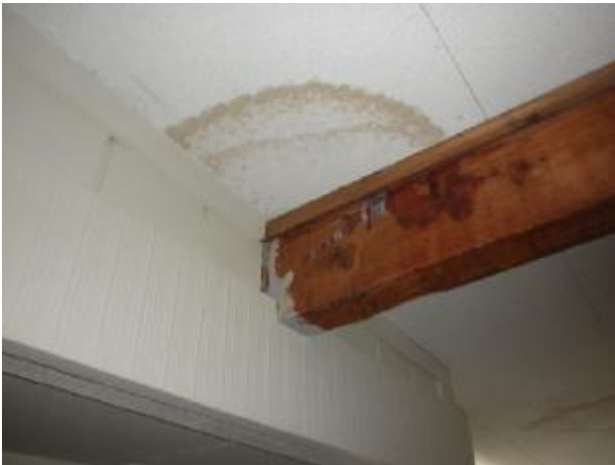
#R9

1.) There is evidence of past leaks with water stains on the ceilings in the master bedroom, the NE bedroom addition and in the enclosed deck off the master bedroom. Most of these leaks appear to have been from prior to the installation of the current roof however; there has been patching on the current roof above the NE bedroom addition indicating leaks above this room have been recent. The patching appears to be amateur in nature and may still be subject to leaks. This condition is recommended to be evaluated by a qualified and licensed Roofing Contractor prior to close of escrow.

Evidence of roof leak in the upstairs NE bedroom addition.

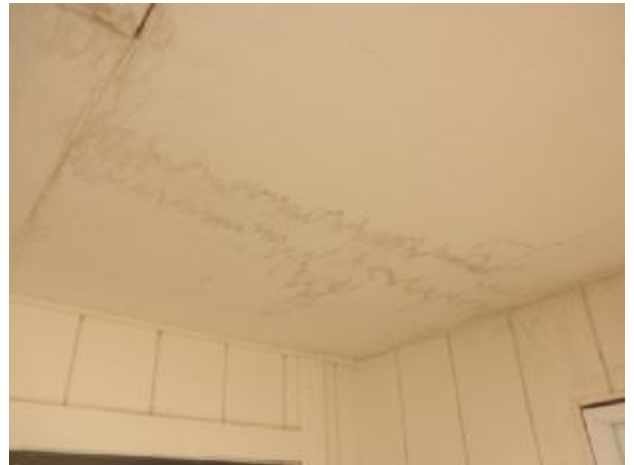
#R10

Evidence of roof leaks inside the enclosed deck.

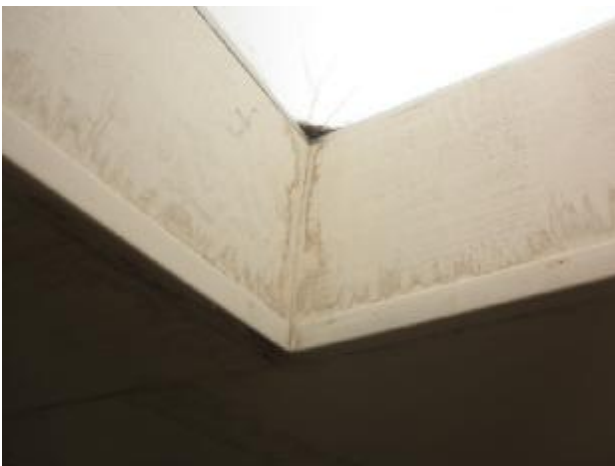
#R11

Evidence of leaks at the skylight above the enclosed deck.

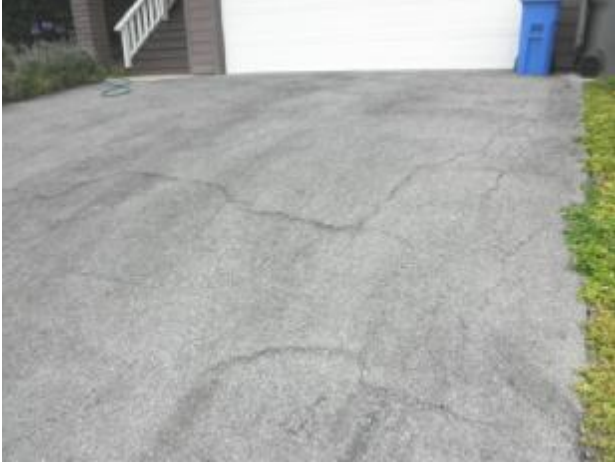
#GD2

Maintenance Note: The asphalt driveway appears to be in reasonable condition but needs sealant. Cracks and general deterioration were observed.

General deterioration and cracks in the asphalt driveway.

Maintenance Note: The asphalt driveway appears to be in reasonable condition but needs sealant. Cracks and general deterioration were observed. **(The driveway has been resealed.)**

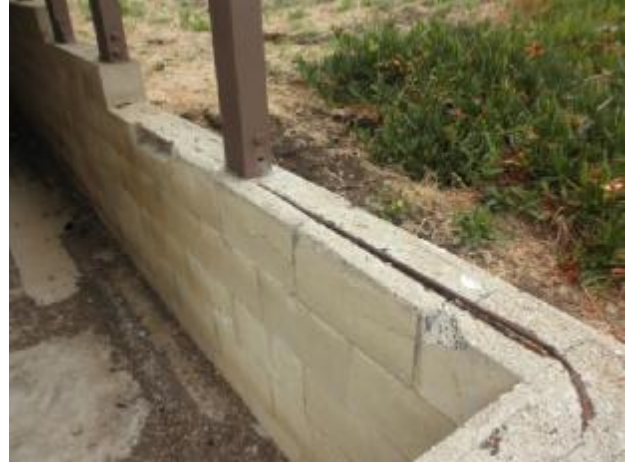
#GD3

- 17 1.) The CMU block wall on the east side of the home is out of plumb and there are some damaged blocks with exposed rebar at the top of the wall. The retaining wall is recommended to be evaluated by a qualified and licensed Structural Engineer prior to close of escrow.

Damaged blocks and exposed rebar at the top of the CMU retaining wall.

1.) The CMU block wall on the east side of the home is out of plumb and there are some damaged blocks with exposed rebar at the top of the wall. The retaining wall is recommended to be evaluated by a qualified and licensed Structural Engineer prior to close of escrow. [\(See the report prepared by JK Engineering\)](#)

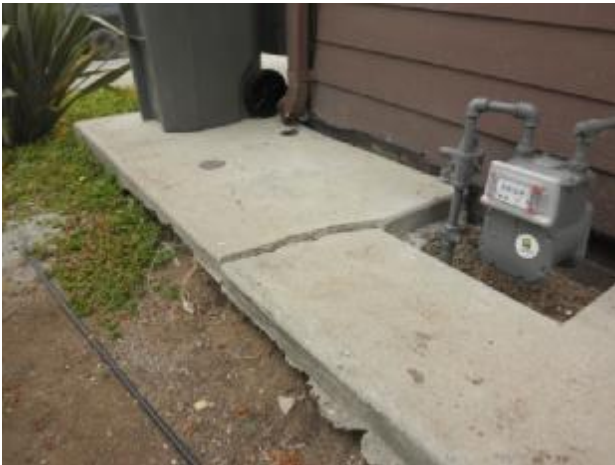
#GD4

Safety Hazard Note: The concrete walkway at the SW corner of the garage has settled and cracked. This has created a tripping hazard.

Settlement cracks with tripping hazards at the concrete walk along the south side of the home.

Safety Hazard Note: The concrete walkway at the SW corner of the garage has settled and cracked. This has created a tripping hazard. **(The concrete has been completely removed and a gravel walkway installed.)**

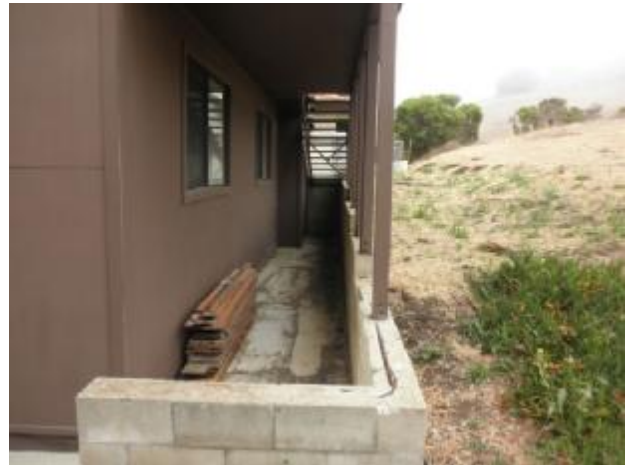
#GD5

The CMU block retaining wall along the east side of the home is leaning.

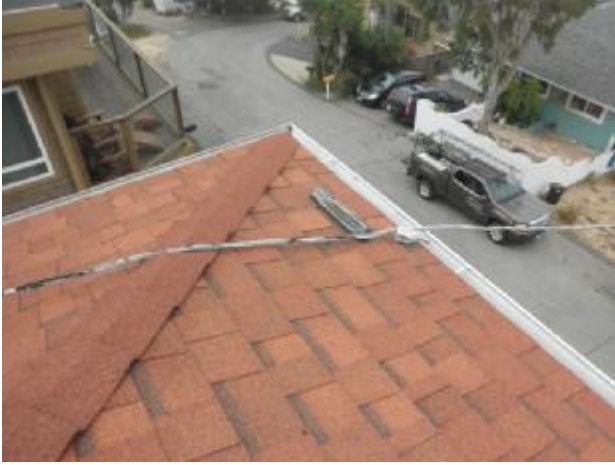
#EL8

Safety Hazard Note: The overhead electrical service conductors are laying on the roof and are in contact with the aluminum gutter. The service conductors are required to be a minimum of 18 inches above the roof.

The support bracket for the overhead electrical wires has failed with the wires laying on the roof.

Safety Hazard Note: The overhead electrical service conductors are laying on the roof and are in contact with the aluminum gutter. The service conductors are required to be a minimum of 18 inches above the roof. [\(This condition has been corrected\)](#)

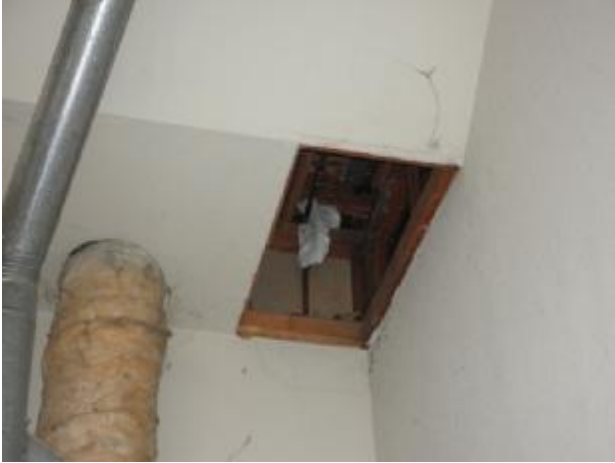
#GC14

Fire Safety Hazard Note: A hole has been cut through the drywall ceiling in the garage above the water heater. This compromises the integrity of the firewall assembly required between the garage and the house.

Hole cut through the ceiling in the garage compromises the integrity of the firewall.

Fire Safety Hazard Note: A hole has been cut through the drywall ceiling in the garage above the water heater. This compromises the integrity of the firewall assembly required between the garage and the house. **(The hole in the drywall has been properly sealed)**

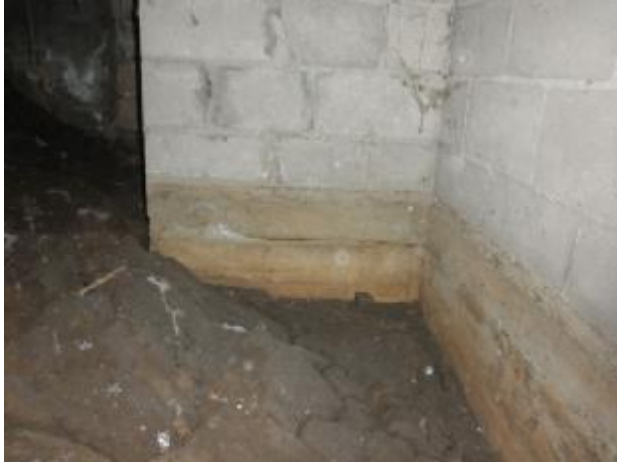
#F12

Evidence of past standing water in the substructure area to 12 inches deep.

- 1.) **There is evidence of past standing water in the substructure area to 12 inches deep. This appears to be due to ground water seepage. Drainage improvements are needed. (This condition still exists)**

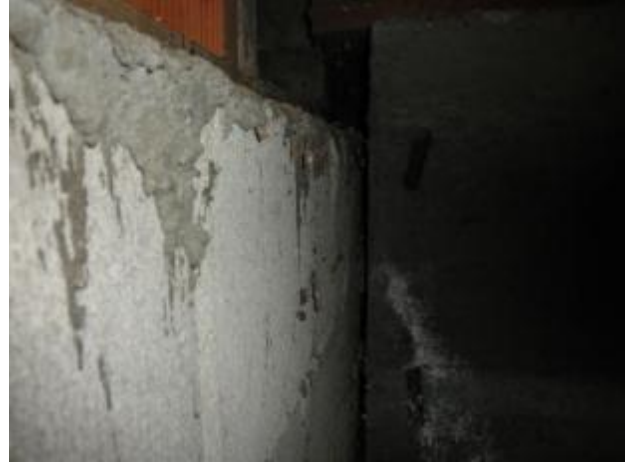
#F13

2.) There is a large gap between the concrete foundation stem wall and the CMU block stem wall at the NW corner of the substructure area. The adjacent cripple wall is out of plumb and most of the downstairs door frames are out of square. This appears to indicate possible structural movement due to foundation settlement. The soil is very expansive below the home and the excessive ground water seepage noted above may be contributing to this condition. The foundation is recommended to be evaluated by a qualified and licensed Structural Engineer prior to close of escrow.

Gap between the concrete stem wall and the block stem wall at the NW corner of the substructure.

2.) **There is a large gap between the concrete foundation stem wall and the CMU block stem wall at the NW corner of the substructure area. The adjacent cripple wall is out of plumb and most of the downstairs door frames are out of square. This appears to indicate possible structural movement due to foundation settlement. The soil is very expansive below the home and the excessive ground water seepage noted above may be contributing to this condition. The foundation is recommended to be evaluated by a qualified and licensed Structural Engineer prior to close of escrow. (See report prepared by JK Engineering)**
