WOOD DESTROYING PESTS AND ORGANISMS INSPECTION REPORT

#: 20180215

BUILDING NO. 1274	STREET BOND STREET	CITY SAN LUIS OBISPO	ZIP 93401	Date of Inspection 04/10/2018	NUMBER OF PAGES 1 of 6
----------------------	-----------------------	-------------------------	--------------	----------------------------------	---------------------------

Central Coast Termite, Inc.
P.O. Box 1614
Nipomo, CA 93444
PH# (805) 929-8500 FAX (805) 929-5487
PR7147

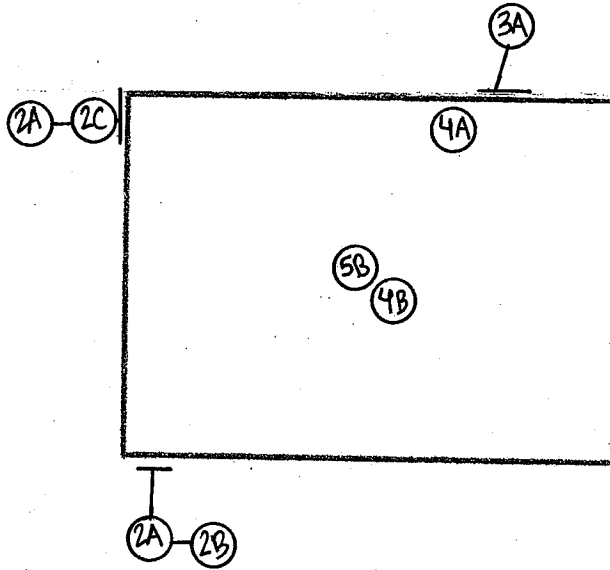
Diagram of Area Inspected:

Drywood termite infestation was found in wood members at the wood siding and beam and appears to extend into inaccessible areas.

Minor drywood termite damage was found at the siding .

Drywood termite damage found at the 4x4 ft beam.

Fungus damage was noted at the wood siding, and it appears to be caused by weather.

Missing or deteriorated caulking was noted at the bath tub surrounding the hall bathroom.

A plumbing leak was noted in the sub area.

A portion of the garage is inaccessible due to occupants storage along the perimeter walls.

RECOMMENDATION: Seal the structure and fumigate with a gas lethal to drywood termites, Vikane (Sulfuryl Flouride). The structure must be vacant until the fumigation is complete. This company will exercise all due caution, but cannot be held responsible for damage to plants, TV antennas or roofing due to fumigation. Two year warranty with a live Drywood Termite infestation found. Treatment type is the sole judgement of Central Coast Termite
RECOMMENDATION 2A-1: Remove or cover accessible drywood termite fecal pellets.

RECOMMENDATION: Repair the minor damage with a wood filler.

RECOMMENDATION: Remove and replace, reinforce or repair, the damaged wood members as needed with todays widths and grades.

RECOMMENDATION: Replace the damaged portions of the wood siding.

RECOMMENDATION: Re-caulk the area to prevent future problems.

RECOMMENDATION: Consult an appropriate tradesman to make repairs.

RECOMMENDATION: The occupant should remove the storage and call for further inspection. A supplemental report will be issued with findings and recommendations.
