# WOOD DESTROYING PESTS AND ORGANISMS INSPECTION REPORT

Building Address: <b>3735 Fallbrook Av., Oroville, CA 95966</b>		Date of Inspection 02/01/2019	Number of Pages 8
John Moss Pest Control 6595 Perry Rd. Magalia CA 95954 Phone: (530) 228-1568 Fax: (530) 873-3276		Report # W10796	
		Lic. Registration # PR 6242	
		Escrow #	
Ordered by: Keller Williams Chico Area Alisha Fickert 2080 E. 20th St. 170 Chico, CA 95928 624-2111 - Cell	Property Owner and/or Party of Interest: Keller Williams Chico Area Alisha Fickert 2080 E. 20th St. 170 Chico, CA 95928 624-2111 - Cell	Report Sent to: Keller Williams Chico Area Alisha Fickert 2080 E. 20th St. 170 Chico, CA 95928 624-2111 - Cell	
COMPLETE REPORT <input checked="" type="checkbox"/> LIMITED REPORT <input type="checkbox"/> SUPPLEMENTAL REPORT <input type="checkbox"/> REINSPECTION REPORT <input type="checkbox"/>			
General Description: Single story occupied and furnished occupied and furnished single family residence		Inspection Tag Posted: Subarea

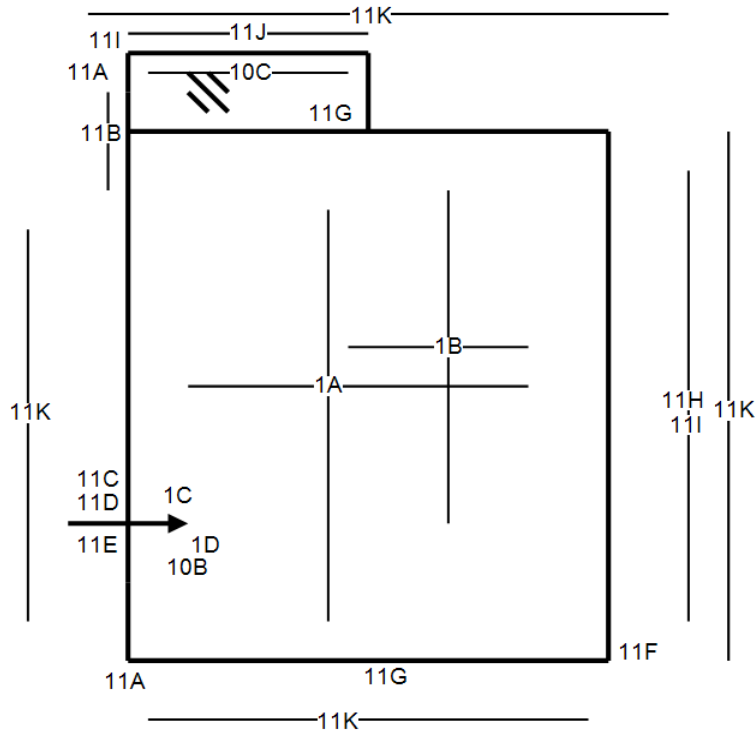
This Diagram is not to scale

- 1B PRICE: Not Estimated (Section II)  
 FINDINGS: There is an excessive moisture condition at the subarea soil as indicated in the area on the diagram. This condition can be conducive to wood destroying organisms.  
 RECOMMENDATION: Interested parties should engage the services of a licensed contractor to further inspect the area and/or repair as necessary.

- 1D PRICE: \$250.00 (Section I)  
 FINDINGS: Evidence of termite damaged wood members noted at time of inspection at the girder as indicated on the diagram.  
 RECOMMENDATION: Replace termite damaged wood members as necessary. No painting is included in this estimate.

- 1E PRICE: \$500.00 (Section I)  
 FINDINGS: Evidence of subterranean termite infestation at 11F as indicated on the diagram.  
 RECOMMENDATION: Pressure "ROD" treat, trench application or low pressure spot spray as necessary. Break accessible sub tubes. Local Treatment is not intended to be an entire structure treatment method. If infestations of wood destroying pests extend or exist beyond the area's of local treatment, they may not be exterminated.

- 11A PRICE: \$300.00 (Section I)  
FINDINGS: Wood decay fungi damage (Dry Rot) and earth to wood contact found at time of inspection to the fence as indicated on the diagram.  
RECOMMENDATION: Replace or repair visible dry-rot damaged wood members as necessary. Break the earth to wood contact.

- 11B PRICE: \$350.00 (Section I)  
FINDINGS: Wood decay fungi damage (Dry Rot) found at time of inspection to the siding as indicated on the diagram.  
RECOMMENDATION: Replace or repair visible dry-rot damaged wood members as necessary.

- 11C PRICE: \$50.00 (Section I)  
FINDINGS: Wood decay fungi damage (Dry Rot) found at time of inspection to the OSB panel as indicated on the diagram.  
RECOMMENDATION: Replace or repair visible dry-rot damaged wood members as necessary.

- 11D PRICE: \$100.00 (Section II)  
FINDINGS: The access cover is inadequate as indicated in the area on the diagram.  
RECOMMENDATION: Replace with a cover that does not allow access and is secured to the structure.

- 11E PRICE: See 11D (Section I)  
FINDINGS: Wood decay fungi damage (Dry Rot) and earth to wood contact found at time of inspection to the access cover as indicated on the diagram.  
RECOMMENDATION: Replace or repair visible dry-rot damaged wood members as necessary. Break the earth to wood contact.

- 11F PRICE: \$750.00 (Section I)  
FINDINGS: Evidence of termite damaged wood members noted at time of inspection at siding trim and sill plate as indicated on the diagram.  
RECOMMENDATION: Replace termite damaged wood members as necessary. No painting is included in this estimate.

- 11G PRICE: \$125.00 (Section II)  
FINDINGS: The attice vent is missing as indicated in the area on the daiagram..  
RECOMMENDATION: Replace or repair the vent as needed.

- 11H PRICE: Not Estimated (Further Inspection)  
FINDINGS: The wood windows were not opened nor were the screens removed throughout the entire structure as indicated in the area on the diagram.  
RECOMMENDATION: If further inspection is required. Owner to make area accessible for inspection. Contact John Moss Pest Control for a supplemental report after the area is opened for inspection.

- 11I PRICE: \$1,500.00 (Section I)  
FINDINGS: Wood decay fungi damage (Dry Rot) found at time of inspection to the bowed siding as indicated on the diagram.  
RECOMMENDATION: Replace or repair visible dry-rot damaged wood members as necessary.
