# Building Inspection Report

**4140 Admirable Dr., Rancho Palos Verdes, CA**

**Inspection Date:**  
11/28/17 9:00am

**Prepared By:**  
Beachside Property Inspection, LLC  
5318 E. 2<sup>nd</sup> St., #707  
Long Beach, CA, 90803  
ph. (562) 433-2288

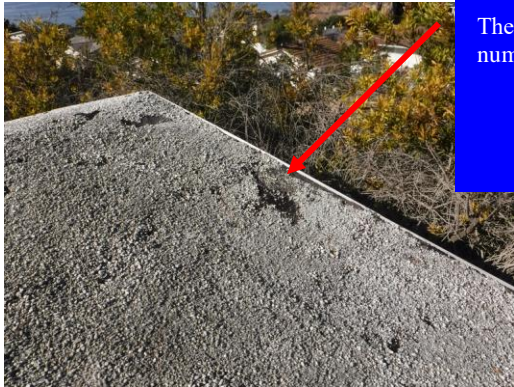
- **Improve:** Voids in the roof gravel were observed on the membranes at the garage and home which leads to a shortened life expectancy and increases the potential for ultraviolet damage to the membrane. Missing gravel should be replaced by a licensed roofing contractor. **Note:** Prior repairs to the home's roofing are evident. As well, the flashings are older and should be monitored. The underside of the garage and house roofs both show water stains indicating previous leaks.

The home's rock roof has a number of bare areas...

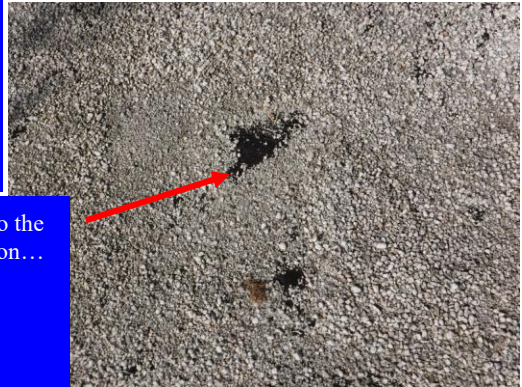
...where UV damage to the system requires attention...

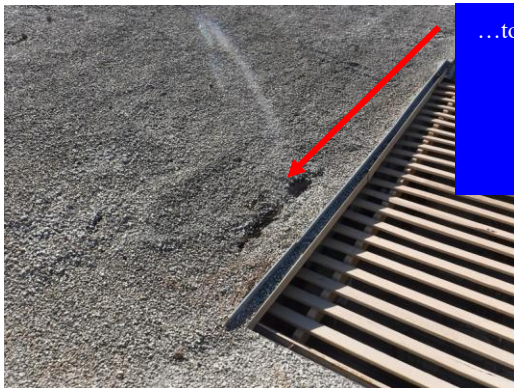
...to prevent leaks

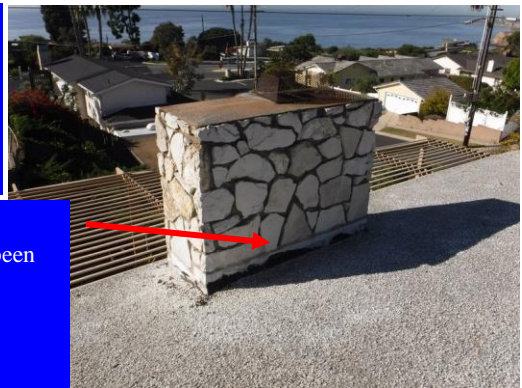
The wide base of the chimney should have been provided a 'cricket' flashing...

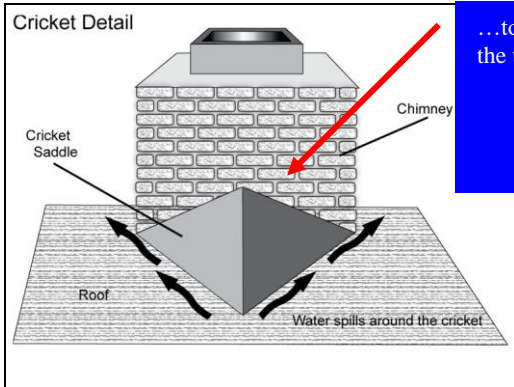
...to divert water around the tower

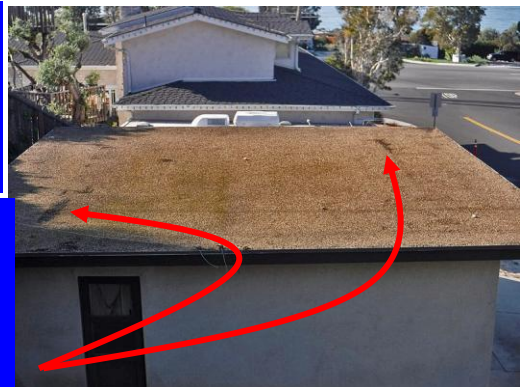
The garage rock roof has bare areas as well

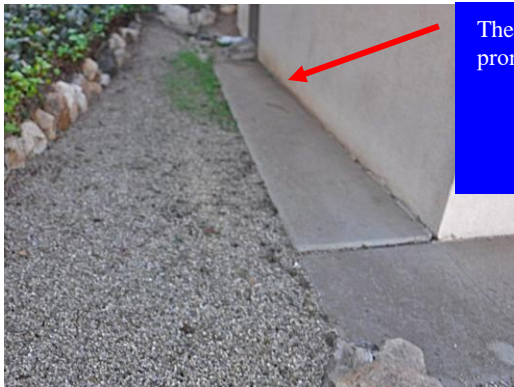
The garage N-sideyard is prone to flooding...

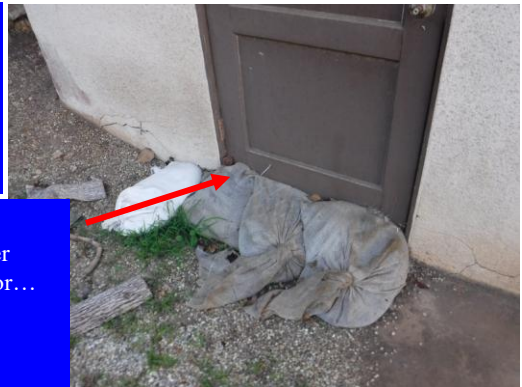
- **Improve:** The chain link fencing is leaning at areas.
- **Improve:** Various screens are damaged/missing; suggest repair as needed.
- **Improve:** The garage is prone to water infiltration due to poor drainage where sandbags were noted at the service door to prevent water entry. As well, water ponds against the N-wall and the built-up soil at the rear wall of the building is against the wood framing which should be excavated. This detached building requires comprehensive perimeter

drainage improvements by a licensed specialist. Note: the garage's cracked floor and off-set service door opening are symptomatic of the dynamic site conditions.

...where sand bags are needed to prevent water entry at the service door...

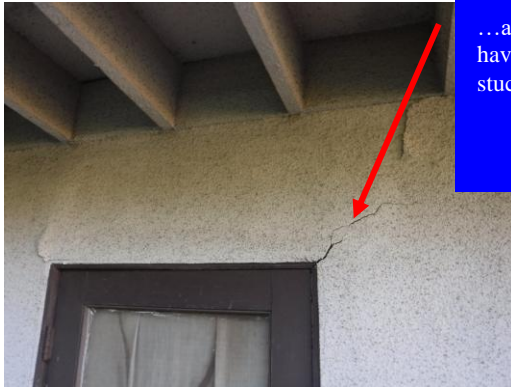
...and the site conditions have heaved/cracked the stucco as well as the floor

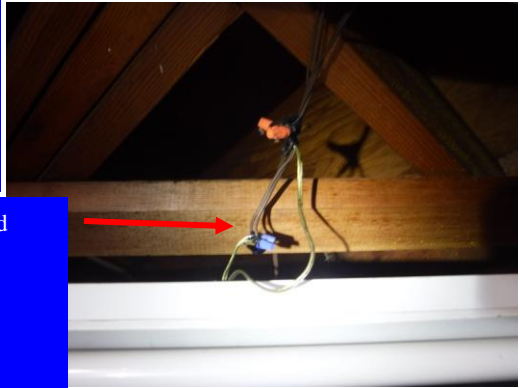
- **Safety Issue:** Exposed non-metallic electrical distribution cable/improper wiring noted at the garage interior as well as exposed strand wiring & connection at the added light fixtures. All visible wiring must be enclosed within flexible or rigid metal conduit with connections in covered junction boxes for the prevention of shock & fire hazards; suggest repairs by a licensed electrical contractor.

The garage has exposed wiring connections...

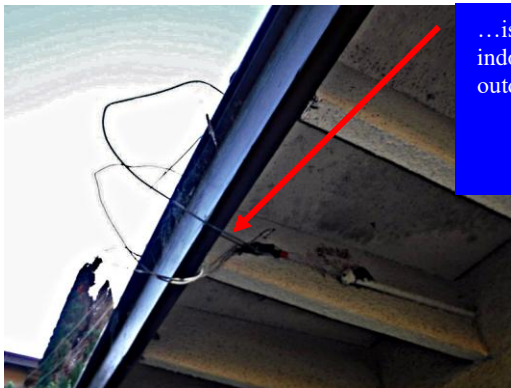
...is provided power with indoor strand wiring routed outdoors...

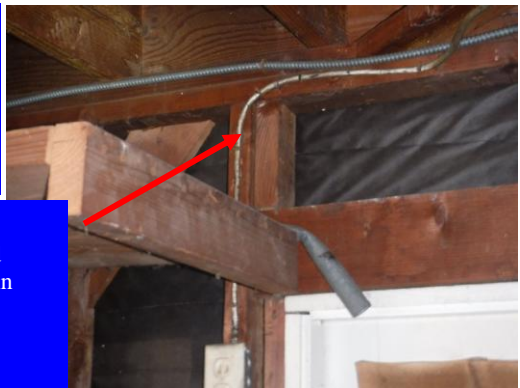
...as well as having exposed cloth-wrapped distribution cable within the garage

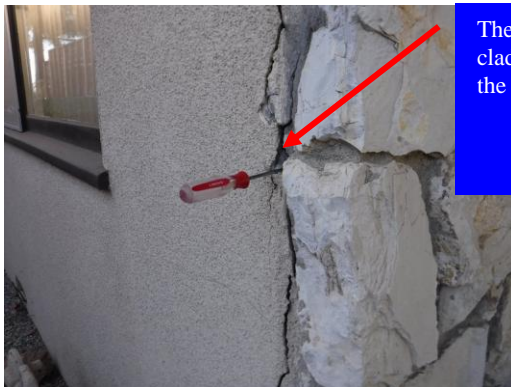
The N-exterior wall's stone cladding has detached from the structure

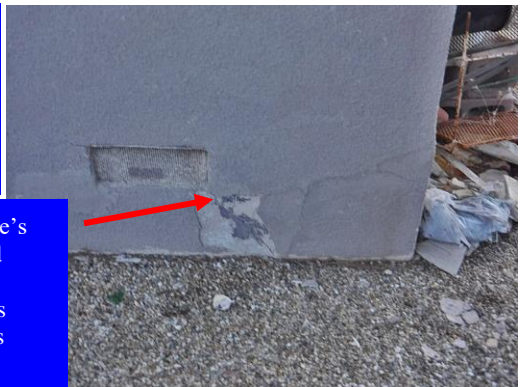
Many areas of the home's perimeter have patched areas at the foundation where blistered finishes and re-occurring cracks have emerged...

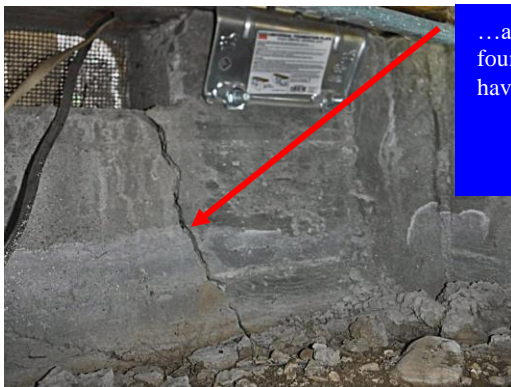
- **Major Improve:** The concrete foundation shows a number of separating vertical cracks throughout the perimeter with gaps wide enough to indicate continuing structural movement. A number of these cracks appear to be candidates for epoxy fill and metal strapping which will stabilize the foundation and help prevent further movement (some of the cracks have been strapped and filled at the kitchen area). It is highly unlikely these cracks would lead to a structural failure in static conditions, but their continued movement will crack the interior/exterior finishes; suggest repairs by a licensed foundation specialist.

...at the numerous foundation wall cracks that have been left untouched...

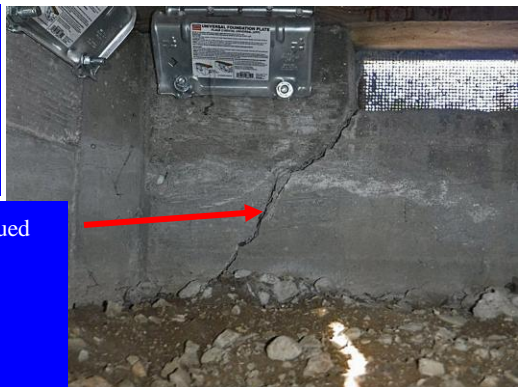
...which allows continued movement...

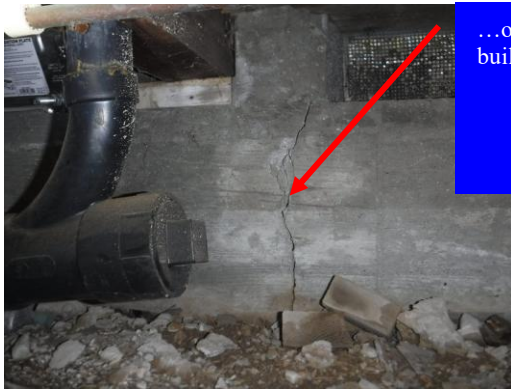
...of the wall and the building...

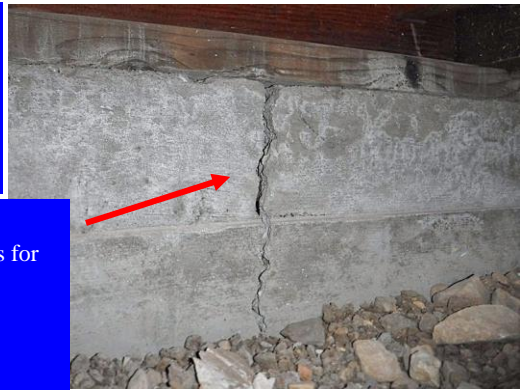
...when these cracks appear to be candidates for epoxy filler...

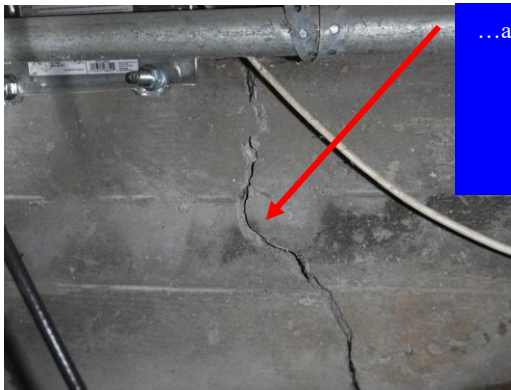
...and metal strapping...

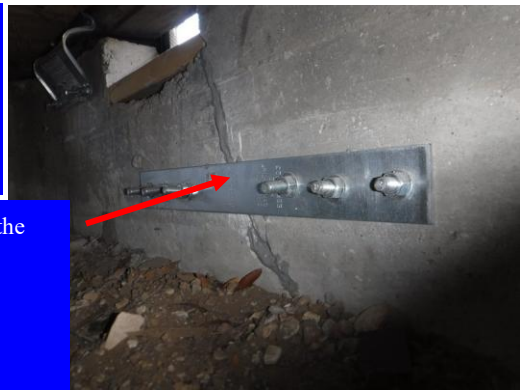
...as has been done at the kitchen N-wall

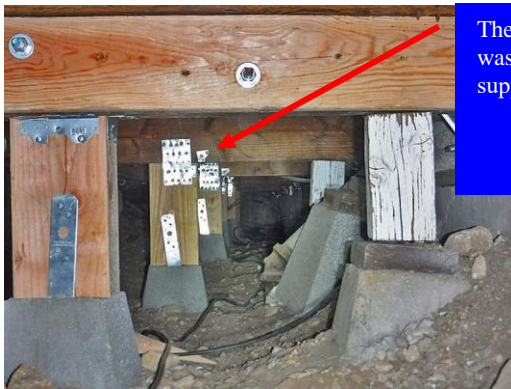
- **Major Improve:** The kitchen sub-floor was ‘re-leveled’ by seismic retrofit specialists who lifted the assembly off the foundation walls where the floor girders were provided new post/pier assemblies and the sill plate (lowest horizontal framing member bearing upon the foundation wall) was secured to the wall with added foundation plates. The issues here are the resultant large gaps at the girder ends which no longer bear upon their provided wall-pockets and that the sill plate is now ‘floating’ above the wall (slick plastic shims and wood wedges fill some areas). The perimeter wood framed walls should be provided contiguous compression load paths upon the foundation wall top face which is usually addressed with the injection of non-shrink grout as well as added wood pads within the girder wall pockets; suggest repairs by a licensed foundation specialist as needed to the provide the proper lateral resistance and compression load paths of this assembly.

The kitchen floor assembly was lifted, leveled and re-supported...

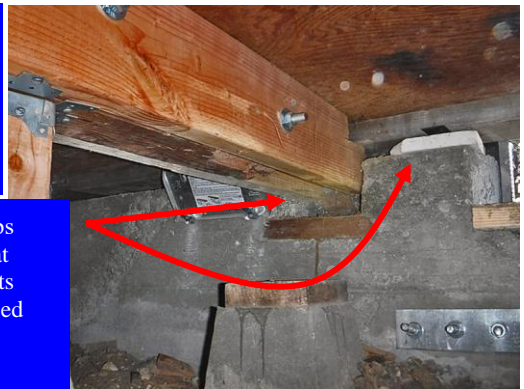
...resulting is large gaps where girders now float above their wall pockets and the sill plate is raised above the foundation wall...

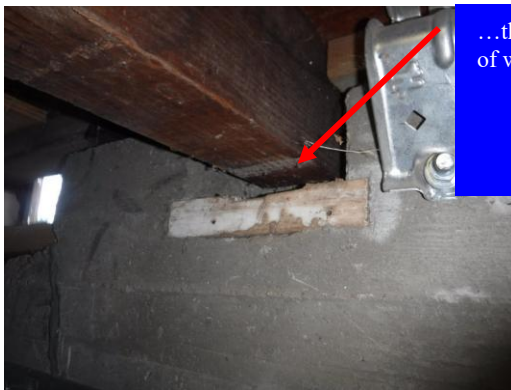
...that requires the addition of wood pads...

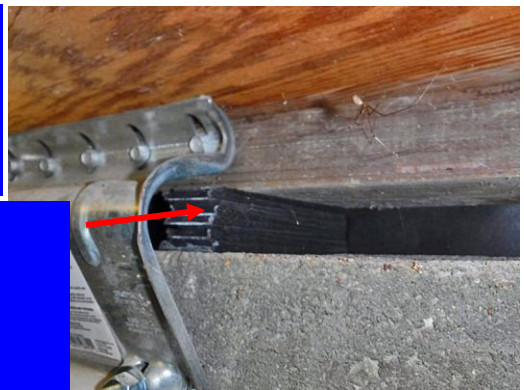
...and replacement of plastic shims...

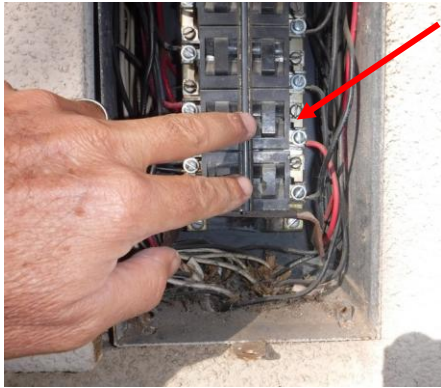
- **Major Improve/Safety Issue:** The “Pushmatic” main electrical panel is an older component with known reliability issues that feature both breaker and buss-bar configurations/design long abandoned by manufactures. As well this unit exhibits a well known safety defect where two breakers indicating they are ‘off’ are in fact ‘on’, and other issues such as a ‘double-tapped’ breaker terminal (each circuit conductor is to be served by a separate breaker) and unused breaker openings that are not capped. The performance/reliability of these older units is considered to be fully depreciated and should be immediately replaced by a licensed electrical contractor.

...and the common problem of breakers that indicate they are 'off' when in fact they tested as 'on'

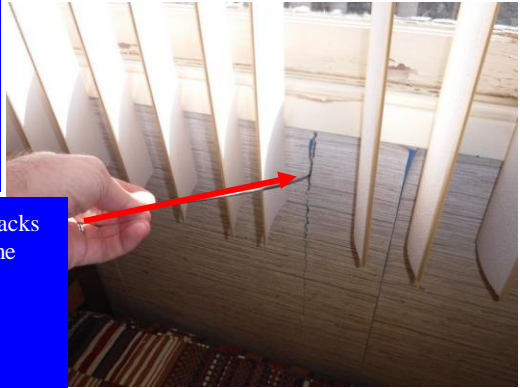
- **Monitor:** The interior walls and some ceiling areas exhibit cracks and off-sets consistent with site settlement. The wall cracks are likely due of foundation wall cracks, off-sets where the framing spans from one foundation wall to another or from girder system to walls where their differential movement (due to seismic activity, stress or settlement) transitions through the framing. Note: The interior wall cracks will likely be re-occurring.

The foundation wall cracks have manifested in some interior wall cracks...

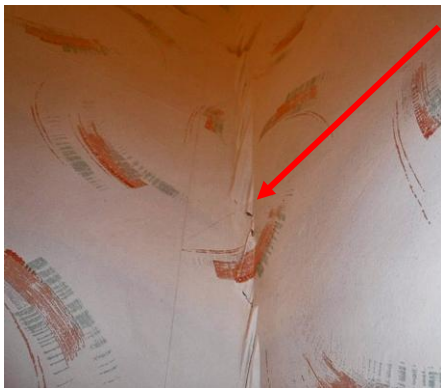
...of which some are masked by wall paper where rippled finishes reveal the off-sets...

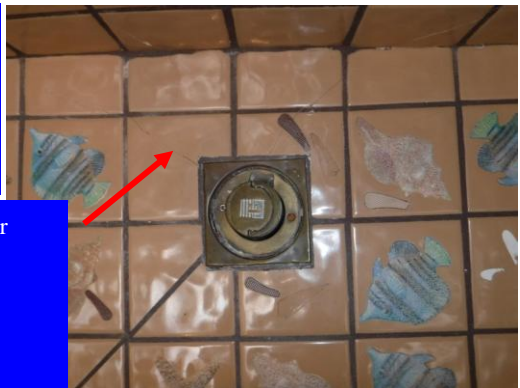
The master bath shower pan is cracked...

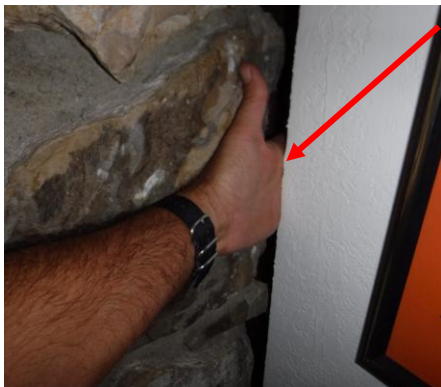
22. **Improve:** The fireplace has settled independent of the home resulting is a large gap developing between it and the dining area partition wall abutment. Inspection of the crawl space revealed a vertical foundation wall crack that aligns with this area; suggest improving the interior finishes as needed to mask the off-set.

...and the chimney has settled resulting in a large opening where abutting the W-wall...

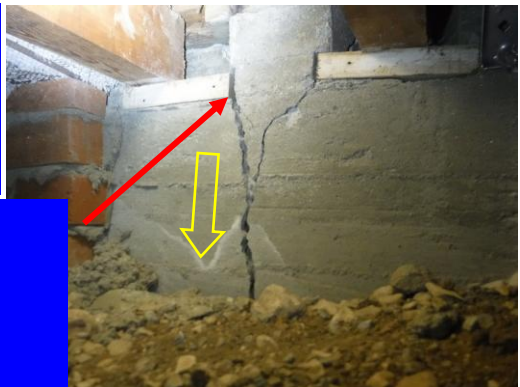
...that cracked the foundation below

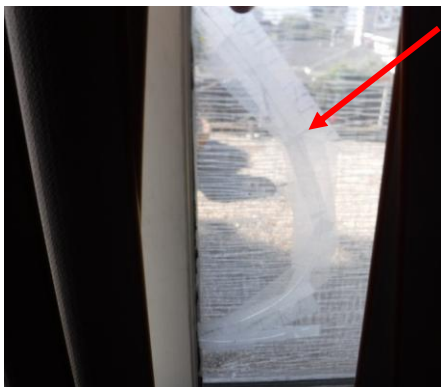
The master bedroom has a cracked window pane

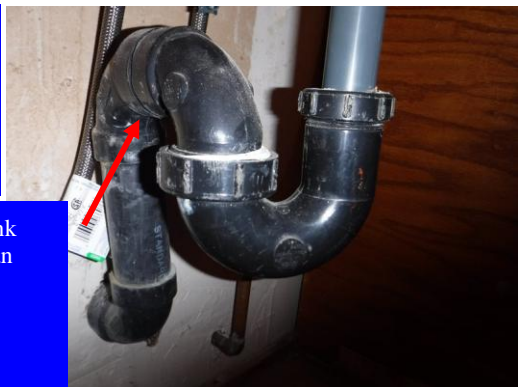
17. **Improve:** A new rain cap/vermin screen should be installed on the masonry chimney (the unit here has lost its rain cap).
18. **Improve:** An "S" trap has been used at the master bath left sink. Ideally, S traps should be replaced as they are subject to siphoning that can result in sewer gases entering the home. As well, the laundry area drain pipe has a 'running' trap (a trap set within a long lateral run verses at the base of a vertical transition to horizontal run); suggest repairs by a licensed plumbing contractor.

The master bath left sink drain is configured in an 'S'-trap

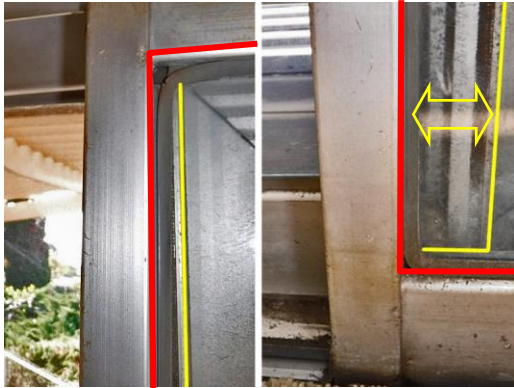
21. **Improve:** The dining room sliding glass door is difficult to roll, has a loose frame (the side the handle mounts to) and the opening is out-of-square.

The dining area sliding glass door is off-set as the top of the door (red) aligns with the fixed panel frame (yellow), but is misaligned at the base

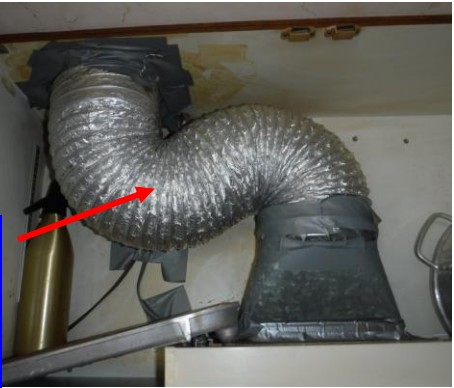
The kitchen exhaust fan may not use a flexible duct

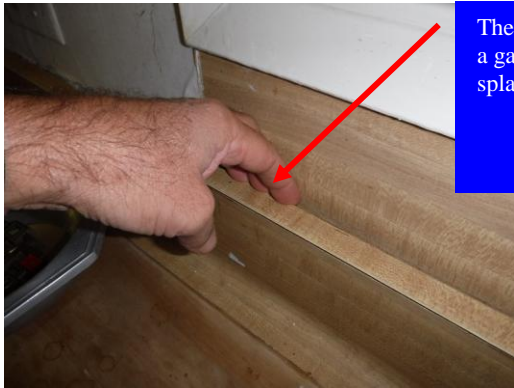
The kitchen countertop has a gap between the back-splash and the wall

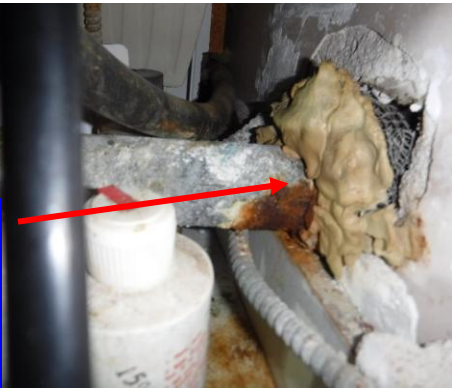
26. **Improve:** The kitchen sink drain trap arm is prone to leaks given the corrosion at the pipe and the stains/damage at the cabinet finishes.
27. **Improve:** The master bath shower neck is not snug to or sealed at the wall and requires improvement to prevent water infiltration.

The kitchen sink waste pipe is prone to leaks

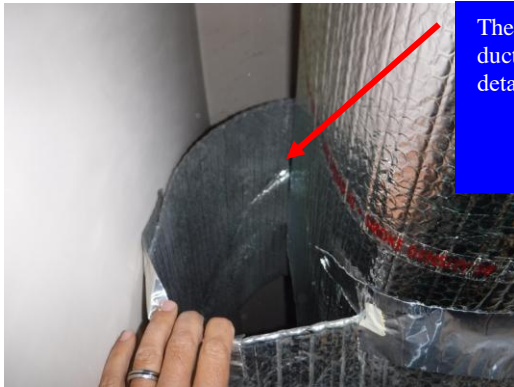
The forced air heating unit duct box insulation is detached...

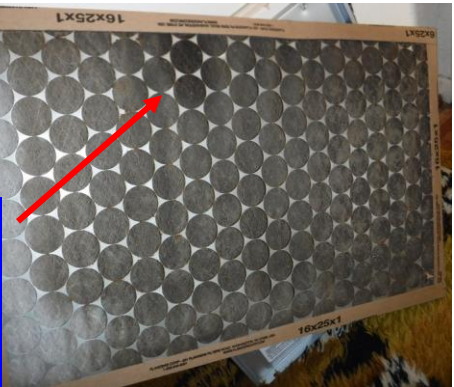
...and the filter is dirty

23. **Improve:** The forced air heating unit's dirty air filter should be replaced.
24. **Improve:** The garage is prone to water infiltration due to poor drainage where sandbags were noted at the service door to prevent water entry. As well, water ponds against the N-wall and the built-up soil at the rear wall of the building is against the wood framing which should be excavated. This detached building requires comprehensive perimeter drainage improvements by a licensed specialist. Note: the garage's cracked floor and off-set service door opening are symptomatic of the dynamic site conditions.
