WOOD DESTROYING PESTS AND ORGANISMS INSPECTION REPORT

20188615

BUILDING NO. 2917	STREET PALOS VERDES DR. NORTH	CITY PALOS VERDES ESTATES	ZIP 90274	Date of Inspection 01/29/2018	NUMBER OF PAGES 1 of 7
-----------------------------	---	-------------------------------------	---------------------	---	----------------------------------

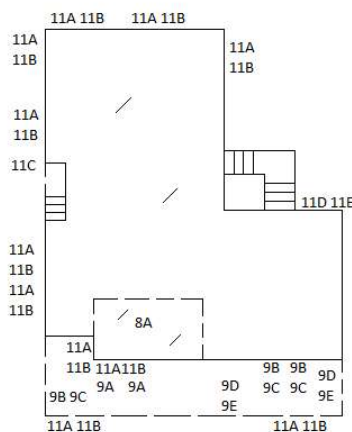
FINDING AND RECOMMENDATION: 8A An INACCESSIBLE AREA exists as indicated by 8A(LOCKED) on the diagram.

ITEM NO. 9A	(Section 1)
FINDING:	FUNGUS DAMAGE indicated by 9A on diagram. The FUNGUS DAMAGE was noted in or near: SPINDLES UNDER DECK.
RECOMMENDATION: 9A	Remove and replace damaged wood as necessary with today's available widths and grades.

ITEM NO. 9B	(Section 1)
FINDING:	Evidence of DRYWOOD TERMITES as indicated by 9B on the diagram. Evidence noted in or near: SPINDLES UNDER DECK.
RECOMMENDATION: 9B	Fumigate the structure with a fumigant lethal to DRYWOOD TERMITES (Sulfuryl Fluoride). See the occupants fumigation notice for further details. This company is not responsible for delays or schedule changes due to inclement weather or other agencies, nor is it responsible for damage to roof or plants as a result of the fumigation. Refer to the occupant's fumigation notice/preparation sheet (sent separately) for additional information.

ITEM NO. 9C	(Section 1)
FINDING:	DRYWOOD TERMITE DAMAGE as indicated by 9C on diagram. The damage was noted in or near: SPINDLES UNDER DECK.
RECOMMENDATION: 9C	Remove and replace damaged wood as necessary with today's available widths and grades.

ITEM NO. 9D	(Section 1)
FINDING:	Evidence of DRYWOOD TERMITES as indicated by 9D on the diagram. Evidence noted in or near: DECKING.
RECOMMENDATION: 9D	Fumigate the structure with a fumigant lethal to DRYWOOD TERMITES (Sulfuryl Fluoride). See the occupants fumigation notice for further details. This company is not responsible for delays or schedule changes due to inclement weather or other agencies, nor is it responsible for damage to roof or plants as a result of the fumigation. Refer to the occupant's fumigation notice/preparation sheet (sent separately) for additional information.
RECOMMENDATION: 9D	This item included in fumigation estimate.

ITEM NO. 9E	(Section 1)
FINDING:	DRYWOOD TERMITE DAMAGE as indicated by 9E on diagram. The damage was noted in or near: DECKING 2x4x16 (2).
RECOMMENDATION: 9E	Remove and replace damaged wood as necessary with today's available widths and grades.

ITEM NO. 11A	(Section 1)
FINDING:	Evidence of DRYWOOD TERMITES as indicated by 11A on the diagram. Evidence noted in or near: FASCIA.
RECOMMENDATION: 11A	Fumigate the structure with a fumigant lethal to DRYWOOD TERMITES (Sulfuryl Fluoride). See the occupants fumigation notice for further details. This company is not responsible for delays or schedule changes due to inclement weather or other agencies, nor is it responsible for damage to roof or plants as a result of the fumigation. Refer to the occupant's fumigation notice/preparation sheet (sent separately) for additional information.
RECOMMENDATION: 11A	This item included in fumigation estimate.

ITEM NO. 11B	(Section 1)
FINDING:	DRYWOOD TERMITE DAMAGE as indicated by 11B on diagram. The damage was noted in or near: FASCIA 3/4x5x60, 1 3/4x7 1/2x64 (CUSTOM LUMBER).
RECOMMENDATION: 11B	Remove and replace damaged wood as necessary with today's available widths and grades.

ITEM NO. 11C	(Section 1)
FINDING:	DRYWOOD TERMITE DAMAGE as indicated by 11C on diagram. The damage was noted in or near: TRIM.
RECOMMENDATION: 11C	Remove and replace damaged wood as necessary with today's available widths and grades.

ITEM NO. 11D	(Section 1)
FINDING:	Evidence of DRYWOOD TERMITES as indicated by 11D on the diagram. Evidence noted in or near: WINDOW TRIM (2).
RECOMMENDATION: 11D	Fumigate the structure with a fumigant lethal to DRYWOOD TERMITES (Sulfuryl Fluoride). See the occupants fumigation notice for further details. This company is not responsible for delays or schedule changes due to inclement weather or other agencies, nor is it responsible for damage to roof or plants as a result of the fumigation. Refer to the occupant's fumigation notice/preparation sheet (sent separately) for additional information.
RECOMMENDATION: 11D	This item included in fumigation estimate.

ITEM NO. 11E	(Section 1)
FINDING:	DRYWOOD TERMITE DAMAGE as indicated by 11E on diagram. The damage was noted in or near: WINDOW TRIM (2).
RECOMMENDATION: 11E	Remove and replace damaged wood as necessary with today's available widths and grades.

FURTHER INSPECTION after owner makes area accessible, issue supplement report with findings, recommendations and costs if any.
