# Maffei Property Inspections Property Inspection Report

120 Wine Blossom Dr, Chico, CA Inspection prepared for: All & Debta Ottone Real Estate Agent: Bankara Weiber Condwell Banker Driff ou Really

Date of Inspection: 3/16/2018 Time: 9am
Age of Home: approx 14 yrs Size: approx 1550 sf
Weather: Sunny and Dry
For the purpose of this report the front of the home faces west. It rained the day before the inspection.

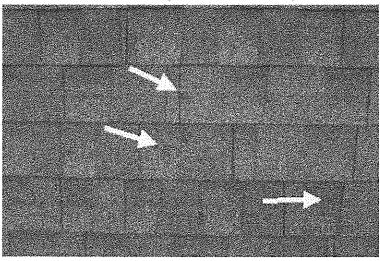
Evidence of hail damage noted.
Recommend contacting a licensed roofing contractor for further evaluation.

Evidence of hail damage

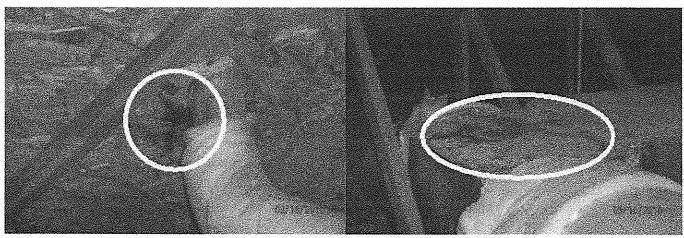
• Moisture stains noted around the dryer vent where it passes through the roof. Moisture stains were also found on the HVAC plenum below this area.

Moisture stains on plenum

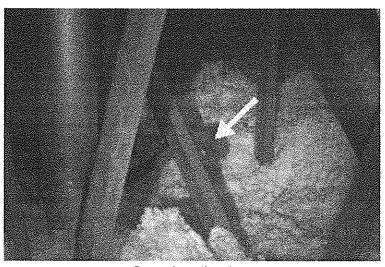
Open junction box noted next to the chimney chase. Recommend covering.

Open junction box

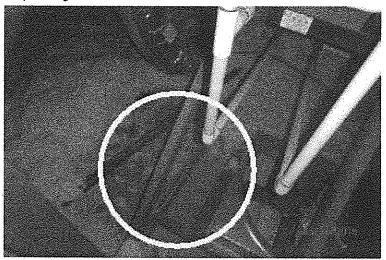
· There was space around the whole house fan where the insulation was missing. It may have been pulled back to install the fan. Recommend replacing.

Missing insulation

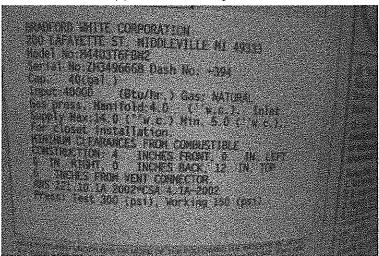
· Water heater appears to be original to home.
