WOOD DESTROYING PESTS AND ORGANISMS INSPECTION REPORT

Building No. 120	Street Wine Blossom	City Chico	Zip 95973	Date of Inspection 3-16-18	Number of Pages 3
---------------------	------------------------	---------------	--------------	-------------------------------	----------------------

REGISTRATION # PR 3101	REPORT # 318-120 WI	ESCROW # n/a
------------------------	---------------------	--------------

General Description: <u>1 story single family dwelling, slab floor, furnished and attached garage. Attic visually inspected from access opening only.</u>	Inspection Tag Posted: Garage
	Other Tags Posted:

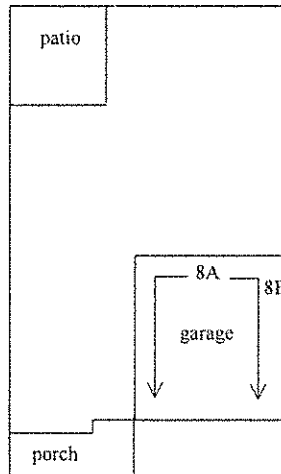
DIAGRAM NOT TO SCALE

8A. **FINDING - FURTHER INSPECTION** - Garage interior perimeter mostly inaccessible to inspect due to storage/cabinet blockage.

8B. **FINDING - SECTION I** - Minor fungus damage to base of garage door jamb.

RECOMMENDATION - If area is made accessible, and if requested, we will make a further inspection and issue a supplemental report.

RECOMMENDATION - Repair/replace door jamb as needed.
