Inspection No. : 202002013 Inspector : Ned McTaggart

Inspection Date : February 06, 2020 Client : The Estate of Merle T. Hanson

Address : 2611 Nearcliff Street, Torrance, CA 90505

This is a single-family dwelling, one story structure built on a hillside lot. Estimated age is approximately 64 to 68 years old. Weather at the time of inspection was sunny.

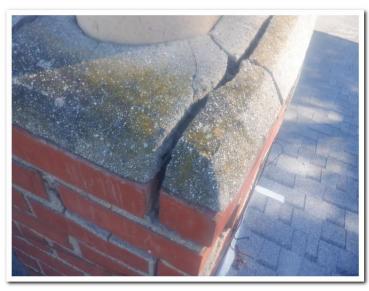
100	EXTERIOR – CONTINUED
110 Exterior Doors:	Serviceable.
111 Bell/Chime:	Non-Applicable.
112 Chimney:	A spark arrester is installed as a safety feature.
	Top of chimney has loose brick, concrete and grout; we advise making necessary corrections.

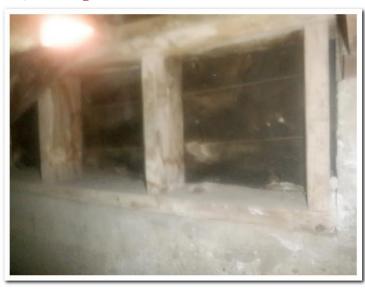
115c Cripple Walls:

Yes, front right and left walls noted not braced.

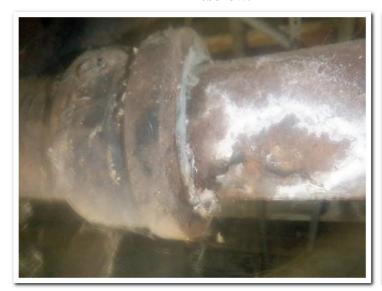
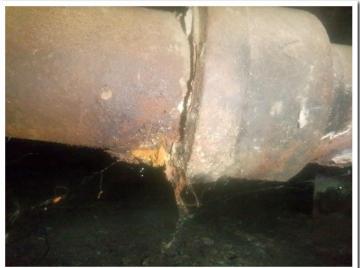
116 Sub-Floor:

Accessible at rear. Plumbing leaking: Corrosion and slight leak noted at drain lines; suggest consulting with specialist for further review prior to close of escrow.

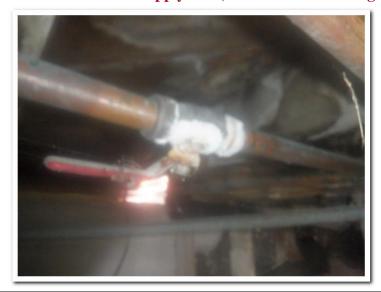
116a Sub-Floor Comments: Corrosion noted at supply lines; no evidence of leakage at time of inspection.

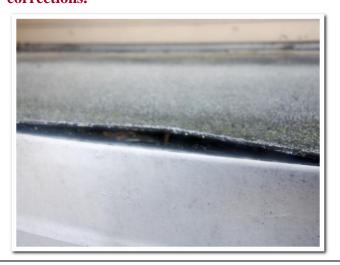
132 Roof Comments: Rolled roofing is lifting noted at right side; we advise making necessary corrections.

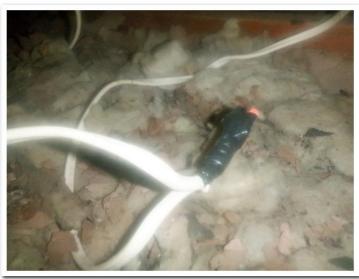
1	35	ATTIC
136	Hatch Location:	Hall.
137	Accessible:	Yes.
138	Sheathing:	Serviceable; 1x6.
139	Evidence of Leaking:	No.
140	Insulation:	Yes, where visible approximate thickness is 1-3 inches.
141	Ventilation:	Appears to be adequate.
142	Attic Comments:	Open splices were observed in attic. This is a safety concern. Whenever an

electric wire is cut and reconnected, the "splice" should be encased in a covered junction box to prevent shocks and separation of the splice. Client is advised to consult with a licensed electrician prior to closing for repairs/replacement as needed to ensure safety.

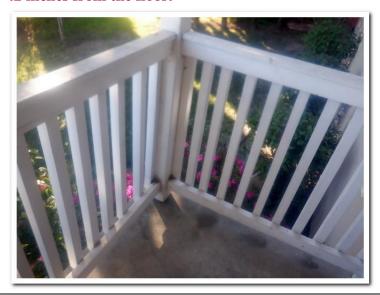
Top of railing is less than 42 inches from the floor which may have been standard at the time of construction; however, today's standards require top of railing be 42 inches from the floor.

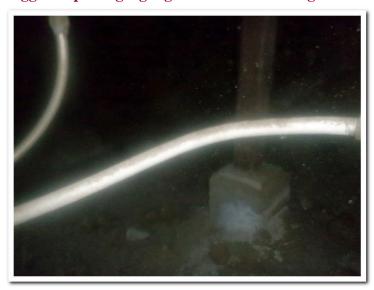
401 Heating: Gas. Floor furnace located in living room. Gas shut off noted.

Suggest replacing rigid gas line with flexible gas line as a safety upgrade.

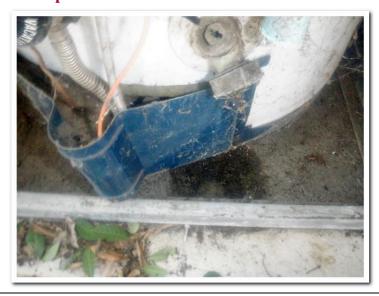
Earthquake straps noted are loose; suggest securing.

Rust noted in burner compartment which indicates the water heater is getting older; no leak noted at time of inspection.

Slight leak noted at drain plug; suggest consulting with specialist for further review prior to close of escrow.

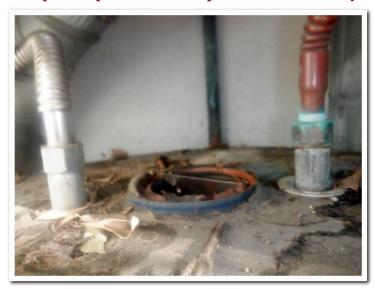
407a Venting:

Disconnected vent pipe noted. This will allow products of combustion to escape, which is a safety hazard requiring immediate attention by a licensed contractor for repairs/replacement as required to ensure safety.

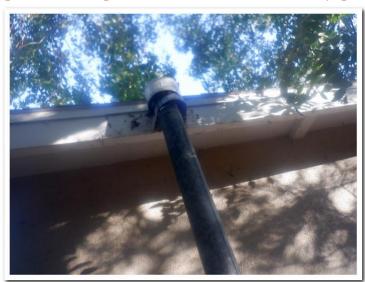
Exhaust vent is too short. The 2-2-10 rule states that the appliance vent should extend at least 2 ft. above the roof opening (measured at the uphill side on sloped roofs) and at least 2 ft. above the roof's (or any other structure's) highest point within 10 ft. for proper drafting. Simple repairs and/or modifications can usually be made to most exhaust vents to correct the problem. Advise a qualified specialist for repair or modification, as necessary, prior to close.

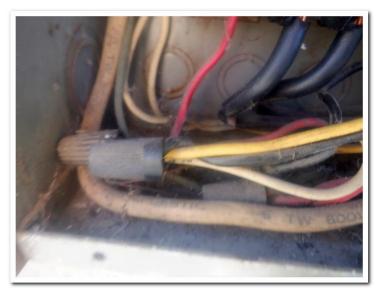
Exposed splices noted in main panel. This condition is not generally allowed in the service panel. Client may wish to consult a licensed electrician for further review.

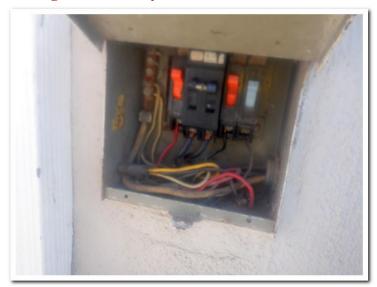
Missing interior safety cover noted.

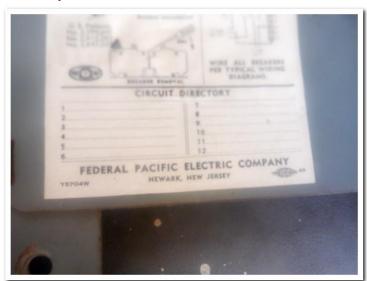
Federal Pacific brand electrical panel noted at garage sub panel. This equipment is associated with known product defects and is problematic. We advise consulting with a licensed electrician for complete review and replacement as necessary.

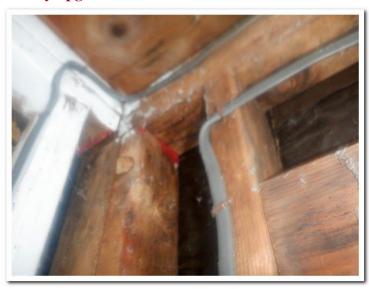
Exposed Romex wiring noted at various areas. This may be a safety concern if used where it could be subject to physical damage. Client may wish to encase as a safety upgrade.

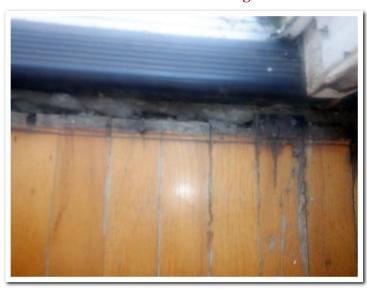
1001 Floor:

Deteriorated wood and water damage noted at rear.
