WOOD DESTROYING PESTS AND ORGANISMS INSPECTION REPORT

#: 20200424

| BUILDING NO. 601-03 | STREET GARNET | CITY REDONDO BEACH | ZIP 90277 | Date of Inspection 01/25/2020 | NUMBER OF PAGES 1 of 7 |

This is a two story, stucco, 5 unit apartment building with attached garages. It has a flat roof and was occupied and furnished at the time of inspection.

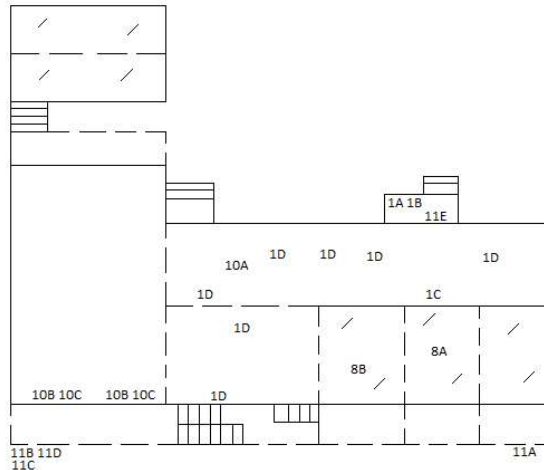
FINDING AND RECOMMENDATION: 1A Evidence of SUBTERRANEAN TERMITES in as indicated by 1A on the diagram. The evidence was noted in or near: SIDING, STUDS.

FINDING: SUBTERRANEAN TERMITE DAMAGE as indicated by 1B on diagram. The damage was noted in or near: SIDING, STUDS.

FINDING: FUNGUS DAMAGE indicated by 1C on diagram. The FUNGUS DAMAGE was noted in or near: SUBFLOOR.

FINDING AND RECOMMENDATION: 1D CELLULOSE DEBRIS noted as 1D on the diagram.

| FINDING AND RECOMMENDATION: 8A | <p>An INACCESSIBLE AREA exists as indicated by 8A(LOCKED) on the diagram.</p> <p>FURTHER INSPECTION after owner makes area accessible, issue supplement report with findings, recommendations and costs if any.</p> |
| FINDING: | Water stains noted as 8B on the diagram. No moisture was noted. The stains were in or near: GARAGE. |

| FINDING AND RECOMMENDATION: 10A | <p>The commode is loose as indicated by 10A(UNIT B) on the diagram.</p> <p>We recommend to contact a licensed plumber to correct this condition.</p> |
| FINDING: | Evidence of DRYWOOD TERMITES as indicated by 10B on the diagram. Evidence noted in or near: WINDOWS/TRIM. |
| FINDING: | DRYWOOD TERMITE DAMAGE as indicated by 10C on diagram. The damage was noted in or near: WINDOWS/TRIM. |

| FINDING: | FUNGUS DAMAGE indicated by 11A on diagram. The FUNGUS DAMAGE was noted in or near: GARAGE DOOR JAMB. |
| FINDING: | Evidence of DRYWOOD TERMITES as indicated by 11B on the diagram. Evidence noted in or near: FRONT DOOR JAMB. |
| FINDING: | DRYWOOD TERMITE DAMAGE as indicated by 11C on diagram. The damage was noted in or near: FRONT DOOR JAMB. |
| FINDING: | Evidence of DRYWOOD TERMITES as indicated by 11D on the diagram. Evidence noted in or near: DOOR. |
| FINDING: | FUNGUS DAMAGE indicated by 11E on diagram. The FUNGUS DAMAGE was noted in or near: THRESHOLD. |

Treat infestation by trenching and treating and/or applying to soil surface for the control of SUBTERRANEAN TERMITES with a state approved toxic chemical and break down all subterranean termite tubing. Foam treat wall area as needed with termidor.

RECOMMENDATION: 1B Reepair/reinforce damaged wood as necessary with today's available widths and grades.

RECOMMENDATION: 1C We recommend scraping or brushing area and treating with a registered fungicide.

We recommend removing CELLULOSE DEBRIS of rake size or larger.

| RECOMMENDATION: 8B | It is recommended that owner contact a state licensed contractor to determine source of water stains and correct. |

| RECOMMENDATION: 10B | Recommendation : Treat infested lumber with a state approved toxic chemical to eradicate drywood termite infestation . (Termidor/Invader HPX) |
| RECOMMENDATION: 10C | Remove and replace damaged wood as necessary with today's available widths and grades. |

| RECOMMENDATION: 11A | Remove and replace damaged wood as necessary with today's available widths and grades. |
| RECOMMENDATION: 11B | Recommendation : Treat infested lumber with a state approved toxic chemical to eradicate drywood termite infestation . (Termidor/Invader HPX) |
| RECOMMENDATION: 11C | Cut off termite damage and repair with appropriate wood filler. |
| RECOMMENDATION: 11D | Recommendation : Treat infested lumber with a state approved toxic chemical to eradicate drywood termite infestation . (Termidor/Invader HPX) |
| RECOMMENDATION: 11E | Remove and replace damaged wood as necessary with today's available widths and grades. |
