Inspection Report

Property Address:
2781 Juniper Ave
Morro Bay CA

5/1/2017

Murphree Building Inspections

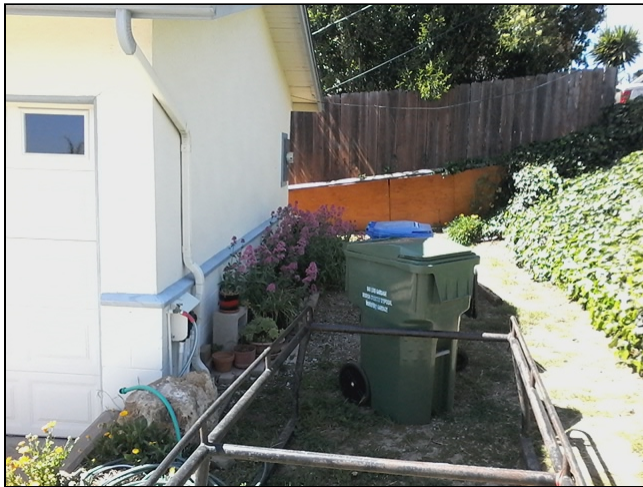
1.0 GRADE / DRAINAGE

ALTERATION NEEDED

Grade / drainage needs improved at the front of the garage. Recommend the soil be sloped away from the home and all surface water be channeled or directed away from the foundation to promote functional drainage.

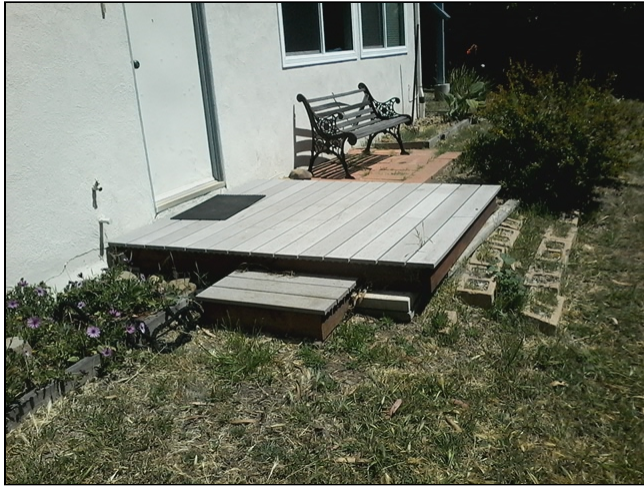
1.1 DECKS / PATIOS

**FURTHER EVALUATION**

The deck at the rear of the home has insufficient clearance for complete inspection. The underside of the framing and decking materials were not inspected due to lack of clearance. Recommend further inspection as needed.

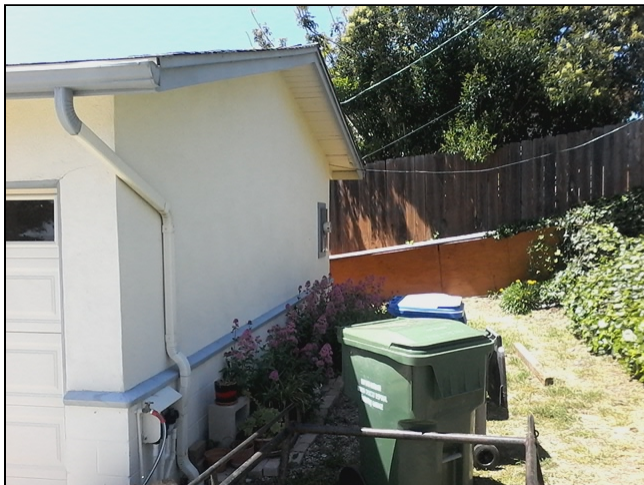
**(1) MAINTENANCE NEEDED**

Foliage needs trimmed back from contacting the siding. This will decrease the probability of moisture and pest intrusion.

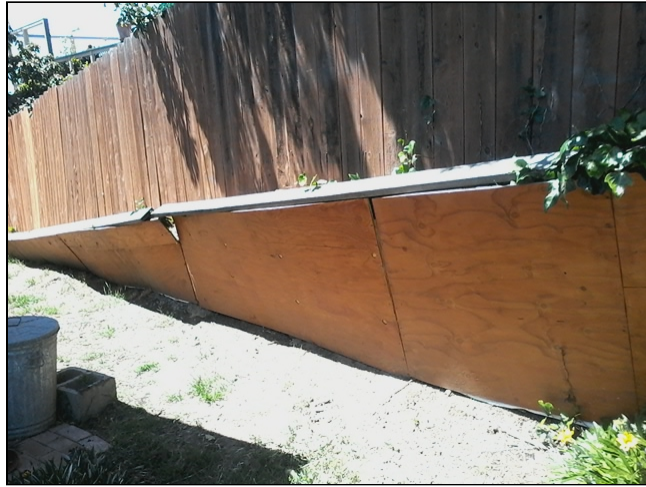
(2) FURTHER EVALUATION

Wood retaining wall at the right side yard is tilted from apparent soil settlement and the stability of the soil is in question. Recommend further evaluation and repairs made.

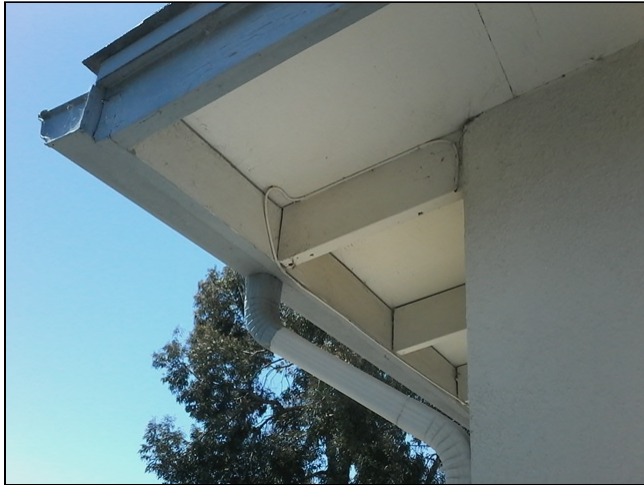
2.0 ROOF

Dry rot and fungus damage noted at the end of the rafters extending from the roofing at the left rear exterior. Refer to the pest report for further details and make repairs as prescribed.

REPAIR NEEDED

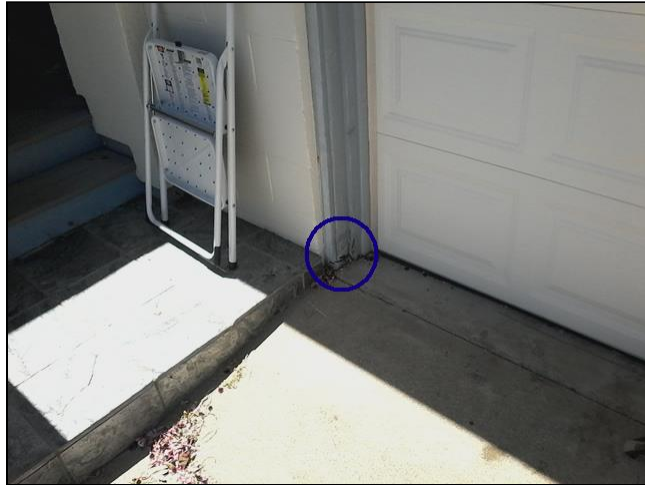
Dry rot or fungus damage noted on the door jamb material at the garage door. Refer to the pest report for further information on this condition and make repairs as needed.

(1) REPAIR NEEDED

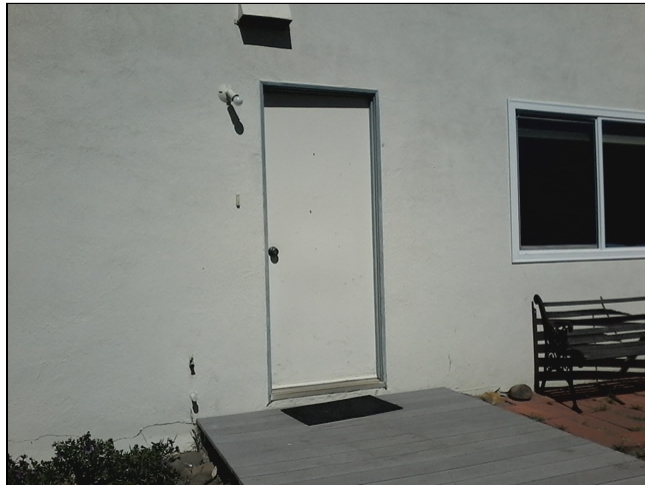
(3) REPAIR AS NEEDED

Door off the rear downstairs room is weathered and can be replaced as needed.

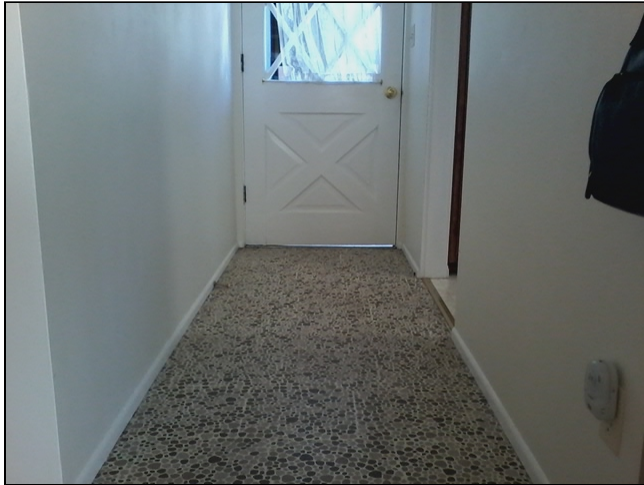
(4) REPAIR NEEDED

Door shoe is damaged at the bottom of the front entry door, allowing passage of unconditioned air. Repairs are needed to insure maximum efficiency of the home.

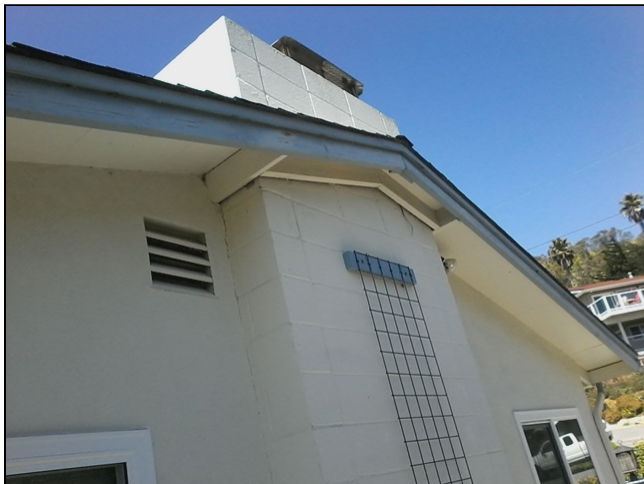
(1) MAINTENANCE NEEDED

Peeling paint was noted at a few areas of the wood fascia and trim, and paint maintenance is needed.

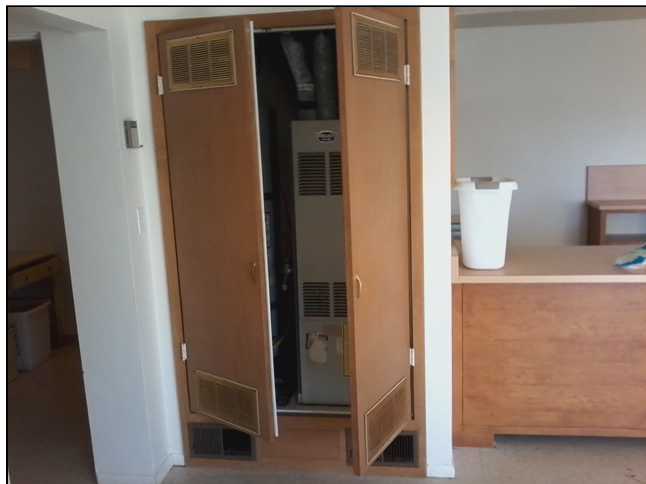
Furnace closet needs proper weather stripping around the door to prevent combustion air from entering the ventilation system. Recommend further evaluation by a SoCal Gas representative and make improvements as prescribed.

**(2) ALTERATION NEEDED**

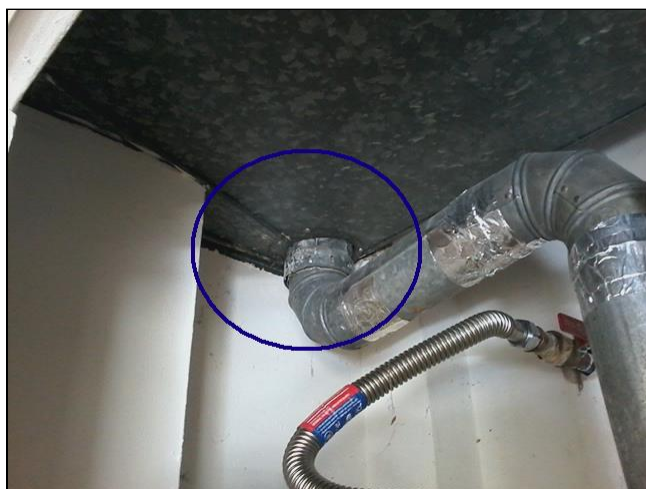
Water heater vent passes through the supply duct, noted in the utility closet, and it was undetermined if this section of ducting was properly sealed. Recommend further evaluation of the ducting and make any necessary repairs to prevent a possible unhealthy condition.

**(1) FURTHER EVALUATION**

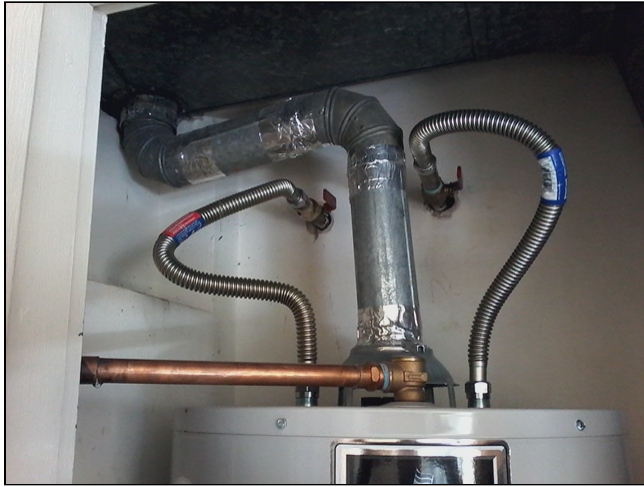
(1) REPAIR NEEDED

Water heater vent pipe connections need proper fasteners installed to prevent displacement in the event of seismic activity.

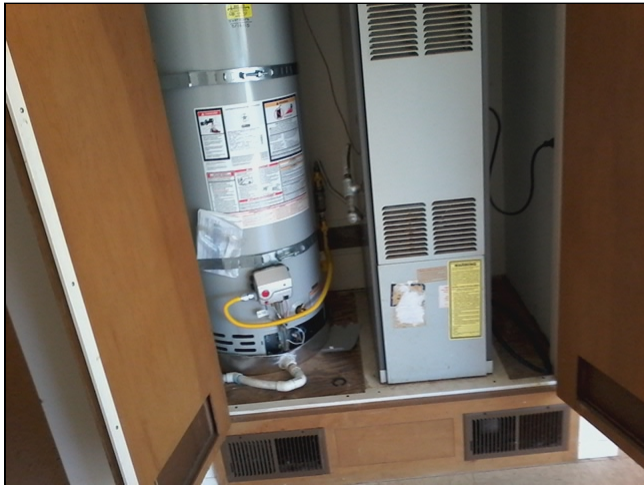
Combustion air in the utility closet is insufficient for both appliances and addition of ventilation is needed for intended function and safety of the systems. Recommend further evaluation by a SoCal Gas representative and make repairs or alterations as prescribed.

(2) ALTERATION NEEDED

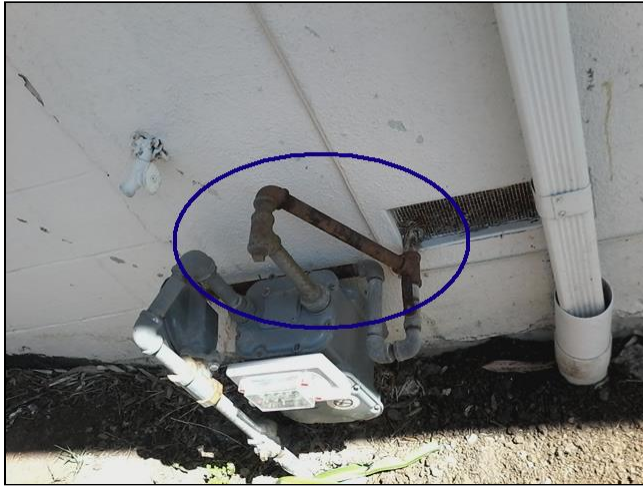
(2) MAINTENANCE NEEDED

Steel gas line is rusted near the gas meter and should have loose rust removed and painted with proper corrosion inhibiting paint to prevent further deterioration.

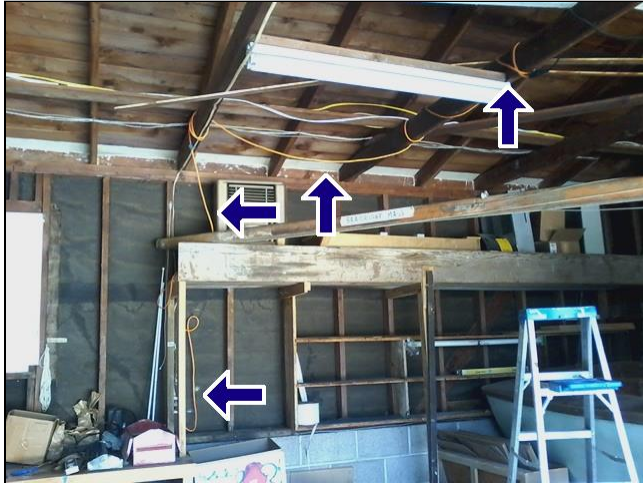
(1) INSTALLATION NEEDED

Extension cord utilized as permanent wiring noted at the garage ceiling for the automatic opener. Recommend proper wiring installed with permanent connections inside junction boxes and in conduit or behind walls for all permanent power supply.

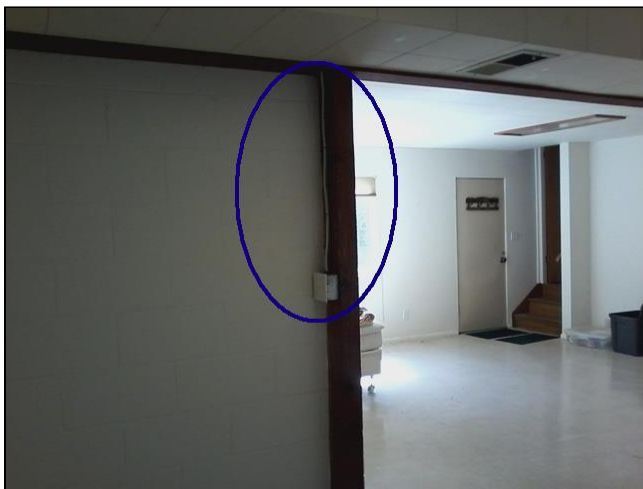
(2) ALTERATION NEEDED

Wiring exposed at the downstairs left front room and should be contained within conduit or behind walls.

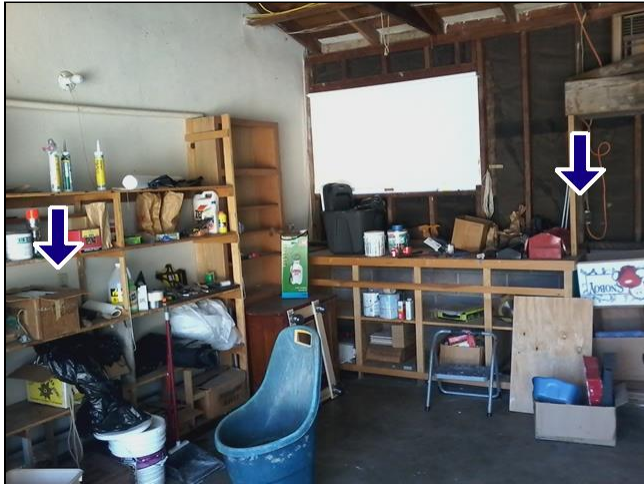
Hot and neutral connections reversed on the receptacles at the left side and rear interior garage walls, and alteration of the connections is needed to prevent possible damage to equipment.

(2) ALTERATION NEEDED

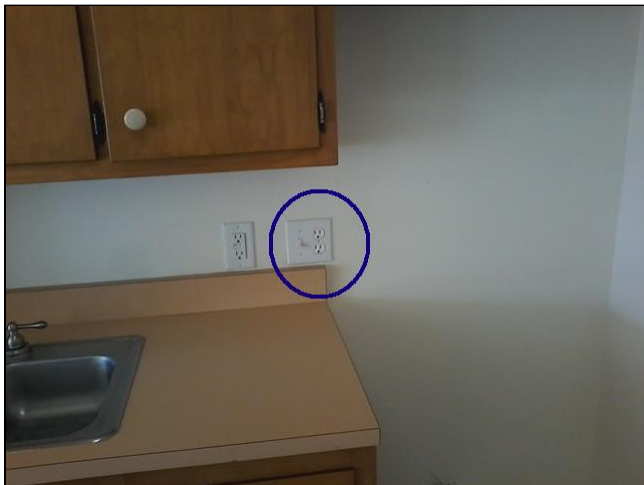
7.7 SYSTEM GROUNDING / GROUND FAULT CIRCUIT INTERRUPT

RECOMMENDED IMPROVEMENT

GFCI protection not provided for receptacles in the garage and at the downstairs bar sink counter. While this

was not required at the time of construction, recommend installation of GFCI protection for these receptacles, by a licensed electrician, for improved safety of the home.

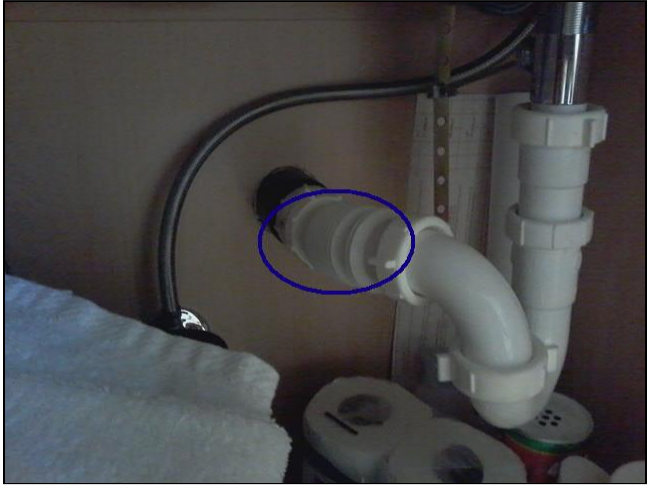
8.2.A SINKS

REPAIR NEEDED
Flex drain line utilized in the drain system under the sink. Recommend proper drain parts and methods utilized to prevent unnecessary clogging or displacement and leaks in the drain line.

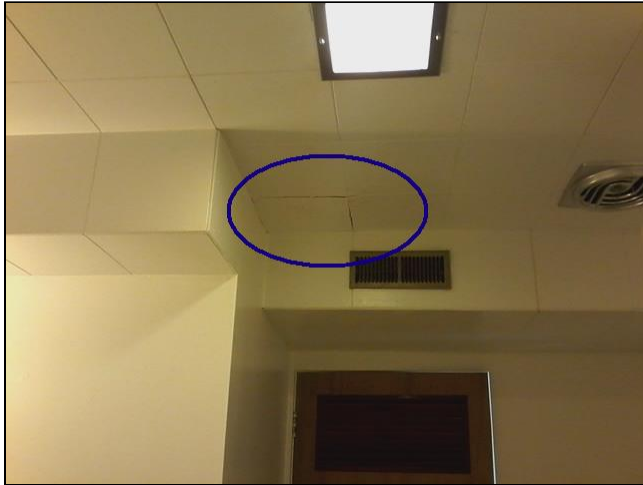
8.5.B CEILINGS, WALLS, FLOORS

REPAIR AS NEEDED

Moisture damage noted at the ceiling tiles. No signs of current moisture or cause were noted. Repairs can be made as needed.

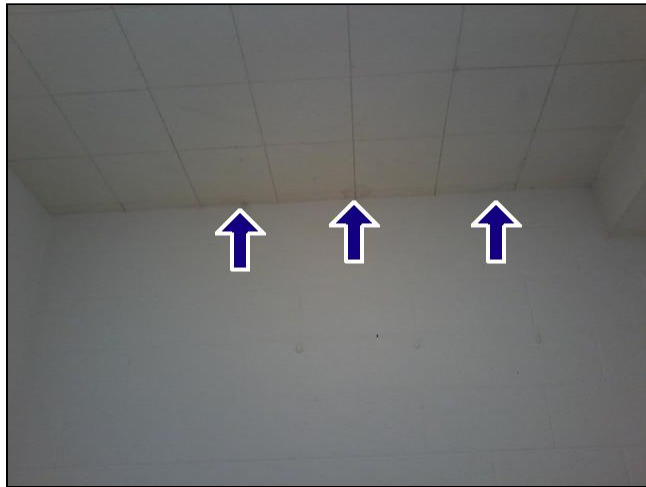
(1) REPAIR AS NEEDED

Slight moisture stains noted on the ceiling at the downstairs left front room near the wall. No signs of current moisture or cause of a leak were noted. Repairs can be made as needed.

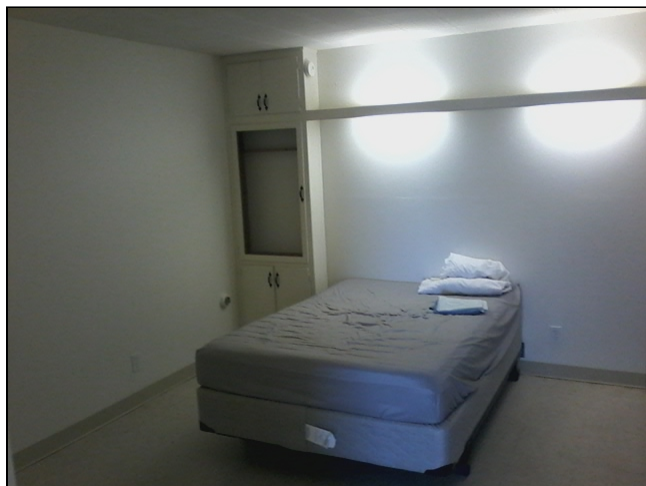
No window installed in the downstairs right front bedroom for emergency egress/exit. This room should not be utilized for a sleeping area until a proper opening is installed.

(1) INSTALLATION NEEDED

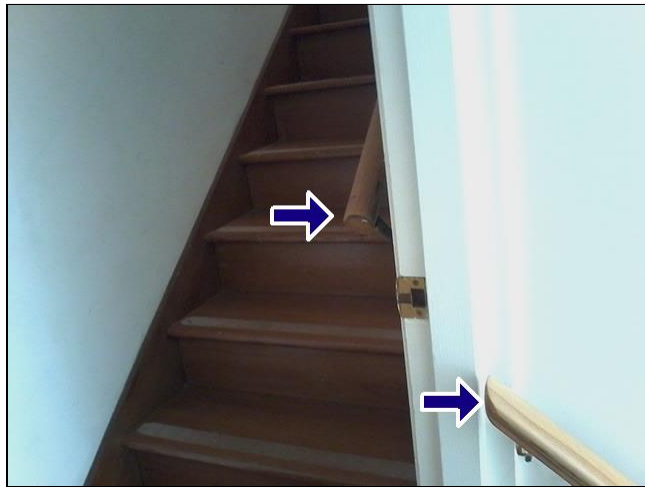
9.4 STEPS, STAIRWAYS, BALCONIES AND RAILINGS

RECOMMENDED IMPROVEMENT

The handrail at the interior stairs does not turn back into the wall and could catch on loose clothing and cause an accidental fall. Recommend the handrail be altered to meet current safety standards.

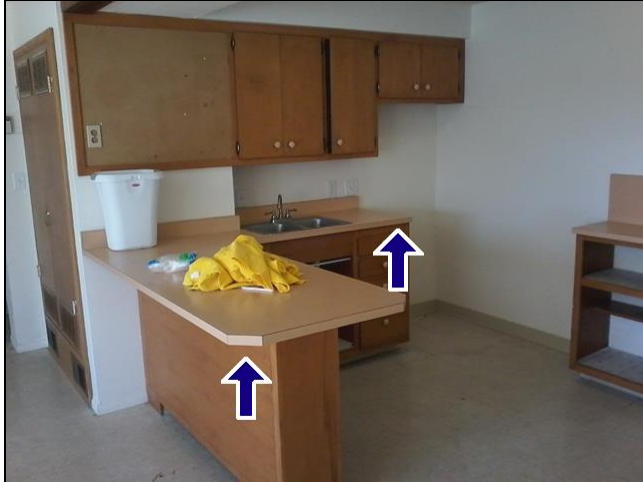
10.4 COUNTERTOPS / CABINETS

INSTALLATION NEEDED

Countertop loose at the downstairs bar sink area and needs properly fastened to prevent displacement or damage.

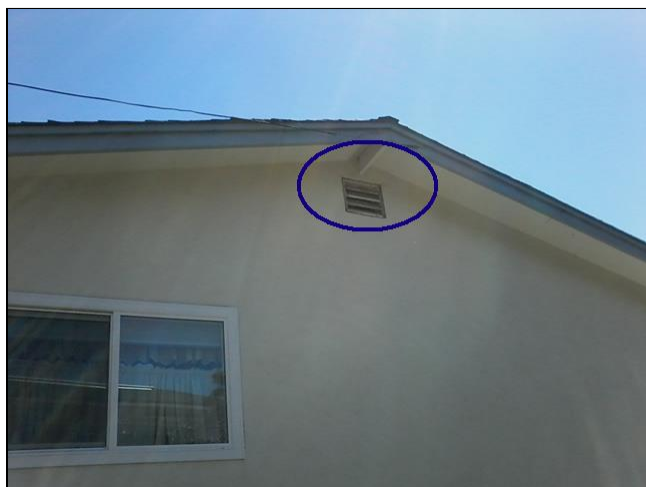
(1) REPAIR NEEDED

Attic vent screen damaged at the right side gable vent. Recommend repair or replacement of the screen material to prevent access for unwanted pests or rodents.
