Transferee Name:	<u>Harry Mckinley</u>	Street Address:	<u>48 Via Divertirse</u>
City:	<u>San Clemente</u>	State / Zip:	<u>CA, 92673</u>
Customer:	<u>Graebel Companies</u>	File Number:	<u>APRO247517</u>
Customer Contact:	<u>Diana Lettieri</u>	Report Date:	<u>6-28-2017</u>

Date of Inspection:	<u>06/27/2017</u>	Time:	<u>12:00 pm</u>
Weather:	<u>Clear</u>	Temperature:	<u>95°F</u>
Occupied:	<u>Yes</u>	Parties Present:	<u>Homeowner</u>

Inspection Type: Stucco Identification

Inspection

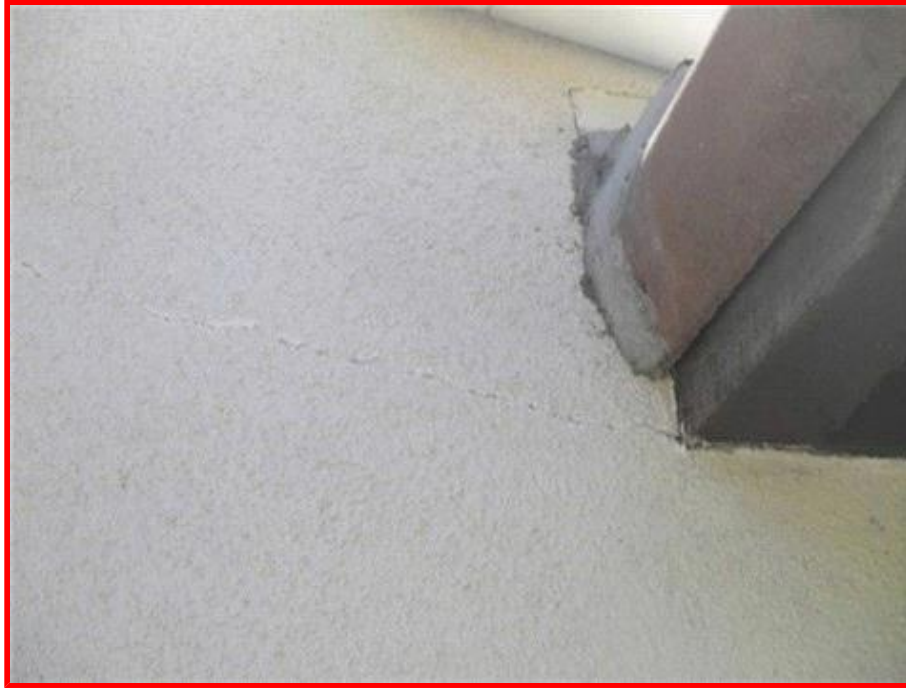
Cracks in Stucco at Front

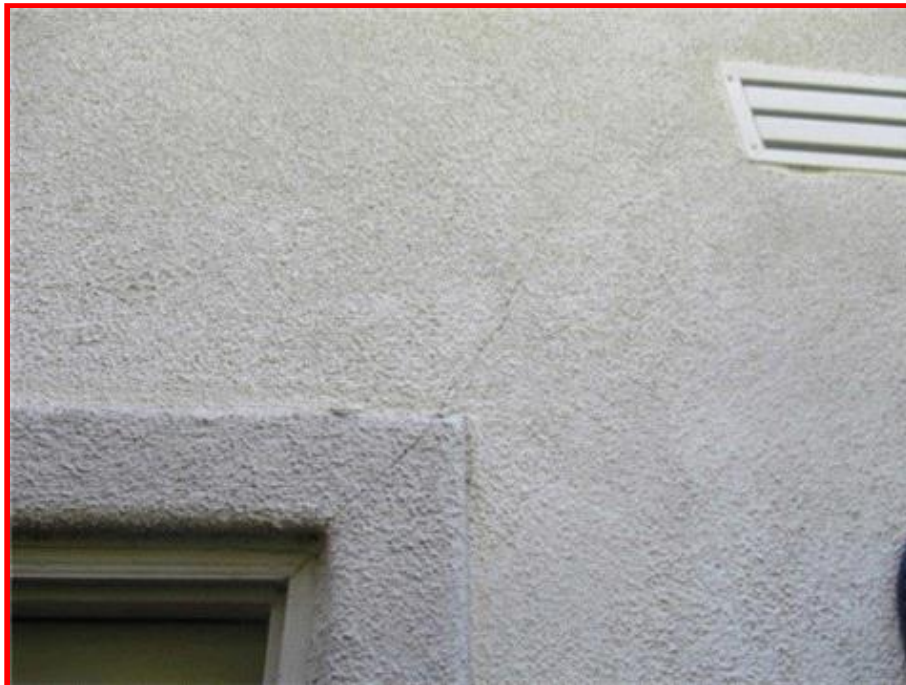
Cracks in Stucco at Garage

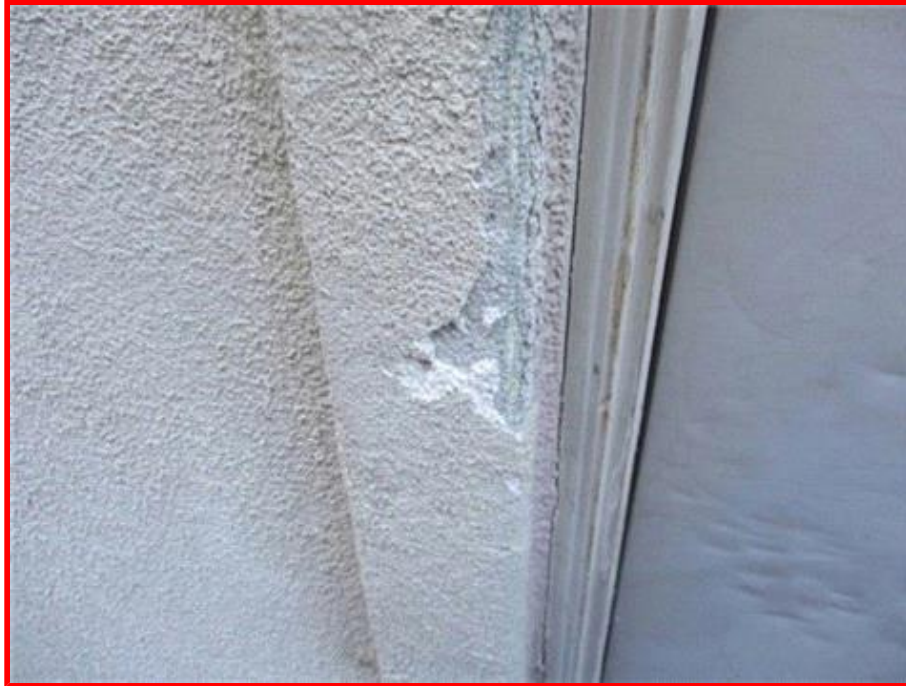
Defects Present in the Stucco: The left side garage door trim is damaged, exposed / damaged corners were observed at the atrium, rear, and right rear side of the home.

Damaged Garage Door Trim

Qualified contractor to repair the stucco.

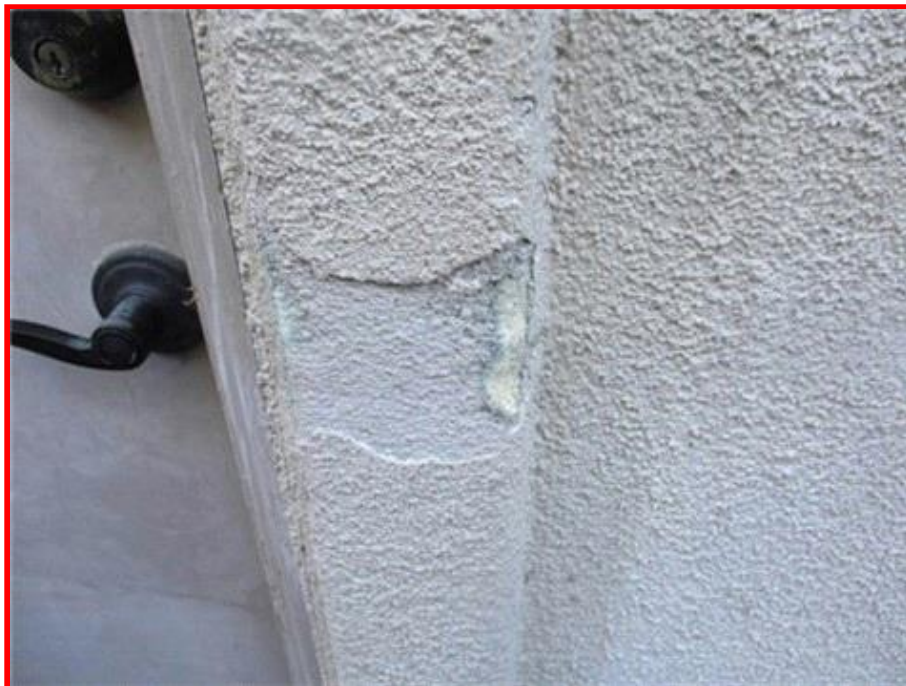
Damaged Garage Door Trim

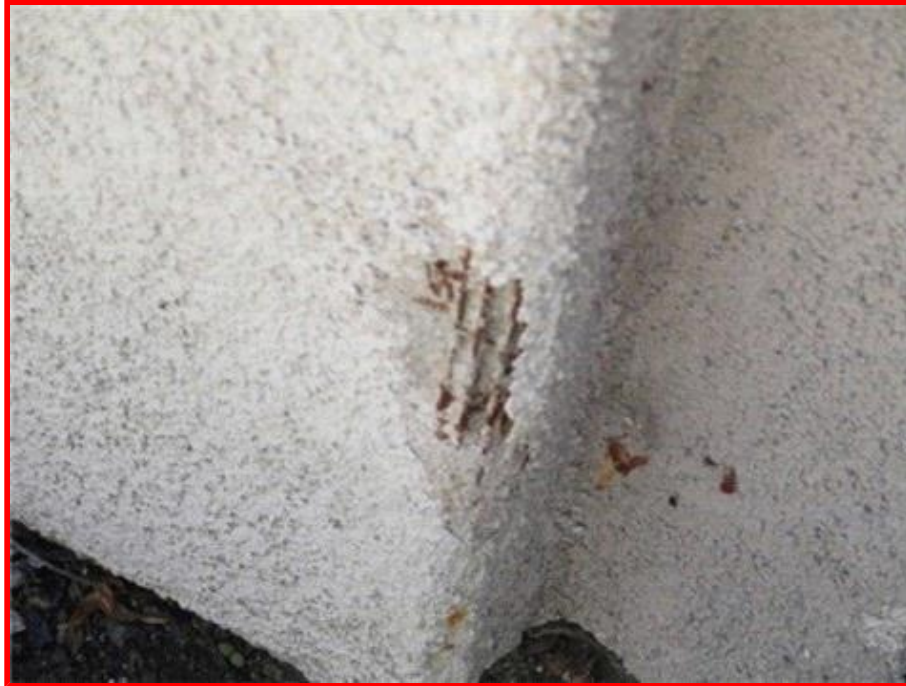
Exposed Corner / Damage at Atrium

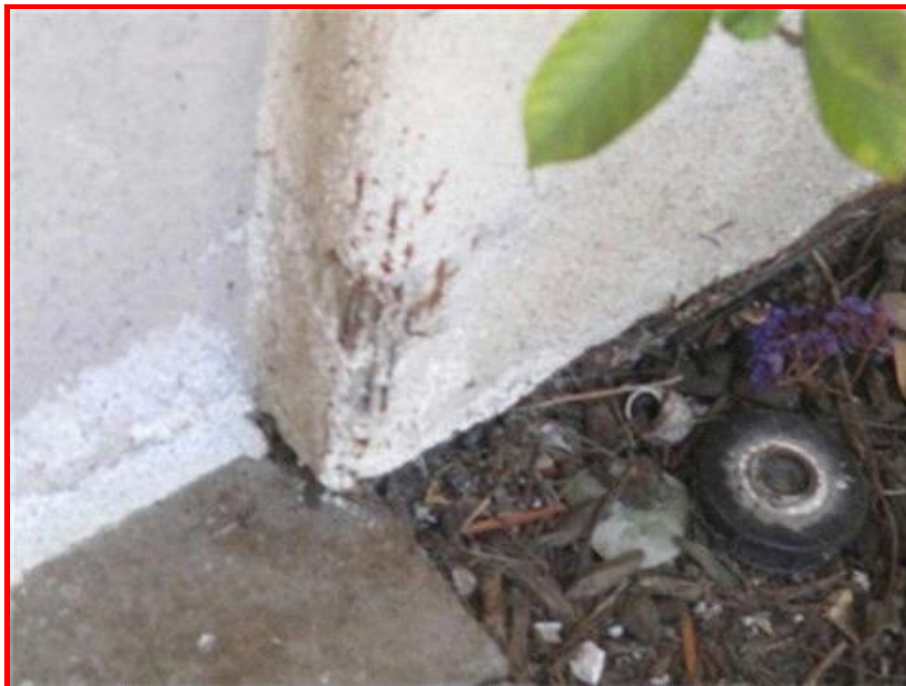
Exposed Corner / Damage at Rear Door
