Certification-Report of Inspection-Individual Sewage Disposal System

Property Address: 2480 Mesa Ranch Road Arroyo Grande, CA.

Al's Septic Pumping Service Inc.-Inspection Report

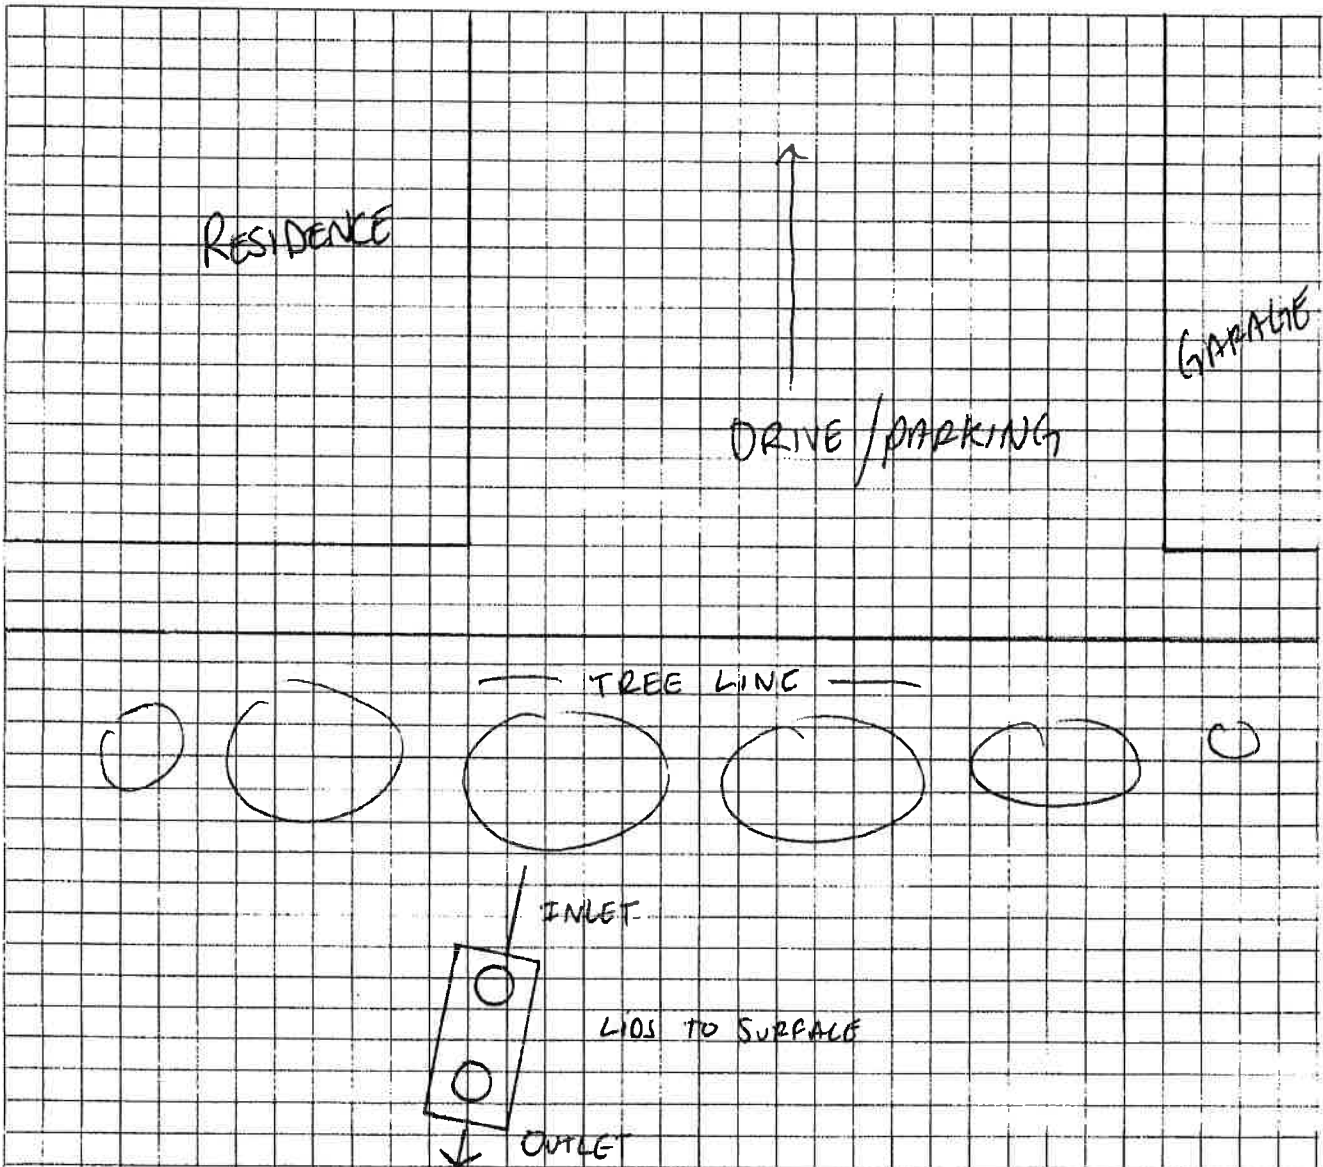
System Location & Site Sketch

Locations of the septic tank and leach field above are approximate only. The exact location or dimensioning is not within the scope of this inspection. Drawing is not to scale.
