Staci's Home Inspections
310-948-9675

Inspection Report

Property Address:
6953 Purple Ridge Dr.
Rancho Palos Verdes CA 90275

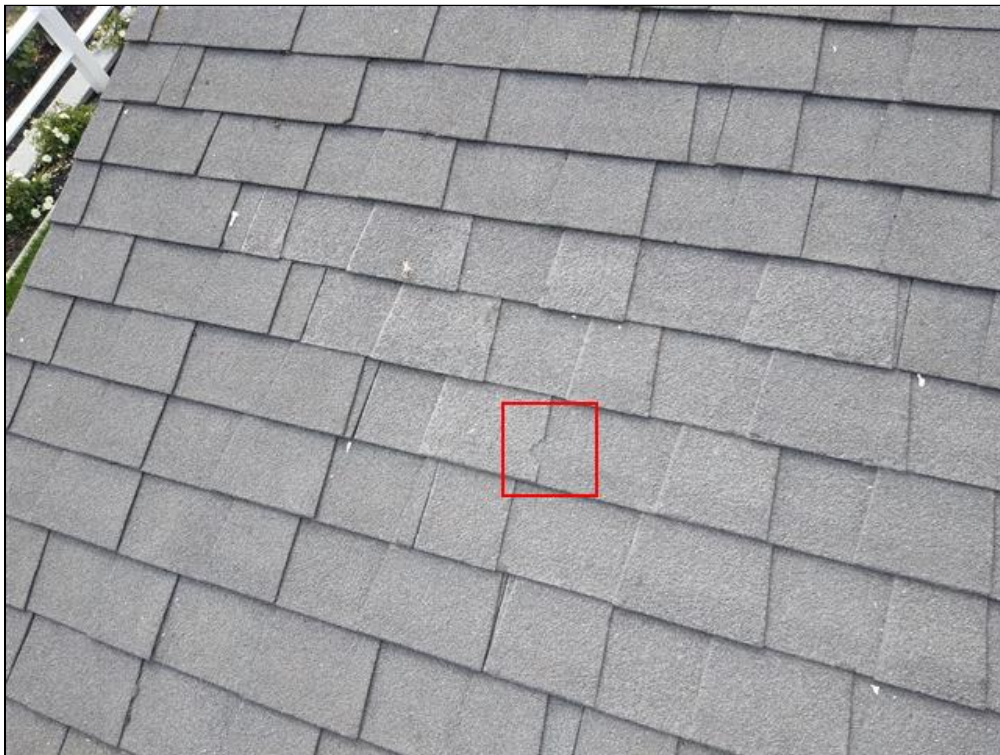
1.0 (1) Asphalt composite shingle roof covering is older and worn. Anticipate replacement, especially as roof cover ages. Consult licensed roofer for full evaluation and cost estimates for repairs/replacement as needed for lasting performance.

1.0 Item 1(Picture) Wear noted

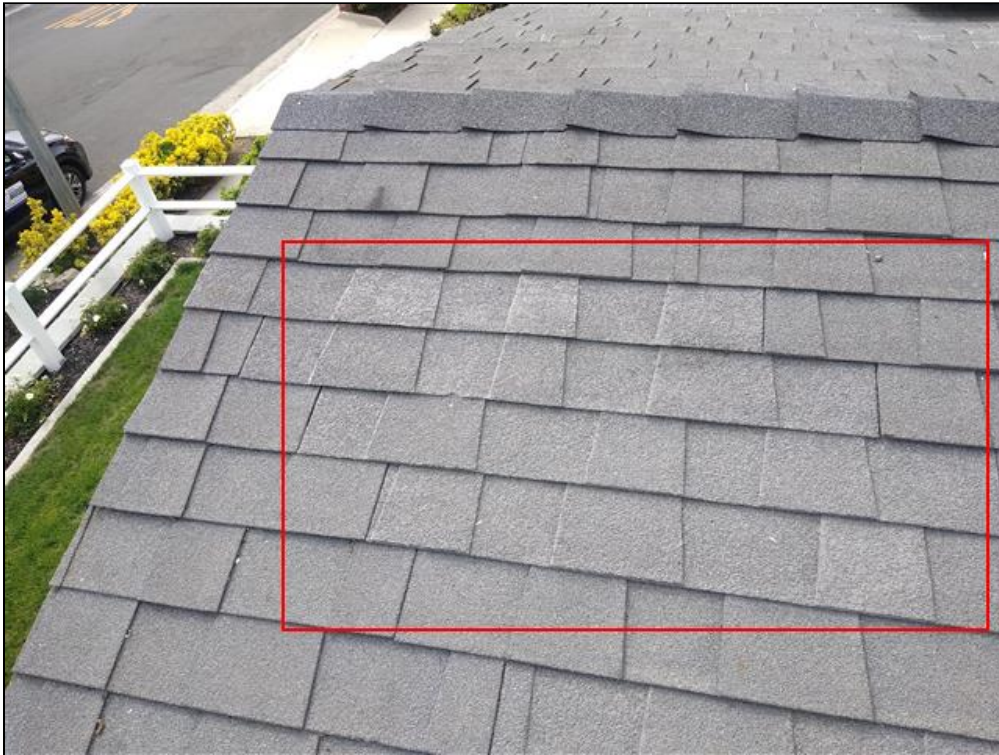
1.0 Item 2(Picture) Wear noted

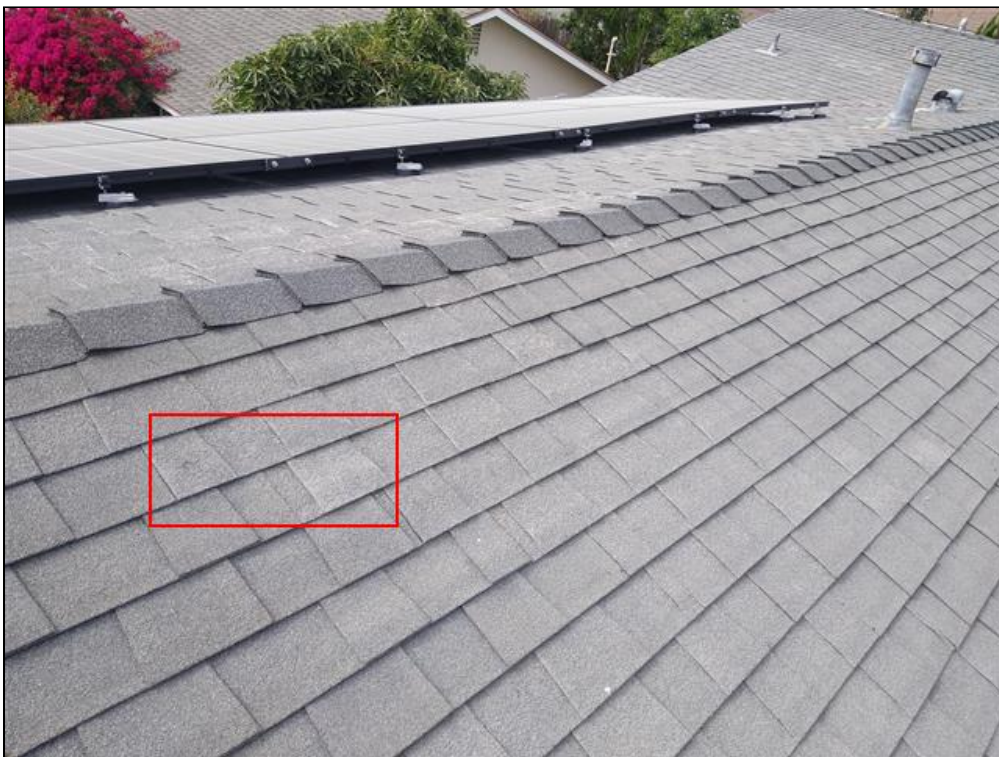
1.0 Item 3(Picture) Wear noted

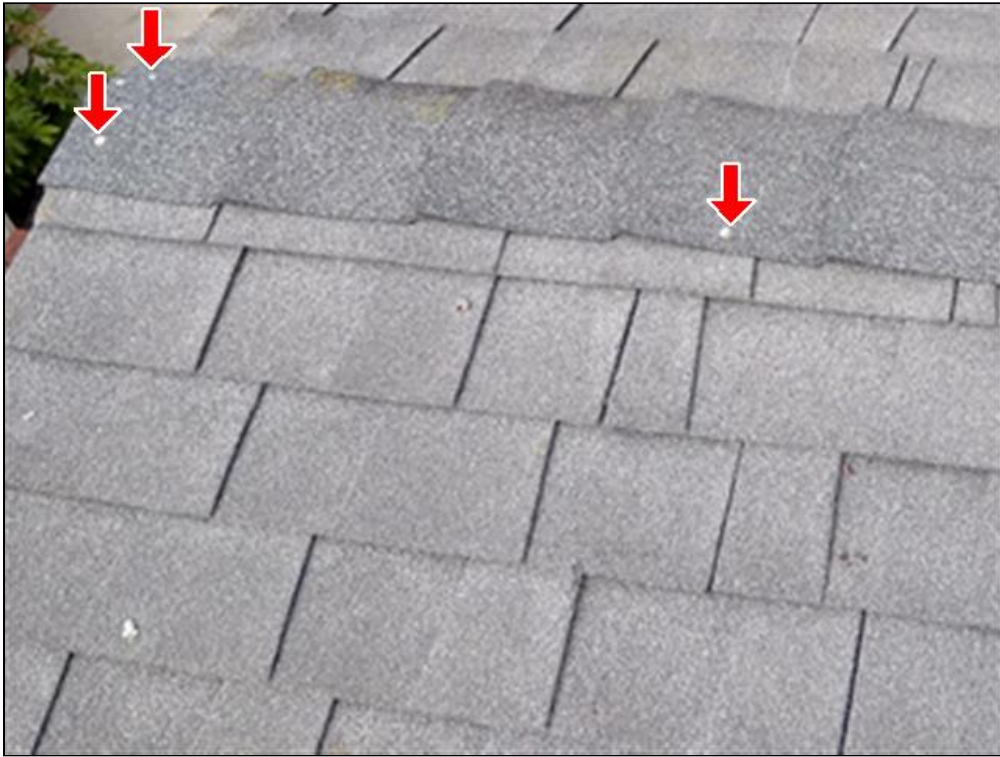
Ex: Item 9 - Exposed fasteners/nails noted at various locations of roofing, which may become pathways for water entry. Recommend sealing at nails/fasteners to prevent moisture penetration.

1.0 Item 9(Picture) Exposed fasteners noted

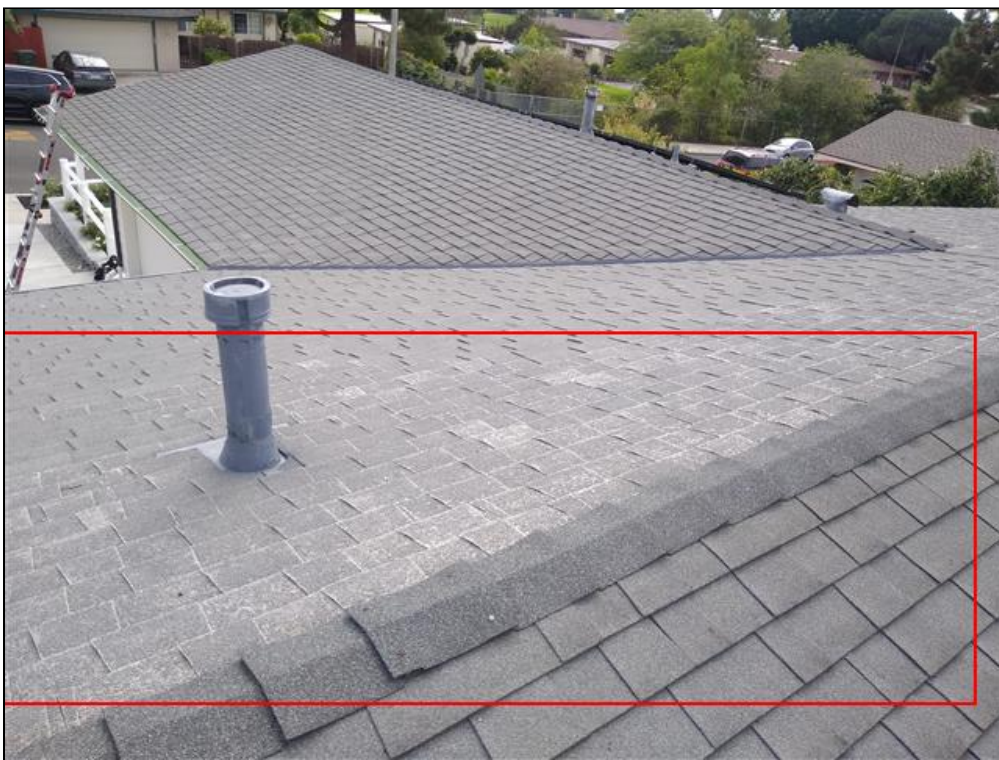
1.0 Item 11(Picture) Wear noted at shingles

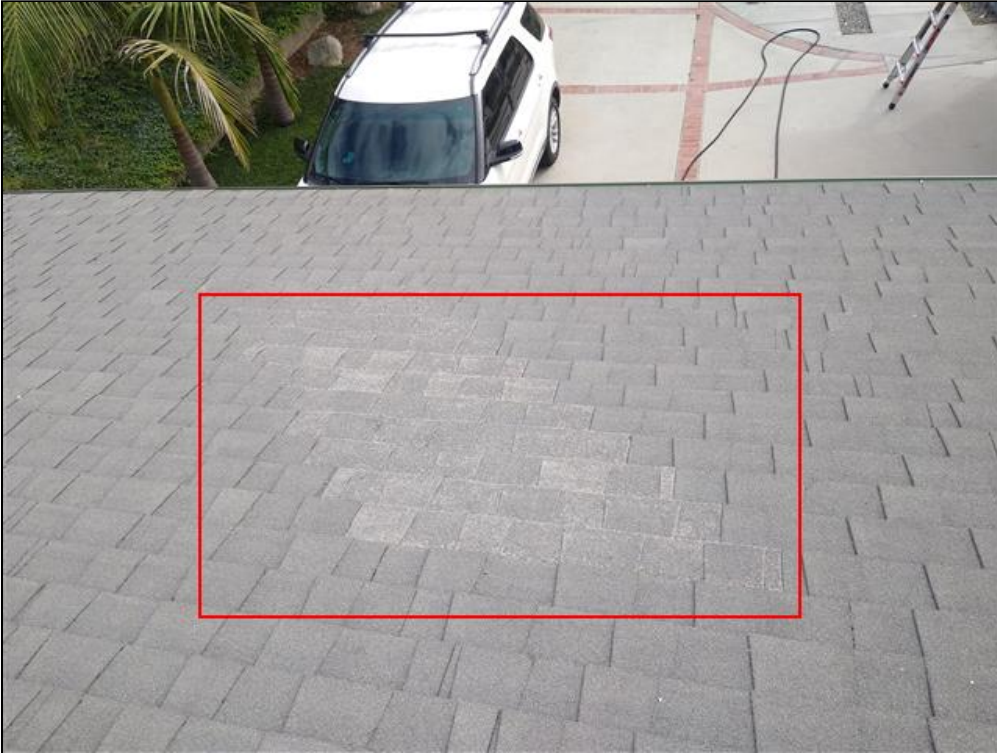
1.0 Item 12(Picture) Wear noted

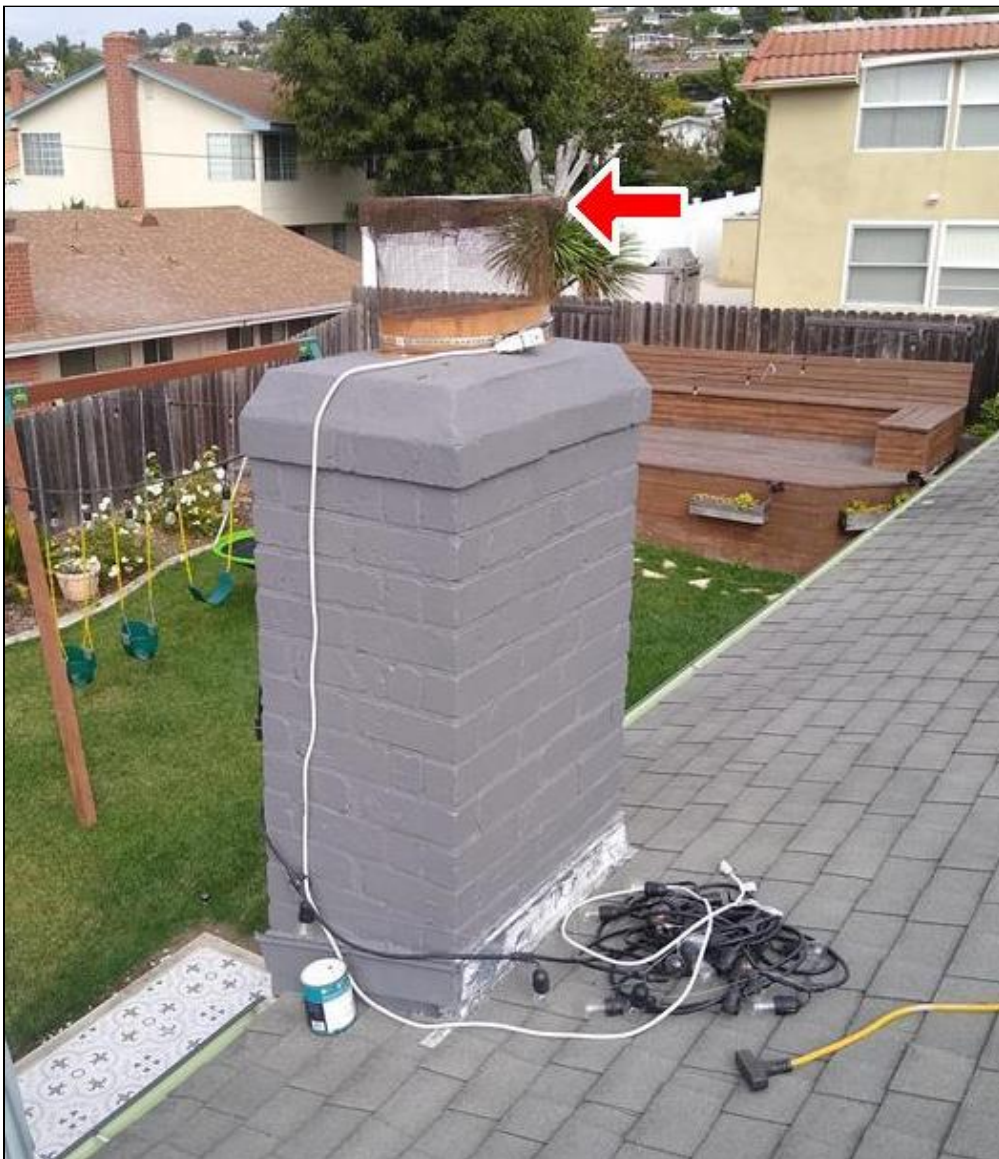
1.1 Item 1(Picture)

1.1 Item 1 - Unconventional raincap noted, which may not provide enough coverage/shielding from rainfall. Contact licensed chimney sweep for further evaluation and upgrades as needed to prevent water intrusion in chimney

assembly. NOTE: Efflorescence (white chalky/crystalline deposits) were already observed at various locations of fire box and smoke chamber area. (See comments under Interior: Fireplace for further details.)

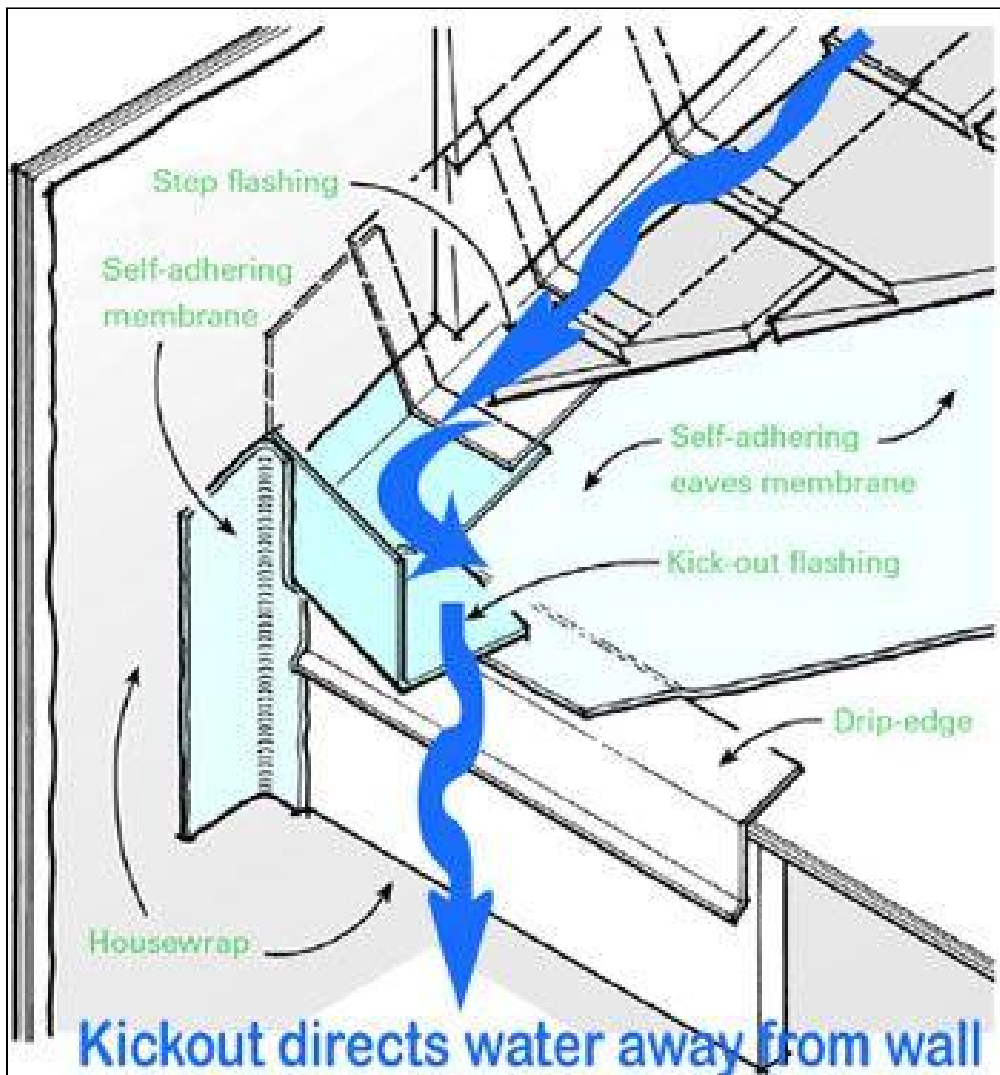
1.1 Item 4(Picture) Diagram of kick-out flashings.

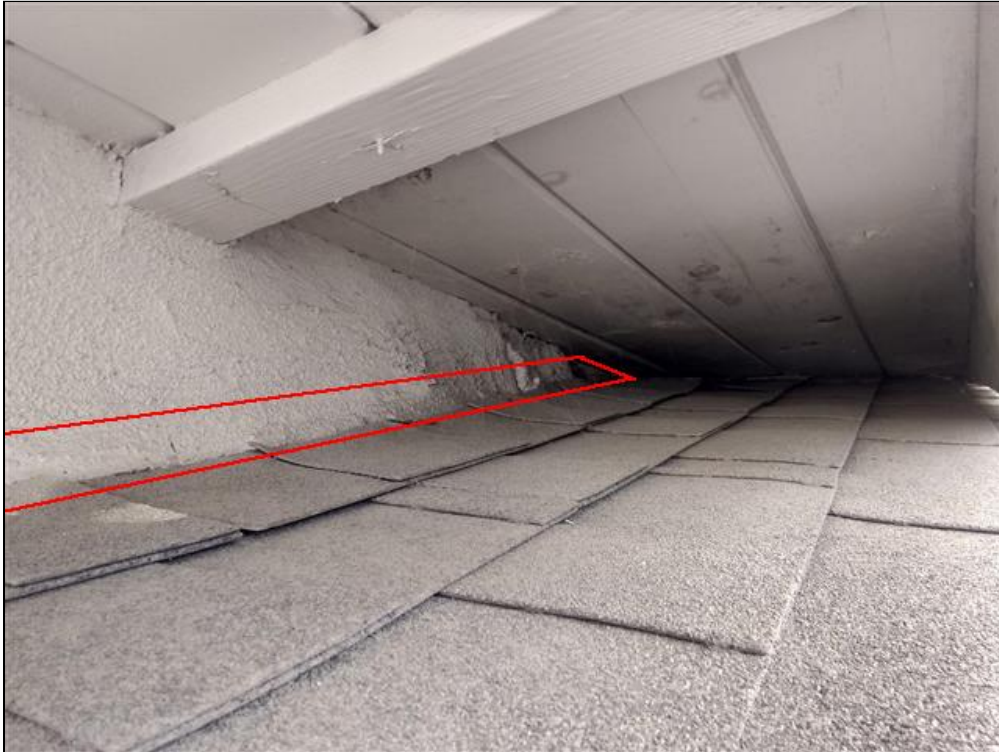
No flashing noted at various locations. Consult roofer for further evaluation and installation for proper drainage of roof system.

1.2 Item 1(Picture) No flashings noted, central/W

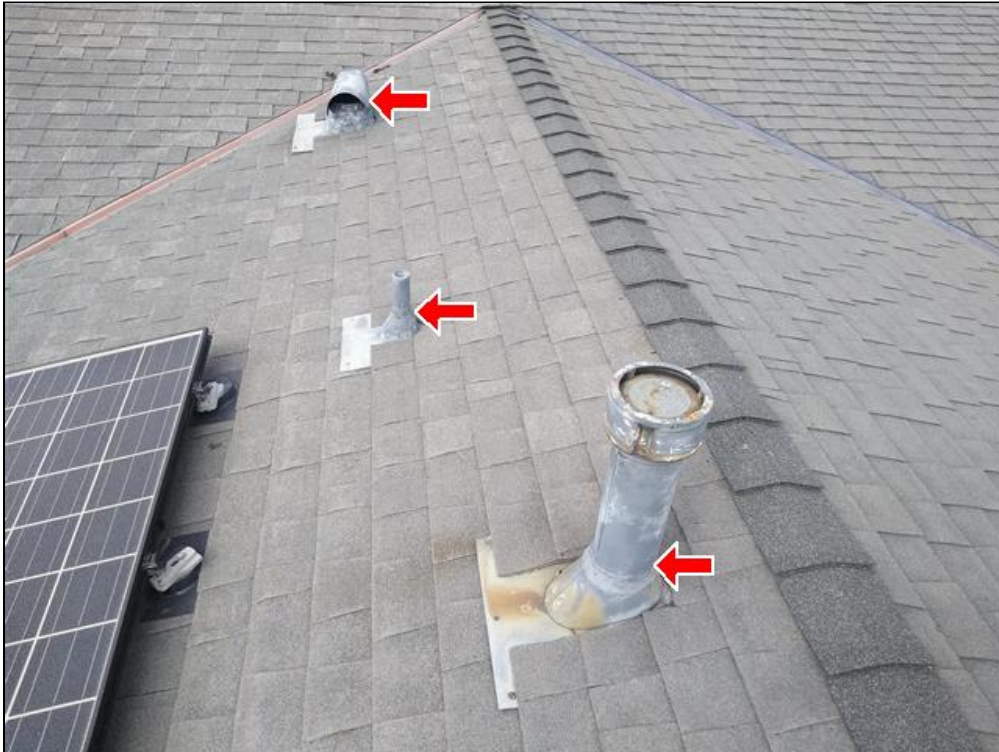
1.4 Item 1(Picture) MAINTENANCE TIP: Suggest painting exterior metal materials to prevent corrosion/weathering.

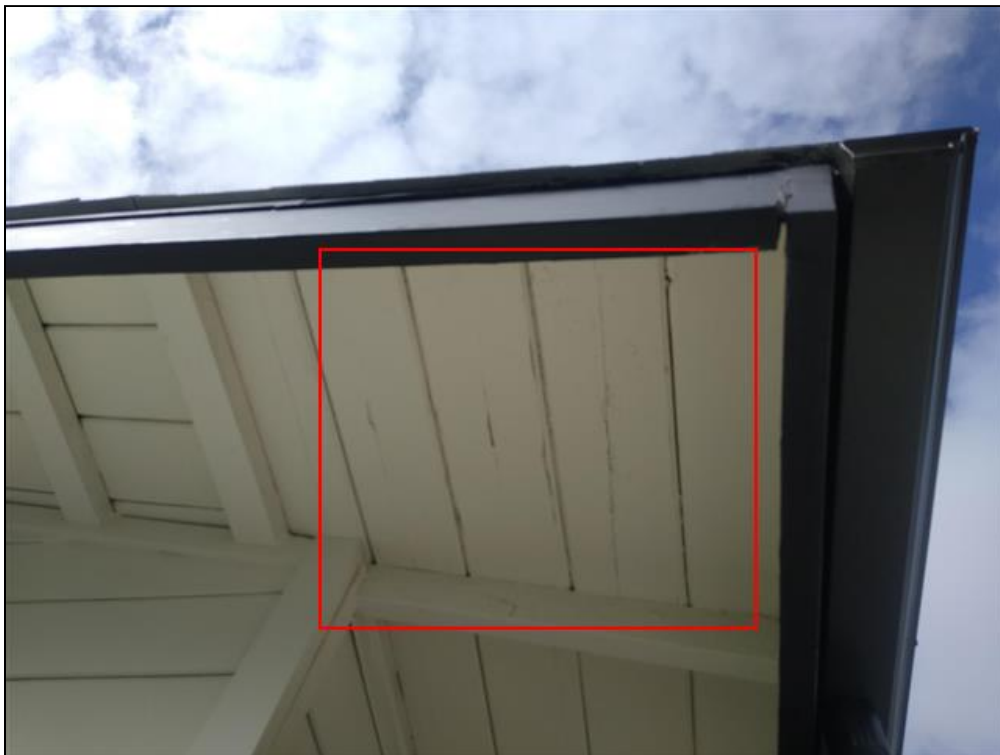
Paint is peeling and/or loose at various locations at fascias / soffits. Older paint layers from before 1979 may contain lead. Suggest repairs and repainting to preserve wood components and protect materials from weathering. Recommend testing paint before working with materials for safety.

1.6 Item 3(Picture) Wear noted

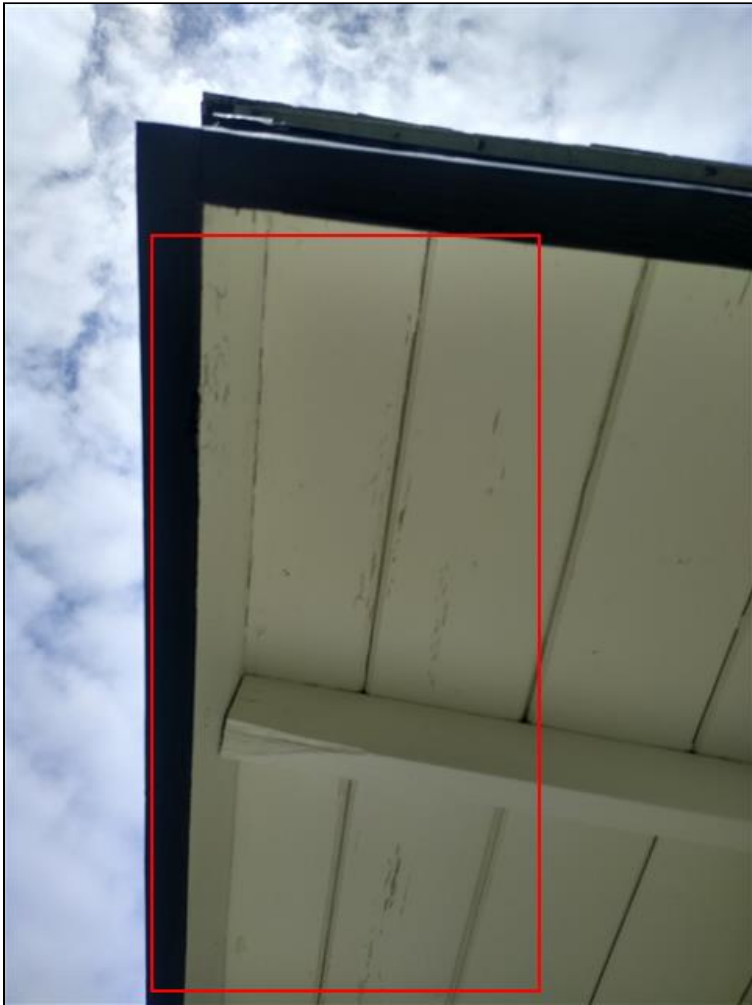
1.6 Item 4(Picture) Wear noted at paint

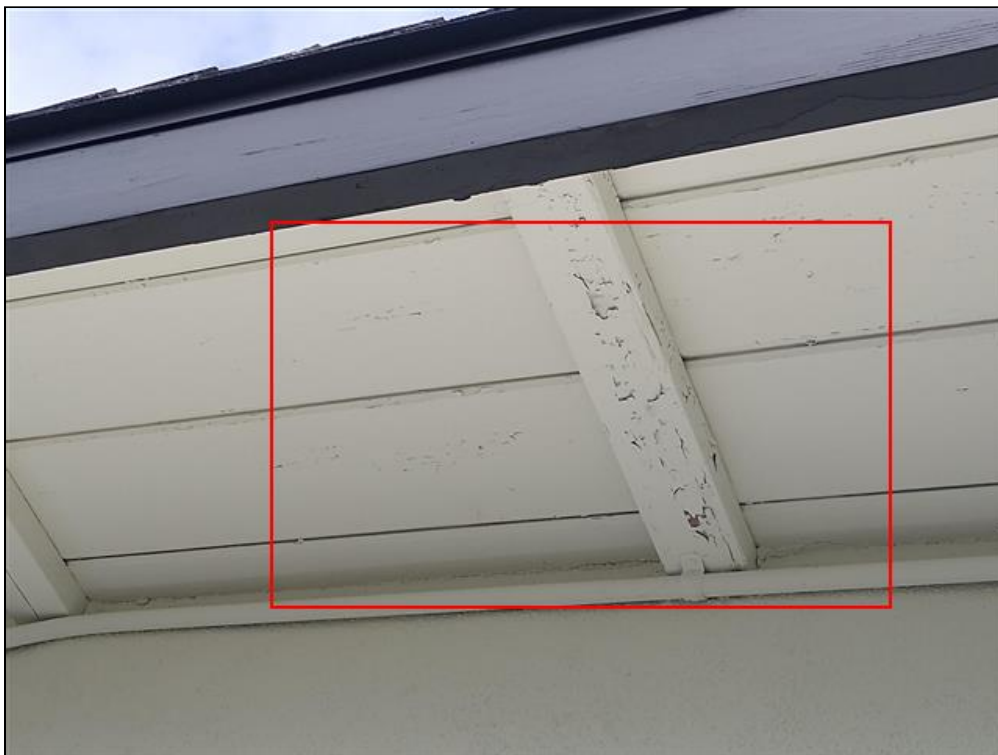
1.6 Item 5(Picture) Peeled paint noted

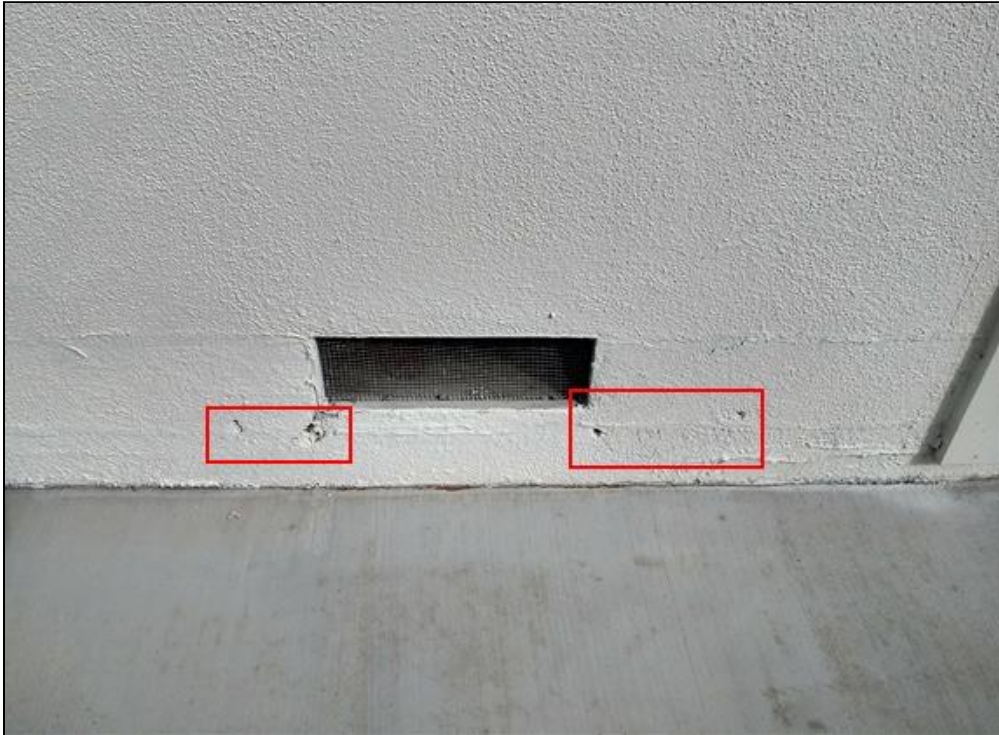
2.0 (1) Stucco exhibits cracking at various locations of structure. Suggest sealing at cracks, any gaps, around light fixtures, windows, doors, trim, penetrations, etc...to aid in preventing water intrusion.

2.0 Item 1(Picture) Wear noted at stucco

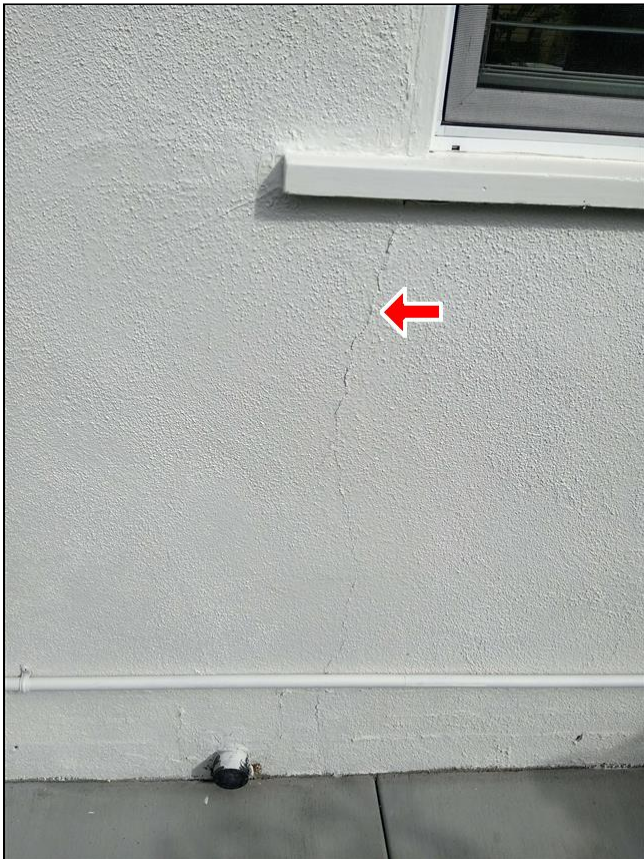
2.0 Item 4(Picture) Cracking noted

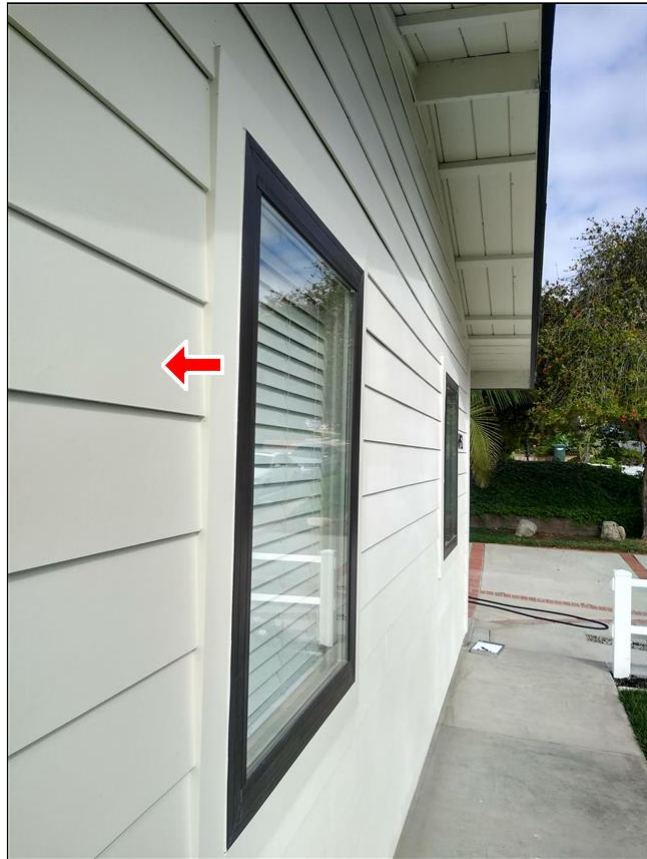
Composite siding also noted at front of structure (Ex: Item 6). Ask seller for history/product information and consult manufacturer's instructions for proper care/maintenance. Recommend routine repairs/repainting to protect materials from weathering.

2.0 Item 6(Picture) Composite siding noted

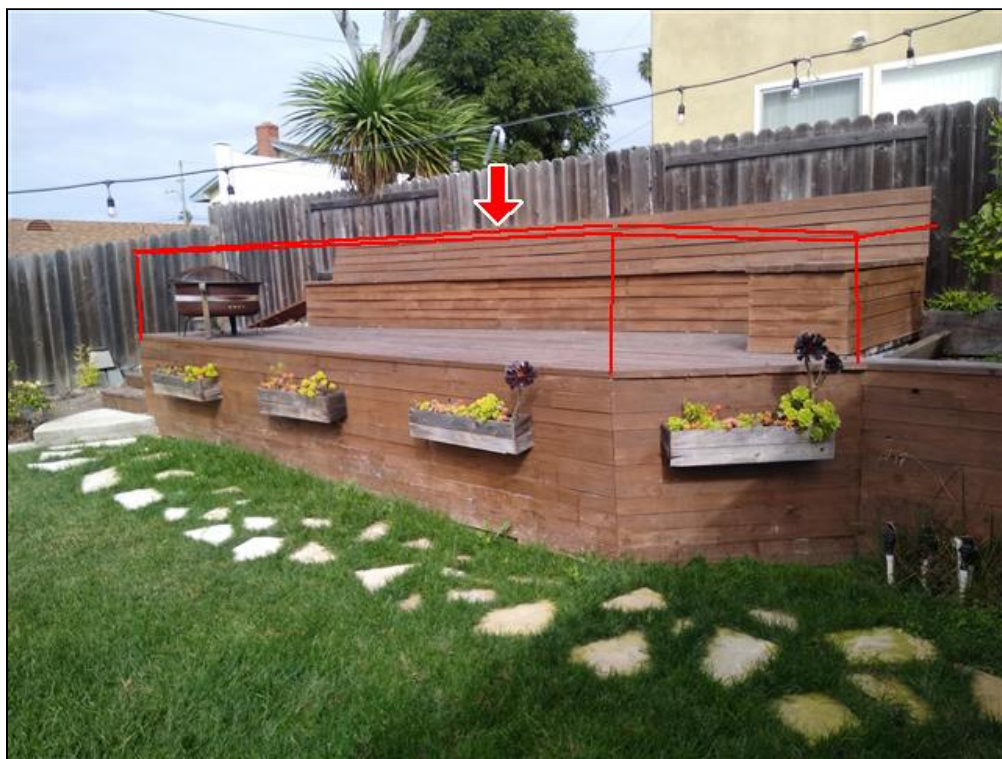
- Item 1 - No guard railing assembly noted at elevated deck, which is more than 30" above grade and presents a safety concern in the presence of children. Contract qualified contractor for further evaluation and cost estimates for proper installation as desired.
- Item 3 - No hand railing noted at steps, which have more than 4 risers. Recommend adding handrailing as needed for safety.
- Wear noted at deck wood components. MAINTENANCE TIP: Recommend periodic repairs/resealing at exterior wood components with weatherproof, UV-protective sealant/stain/paint to protect materials and for lasting performance.
- Checking/splitting/wear noted at planks at various locations. (Ex: Item 7 and Item 10). Warping noted. (Ex: Item 9 at benching).
- Item 8 - Loose plank noted at benching (towards left area).

2.2 Item 1(Picture) No guard railing noted

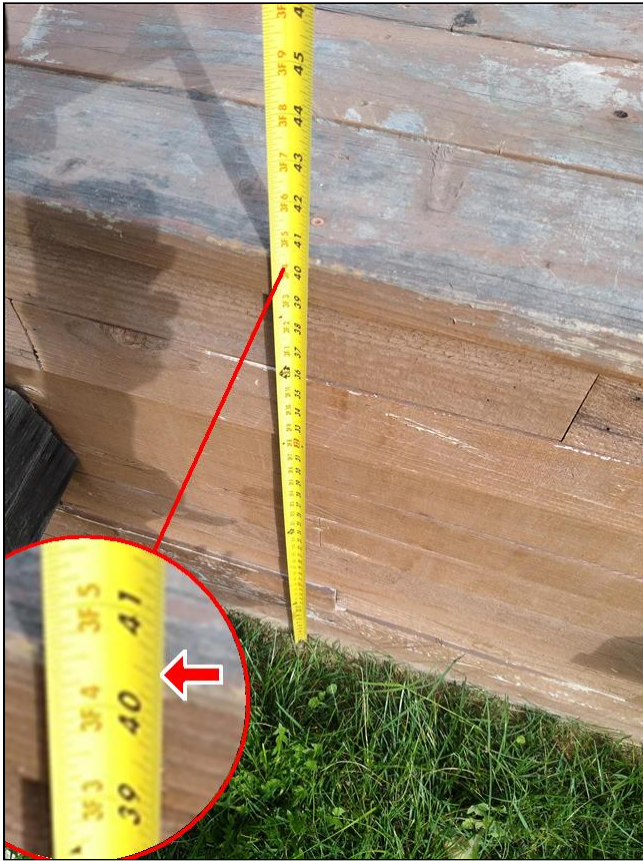
2.2 Item 2(Picture) Deck is greater than 30" above grade

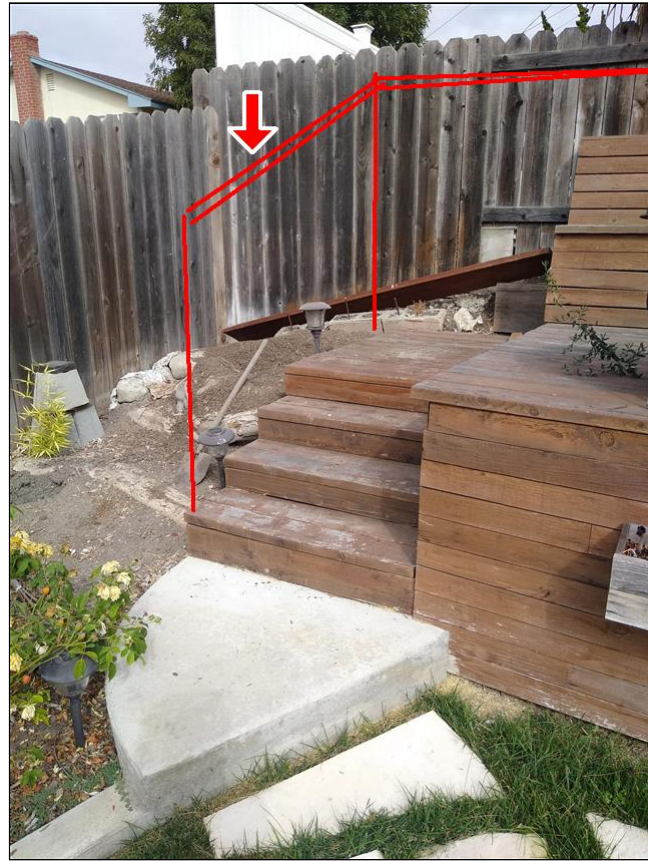
2.2 Item 3(Picture) No handrailing noted

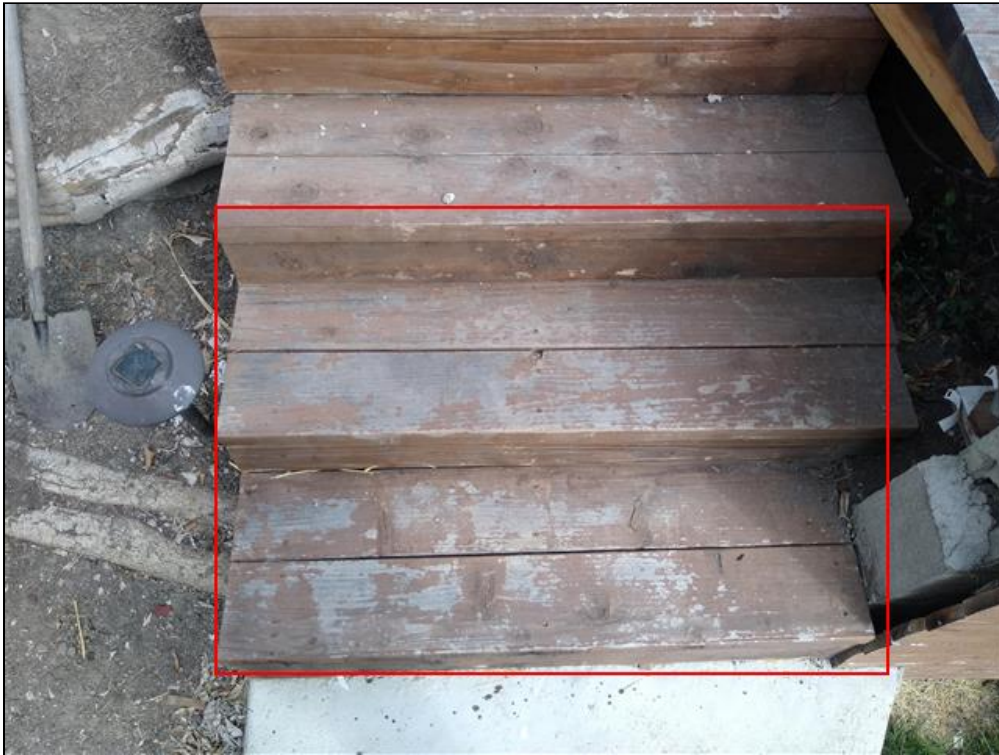
2.2 Item 4(Picture) Wear noted at deck

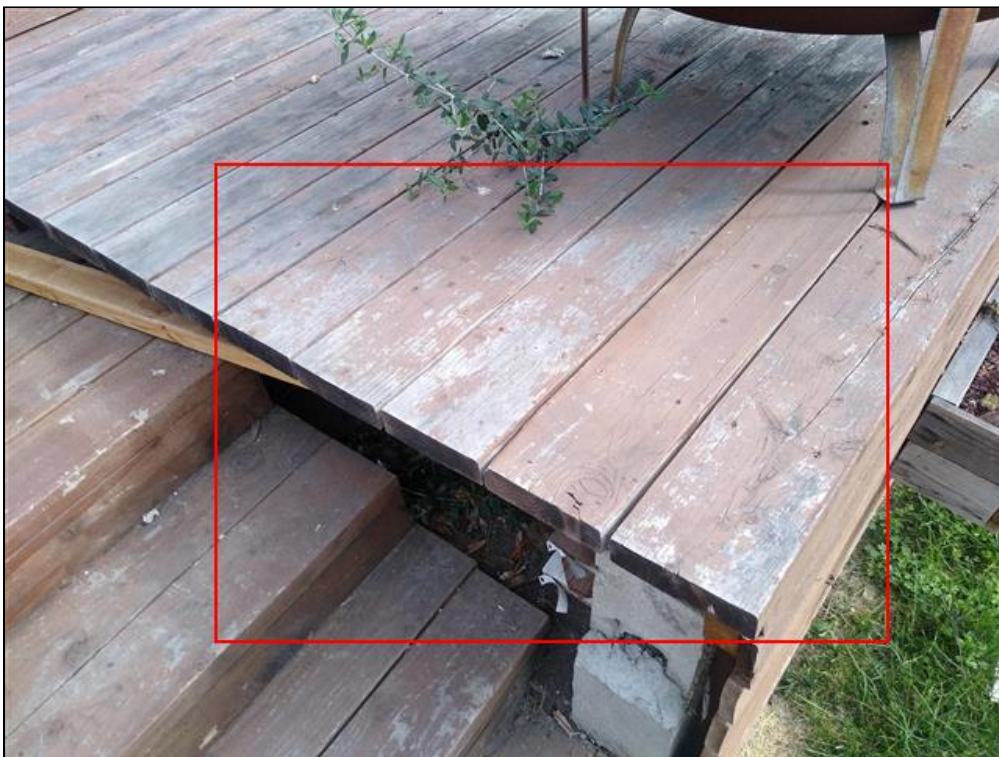
2.2 Item 5(Picture) Wear noted at deck

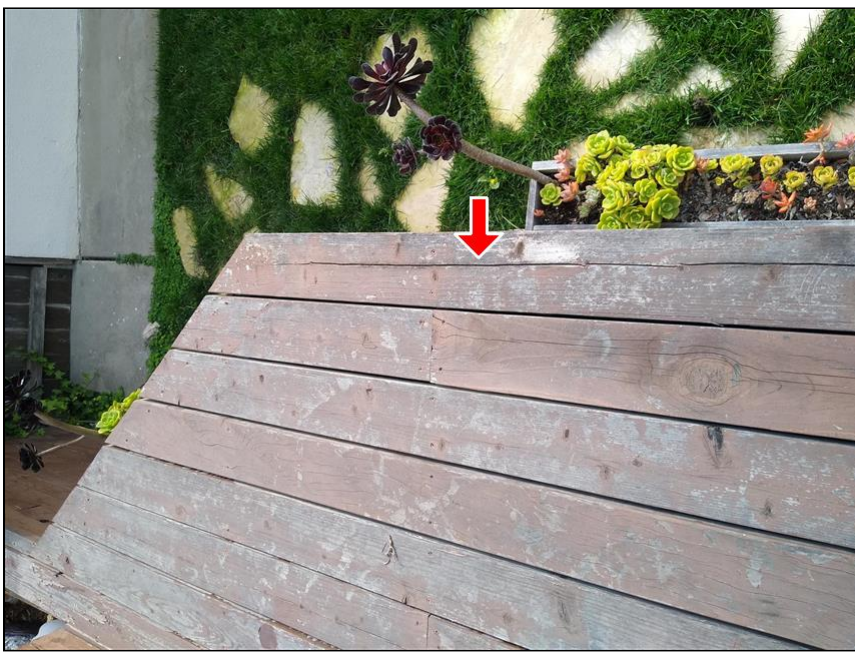
2.2 Item 7(Picture) Splitting noted at plank. Suggest repairs/ replacement.

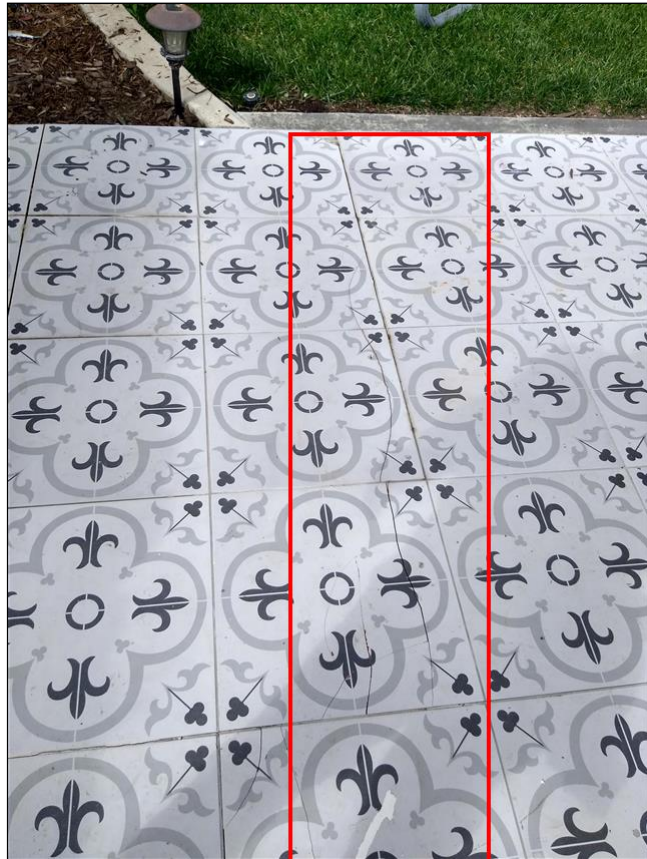
2.3 (1) Tiled area noted at patio. Tiles at various locations are cracked/missing. Suggest repairs/replacement as desired.

2.3 Item 2(Picture) Cracking noted at tile

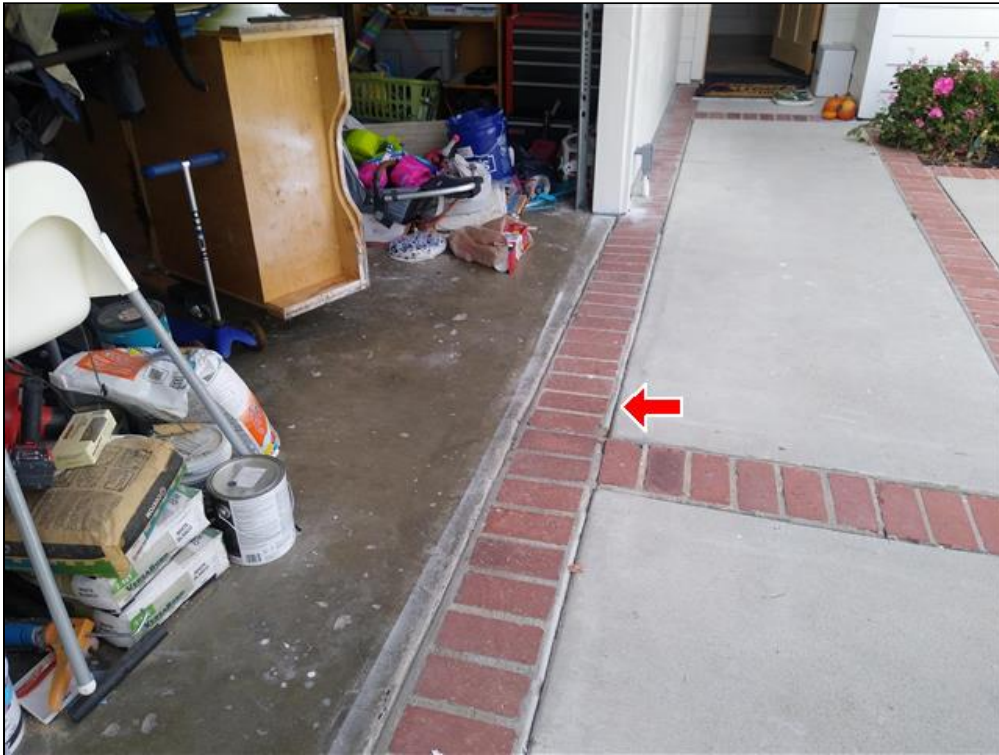
2.4 Item 2(Picture) MAINTENANCE TIP: Suggest repairs/sealing with elastomeric expansion joint to prevent water seepage and subsequent differential settlement/cracking

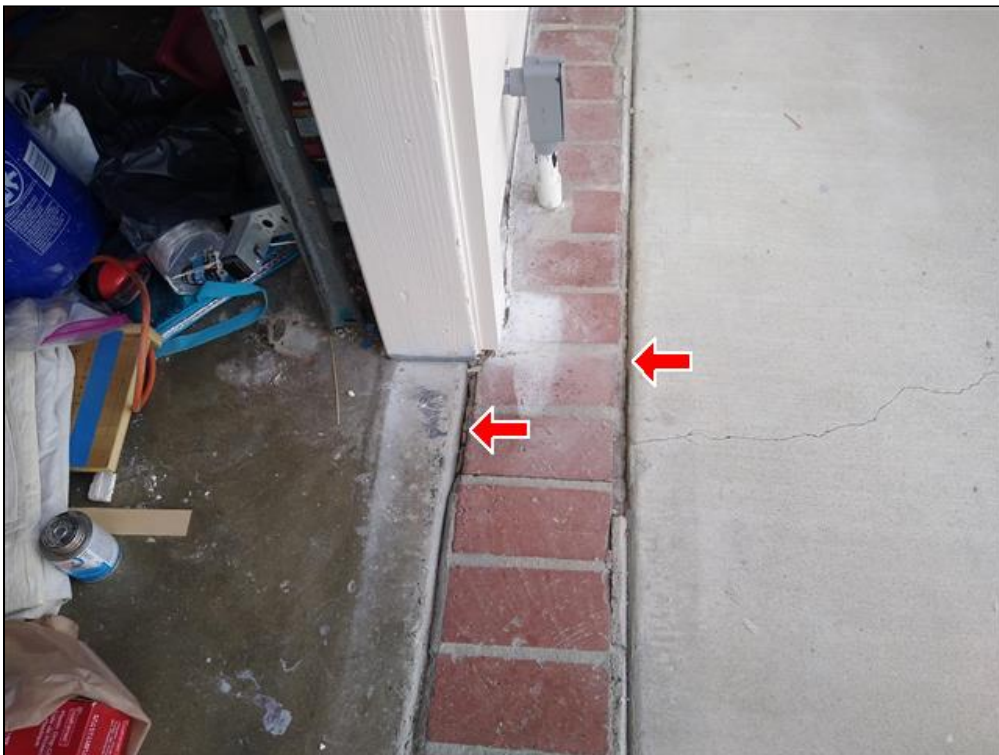
2.4 Item 3(Picture) Close-up of Item 2

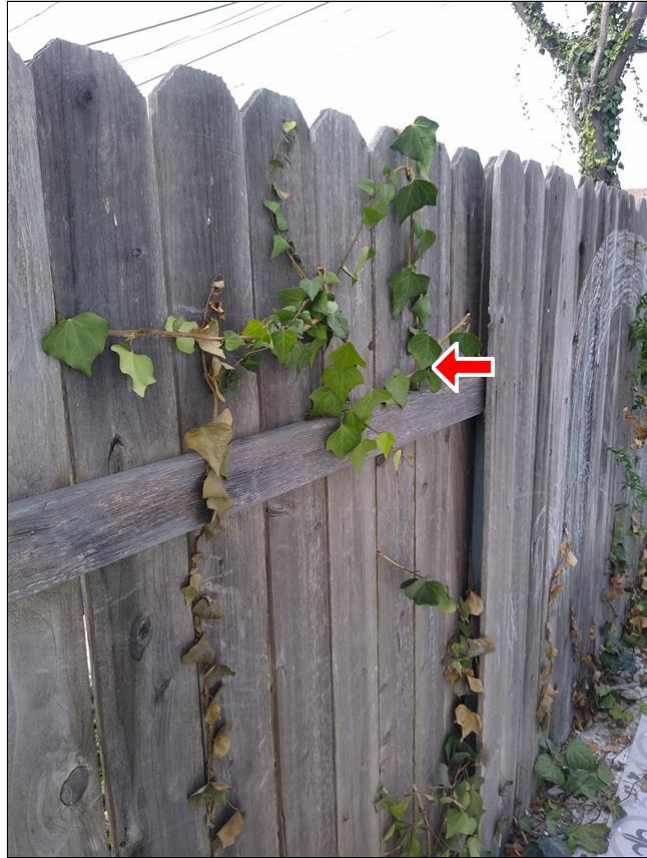
2.6 Item 3(Picture) Vegetation noted

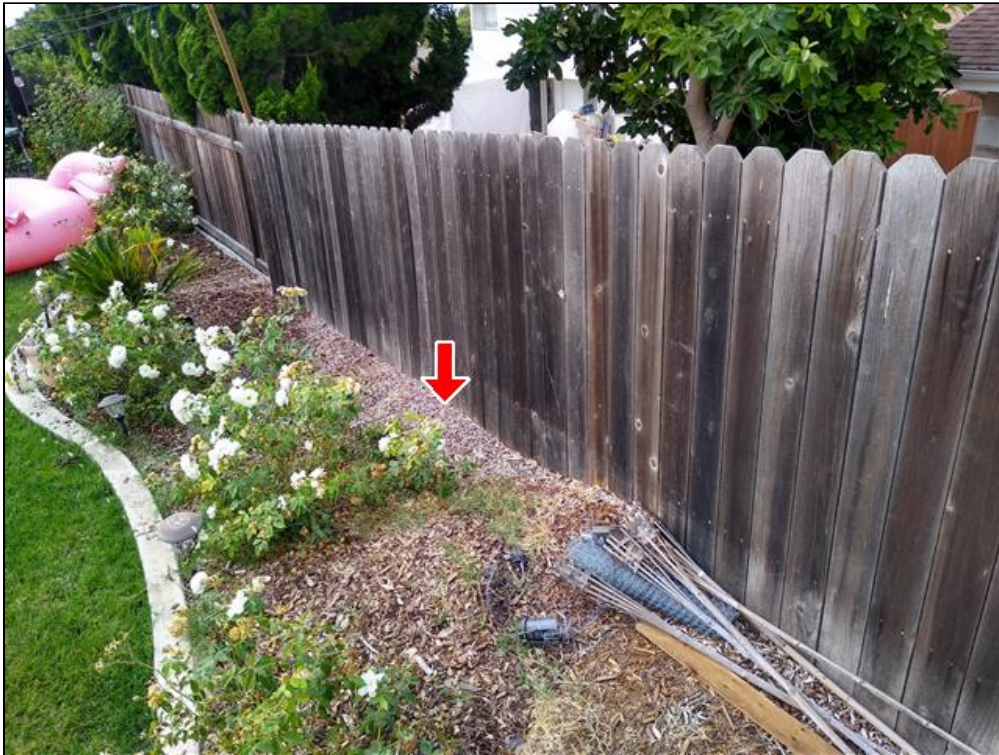
Item 3 - Soil is too high at fence areas. Recommend lowering and removing soil away from wood to prevent moisture deterioration.

2.6 Item 4(Picture) High soil noted

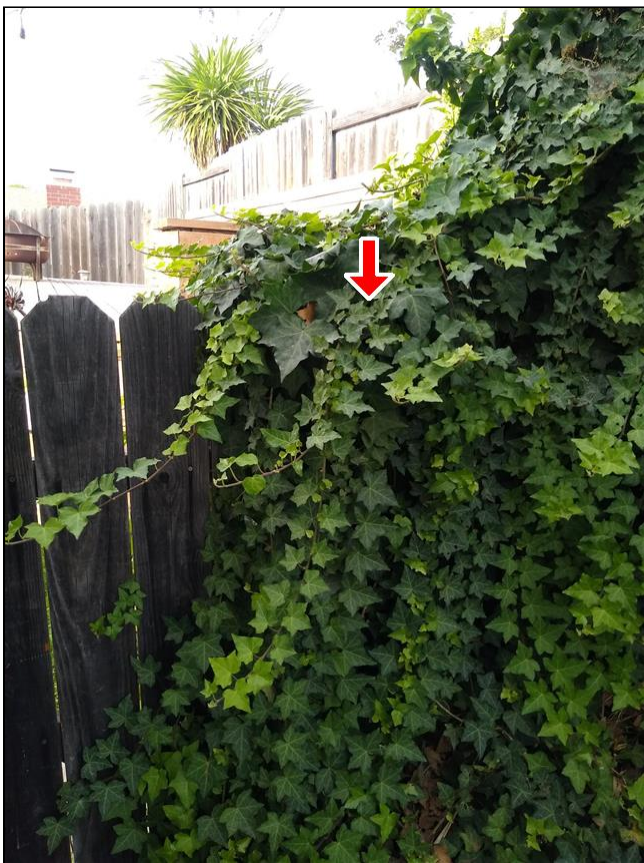
2.6 Item 5(Picture) Vegetation noted at fencing

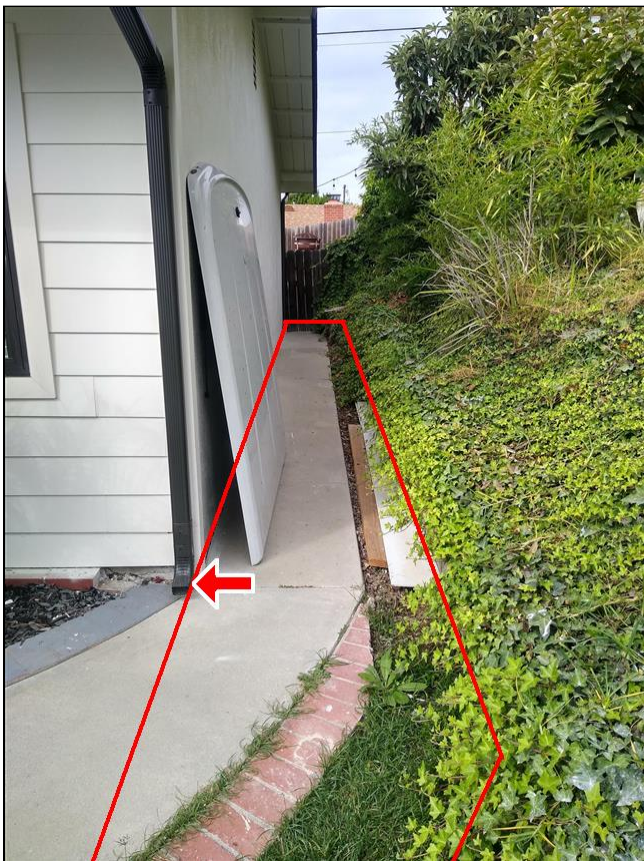
2.7 Item 1(Picture) Area of drainage concern with nearby downspout

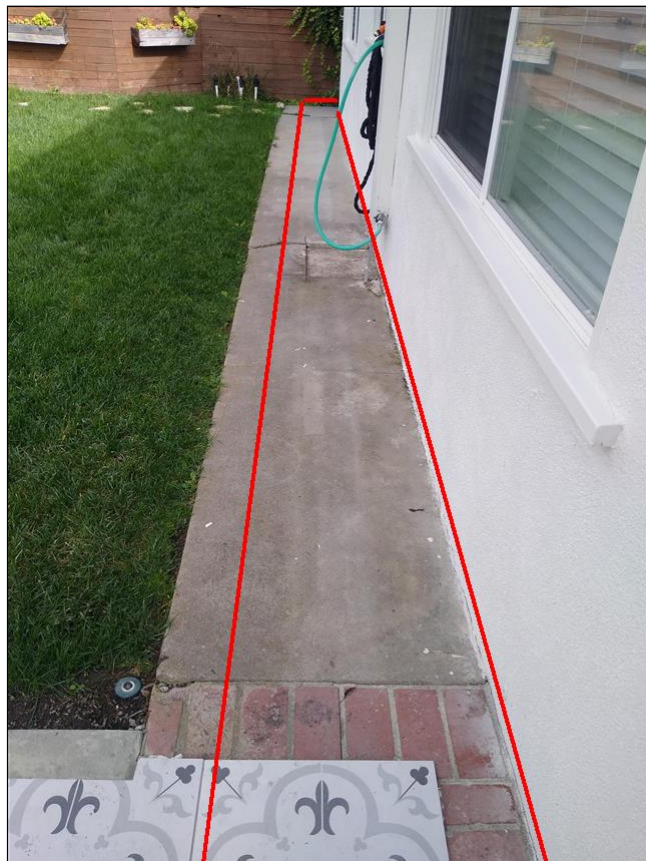
2.7 Item 2(Picture) Area of drainage concern

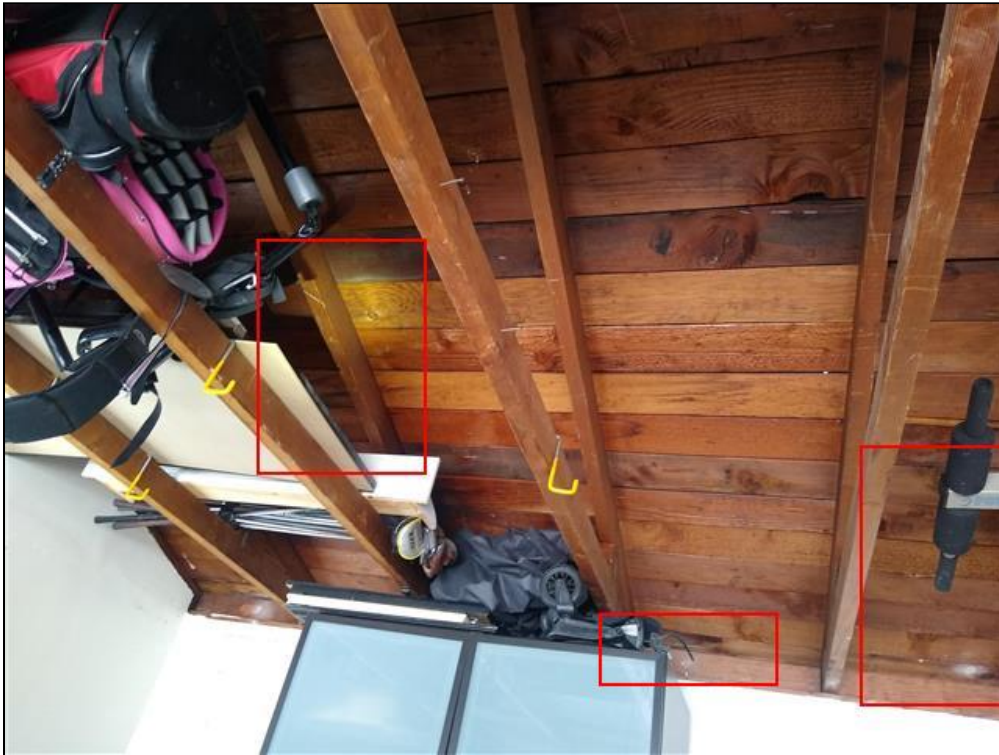
3.0 Item 2(Picture) Staining noted
