Staci's Home Inspections
310-948-9675

Inspection Report

Property Address:
6953 Purple Ridge Dr.
Rancho Palos Verdes CA 90275

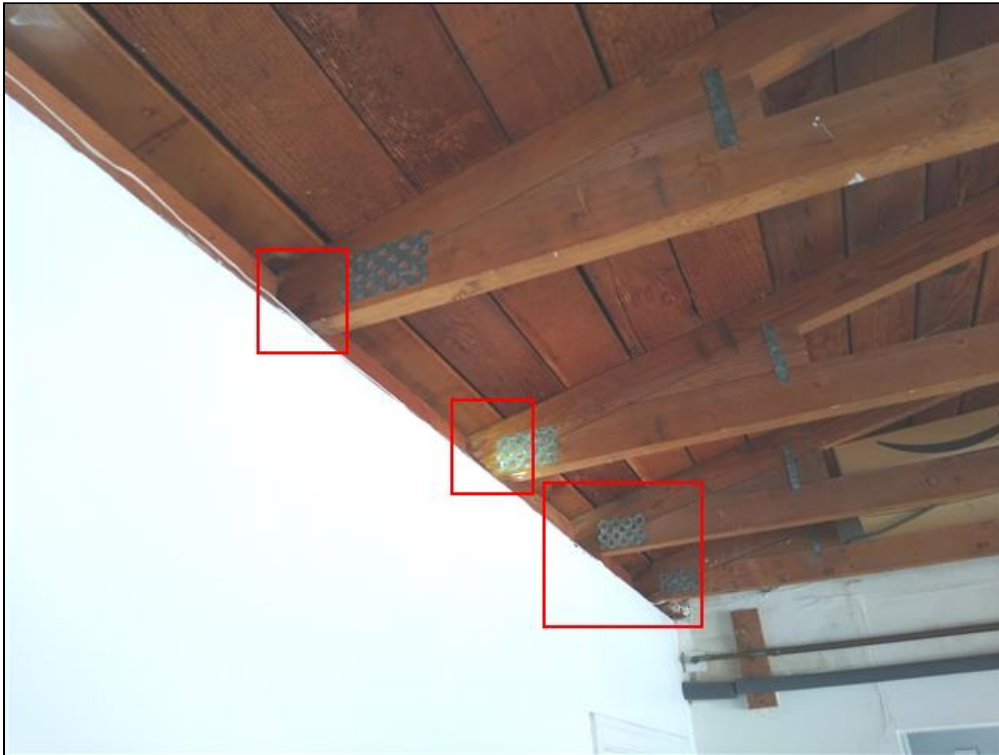
3.0 Item 5(Picture) Staining noted

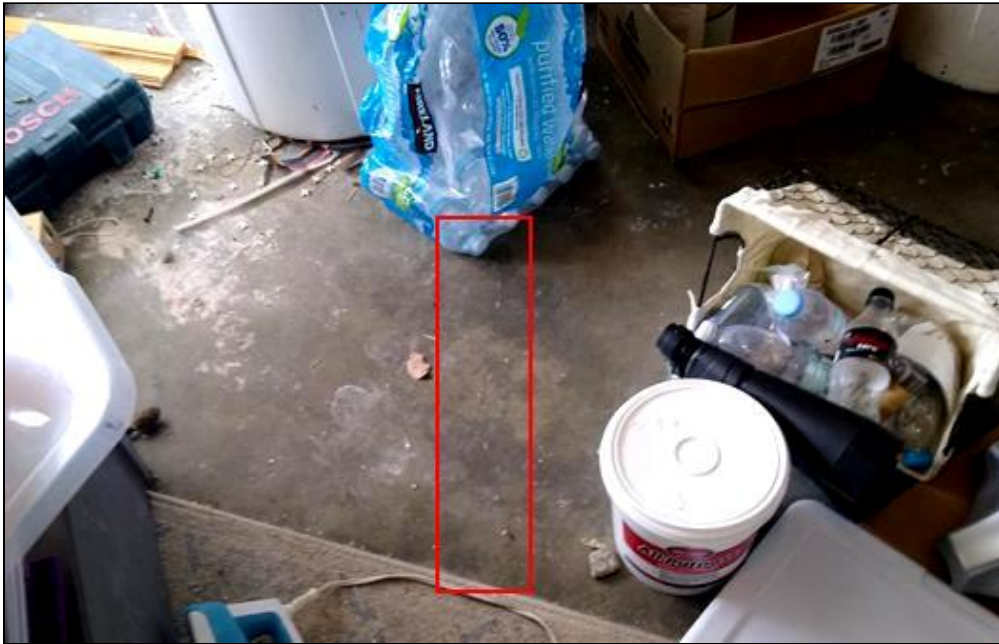
3.1 Item 2(Picture) Crack noted

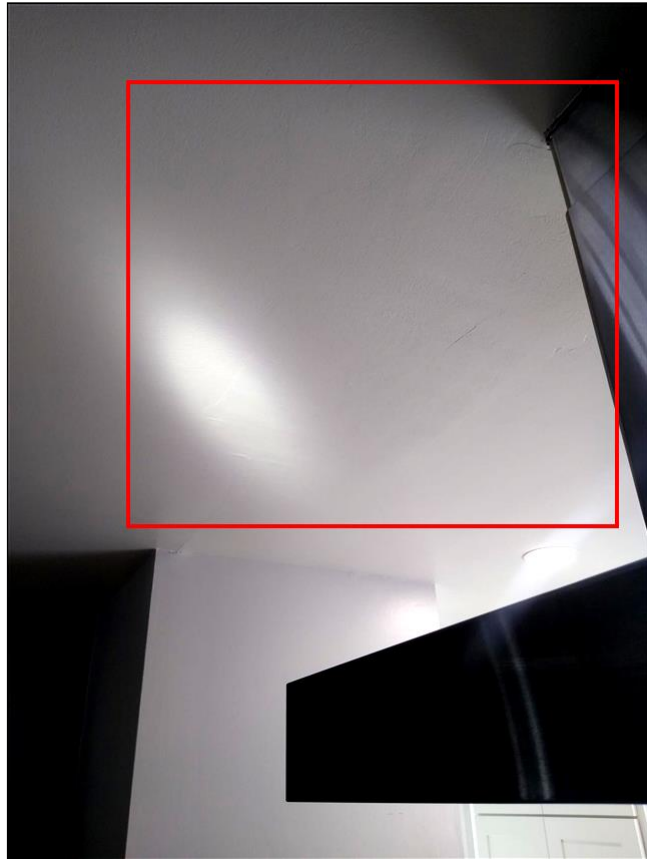
4.0 Item 6(Picture) Repairs noted at ceiling by kitchen area.

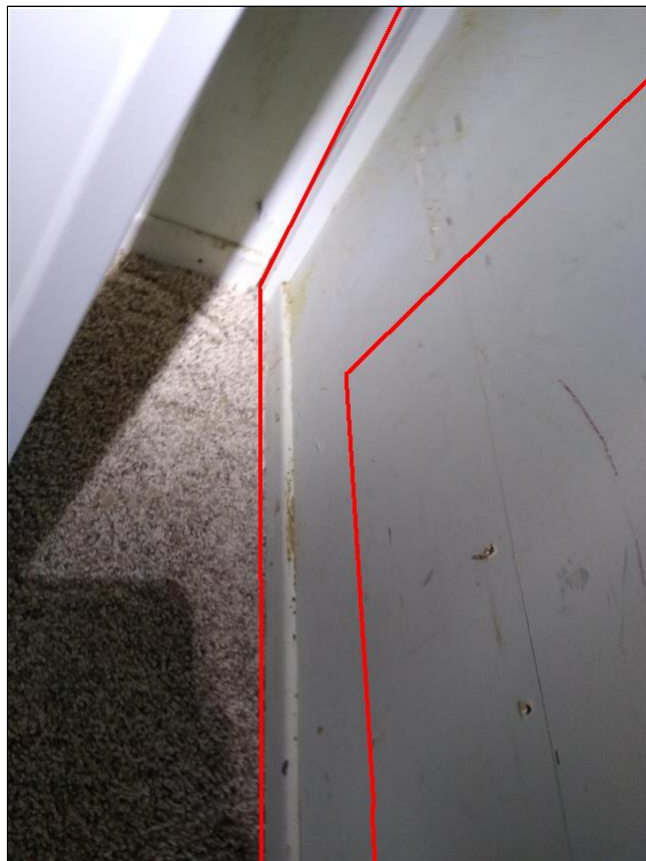
4.0 Item 8(Picture) SE front bedroom - Area of concern - Discoloration, possible mold growth noted.

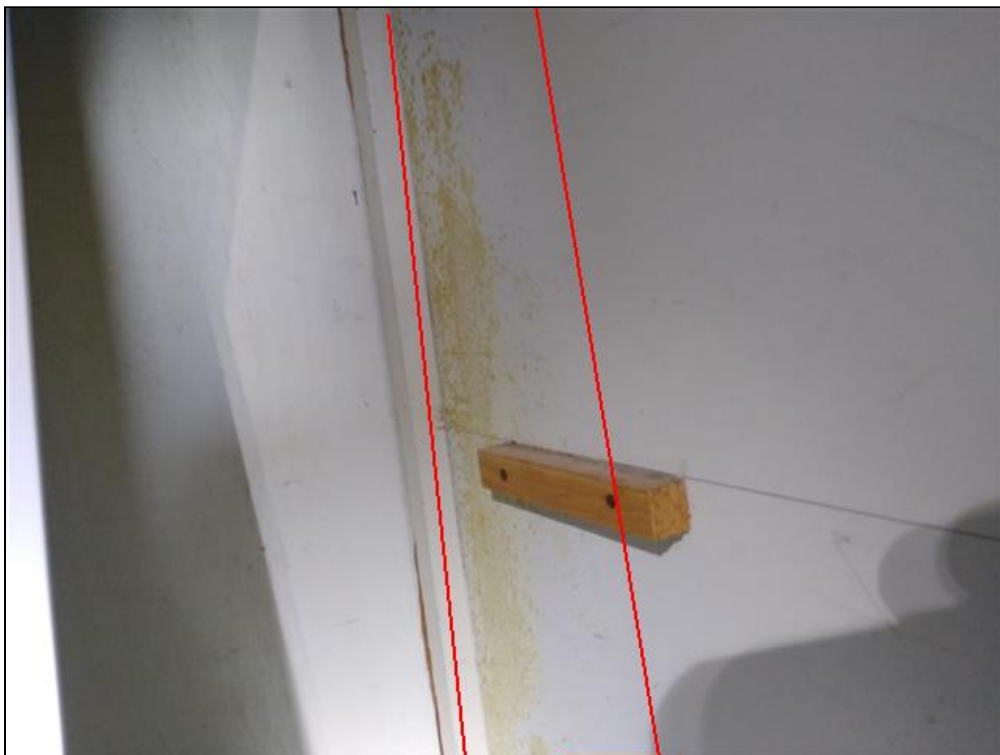
4.0 Item 9(Picture) SE front bedroom - Area of concern - Discoloration, possible mold growth noted.

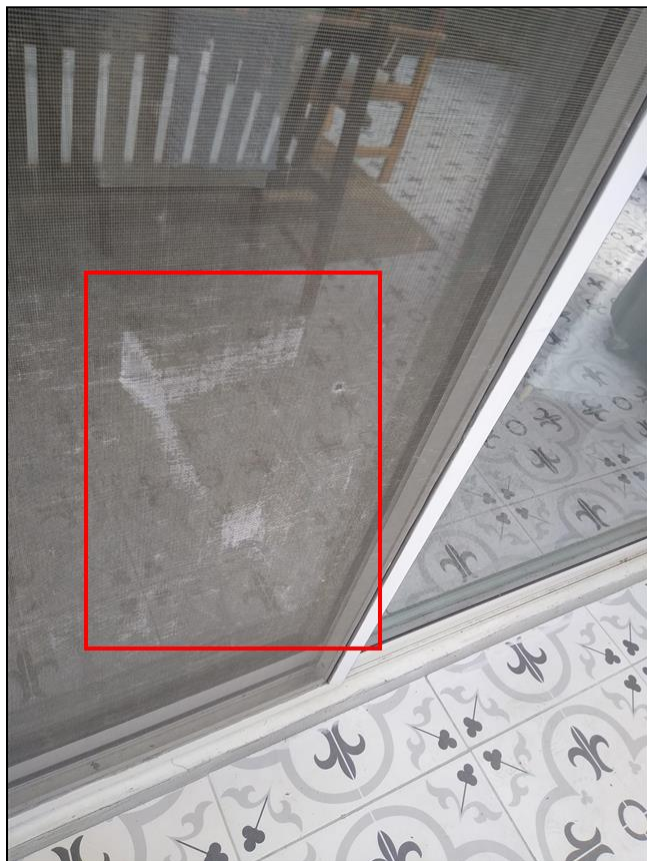
Item 3 - Wear noted at sliding screen door. Recommend repairs/replacement to prevent insect pest intrusion.

4.4 Item 3(Picture) Wear noted at sliding screen door

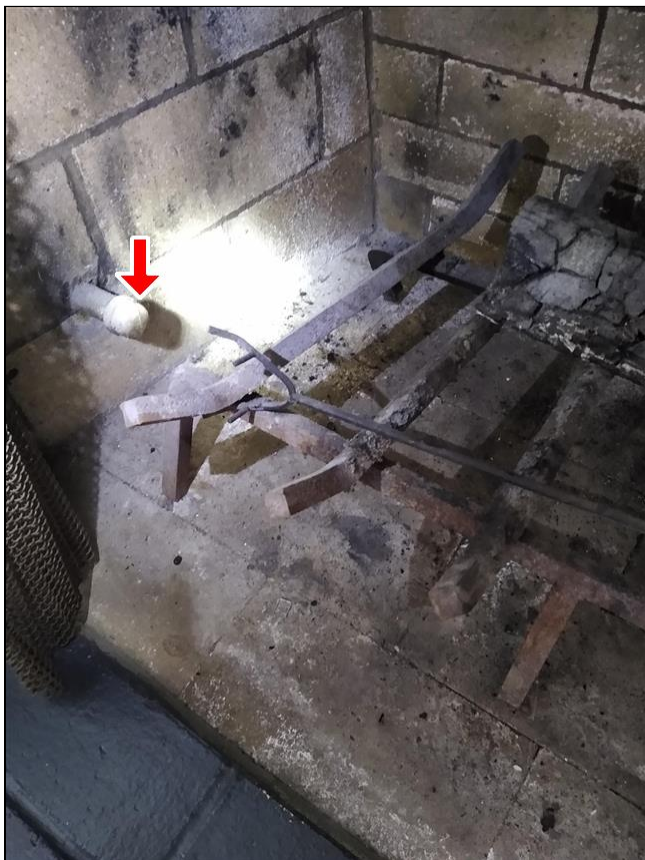
4.6 Item 1(Picture) Gas piping was capped

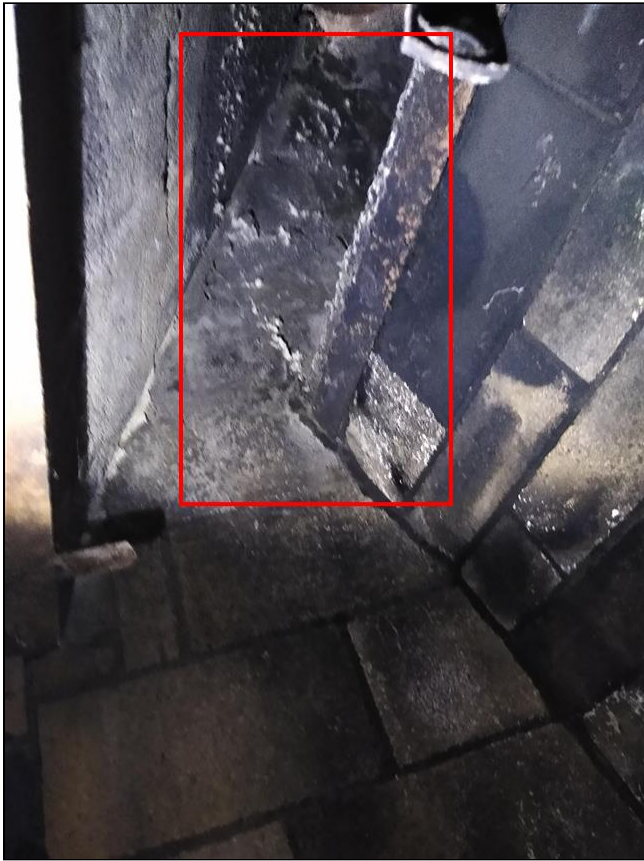
4.6 Item 3(Picture) Uneven surfaces noted in smoke chamber area. Efflorescence also noted.

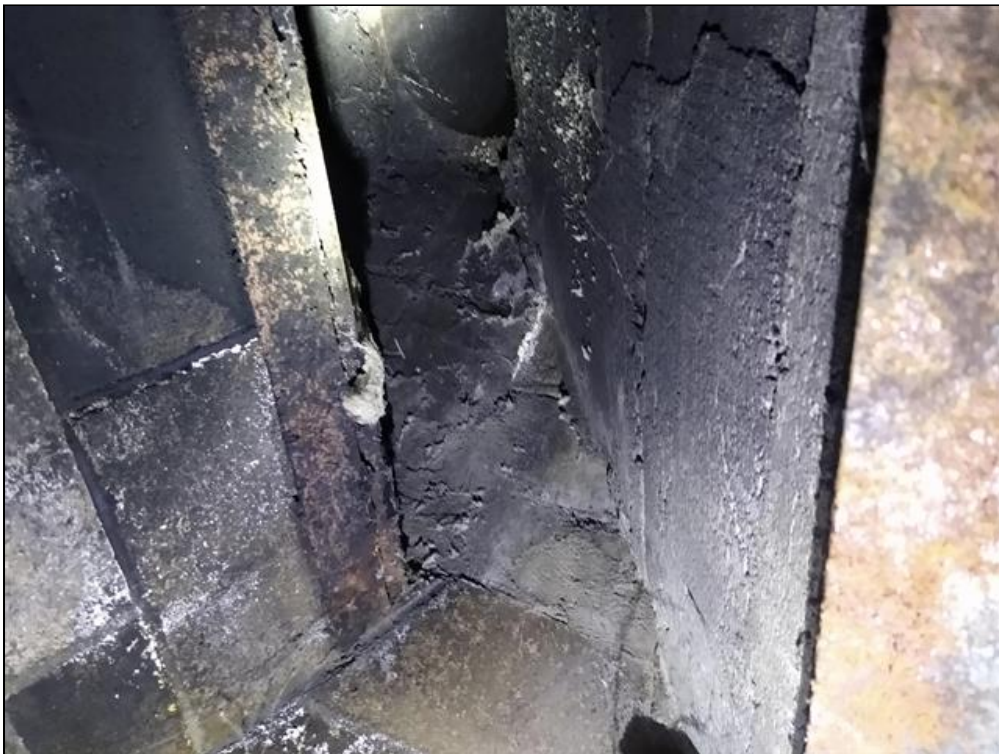
4.6 Item 4(Picture) View into smoke chamber on left side

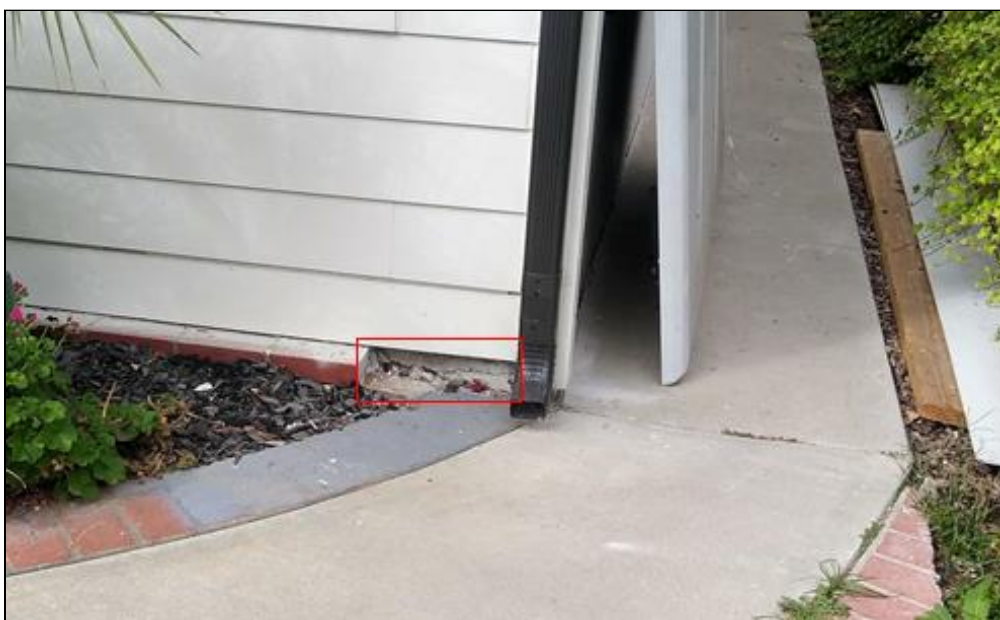
Item 1 - Cracking/wear noted at floor slab exterior by downspout. Recommend adding downspout extender to direct runoff from roof covering further away from base of structure. Contact qualified contractor (i.e. foundation contractor) for further evaluation and repairs at area as needed to prevent moisture penetration. Conditions beyond concealed areas remain indeterminate.

5.1 Item 1(Picture) Cracking/wear noted

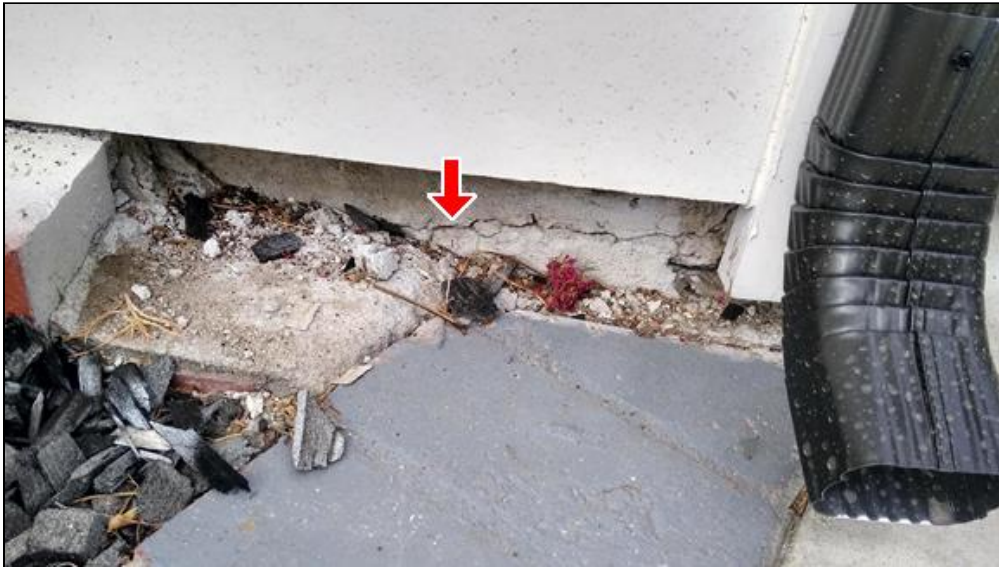
5.1 Item 2(Picture) Close-up of cracking

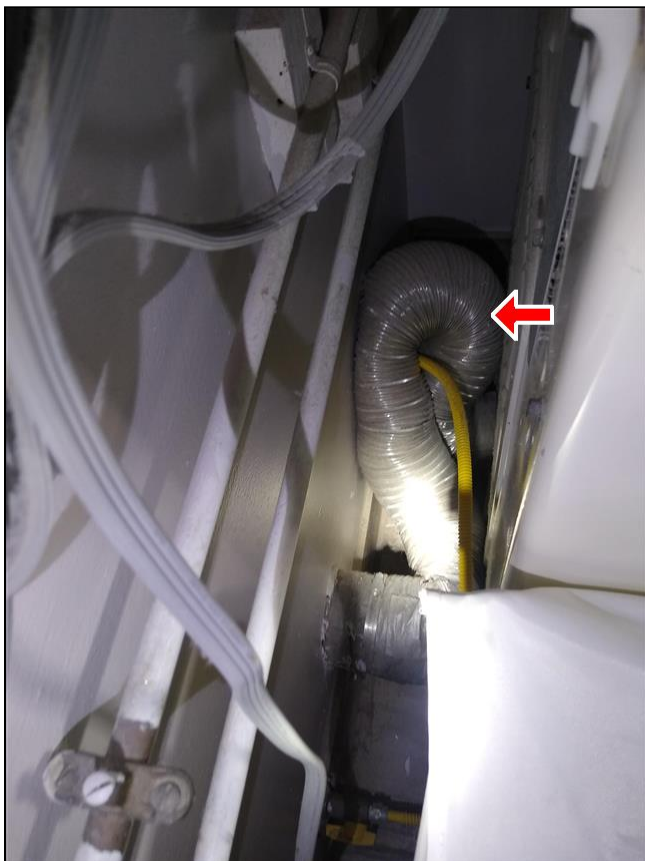
6.4.A Item 3(Picture) NOTE: Dryer vents that angle uphill and long dryer vent runs require frequent maintenance and cleaning of lint for fire-life-safety.

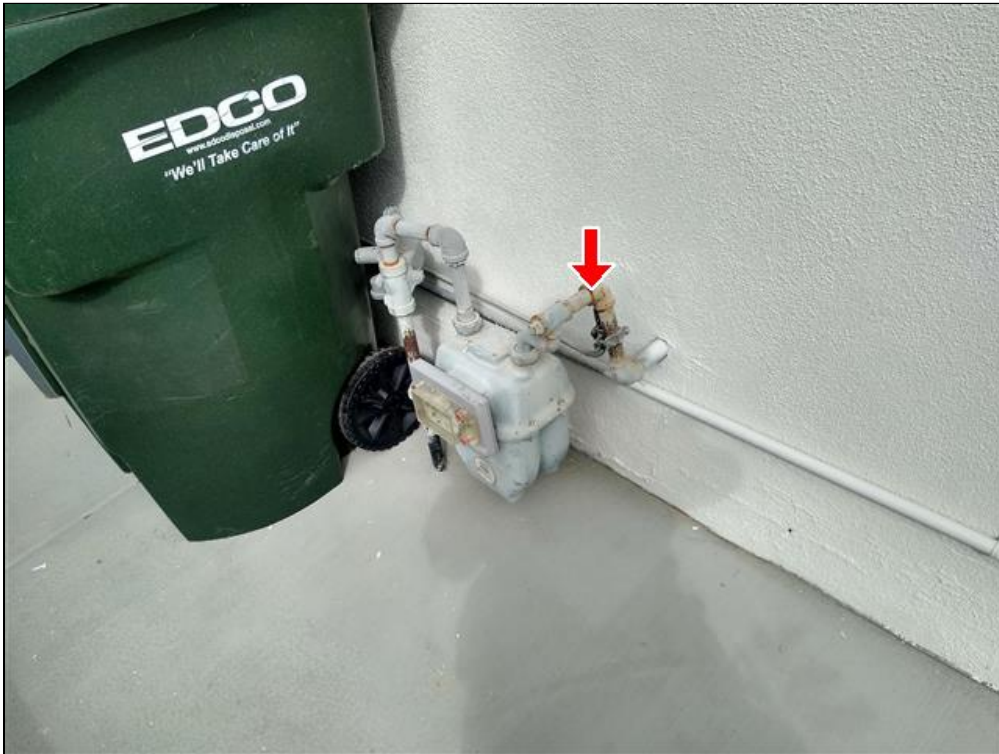
Although not required by local jurisdiction, a seismic shut-off valve is recommended, for it improves safety during seismic activity by providing instantaneous shut-off of gas flow at gas main.

6.5.A Item 1(Picture) No seismic shut-off valve noted

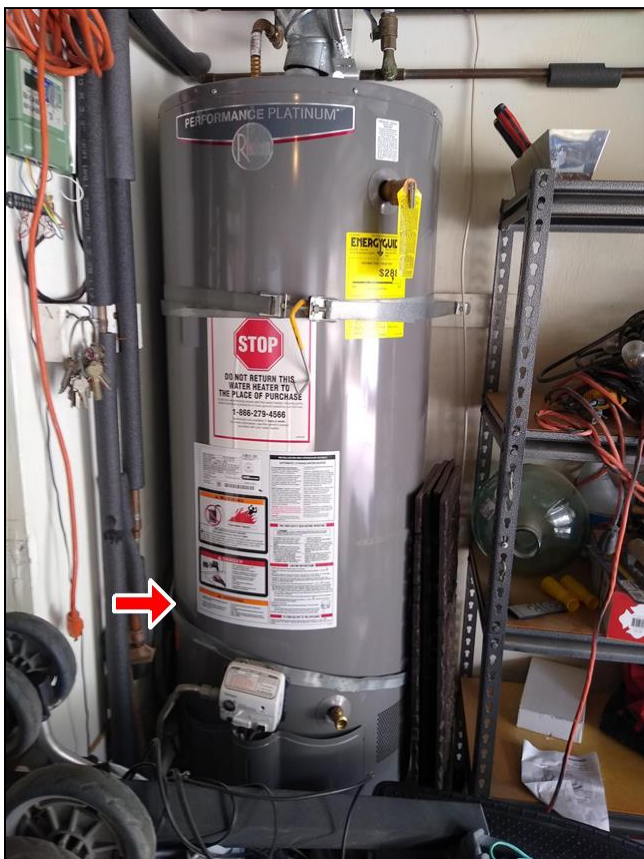
6.6.A Item 1(Picture) Lower strap is loose and does not have minimum 4" clearance from heating element-

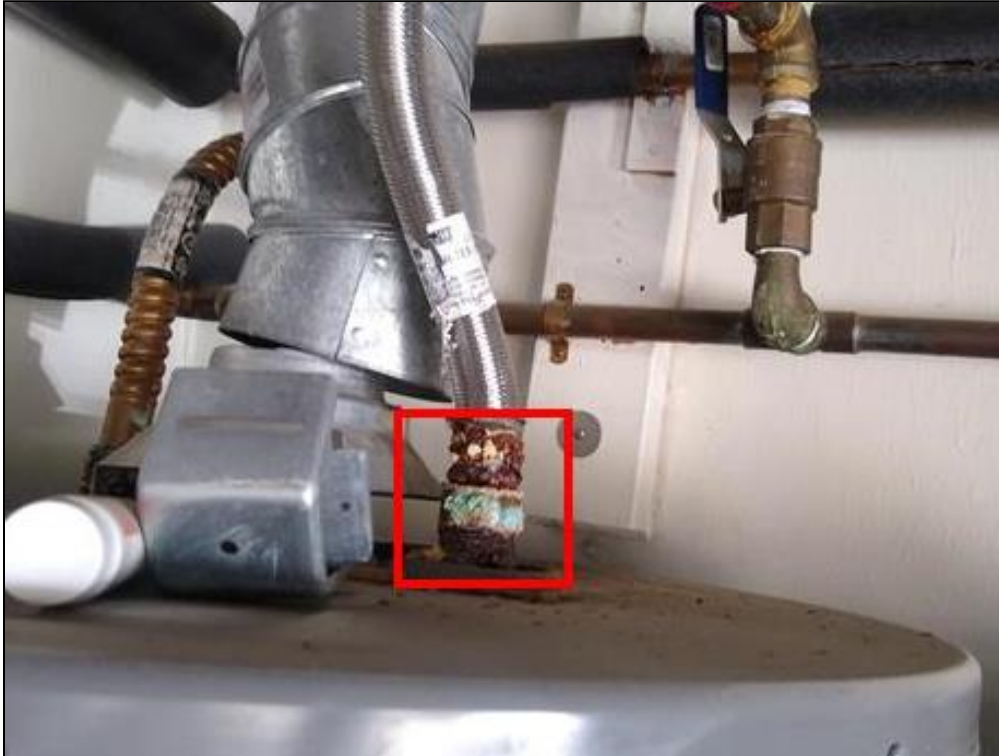
(2) Corrosion noted at various locations of piping by water heater. Contact licensed plumber for further evaluation and repairs as needed to prevent leaks.

6.6.A Item 4(Picture) Corrosion noted

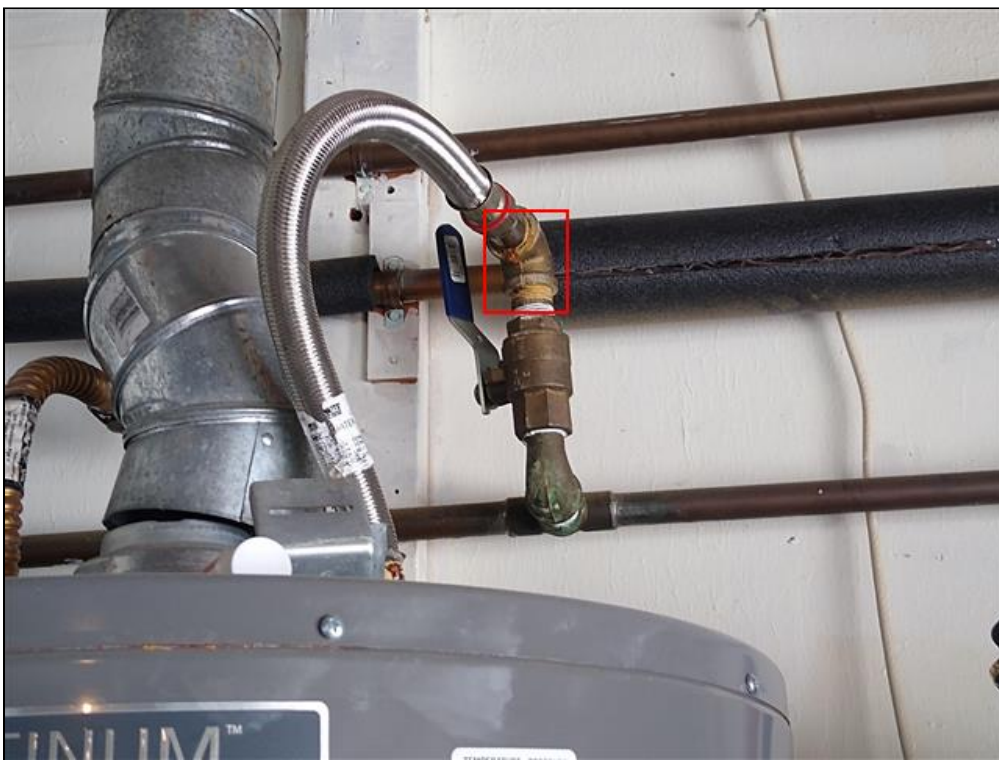
6.6.A Item 6(Picture) Corrosion noted

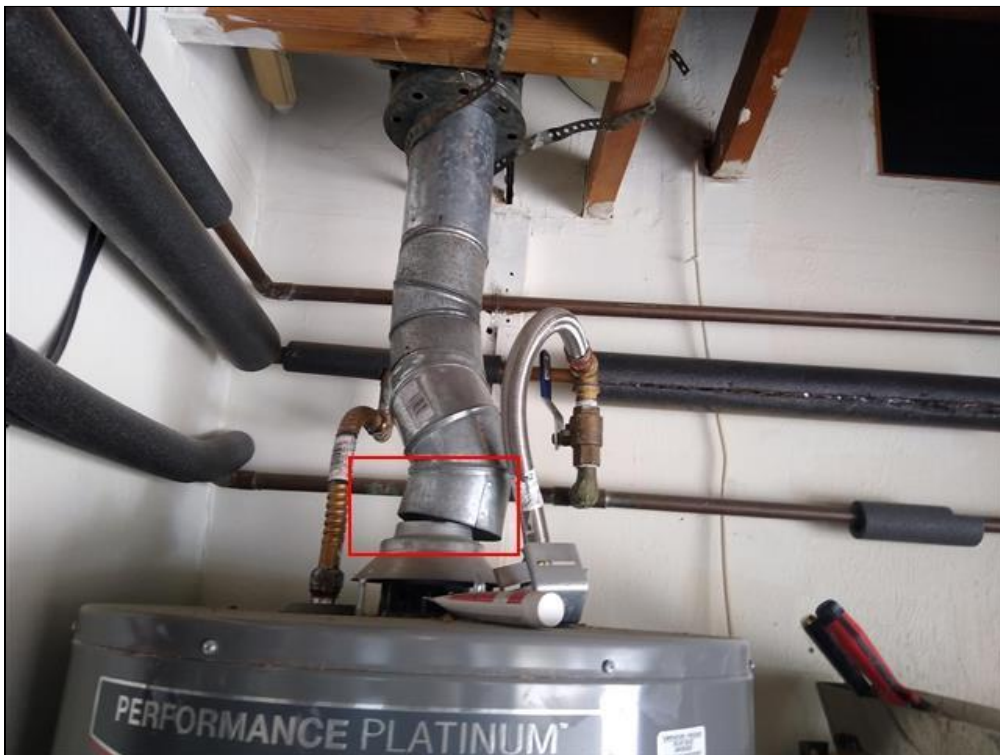
6.7.A Vent connector is misaligned and presents a safety hazard, which may result in the seepage of combustion gases such as CO. No screws noted where vent connector joins draft hood. Recommend adding 3 screws to each joint of single-wall vent piping to keep joints connected properly, especially during possible seismic activity. Consult licensed plumber for further evaluation and repairs as needed for safety.

6.7.A Item 1(Picture) No screws noted and gaps observable, which are a safety concern

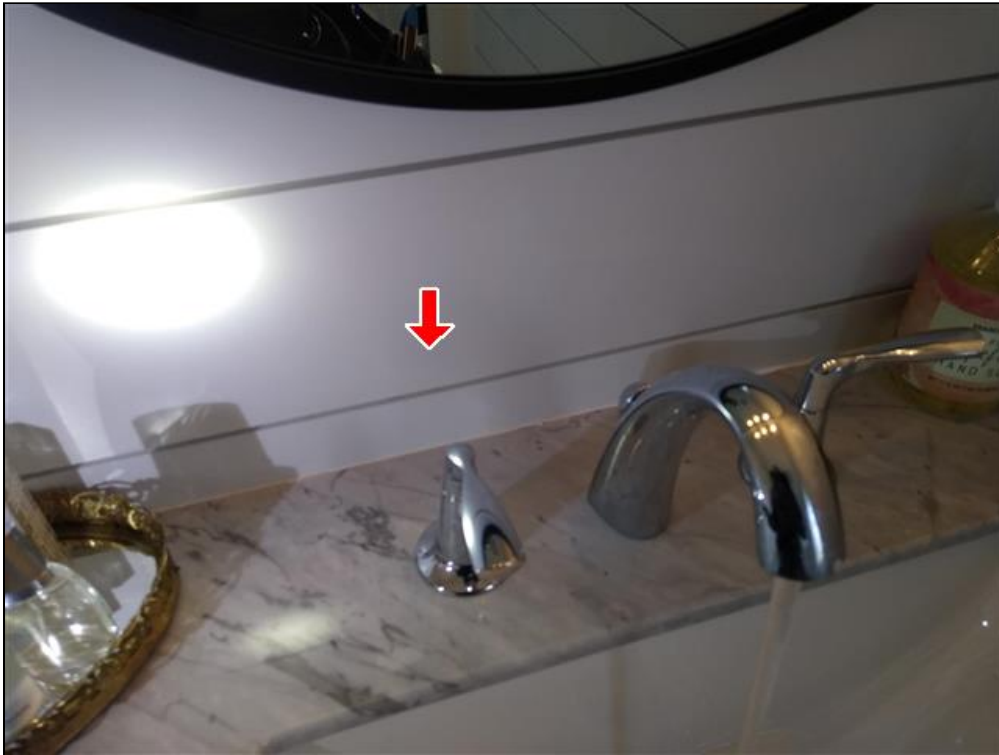
6.0.C Item 2(Picture) NOTE/MAINTENANCE TIP: Material behind bathroom sink is not optimized for wet locations. Recommend monitoring over time and upgrading materials as desired for improved performance.

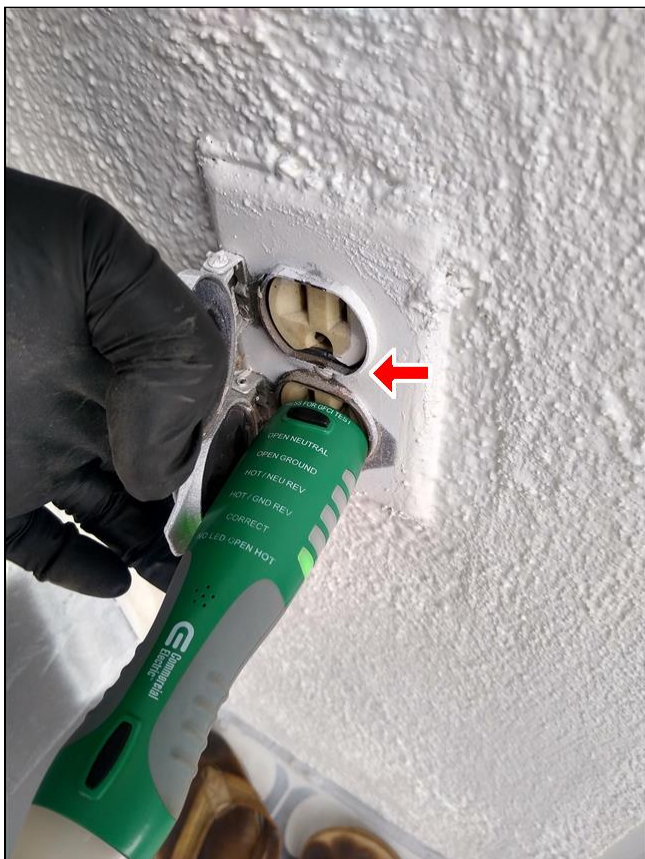
7.3 Item 1(Picture) Exterior outlets, Not GFCI. No weather covering noted (rear area)

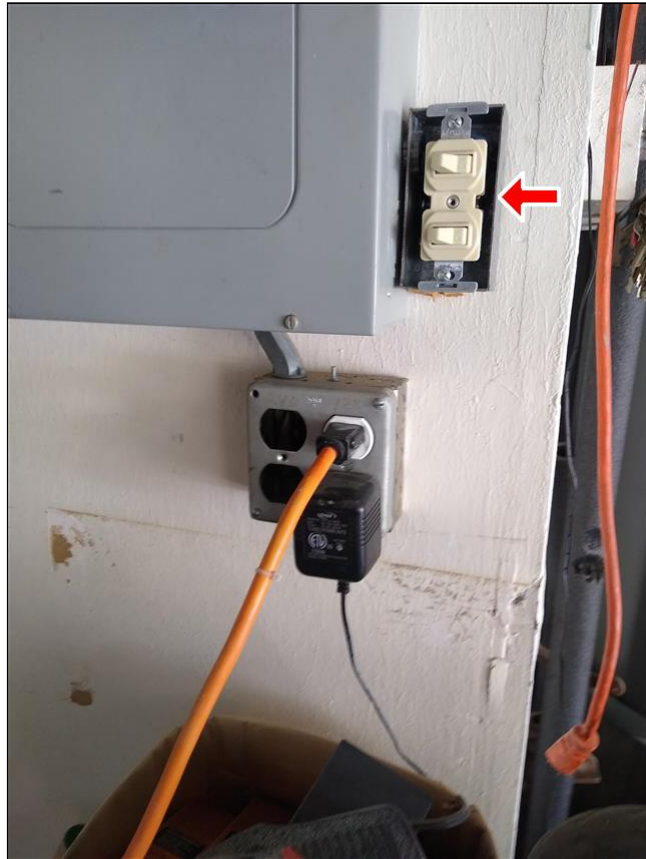
7.3 Item 4(Picture) Missing coverplate noted at garage light switch

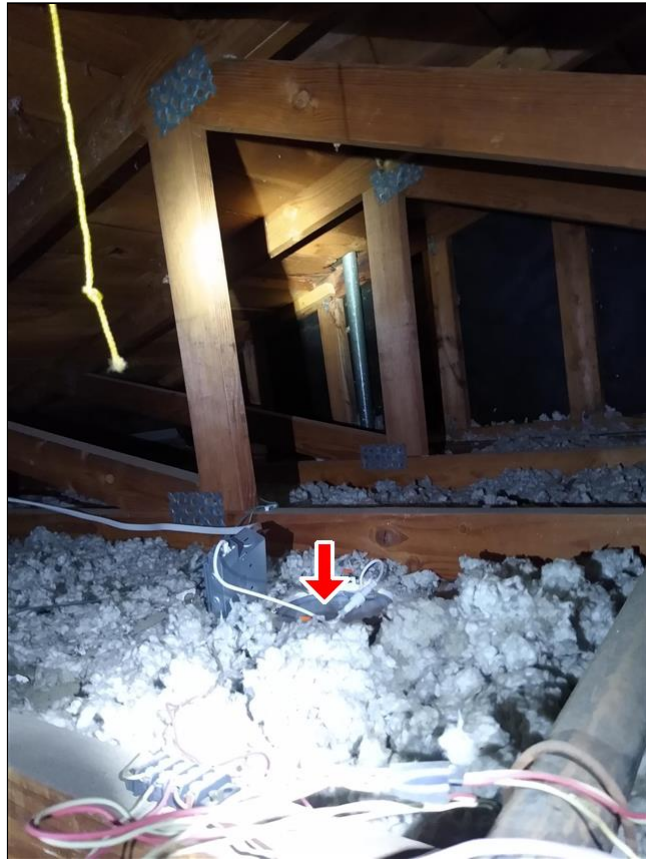
7.4 Item 5(Picture) Open junction box noted, W attic area

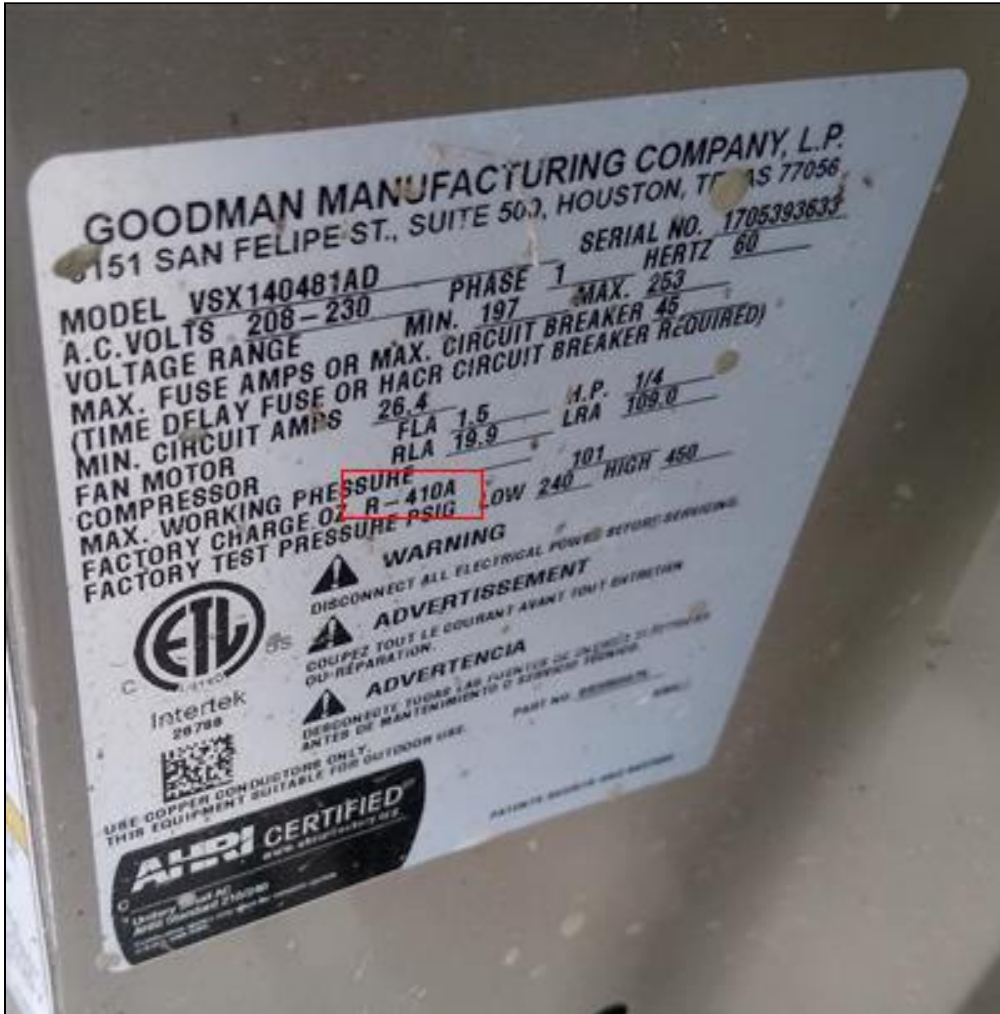
8.1 Item 1(Picture)

8.1 Goodman 2017 condensing unit with refrigerant 410A

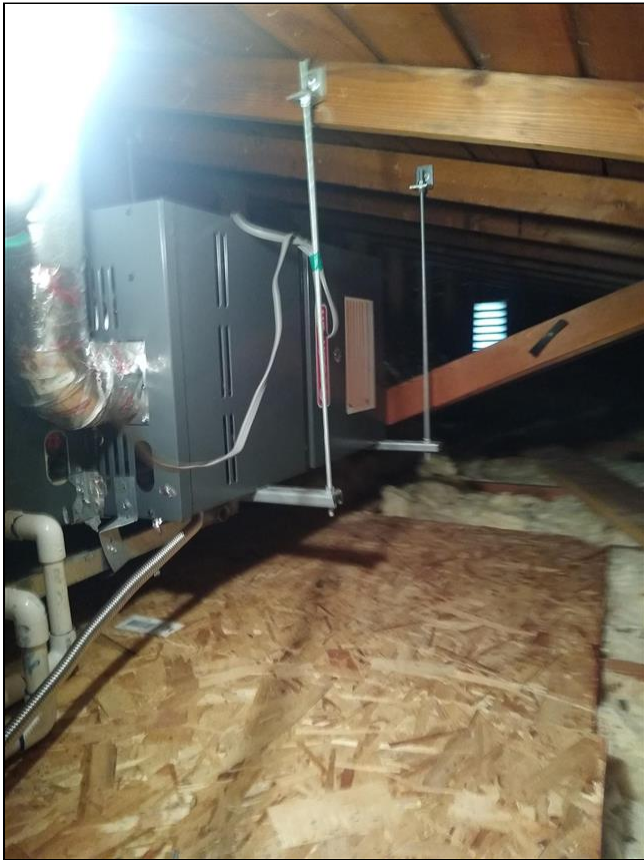
8.5 Item 1(Picture) Goodman gas-fueled furnace

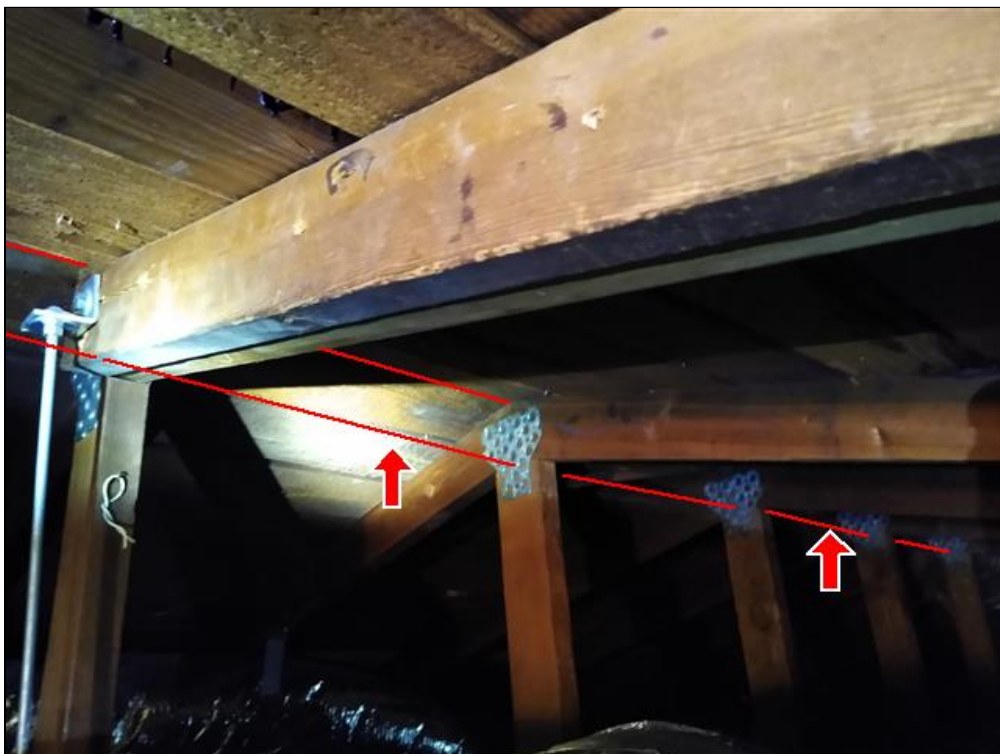
Item 1 - No ridge board/beam noted, which is common in older structures. Item 2 - Broken sheathing noted at E gable ridge area. Item 3 - Over-notching noted at rafter by attic area fan. Recommend further evaluation by licensed roofer and repairs as needed for enduring stability.

9.0 Item 1(Picture) No ridge board/beam noted

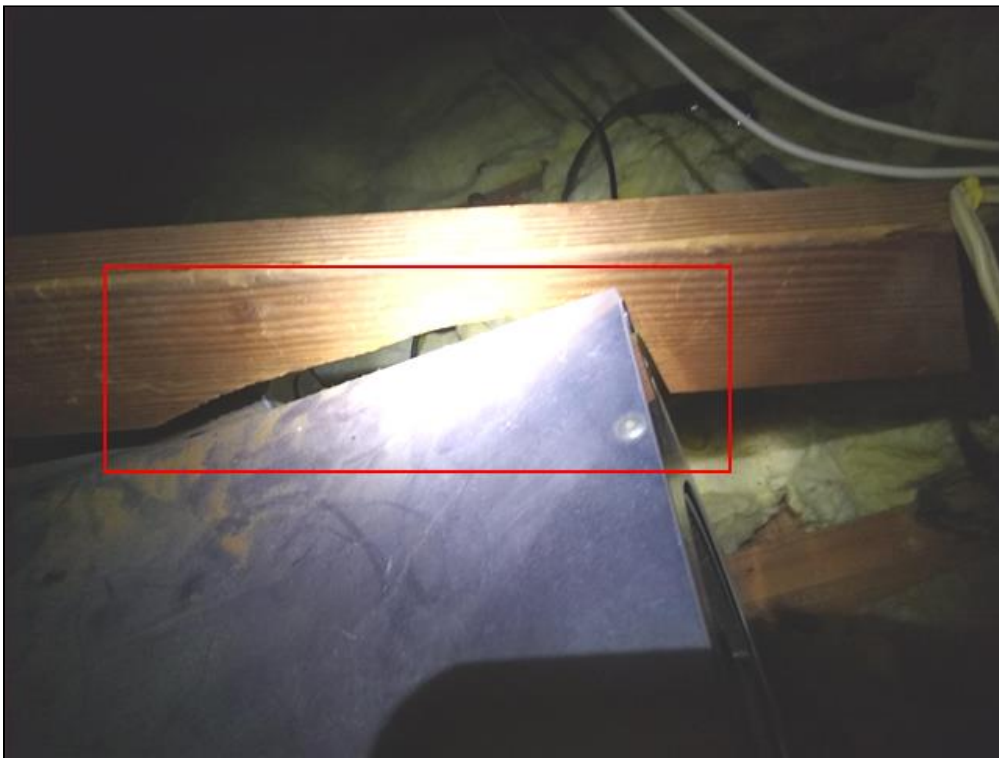
9.0 Item 3(Picture) Over-notching noted at rafter by attic area fan

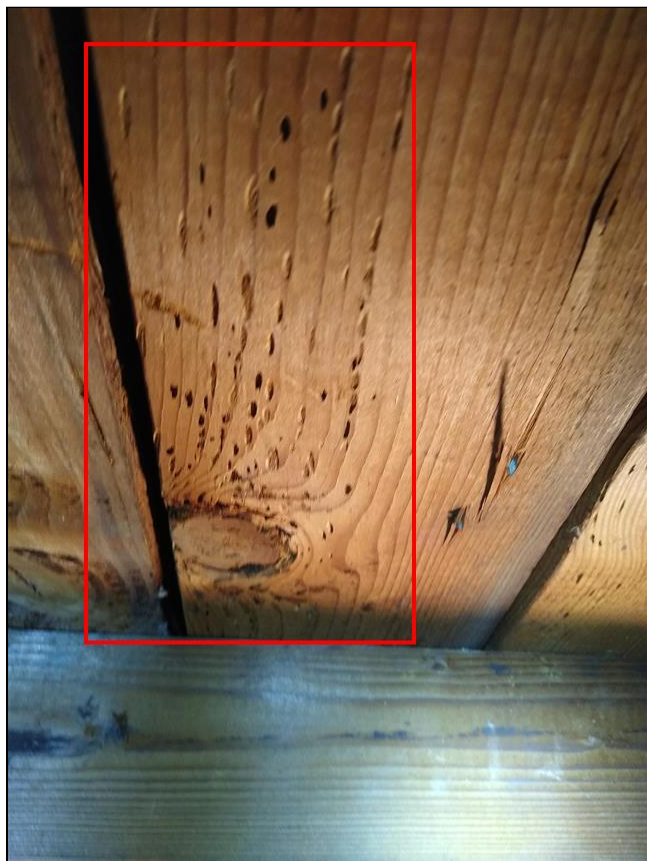
Wood damage noted at various locations. Consult licensed pest control for further evaluation, treatment, and repairs as needed.

9.1 Item 1(Picture) Wood damage noted

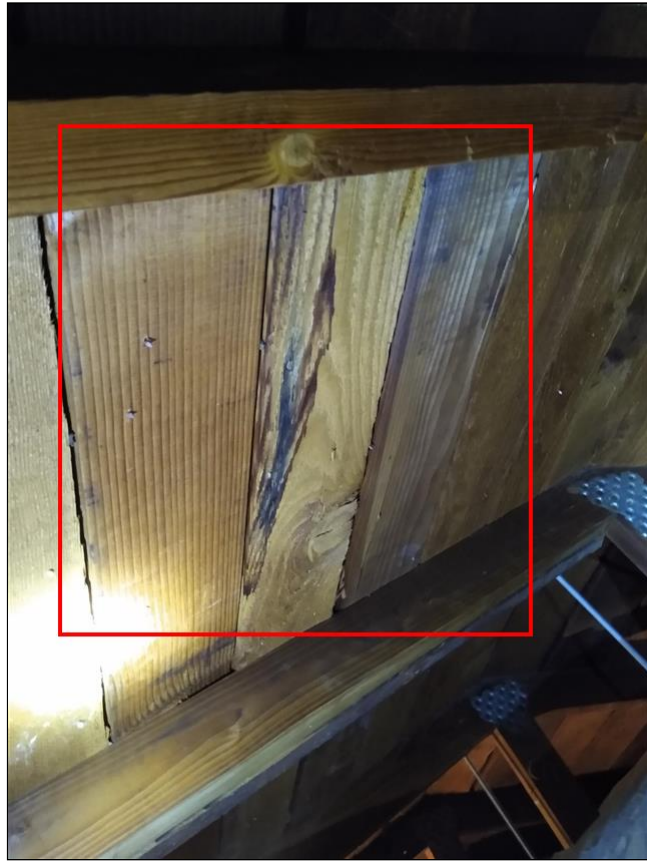
9.1 Item 4(Picture) Staining noted

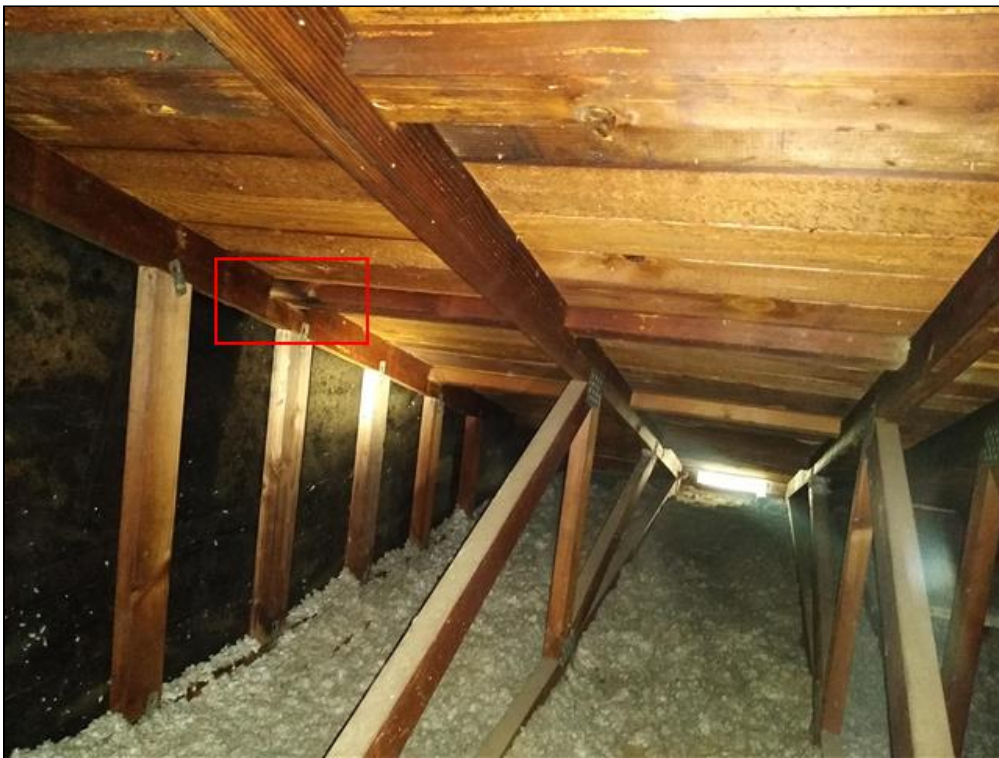
9.1 Item 5(Picture) Staining noted at gable

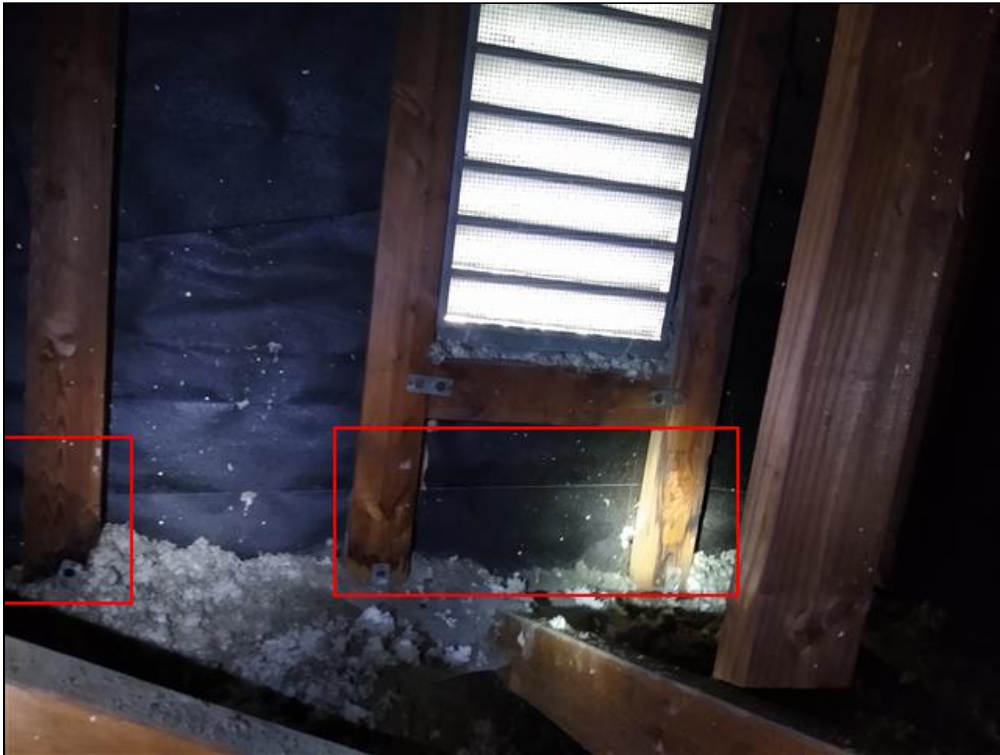
9.1 Item 6(Picture) Staining noted

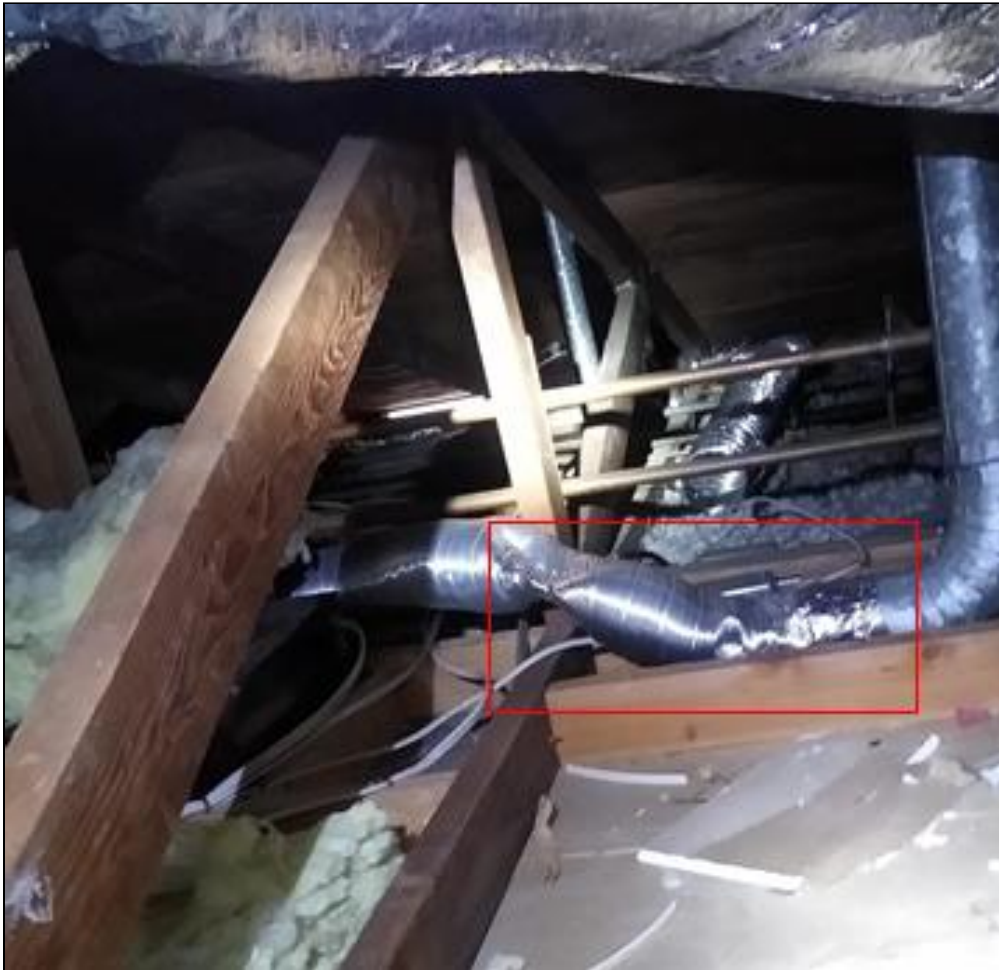
9.2 Item 1(Picture) Bath exhaust ducting is kinked
