# Inspection Report

**Antonio R & Ida Martinez Revocable Living Trust  
1511 Dale Avenue  
Arroyo Grande, CA 93420**

Report Date: 3/27/2017

Inspection location: 1511 Dale Avenue
Arroyo Grande, CA 93420

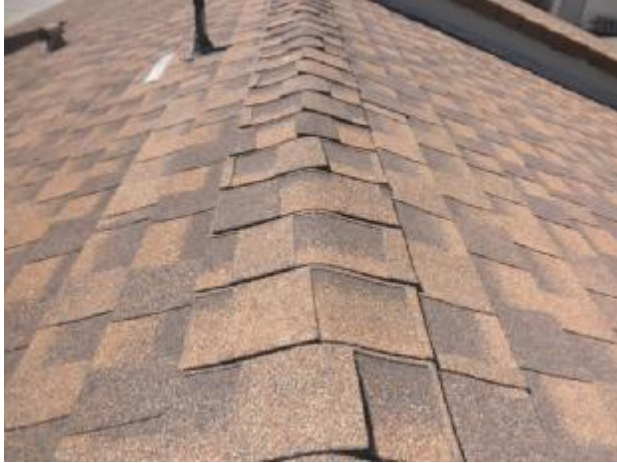
**#R23**

2.) Field shingles have been used for caps at the ridge line on the roof. This is an unconventional installation and may subject the ridge shingles to future wind damage particularly as the roof gets older.

Field shingles used for ridge caps on the roof.

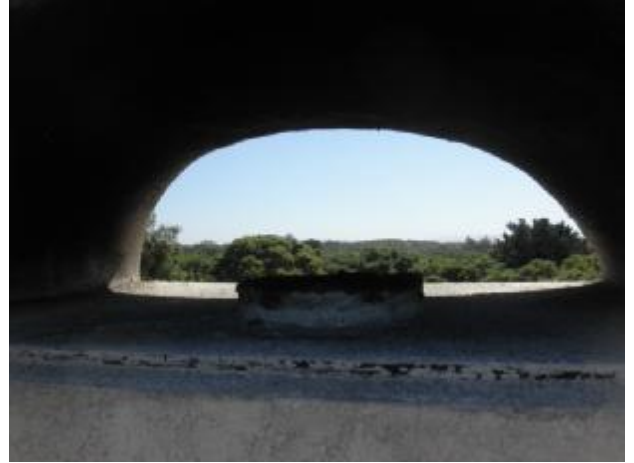
**#R25**

**Fire Safety Hazard Note:** The spark arrestor is missing at the top of the family room fireplace and the spark arrestor is damaged at the top of the living room fireplace.

Missing spark arrestor at the top of the family room chimney.

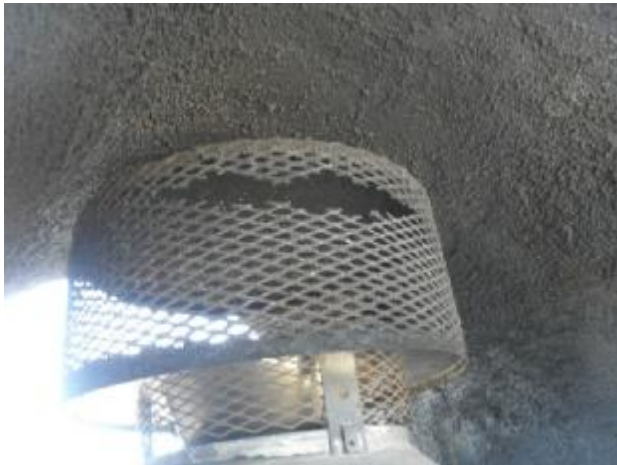
**#R26**

Damaged spark arrestor at the top of the living room chimney.

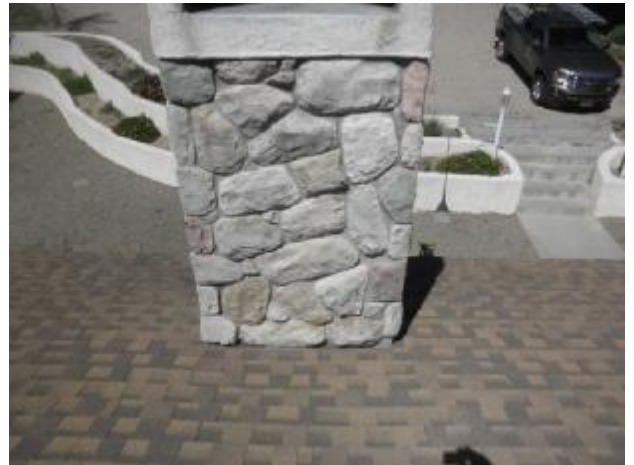
**#R27**

1.) There are no cricket flashing behind the chimney enclosures. This is required when the chimney enclosure is greater than 30 inches in width to divert water around the chimney. This may render these areas to potential leaks.

No cricket flashing installed behind the chimney enclosures.

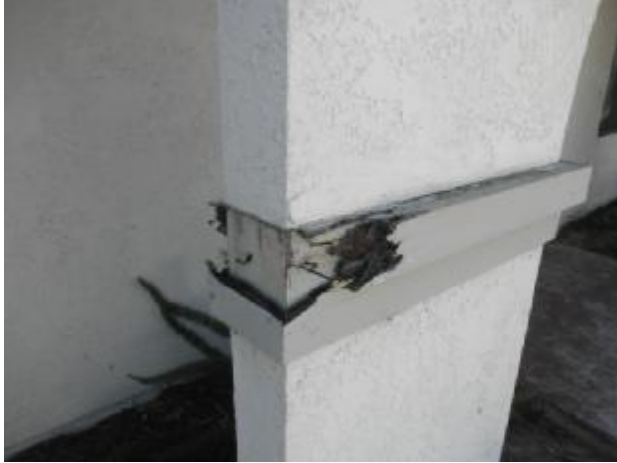
**#EX3**

**Moisture damage to the wood trim at the front entry arch.**

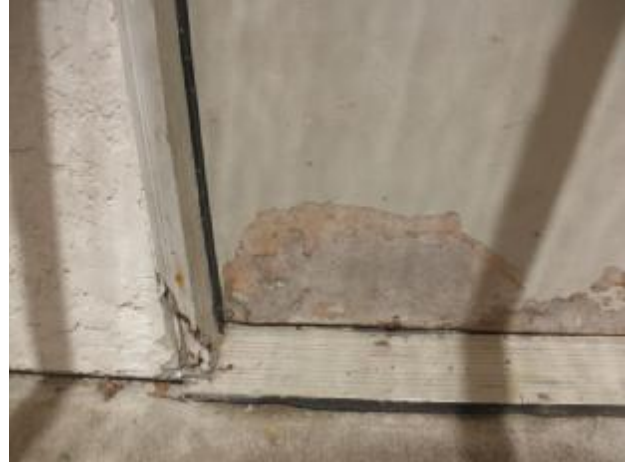
**#EX5**

**Moisture damage to the exterior door and jamb at the west hall bathroom.**

**3.) There is moisture damage to the exterior door and both jambs in the west hall bathroom. This door is in need of complete replacement.**

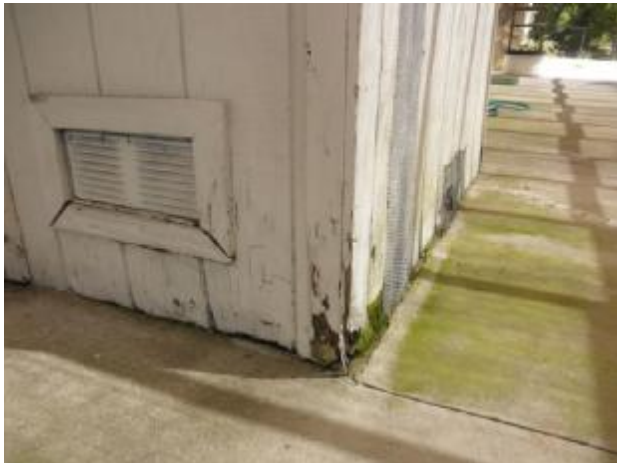
**#EX6**

**Moisture damage to the base of the water heater closet.**

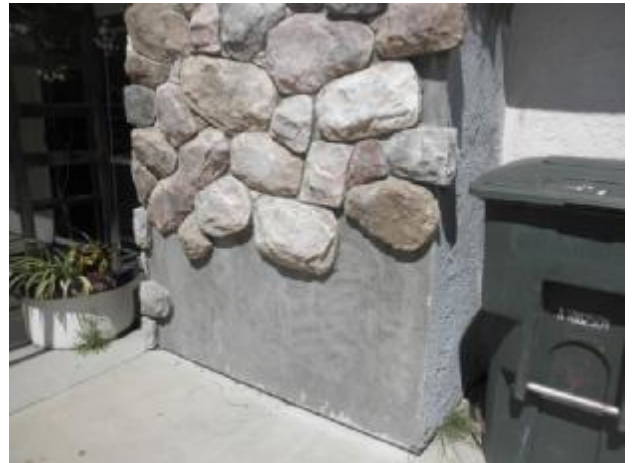
**#EX7**

**Parts of the stone veneer are missing at the family room chimney enclosure.**

11.) Parts of the stone veneer are missing at the family room chimney enclosure.

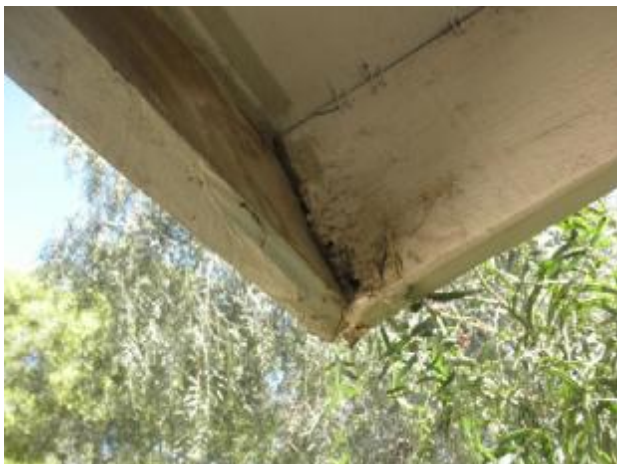
**#EX8**

**Moisture damage to the fascia board at the NE corner of the roof.**

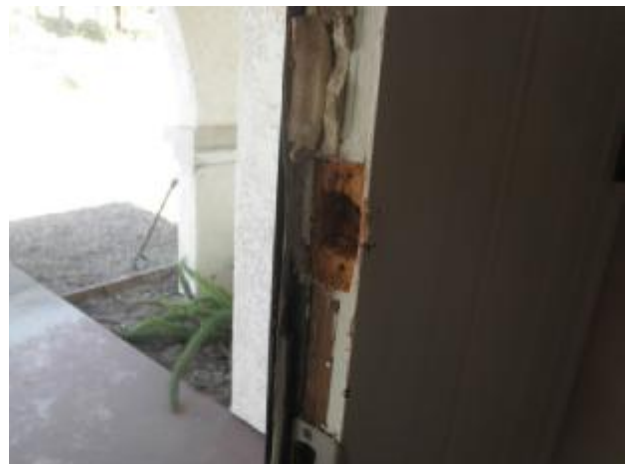
**#EX9**

**Damage to the astragal at the front entry door.**

**1.) The front entry door needs to be refinished. The astragal is damaged and the strike plate is missing for the dead bolt.**

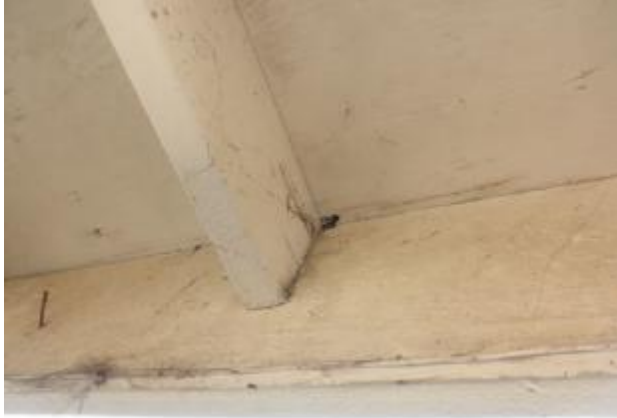
**#EX10**

**Moisture damage to the eave at the north side of the dining room.**

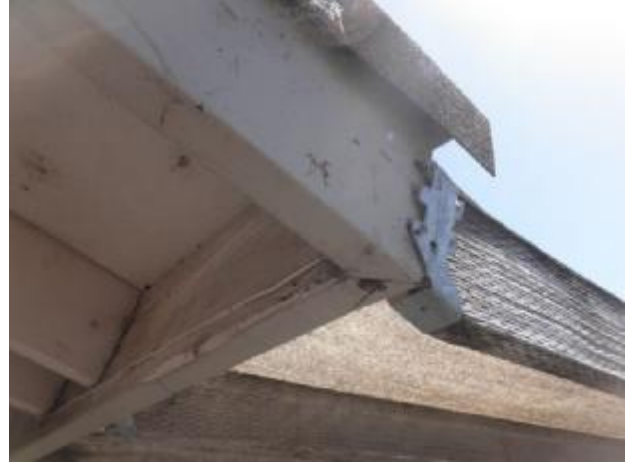
**#EX11**

**Moisture damage to the fascia board at the SW corner of the roof.**

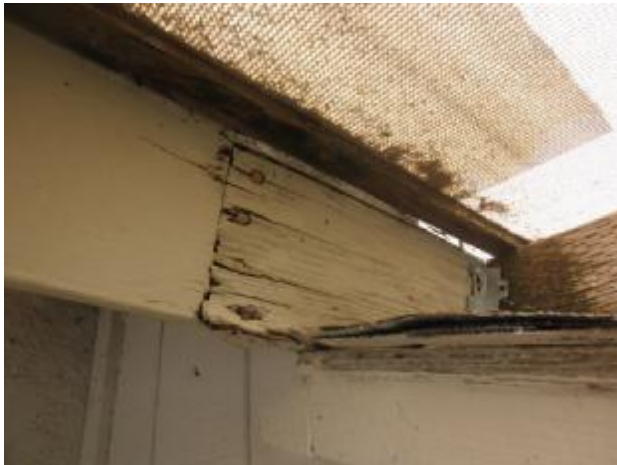
**#EX12**

**Moisture damage to the fascia board above the water heater closet.**

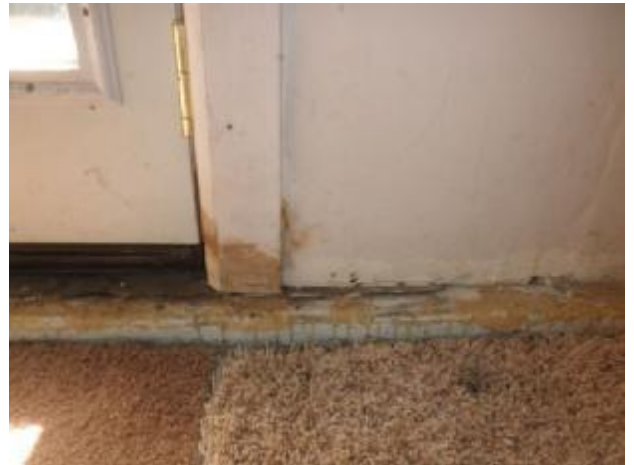
**#EX13**

**Evidence of water intrusion at the exterior door in the SW bedroom conversion.**

**4.) There is moisture damage to the base of the double exterior doors in the SW bedroom. Evidence of water intrusion was present on the base boards and walls inside of these doors.**

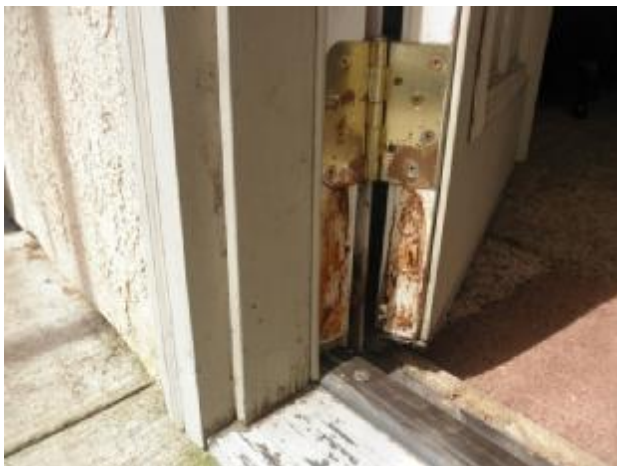
**#EX14**

**Moisture damage to the door and jamb at the exterior door in the SW bedroom.**

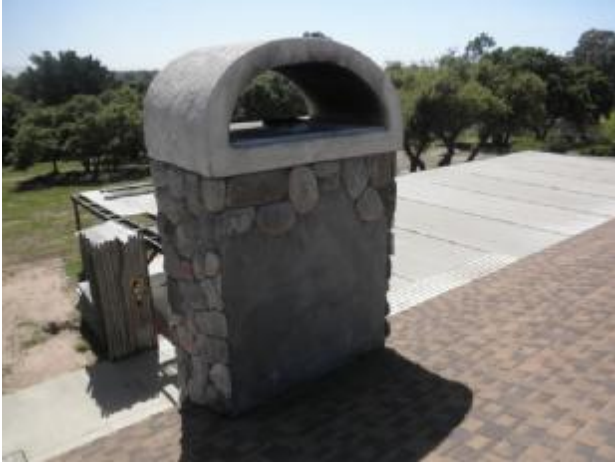
#EX24

Parts of the stone veneer are missing at the family room chimney enclosure.

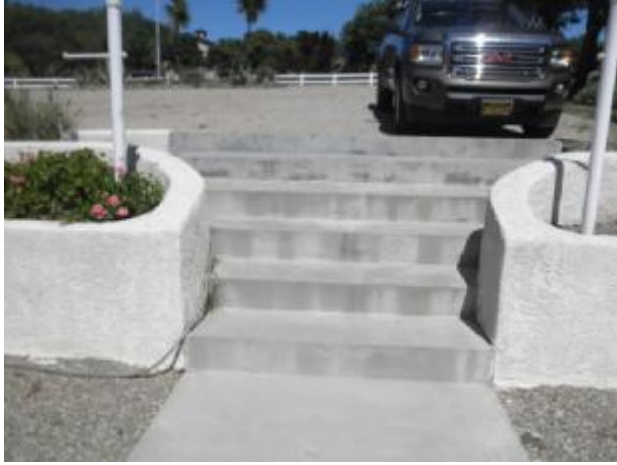
**#GD2**

**Safety Hazard Note:** There is no railing at the front entry concrete stairs off the driveway. This can be a falling hazard.

**Missing railing at the front entry concrete stairs.**

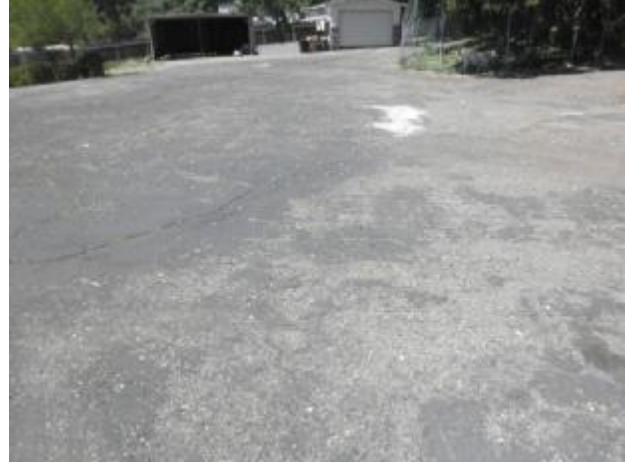
**#GD4**

**Maintenance Note:** The asphalt driveway appears to be in reasonable condition but needs sealant. Cracks and general deterioration were observed.

**General deterioration and cracks in the asphalt driveway.**

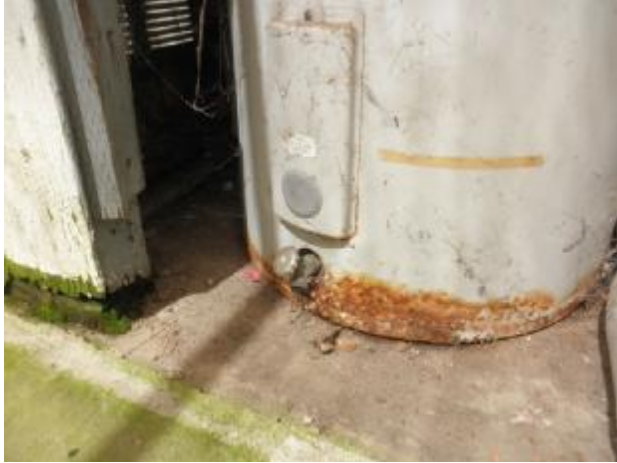
**Plumbing #P15**

The solar hot water reserve tank is old and beyond a normal life expectancy.

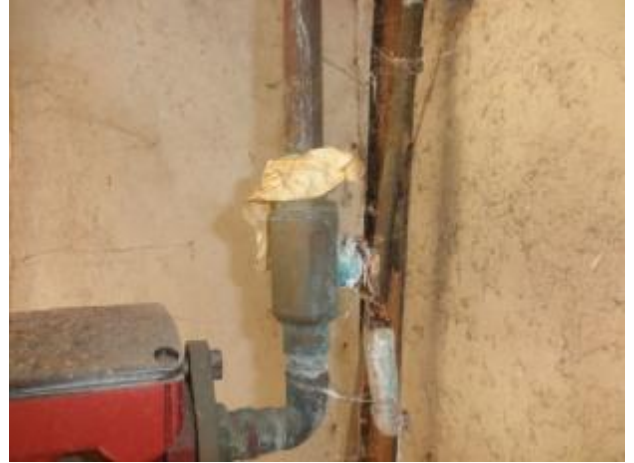
**Plumbing #P16**

Corroded valve at the water heater.

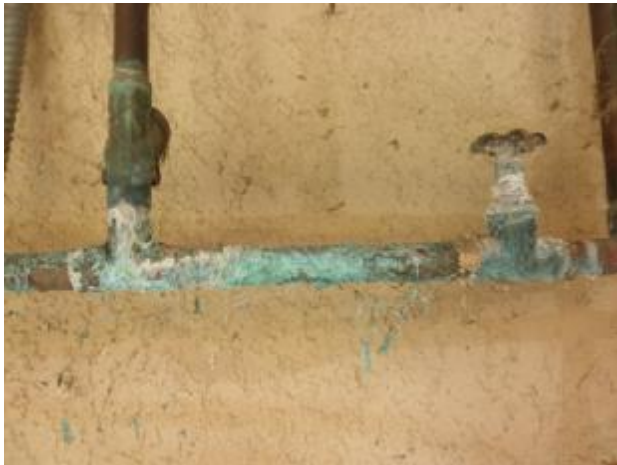
**Plumbing #P17**

Corroded water line above the water heater.

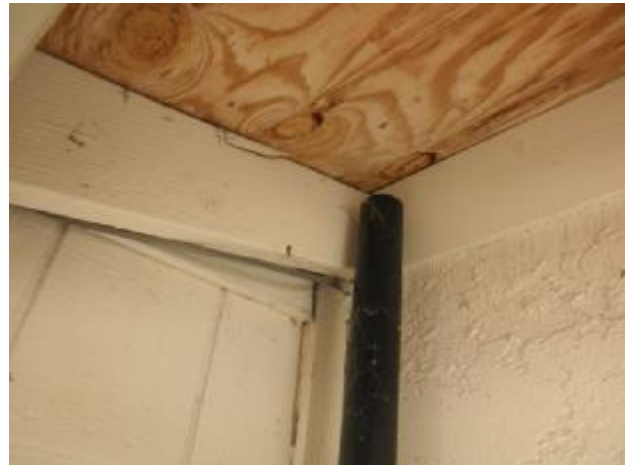
**Plumbing #P18**

Improperly terminated vent pipe at the exterior north wall of the kitchen.

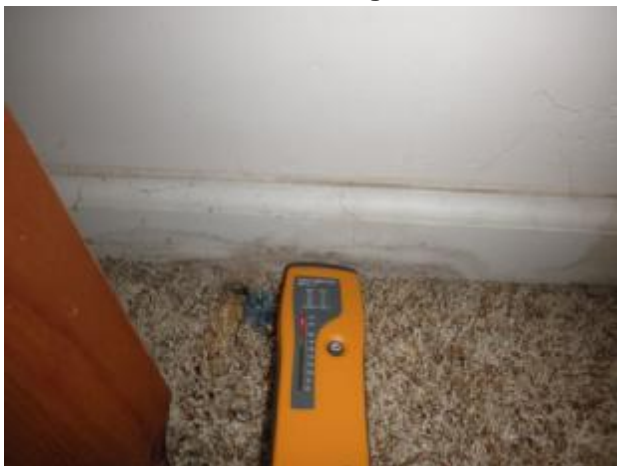
**Plumbing #P29**

Concealed plumbing leak behind the vanity in the east hall bathroom.

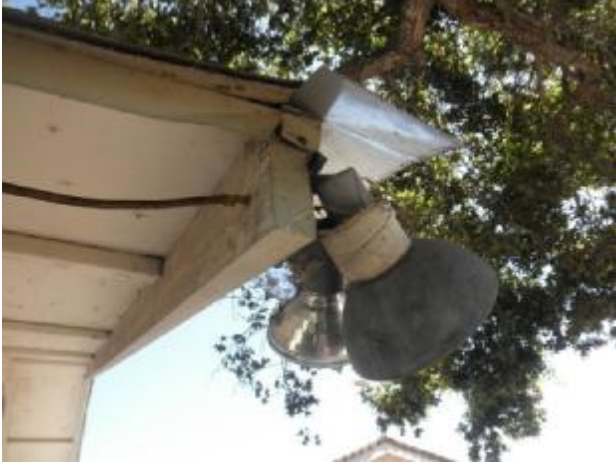
**#EL21**

19 2.) There is a broken light fixture that has been wired with a temporary chord on the exterior SW eave of the garage. This light is recommended to be removed.

**Damaged light fixture at the exterior SW corner of the garage.**

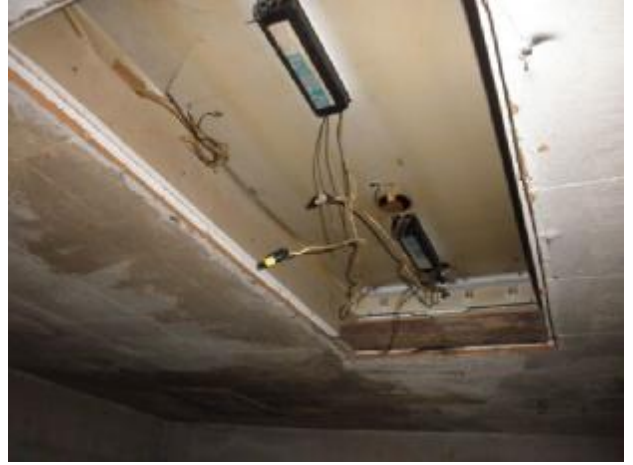
**#EL22**

**Safety Hazard Note:** Most of the ceiling florescent lights in the garage are inoperable with exposed live wiring.

**Damaged ceiling light fixtures in the garage.**

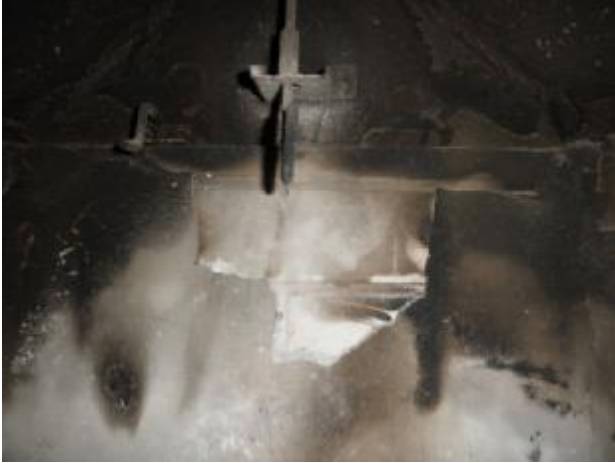
**#IR30**

**Fire Safety Hazard Note:** The refractory plates are damaged in the living room fireplace and the metal plates are rusted and pitted in the family room fireplace. These fireplaces may be unsafe to use. Recommend further evaluation of this condition by a certified and licensed Fireplace Contractor prior to close of escrow.

**Damaged refractory plate in the living room fireplace.**

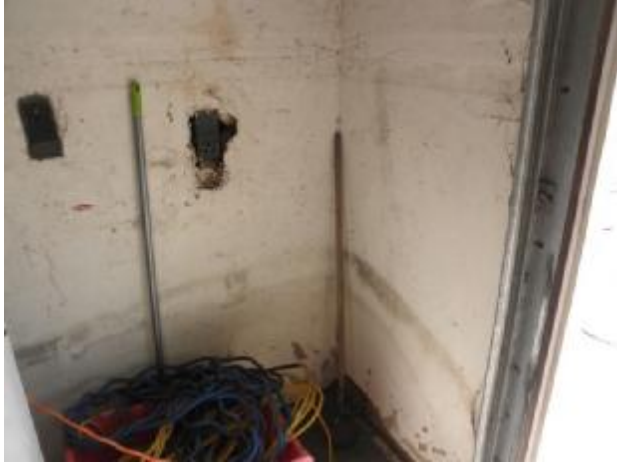
**#GC20**

2.) The drywall is damaged in places at the interior of the garage.

**Damaged drywall at the interior SE wall of the garage.**

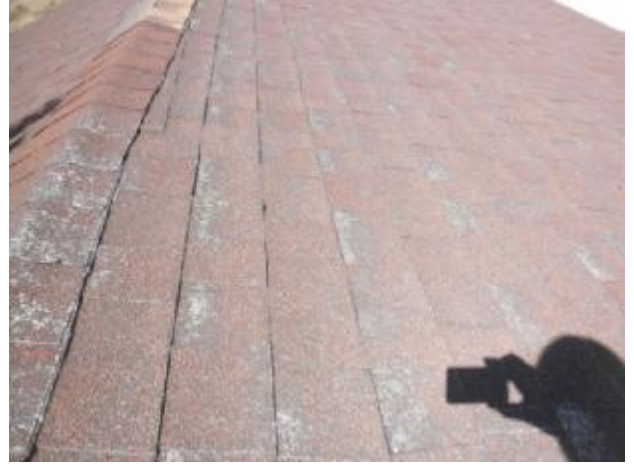
**#GC28**

1.) The garage roof shingles are older with general deterioration and delamination of the aggregate coating on the shingles. This roof is near the end of a normal life expectancy.

**General deterioration of the garage roof shingles.**
