Inspection Report

7 Cinchring Rd
Rolling Hills, CA 90274

Friday, September 27, 2019

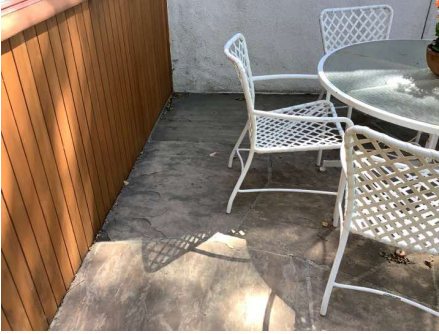
CR s-26: The walkway is sloped toward the building, mainly at the right rear. This condition can promote water entry into the structure. The walkway should be repaired or rebuilt as necessary.

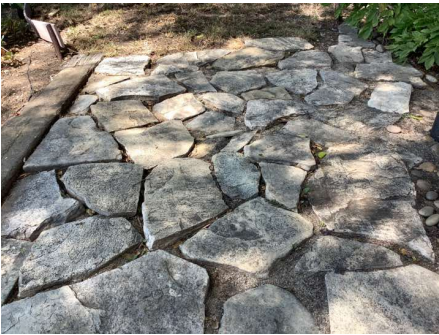
SC s-27: Uneven sections are observed in the walkway surface. This condition poses a trip hazard. We recommend correcting the condition(s) noted for safety reasons.

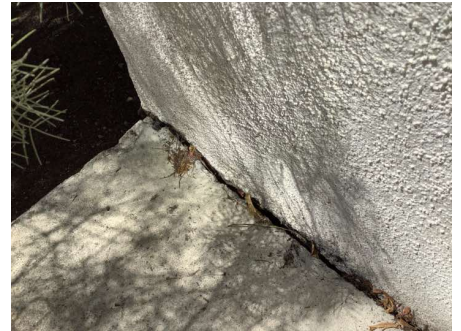
FE s-28: The hardscape has settled or moved away from the left side of the building. Due to the hillside location, we suggest a qualified Geotechnical engineer should evaluate the entire property to assess soil stability or potential for movement.

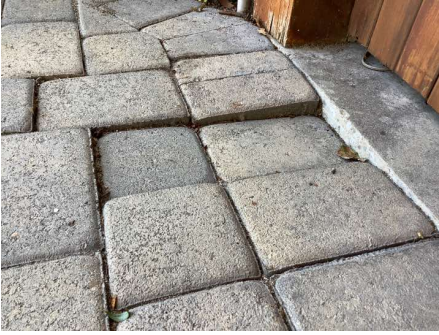
SC s-29: Uneven sections were observed in the driveway surface. This condition poses a trip hazard. We recommend correcting the condition(s) noted for safety reasons.

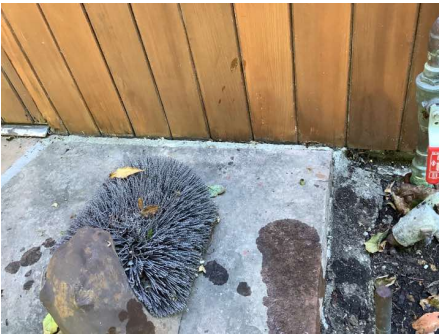
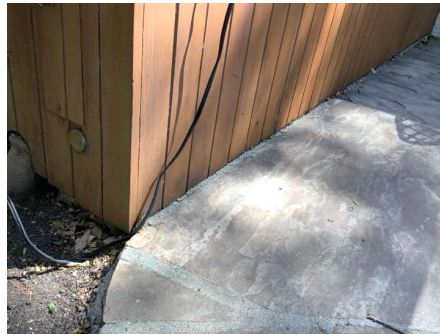
CR s-35: The wood siding is in contact with or covered by hardscape. This condition is conducive to moisture intrusion and deterioration. We recommend further evaluation and corrections by a specialist in the appropriate trade.

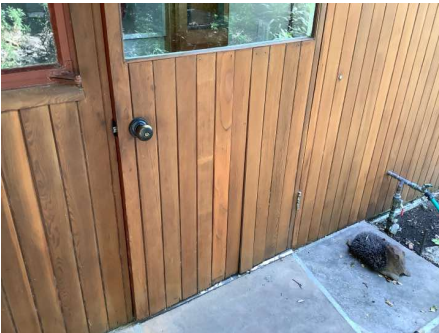
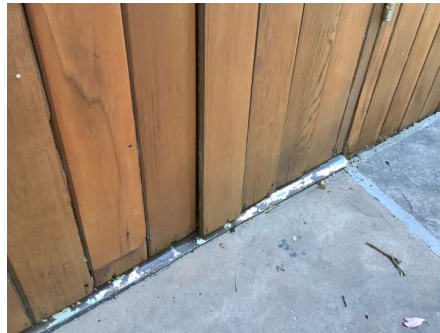
CR s-37: The exterior door is damaged on the right side of the building. We suggest damaged doors should be repaired or replaced as necessary.

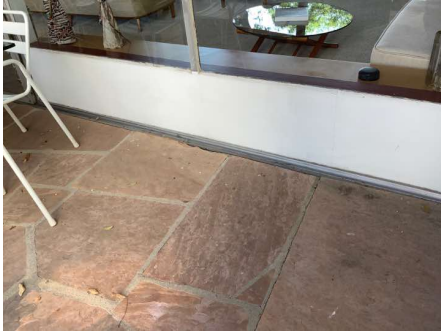
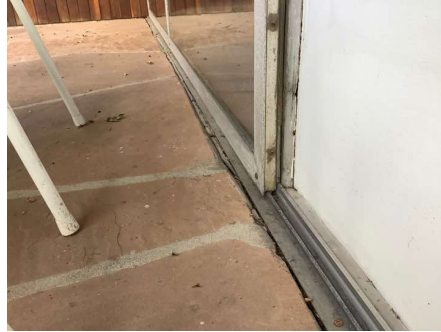
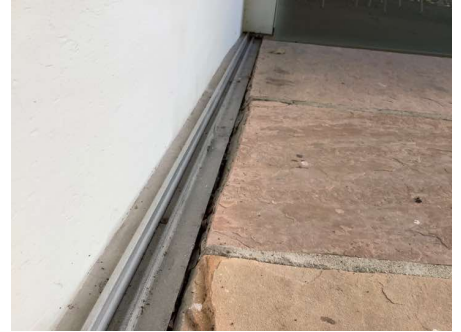
FE CR s-39: The sliding glass door track is installed below hardscape level on the front of the building. During wind driven rain this can promote moisture intrusion and damage at the surrounding areas. We suggest the hardscape should be lowered as necessary by a qualified technician.

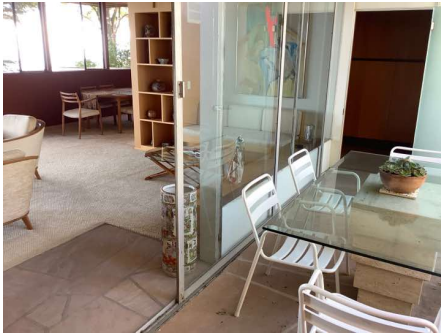
CR s-40: The sliding door is difficult and doesn't fully open. We suggest the sliding door and its associated hardware should be repaired or replaced as needed.

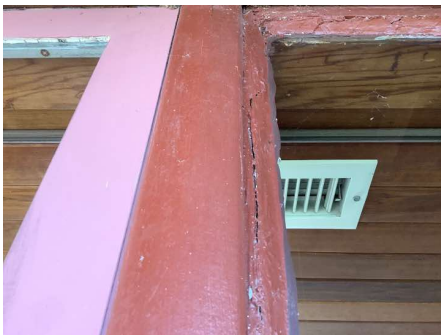
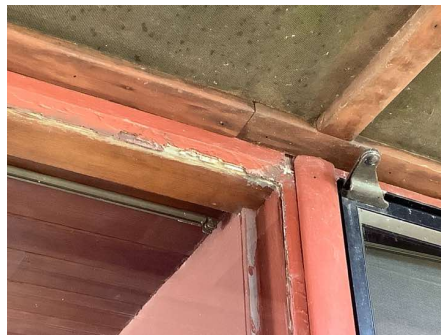
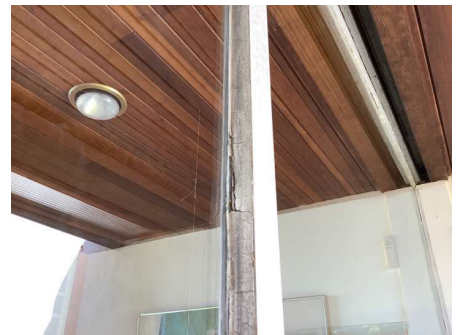
CR s-41: Glazing putty is dry and cracked at the window(s) on several sides of the building. Some putty is loose or missing. This can promote water entry or loose panes. We suggest a qualified window technician should check all windows make repairs or modifications as necessary.

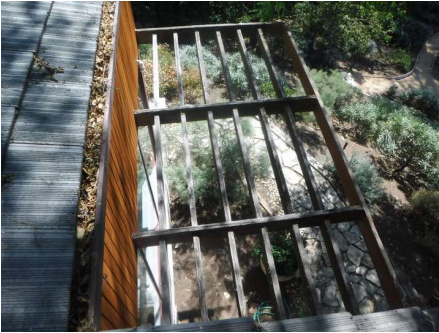
CR s-43: The "outriggers" or exposed beams projecting from the building are weathered and deteriorated at the left rear of the building. We suggest to repair or replace outrigger material as needed as well as capping these beams with metal flashing material. NOTE: Review of a current pest control operator's report, if available is recommended to determine what action might be appropriate. If no current report is available, a report should be ordered from a qualified, licensed pest control operator.

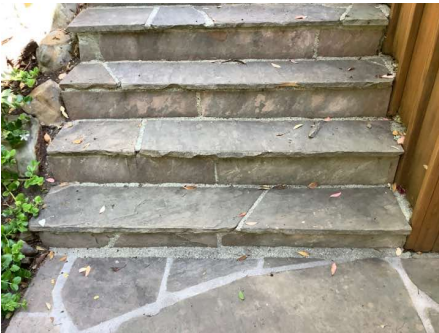
SC s-44: The height of individual stairs are different on the right side of the building. This could present a hazard to the safety of persons who might use them. Standard trade practices dictate that all steps be almost identical in "rise" and "run" for safety. We suggest the stairs should be repaired or replaced by a qualified technician to conform to standard trade practices. If the stairs are not modified or rebuilt, users of the stairs should exercise caution to avoid personal injury.

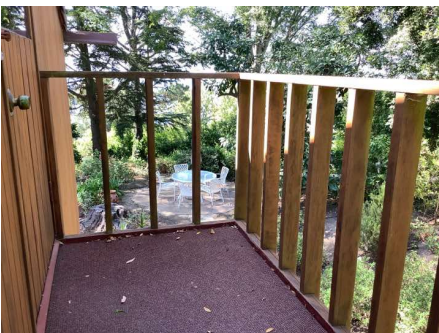
SC s-45: The railing openings between the balusters are wider than the current industry standards on the right side of the building. Although this may have been allowed at the time of construction, this is a safety hazard to small children who could fall through them. Modification in accordance with current standards is recommended as an upgrade.

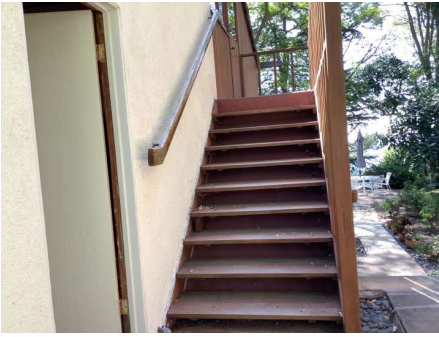
SC s-46: The stair handrails are too high on the right side of the building. We suggest the height of the existing railings could be lowered, or new railings with the proper height could be installed.

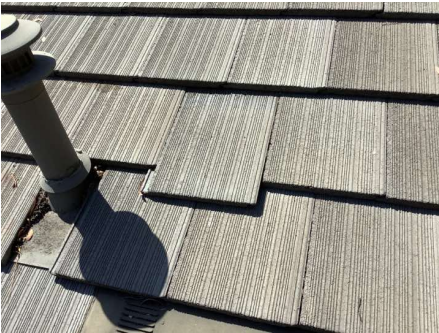
CR s-53: There are a number of cracked, damaged or dislodged tiles on the roof. We suggest a qualified roofer should evaluate the entire roof and make repairs or modifications as necessary.

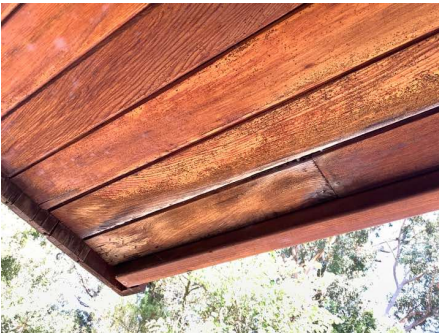
FE s-54: There are water stains on the underside of the eaves at the right front of the building. These visible conditions strongly indicate a prior or active leak. We suggest the source of the water penetration should be located and appropriate repairs made to prevent more damage to the eaves.

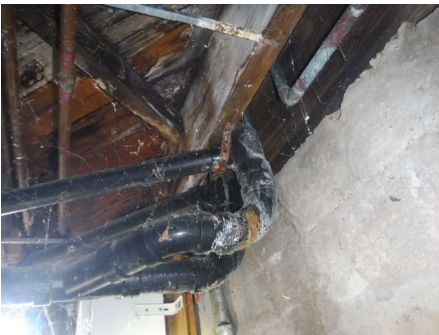
FE s-75: There are water stains on the subfloor and plumbing drain under the master bathroom. The areas were dry at the time of this inspection. Inquires should be made to the sellers as to their knowledge of the leaks and what repairs were performed. If concerns remain we suggest a qualified plumber evaluate the plumbing components in this area.

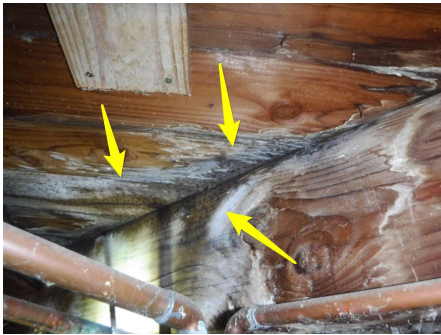
FE CR s-76: There is surface growth on the subflooring under the master bathroom. This may indicate the presence of mold, fungus or other microbial organisms. The identification of molds, fungus and other microbial organisms is outside the scope of this inspection. A qualified environmental specialist should be retained to evaluate the surfaces and make further recommendations. Testing and remediation of mold growth can only be accomplished by a qualified environmental specialist. If strict protocol is not followed, spores can be released into the interior of the building and may create a health hazard for those with low tolerances to such organisms.

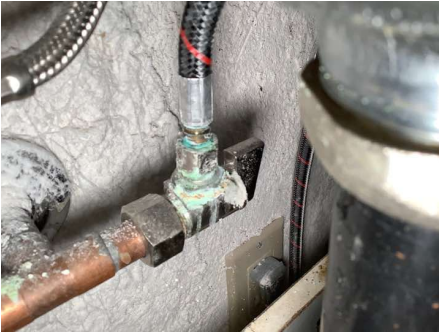
Hallway bathroom toilet

CR s-92: In the area(s) listed below the water supply shutoff valves are noticeably corroded, but are not leaking at this time. We recommend replacing any corroded valve before leaks are discovered.

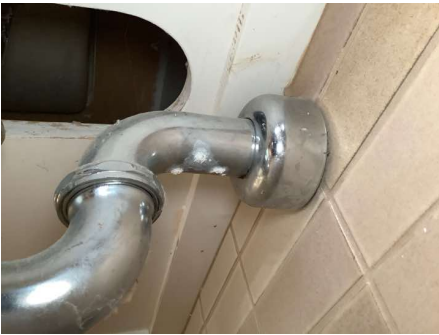
Max bathroom left wash basin

CR s-93: In the area(s) listed below although no active leak was observed, there is/are corroded and/or deteriorated drain line(s) with a limited useful life. We suggest considering replacing such drains before leaks occur.

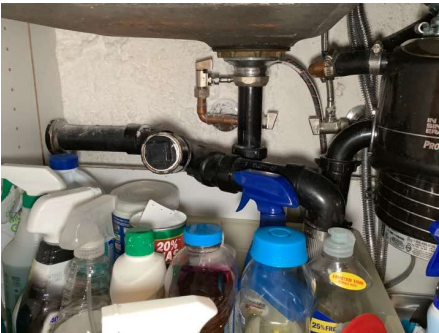
Kitchen sink

CR s-94: In the area(s) listed below the drain lines have an improper slope. Drains must slope down. Incorrect pipe slope can prevent proper drainage. We suggest a qualified plumber should make repairs or modifications as necessary.

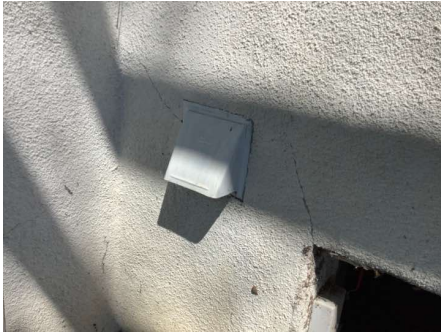
CR s-105: The tankless water heater has a category III stainless vent. The termination hood is not approved. We suggest a qualified plumber should install a vent cap approved by the water heater manufacture.

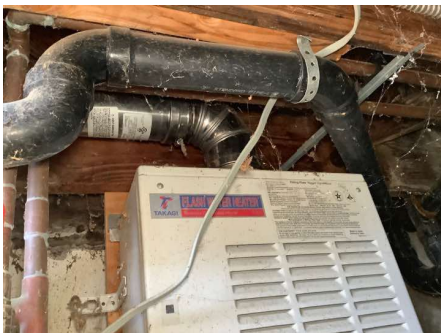
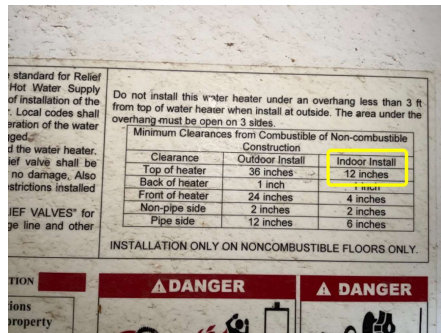
CR s-107: The tankless water heater is installed too close to the surfaces above. This could be a fire hazard. We suggest a qualified plumber adjust the appliance location to provide adequate clearance to meet the manufacturer's specifications.

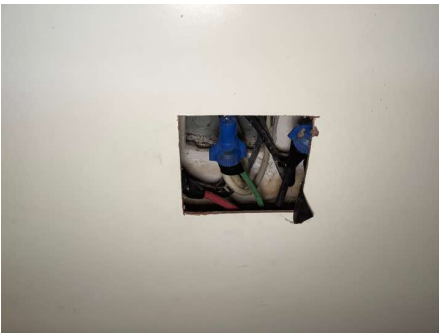
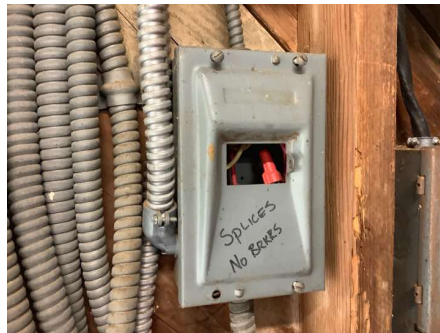
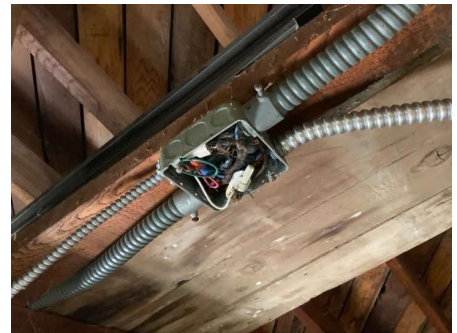
Kitchen cabinet under the cooktop
Garage

CR s-146: In the area(s) listed below there is open junction box(es). Lack of covers on junction boxes is a shock or fire hazard. We DID NOT necessarily list all locations. We suggest a qualified electrician should check the system and install a proper cover on all junction boxes.

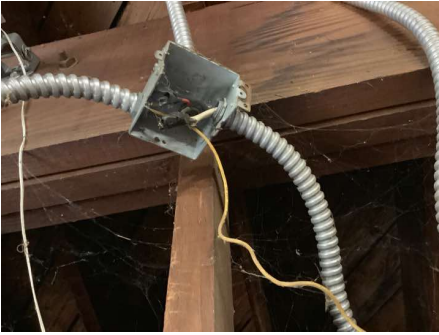
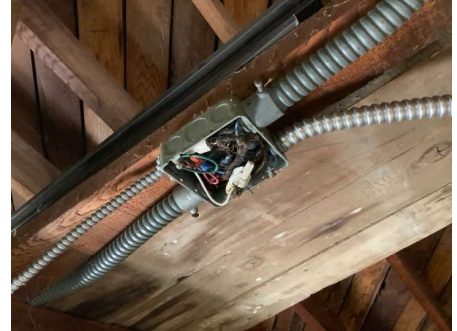
CR s-147: In the area(s) listed below there is an open wire splice(s). We DID NOT necessarily list all locations. Open splices can be a shock or fire hazard. We suggest a qualified electrician should properly splice all wiring inside covered junction boxes.
Garage

CR 147: In the area(s) listed below there is an open wire splice(s). We DID NOT necessarily list all locations. Open splices can be a shock or fire hazard. We suggest a qualified electrician should properly splice all wiring inside covered junction boxes.

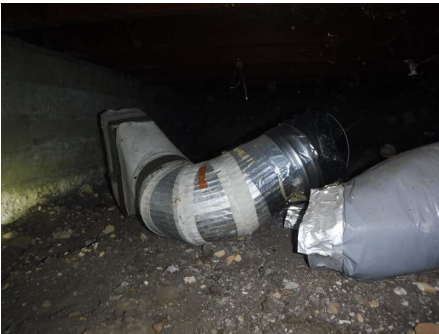
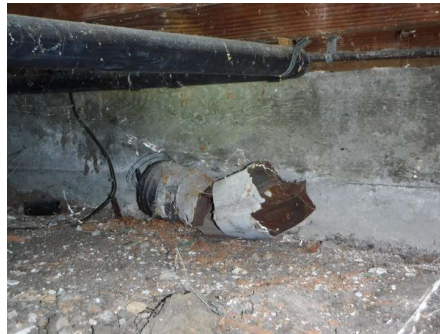
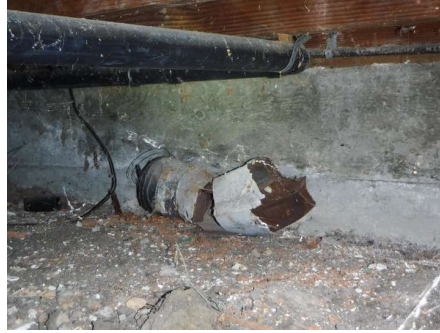
FE CR s-158: The original ducts are made a material that may contain asbestos. Some of the ducts are abandoned and generally in poor condition or damaged. We suggest the abandoned ducts are removed by a licensed asbestos abatement contractor as necessary.

FE CR 158: The original ducts are made a material that may contain asbestos. Some of the ducts are abandoned and generally in poor condition or damaged. We suggest the abandoned ducts are removed by a licensed asbestos abatement contractor as necessary.

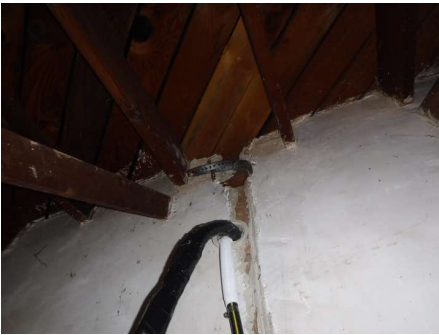
CR s-181: There are holes/damage in the fire-resistive barrier between the garage and interior or attic. This condition can allow more rapid spread of smoke and flames in the event of a fire. We suggest all voids should be repaired per current industry standards.

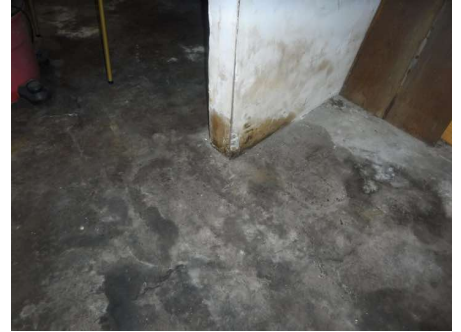
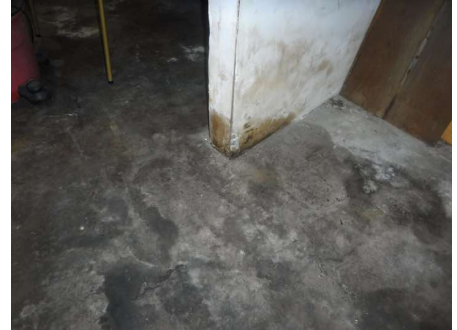
FE CR s-184: There are dark stains on the garage floor adjacent wall surfaces. This may indicate motor oil spills. We suggest a qualified environmental specialist should evaluate the staining to advise on necessary repairs.

FE CR 184: There are dark stains on the garage floor adjacent wall surfaces. This may indicate motor oil spills. We suggest a qualified environmental specialist should evaluate the staining to advise on necessary repairs.

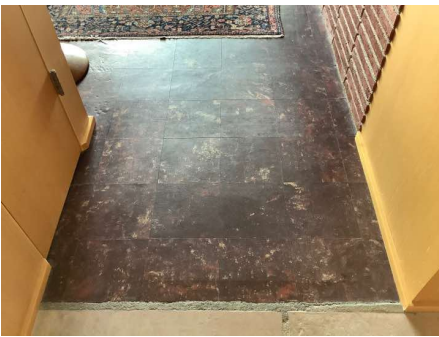
FE s-185: The floor tile material in the middle room and master closet may contain asbestos. Asbestos content can be determined only by laboratory testing. We suggest you to obtain further information on asbestos from a licensed asbestos consultant or abatement contractor.

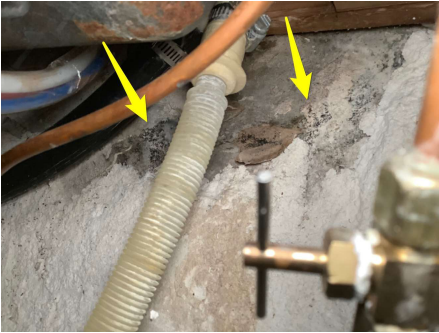
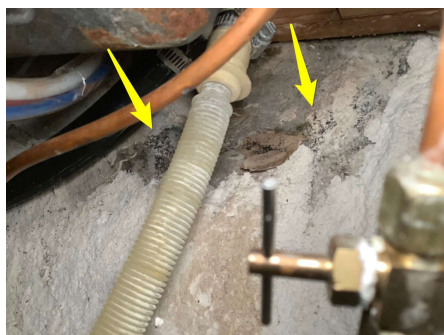
Kitchen cabinet under the sink

FE s-190: In the area(s) listed below there is surface growth and/or an earthy odor on the walls. This may indicate the presence of mold, fungus or other microbial organisms. The identification of molds, fungus and other microbial organisms is outside the scope of this inspection. We suggest a qualified environmental specialist should be retained to evaluate the surfaces and make further recommendations. Testing and remediation of mold growth can only be accomplished by a qualified environmental specialist. If strict protocol is not followed, spores can be released into the interior of the building and may create a health hazard for those with low tolerances to such organisms.

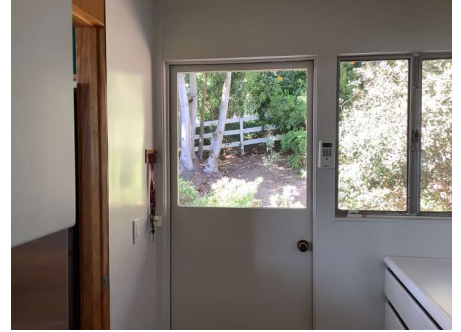
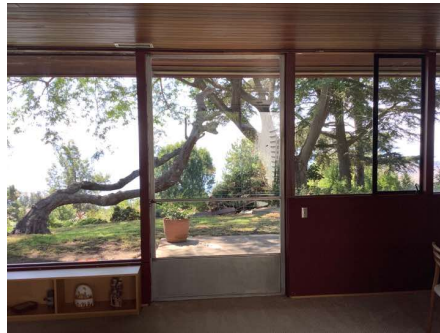
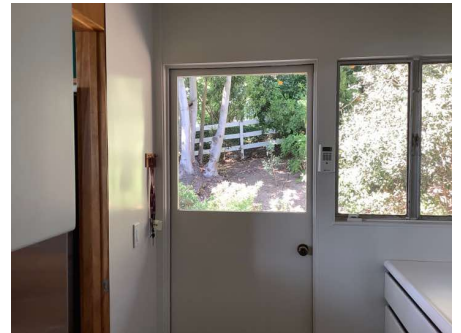
SC RU s-192: The glass in the older original openings has no markings that indicates that it is safety glass. However, the glass in the newer doors and/or windows did have such markings. Non-safety glass can be hazardous if broken. We recommend that glass be upgraded as appropriate to provide safety glazing in all locations where present industry standards require.

SC RU 192: The glass in the older original openings has no markings that indicates that it is safety glass. However, the glass in the newer doors and/or windows did have such markings. Non-safety glass can be hazardous if broken. We recommend that glass be upgraded as appropriate to provide safety glazing in all locations where present industry standards require.

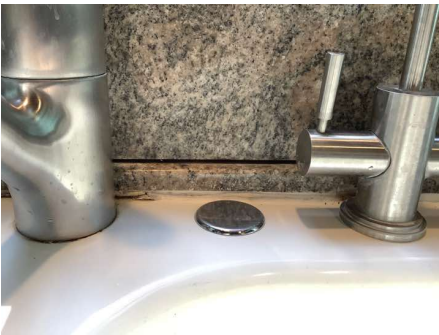
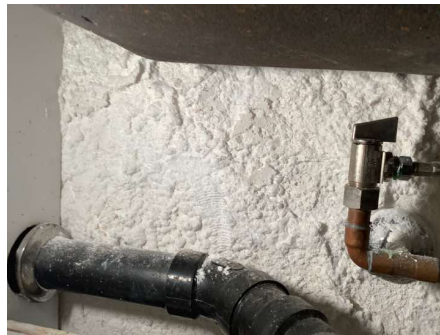
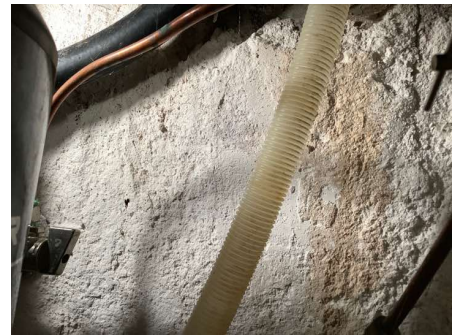
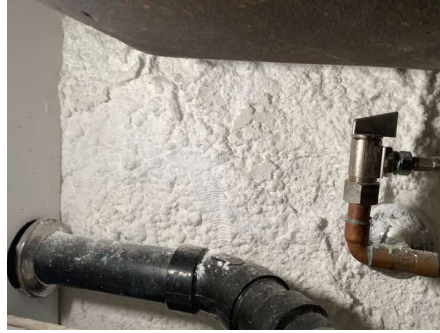
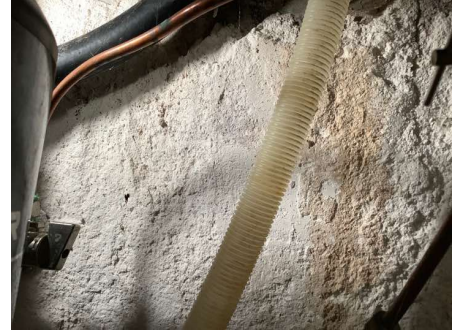
CR s-209: The joint between the countertop and the backsplash is cracked or open and subject to moisture damage from water penetration. Water stains and/or damaged were present in the cabinet below. We suggest a qualified technician re-caulking the backsplash and repair the cabinet as necessary.

CR 209: The joint between the countertop and the backsplash is cracked or open and subject to moisture damage from water penetration. Water stains and/or damaged were present in the cabinet below. We suggest a qualified technician re-caulking the backsplash and repair the cabinet as necessary.

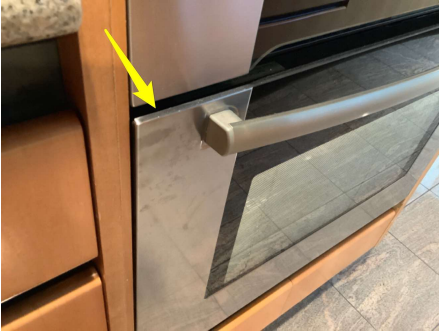
CR s-216: The oven door does not fully close, preventing the door from sealing properly. We suggest having a qualified appliance technician repair the appliance as needed.

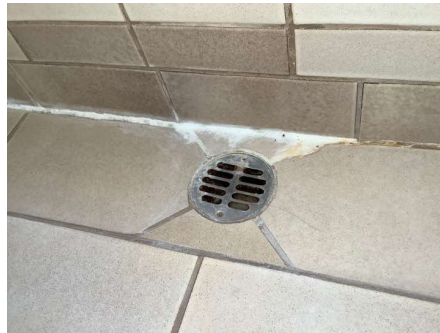
CR s-241: There are mineral deposits above some of the shower pan tiles. The mineral deposits are hard and can be abrasive. This can indicate the shower pan drains are obstructed or the shower pan under the tiles is not properly sloped. We suggest a qualified shower pan technician should evaluate this condition and make repairs or modifications as necessary.

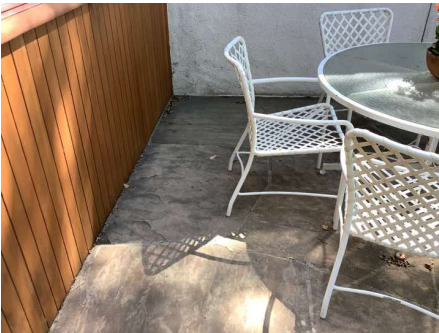
CR 26: The walkway is sloped toward the building, mainly at the right rear. This condition can promote water entry into the structure. The walkway should be repaired or rebuilt as necessary.

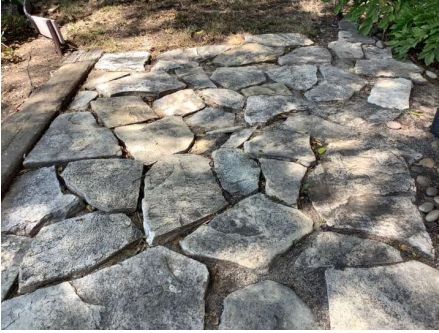
SC 27: Uneven sections are observed in the walkway surface. This condition poses a trip hazard. We recommend correcting the condition(s) noted for safety reasons.

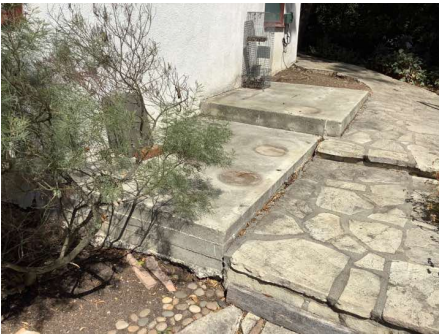
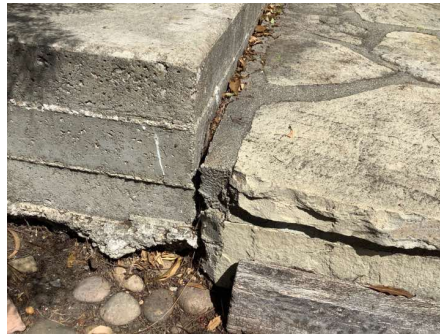
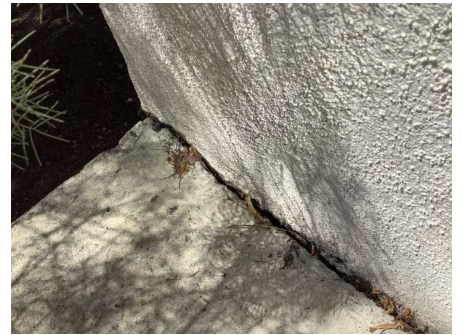
FE 28: The hardscape has settled or moved away from the left side of the building. Due to the hillside location, we suggest a qualified Geotechnical engineer should evaluate the entire property to assess soil stability or potential for movement.

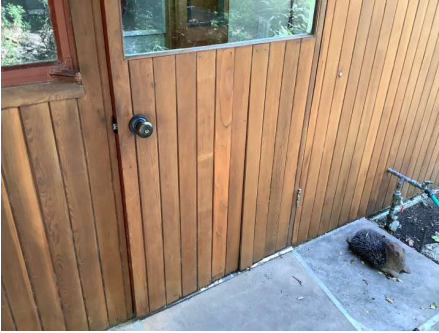
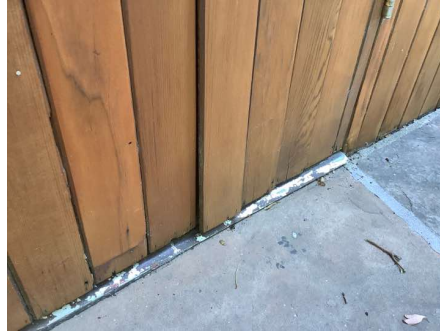
CR 37: The exterior door is damaged on the right side of the building. We suggest damaged doors should be repaired or replaced as necessary.

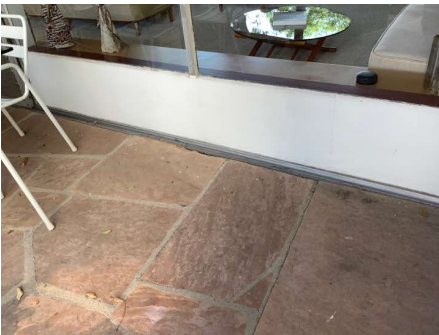
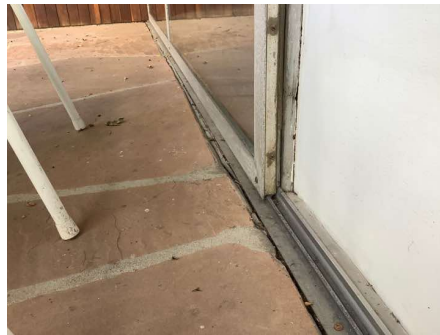
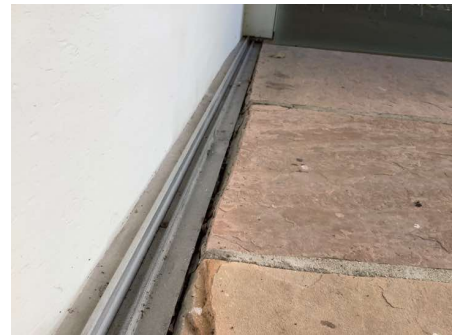
FE CR 39: The sliding glass door track is installed below hardscape level on the front of the building. During wind driven rain this can promote moisture intrusion and damage at the surrounding areas. We suggest the hardscape should be lowered as necessary by a qualified technician.

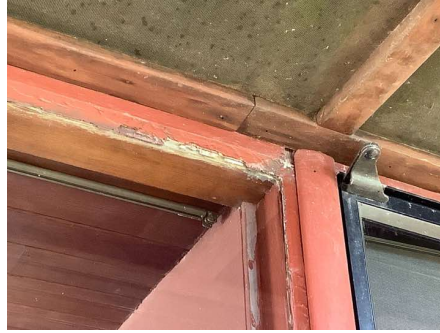
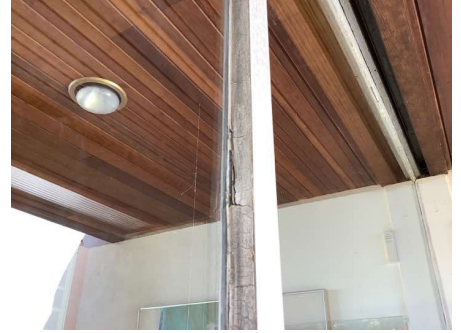
CR 41: Glazing putty is dry and cracked at the window(s) on several sides of the building. Some putty is loose or missing. This can promote water entry or loose panes. We suggest a qualified window technician should check all windows make repairs or modifications as necessary.

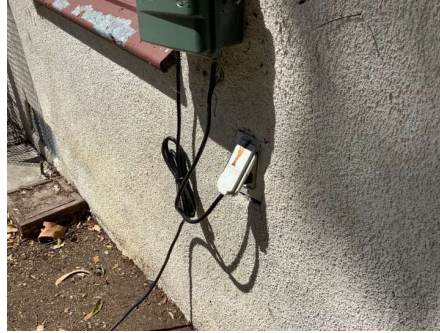
CR 140: There is a permanently installed extension cord on several sides of the building. All permanently installed cords are required to have a cover that allows the plug to be installed and still maintain a weather-tight enclosure. We suggest approved weatherproof covers should be installed as needed.

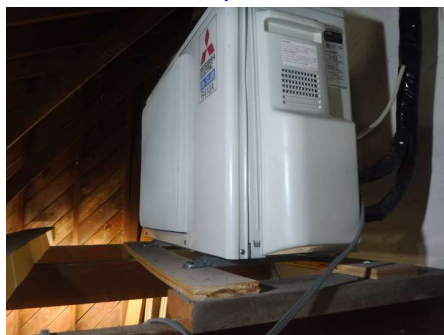
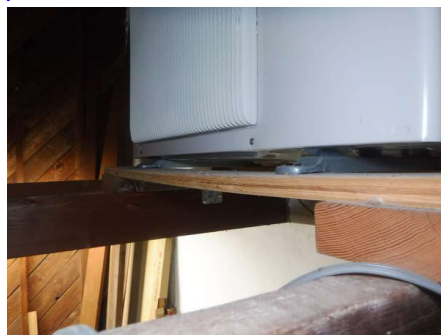
CR s-169: The condensing unit is not loaded on the exterior of the building. It is also improperly mounted on garage roof framing and the planks are sagging. We suggest a qualified HVAC technician should relocate the unit per manufactures specifications.

CR 169: The condensing unit is not loaded on the exterior of the building. It is also improperly mounted on garage roof framing and the planks are sagging. We suggest a qualified HVAC technician should relocate the unit per manufactures specifications.

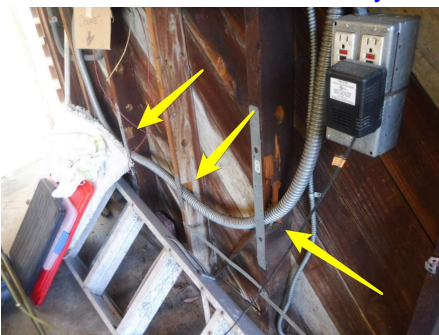
CR s-182: One or more of the wall studs in the garage is over notched. This could affect its ability to support the structure above. We suggest a qualified carpenter could evaluate the studs and make repairs or modifications as necessary.

CR 182: One or more of the wall studs in the garage is over notched. This could affect its ability to support the structure above. We suggest a qualified carpenter could evaluate the studs and make repairs or modifications as necessary.

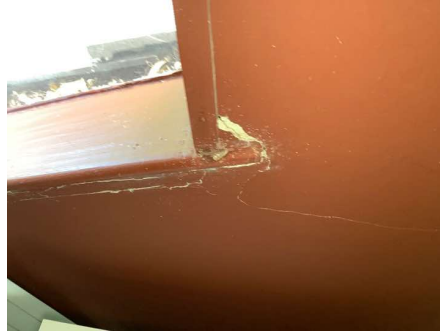
Upper floor

FE CR s-191: In the area(s) listed below there are water stains and/or damage at the wall or sill near the window(s). The leaks that caused the damage may still exist. We suggest a qualified technician should identify and repair all leaks. If damage to finished surfaces and underlying materials are discovered during the course of repairs, repairs should be made as necessary.
