# Property Inspection Report

**4170 Whispering Oak Way  
Paso Robles, CA 93446**

**Inspection Date:  
06/21/2017**

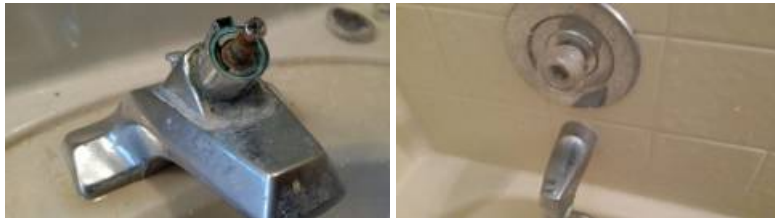
[CR] The sink faucet was missing parts in the master bath. Under these conditions the faucet may not be operating as designed.

[CR] The bath tub faucet(s) were difficult to operate in the hall bath. This condition usually indicates that the faucet is aging and could malfunction.

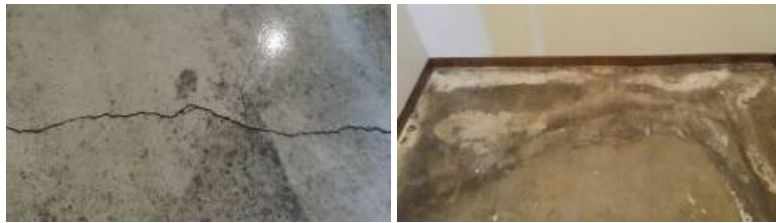
[FE] Efflorescence stains (mineral salts) were noted on the concrete floor in the master bedroom, second bedroom, and guest bedroom. This condition is from the floor experiencing wet and dry cycles and may continue until the moisture source is located and corrected.

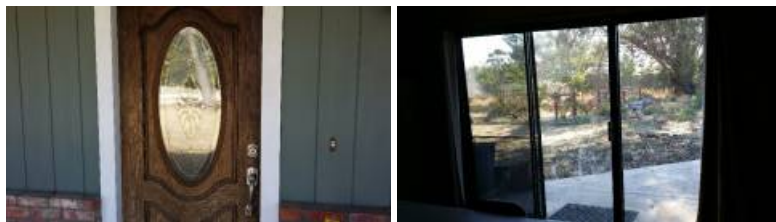
[CR] The sliding-glass door(s) were difficult to operate in the dining room. Continued use in this condition may lead to damage.

[CR] The rear screen door(s) were damaged.
