Address: 1327 S Helberta Ave, Redondo Beach

Date of Inspection: 01-02-21

West Coast Sewer Inspection: (310) 876-4653

Main Sewer Line Inspection Report

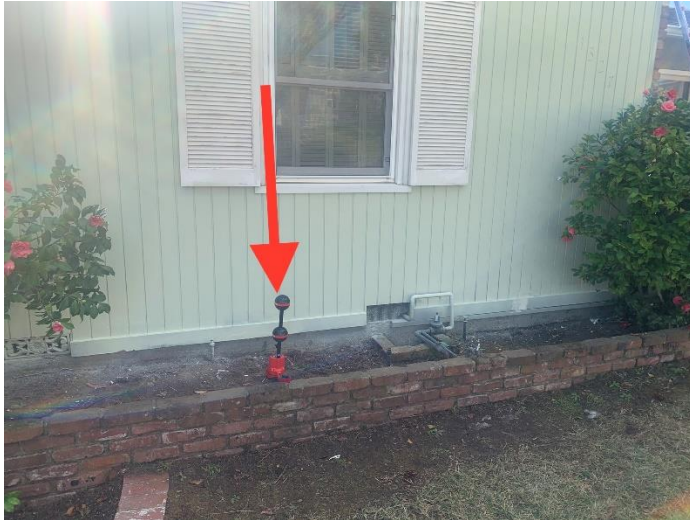
Good location for a cleanout under tool. Depth 3'

Areas Needing Attention: It is advised to install a main sewer line cleanout for the house in order to inspect and clean the sewer line thoroughly. A cleanout is an access point that allows plumbers to inspect and clean the sewer line without having to travel through a roof vent or removing a toilet.

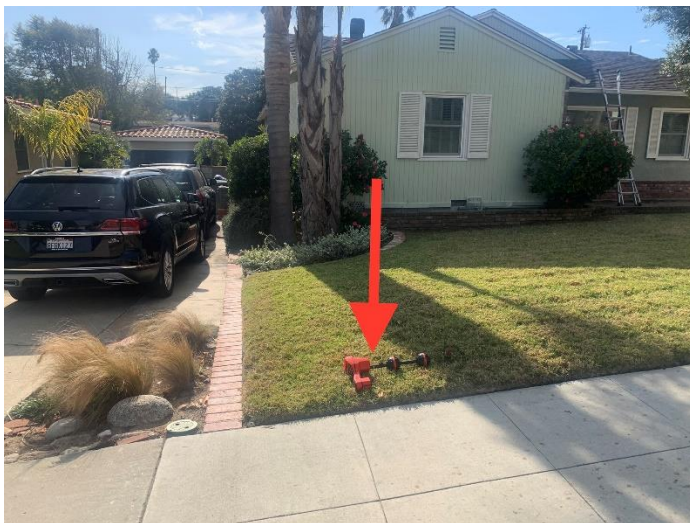
The main sewer line for this property appears to be shared with the neighbor's. The paperwork for the property should be checked to find if allowance for this has been included in the documentation for the house. If not, it is advised to obtain some agreement in writing allowing for the line to be shared. Typically an arrangement splitting the costs of maintenance and repair is sufficient to gain written agreement for a shared sewer line.

Where this line and neighbors connect under tool.

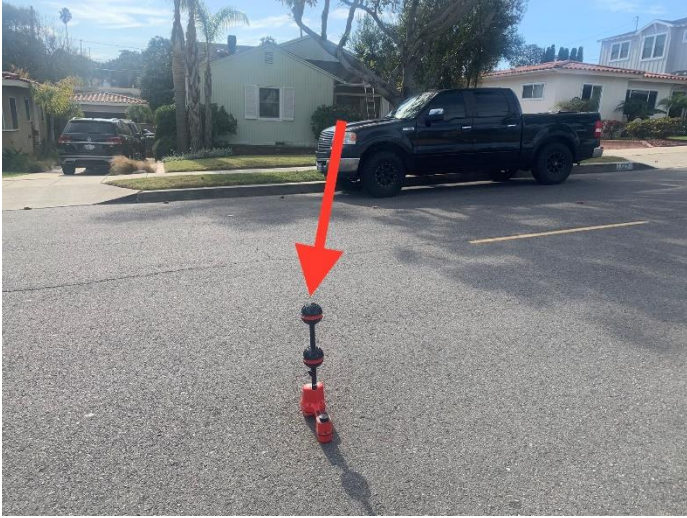
Connection to city sewer under tool.
