Confidential Inspection Report

LOCATED AT:
1516 Ford Ave
Redondo Beach, California 90278

INSPECTED ON:
Tuesday, September 8, 2020

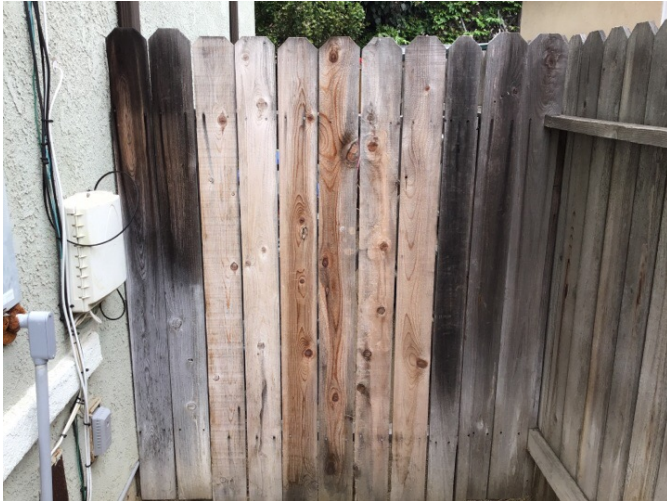
GATES

13: The gate should be water sealed or painted to prevent premature deterioration of the wood.

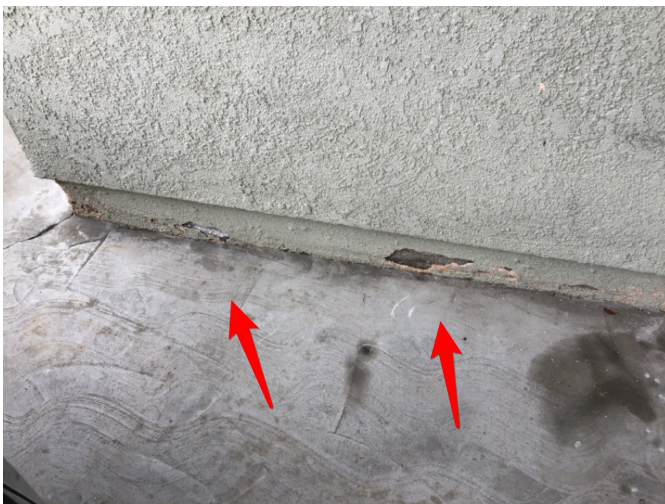
21: The stucco walls have been painted. The paint is older, degraded, and peeling in some areas below the weep screed flashing. It should be evaluated for the cost of touch up repainting in the near term.

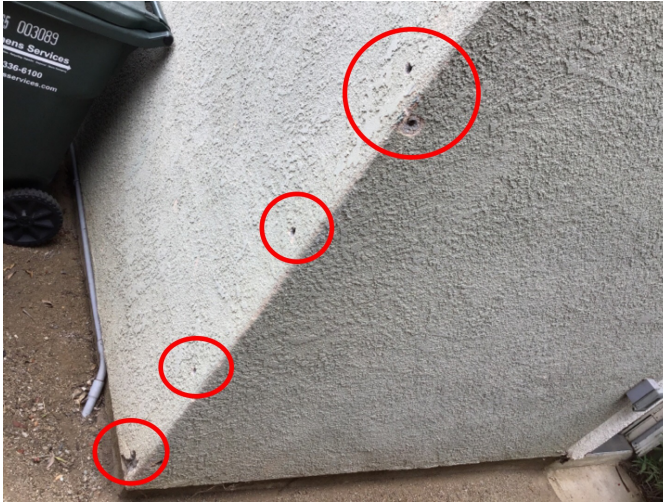
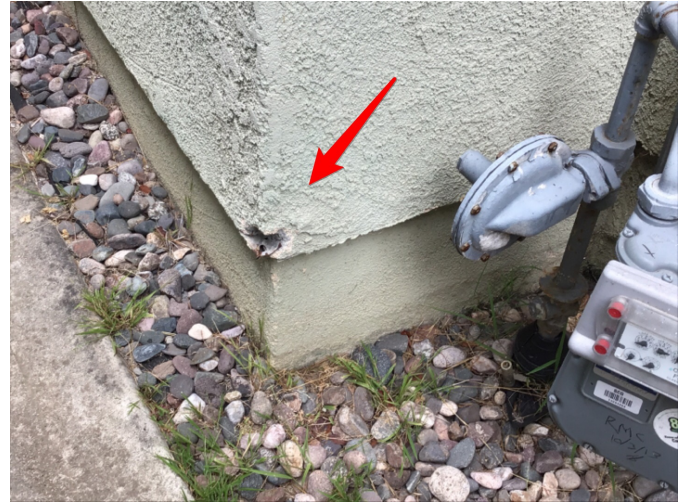
22: At the north backyard and west front yard walls, there are holes in the stucco cladding, which should be repaired to prevent water from entering the wall cavity and damaging the home. In addition, the holes are a potential source of entry for insects, rodents and other pests.

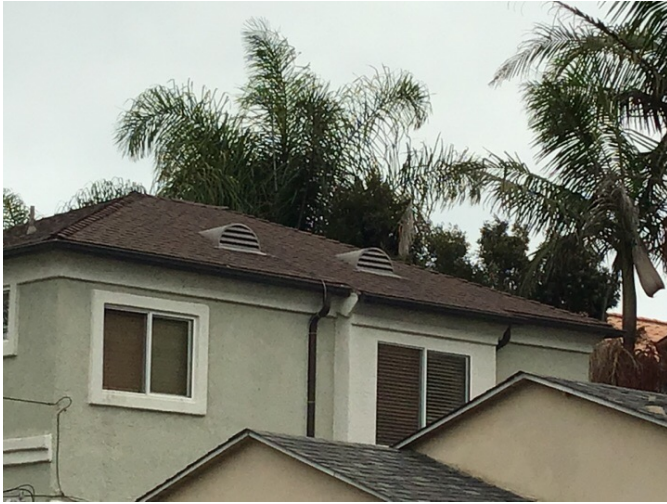
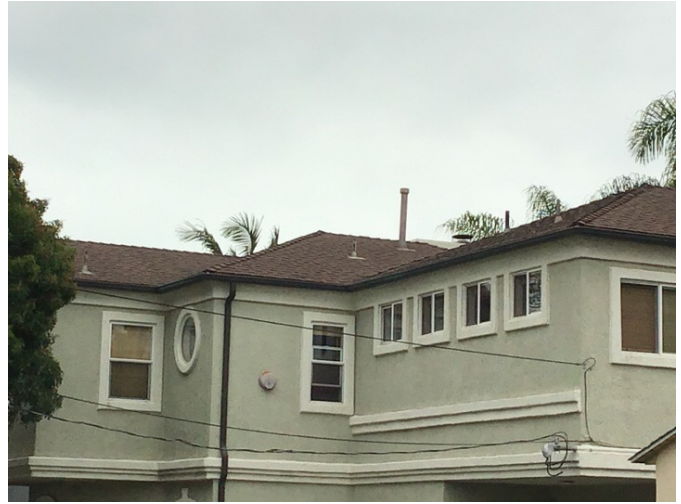
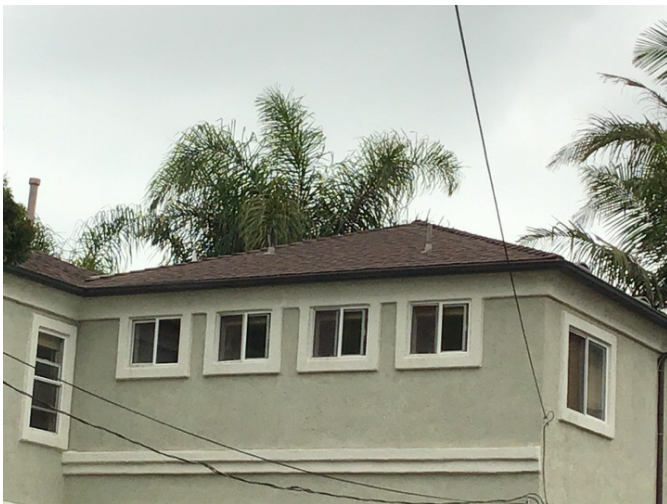
METHOD OF EVALUATION

46: We were unable to directly walk on the second-story roof due to its height. We evaluated the roof covering from various areas around the home. Because of this, the inspection was limited. We recommend a licensed roofer further inspect the roof.

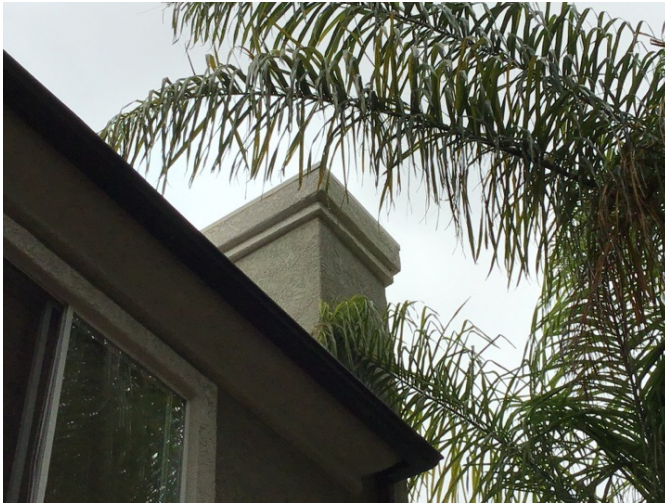
CHIMNEY STACK

59: Due to the location of the chimney, we could not gain access to fully examine it. You should therefore have a specialist evaluate the chimney. This should be done before the close of escrow.

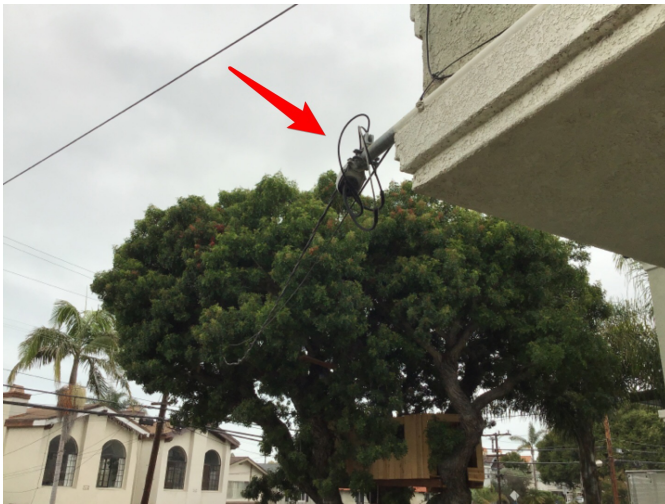
98: The overhead service wires are passing through trees or other foliage. We recommend the trees be trimmed clear of the wires or the service be reconfigured. To reduce shock hazard during this procedure, the work should be coordinated with the utility provider.

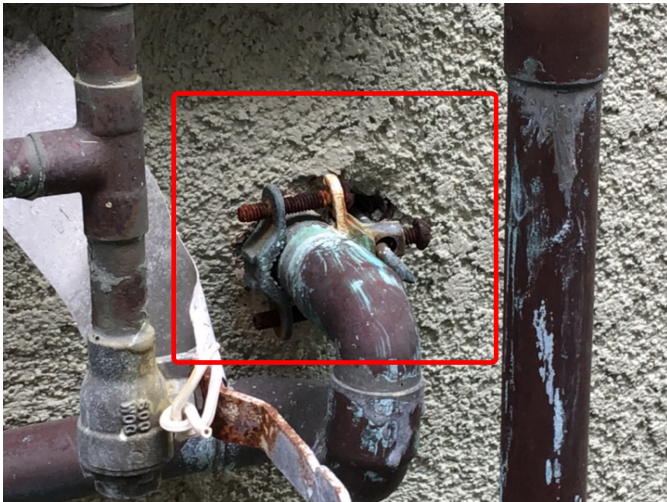
GROUNDING

108: The electrical panel appears to be only grounded to a water pipe, although an additional ground may be located elsewhere and not visible. Current standards require the panel to be double-grounded. You may wish to consider having this done as a safety upgrade.

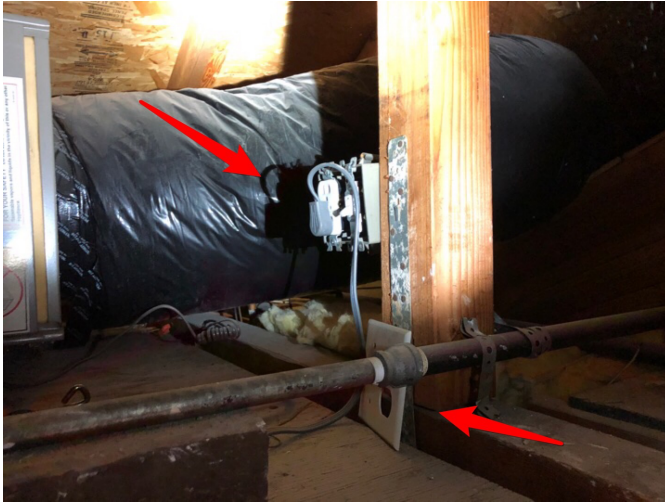
ATTIC

111: A cover plate is not installed at the pictured outlet.

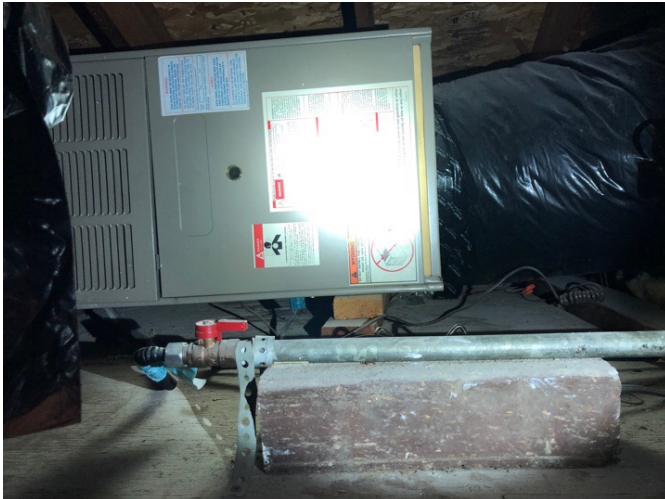
114: The heating system is supported by wood blocks. The manufactures required clearance to combustibles should be reviewed as typically the units are not in contact with combustible material.

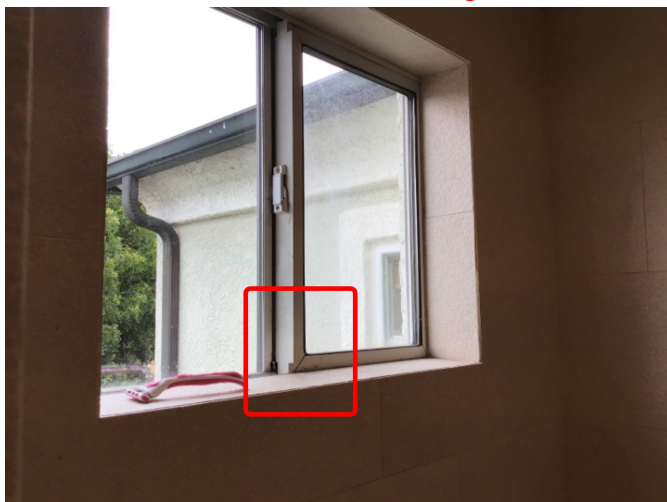
189: Two of the window screens are damaged.

190: The window frame is damaged and needs to be repaired.

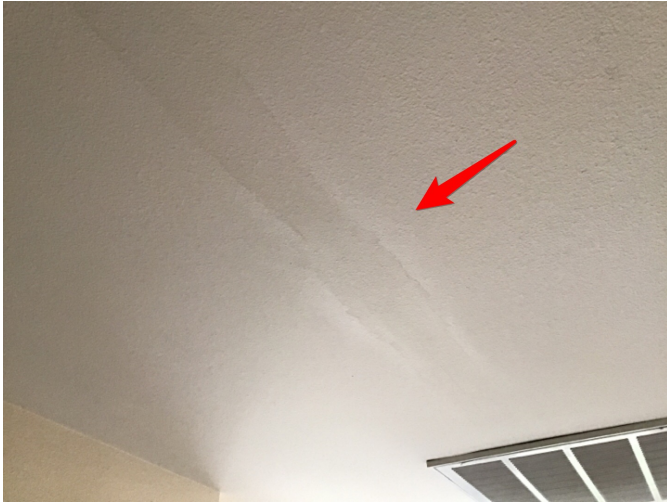
CEILING

229: There is moisture-related damage on the ceiling that you should ask the sellers to explain or have explored further.

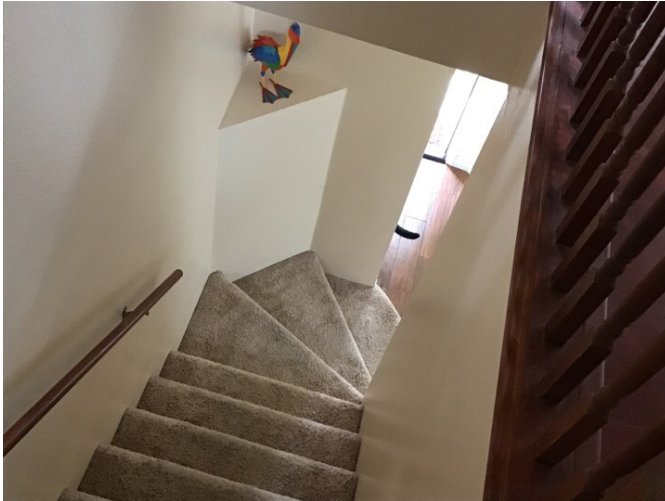
STAIR RAILS

240: A continuous handrail is required the full length of the stairs from a point directly above the top riser of the flight to a point directly above the lowest riser of the flight.

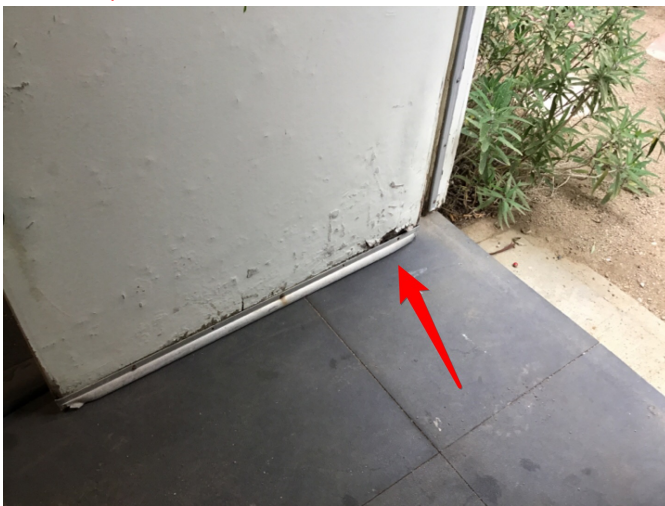
EXTERIOR PASSAGE DOORS

245: The garage passage door is moisture damaged and delaminating (repair or replacement needed).

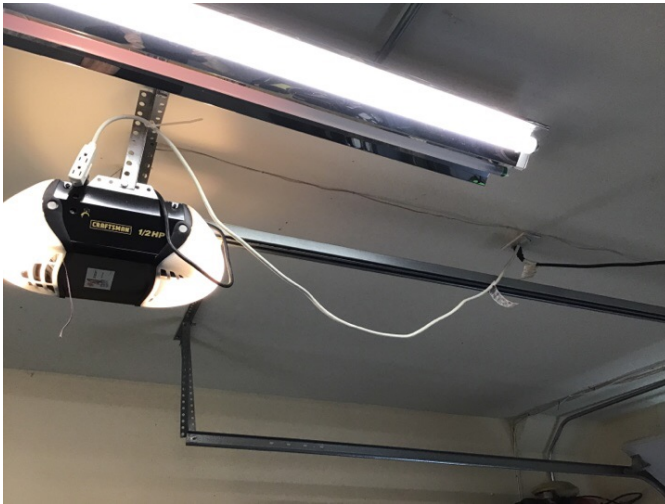
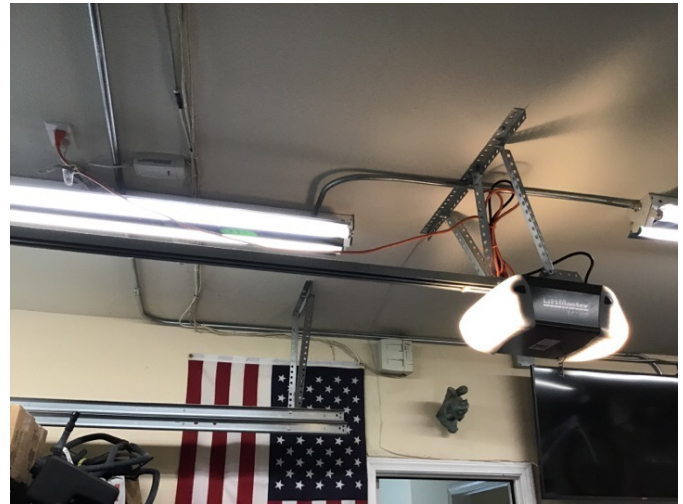
260: The vehicle door openers are powered by an extension cord which is not an approved installation.
