WOOD DESTROYING PESTS AND ORGANISMS INSPECTION REPORT

| Building No. 26 | Street Parkside Ct. | City Chico | Zip 95928 | Date of Inspection 01/12/2017 | Number of Pages 4 |

Report # : 11062
 Registration # : PR5960
 Escrow # :
☐ CORRECTED REPORT

GENERAL DESCRIPTION:
 Two story wood frame single family dwelling.

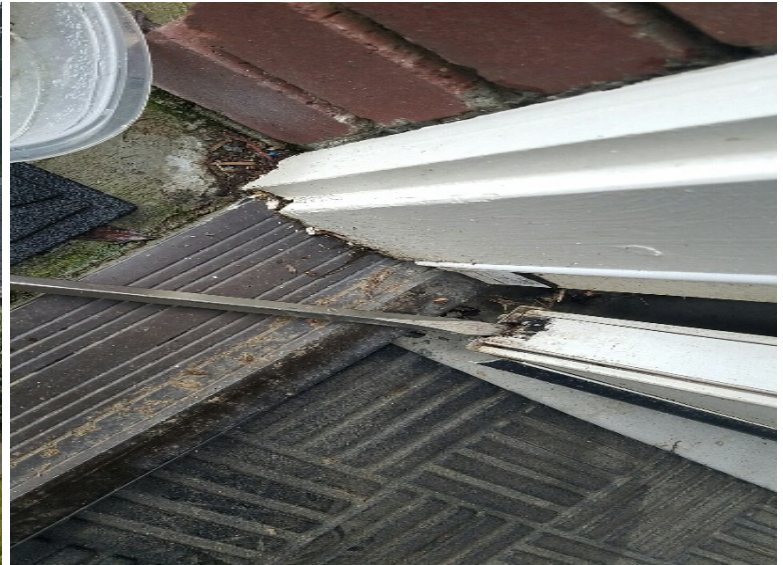
FINDING: Fungus damage was found to the base of the side garage door and to the base of the door jambs.

3A - Damaged to the base of the door and door jambs.

RECOMMENDATION: We recommend the owner/agent engage the services of a licensed contractor to remove all damaged members and to replace with new appropriate material.

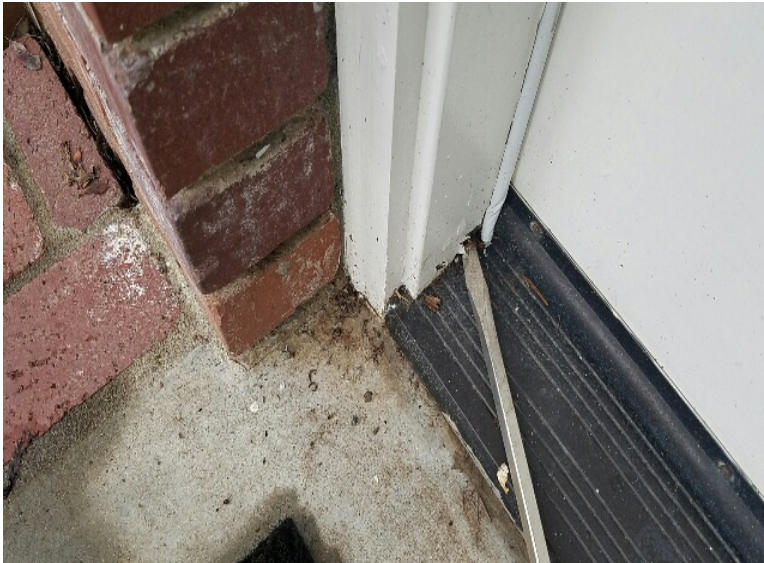
FINDING: Fungus damage was found to the base of the rear door jambs.

3B - Damaged to the base of the rear door jambs.

RECOMMENDATION: We recommend the owner/agent engage the services of a licensed contractor to remove all damaged members and to replace with new appropriate material.

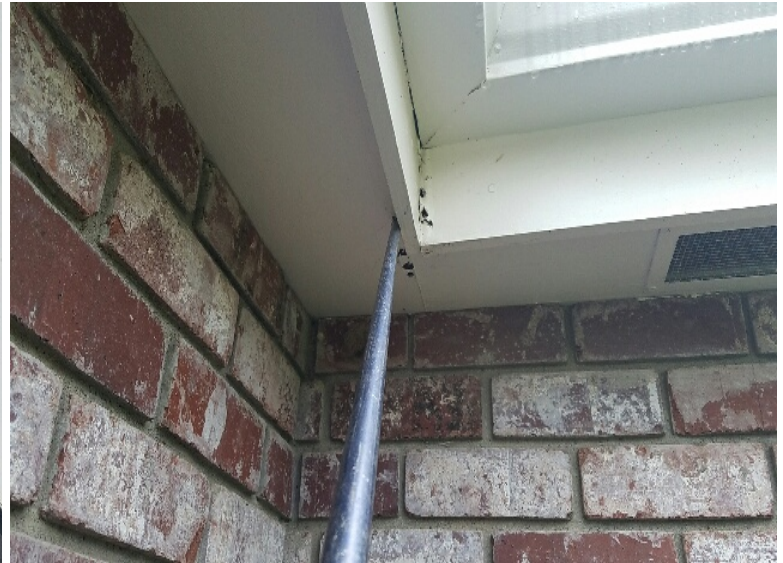
FINDING: Fungus damage was found to roof eaves and fascia.

3C - Damaged eaves and fascia.

RECOMMENDATION: We recommend the owner/agent engage the services of a licensed contractor to remove all damaged members and to replace with new appropriate material.

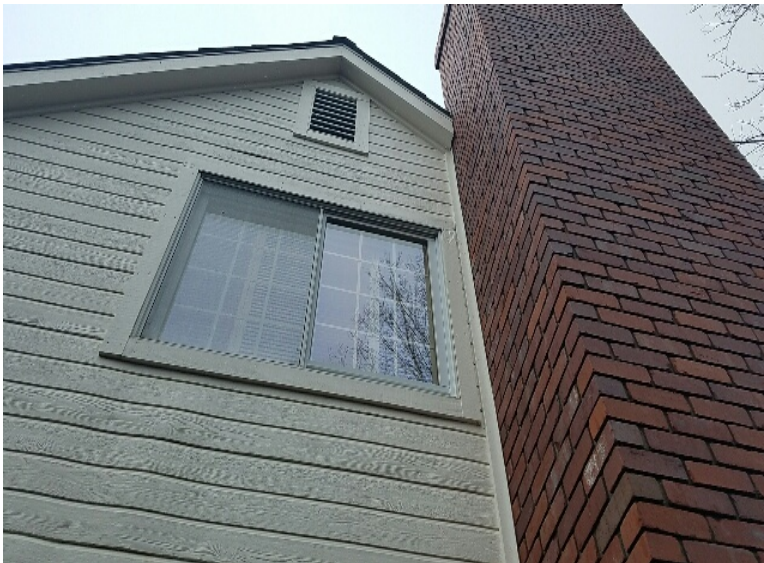
FINDING: Fungus damage was found to upper wood window trim as viewed from ground. The siding below this area was bowed. This inspection is from the ground level only. We did not go on the roof. No opinion to areas which could not be probed from the ground.

3D - Damaged upper window trim.

RECOMMENDATION: We recommend the owner/agent engage the services of a licensed contractor to remove all damaged members and to replace with new appropriate material.
