Building Inspection Report

30162 Cartier, Rancho Palos Verdes, CA

Inspection Date:
1/4/21 9:00am

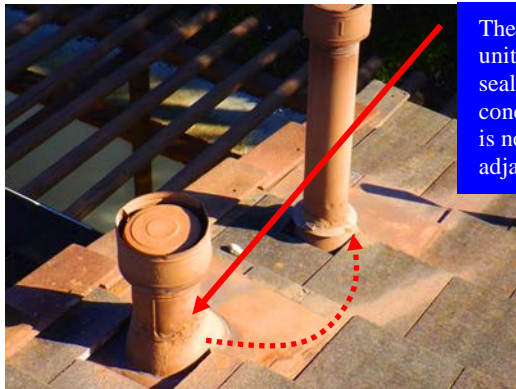
The forced air heating unit's exhaust vent pipe is sealed to the roof flashing cone when a 'storm collar' is needed (seen at the adjacent water heater vent)

- **Improve:** Minor repairs to the roofing are recommended (cracked tile at the NE-area, a few tiles have corner chips that should be improved, etc.). As well, the forced air heating unit exhaust vent pipe rooftop jack flashing cone is sealed to the flashing cone where a gap should be provided along with an added 'storm collar'; suggest repairs by a licensed roofing contractor.

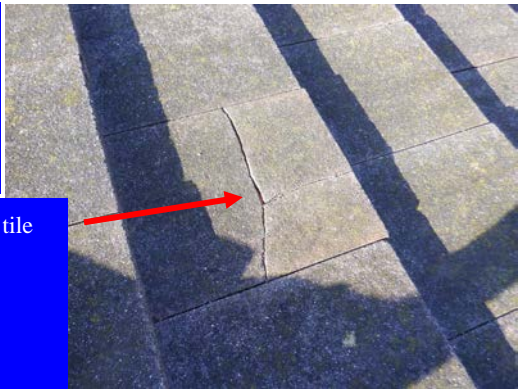
The roof has a cracked tile at the NE-corner area

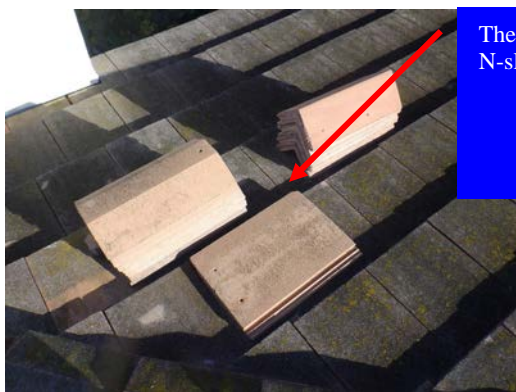
The spare tiles at the roof N-slope should be removed

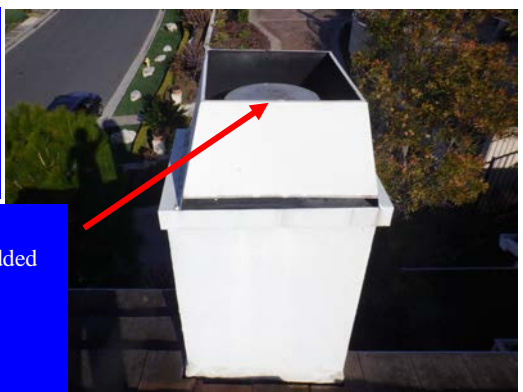
The chimney cap is obstructed within an added chimney tower shroud

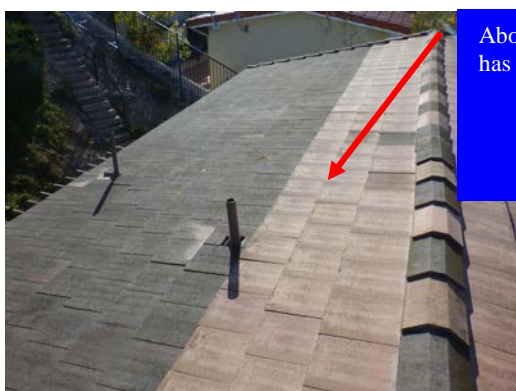
About 15-20% of the roof has replaced tiles...

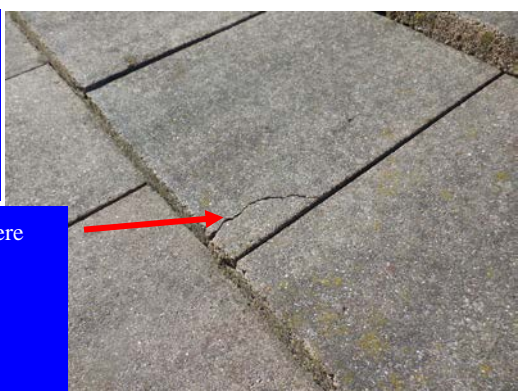
...and corner cracks were noted here and there

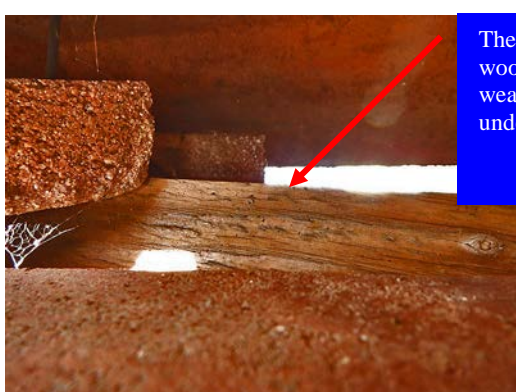
The roof's hip and ridge wood riser boards lack weather protection with underlayment wrap

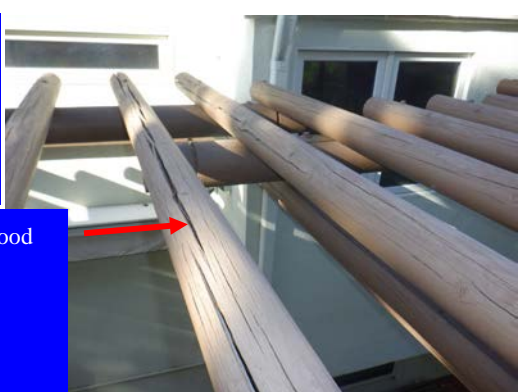
The rear patio trellis wood is weathered

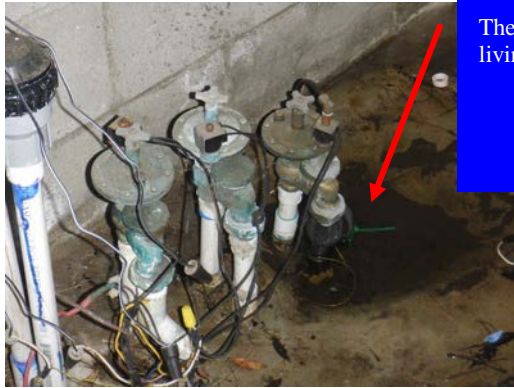
The sprinklers below the living room deck leak

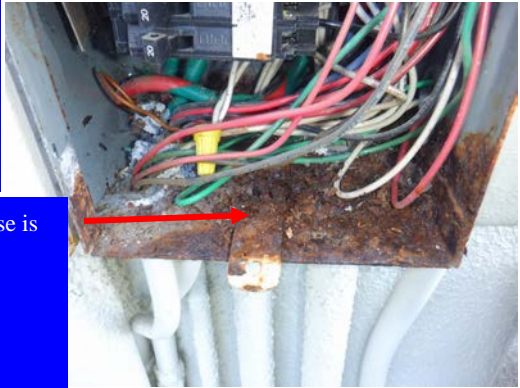
15. **Improve/Safety Issue:** The main electrical panel shows extensive corrosion at the base of the unit and its dead front cover will not fasten closed; suggest repairs by a licensed electrical contractor.

The electrical panel base is rusted...

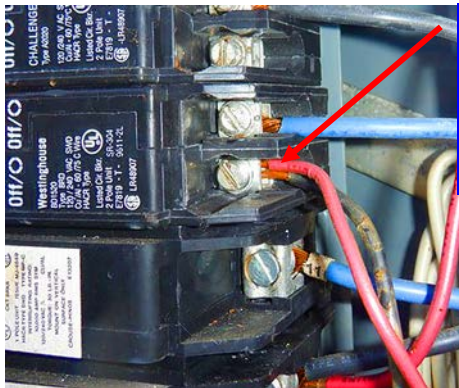
- **Safety Issue:** Two circuit conductors within the main distribution panel are doubled up (referred to as “double taps”) to a single breaker and must be separated. Each circuit conductor is to be served by a separate breaker; suggest repairs by a licensed electrical contractor.

...and contains a 'double-tapped' circuit breaker

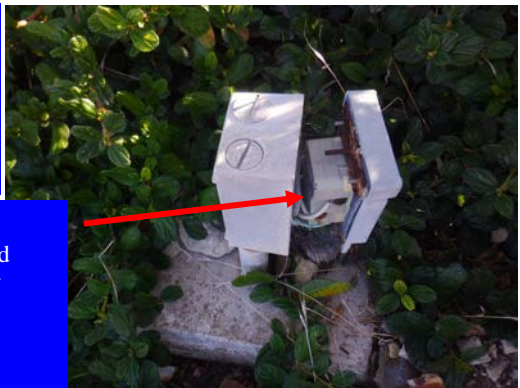
- **Safety Issue:** A number of GFCI outlets (backyard upper terrace N-deck, home’s E-exterior wall area and garage) could not be tripped with test equipment indicating damaged units or improper wiring that presents shock hazards that requires immediate repairs by a licensed electrical contractor.

A damaged outlet was noted up on the terraced backyard slope's lower patio...

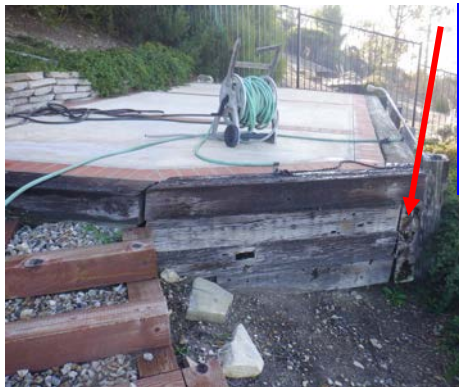
- **Monitor:** The terraced slope has wood framed earth retaining systems that exhibit rot, movement and deterioration (the upper most patio atop one of the retaining systems has tipped) where improvement is costly.

...and the upper patio wood retaining system is deteriorated while the hardscape is off-set

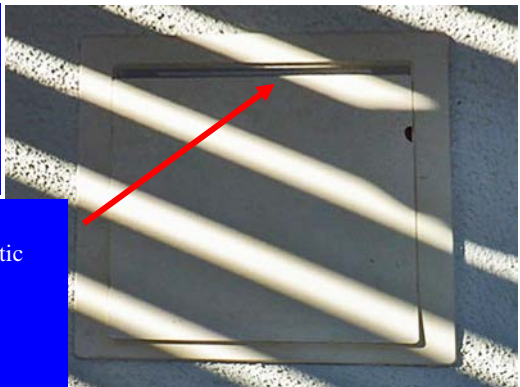
- **Improve:** The master bath tub exterior wall plumbing access hatch consists of plastic which is intended for indoor applications where a steel hinged access hatch is recommended at exterior locations; suggest improving as needed.

The master bath tub exterior wall has a plastic plumbing access hatch intended for indoor installations...

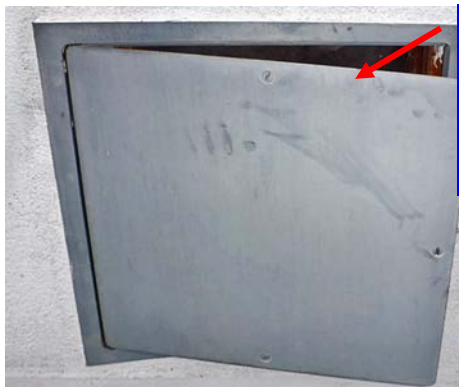
...when hinged steel hatches are used at exterior areas (sample photo)

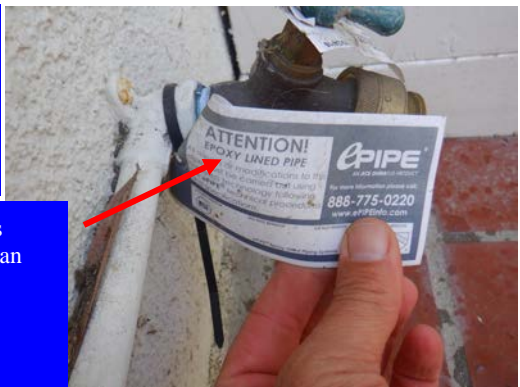
43. **Monitor:** The water supply copper piping system appears to have been epoxy coated/lined that can suggest past pin-hole leaks where further disclosure from the client is recommended.

The copper water pipes have been tagged with an epoxy liner/coating warning label

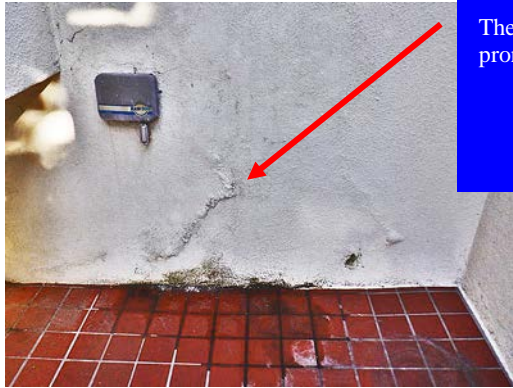
The rear patio N-wall is prone to water infiltration

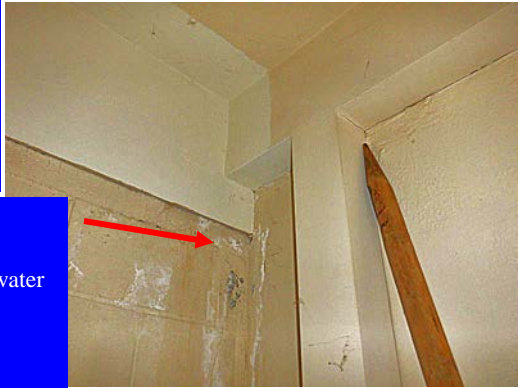
- **Monitor:** Water stains were noted on the garage NE-ceiling/corner area. This is usually an indication of past plumbing leaks (previous water heater?). This area should be monitored.

The garage NE-corner shows water damage suspected from a past water heater leak

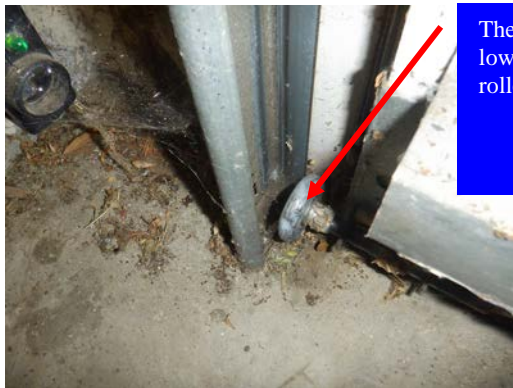
The 2-car vehicle door lower panel has a dislodged roller

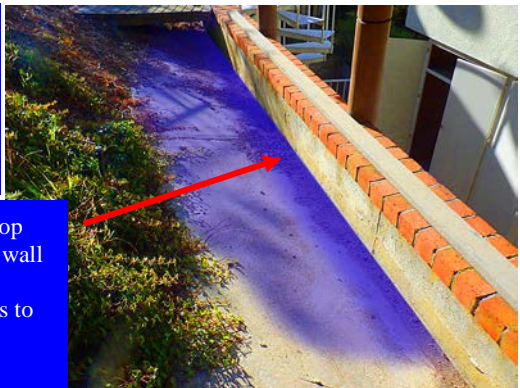
The concrete 'swall' atop the rear patio retaining wall has sunk where water (animated here) appears to flood

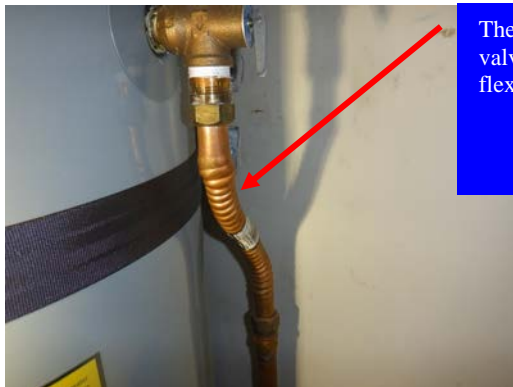
The water heater TPR valve may not use a flexible connector

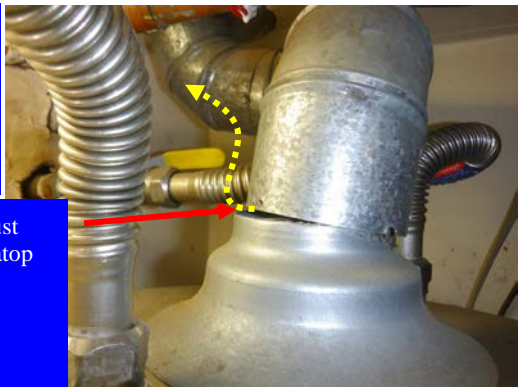
7. **Safety Issue:** The water heater venting system shows evidence of exhaust "spillage" due to a separating connection atop the unit. As well, given this replacement tank is taller than the previous unit, the required 1-foot vertical riser directly above the draft hood is missing. ***This is a serious condition that could be a health threat to the occupants of the home.*** This condition should be addressed promptly.

The water heater exhaust vent pipe is separated atop the draft hood

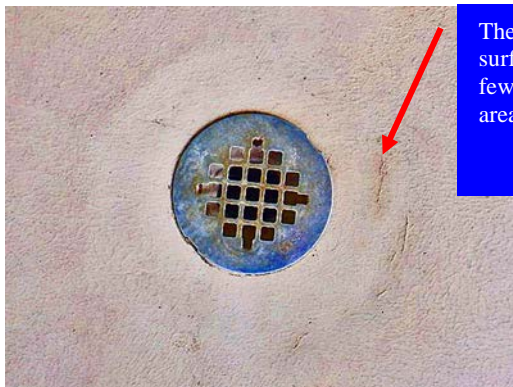
The living room deck surface has developed a few splits at the N-drain area

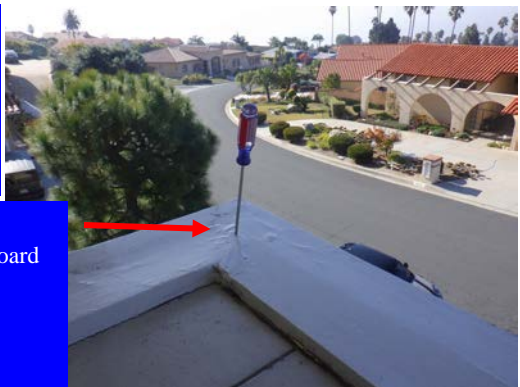
The master bedroom balcony rail wall cap board is weathered and deteriorated

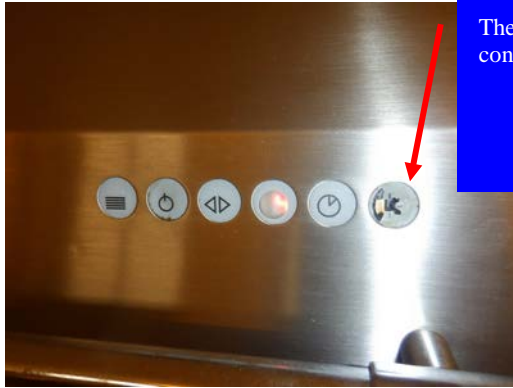
The kitchen exhaust hood controls are worn

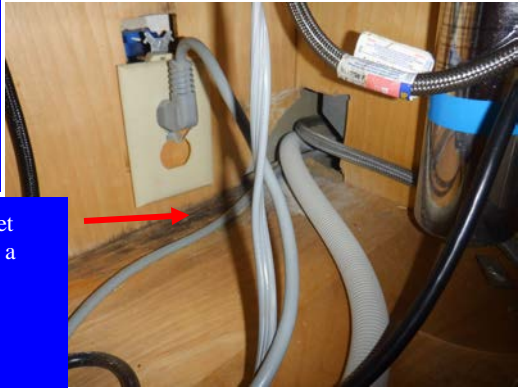
The kitchen sink cabinet shows water stains and a detached outlet cover

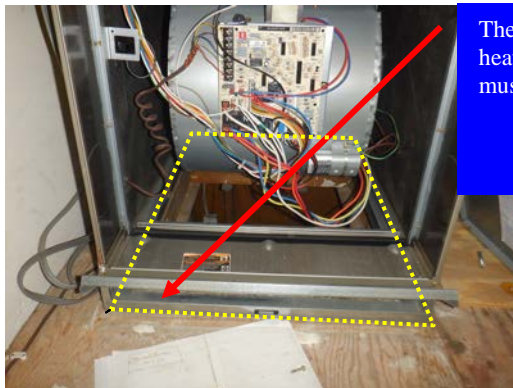
The base of the forced air heating unit filter housing must be sealed to the shelf

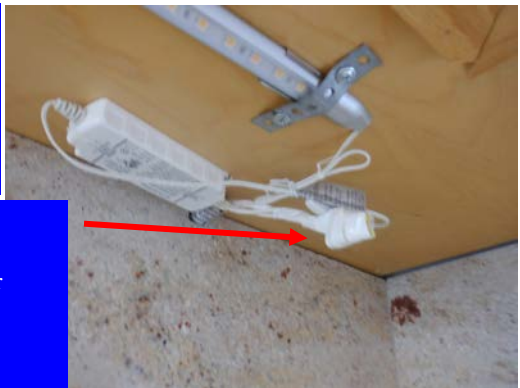
- **Safety Issue:** The wet bar sink area countertop down-lighting has an exposed spliced power cord (where that cord is suspected to be tapped-off of an adjacent outlet circuit) that presents shock/fire hazards. The power cord must be exposed where the light transformer is ‘line-of-sight’ of the outlet to which it is plugged in (not hardwired within the outlet box); suggest repairs by a licensed electrical contractor.

The wet bar sink area countertop down lights have an exposed power cord splice

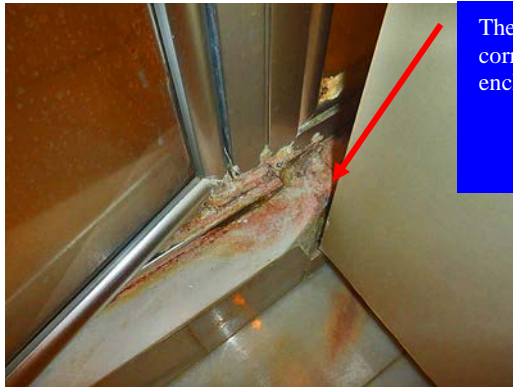
The upper hall bath shows corrosion at the shower enclosure frame

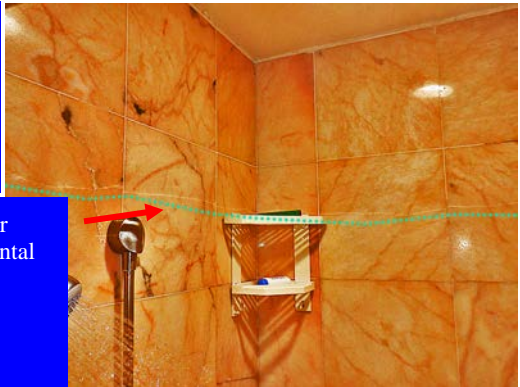
The master bath shower has developed a horizontal crack (just above the dashed line)

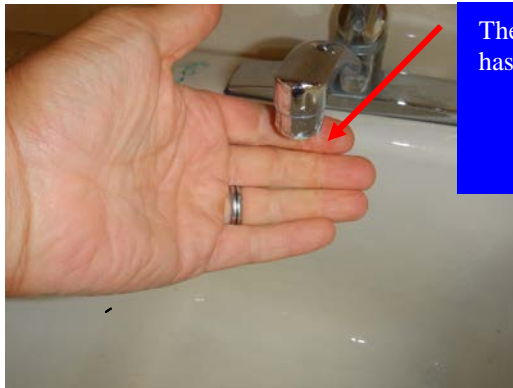
The laundry sink spout has a drip leak

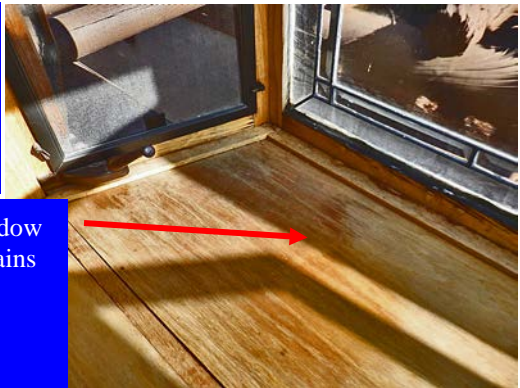
The master bath window shelf shows water stains
