Subject: Limited Structural Site Inspection
1104 Palos Verdes Drive West
Palos Verdes Estates, CA 90274

PVEC #: 2-18-0421

Date of Inspection: September 5, 2018

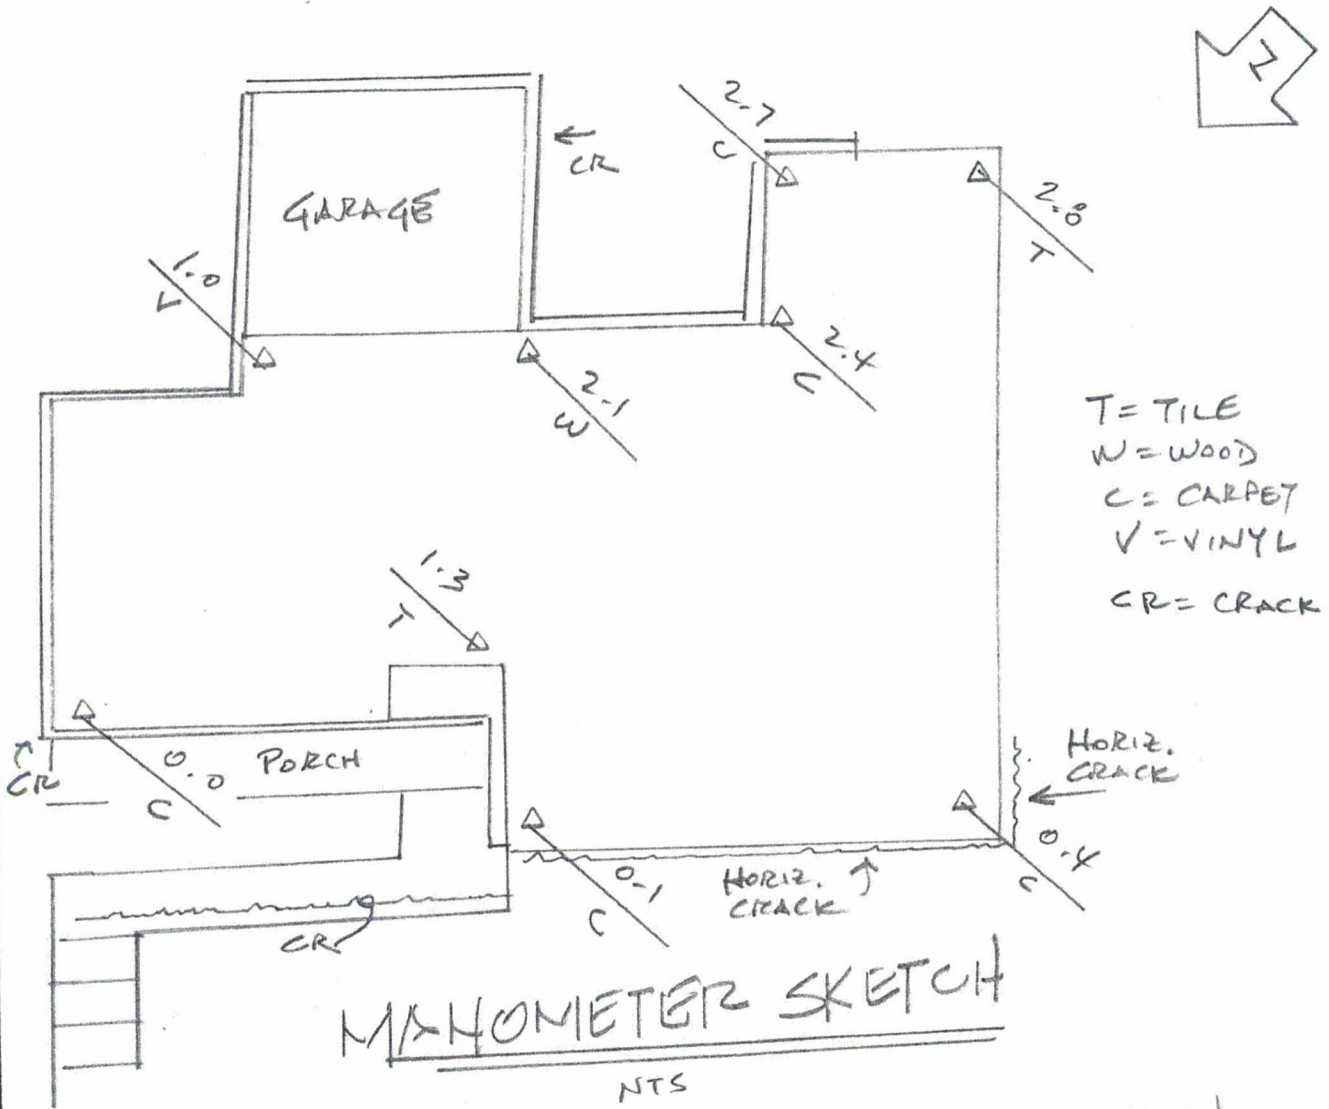
1104 P.V. DR. WEST
P.V. ESTATES, CA 90274

The various retaining walls around the property have typical flexure and shrinkage cracks. At the front porch and walkway, and along the front exterior wall of the house, evidence of long term settlement due to the underlying expansive soil is visible. However, the house floor is level to within 2.8 inches. This amount of slope is typical of houses of this age in this vicinity.

At the time of our inspection on Wednesday, September 5, 2018, we were allowed full access to the property for the purpose of our inspection. The house was built around 1956 and appears to have been well constructed. It survived the 1964 Northridge earthquake and subsequent seismic and storm events. Although the original building plans show the concrete foundations being only eight inches deep, the house shows minimal settling for being sixty-two years old. Our manometer survey measured 2.8 inches of northerly tilt in the floor. The industry standard is

approximately one inch of slope in twenty feet of horizontal distance for new construction. This house exceeds this amount but is consistent with similar houses of this age in this vicinity.
