# WOOD DESTROYING PESTS AND ORGANISMS INSPECTION REPORT

#: 20212074

| BUILDING NO.<br><b>1</b> | STREET<br><b>GOLDEN SPAR PL.</b> | CITY<br><b>ROLLING HILLS ESTATES</b> | ZIP<br><b>90274</b> | Date of Inspection<br><b>06/30/2021</b> | NUMBER OF PAGES<br><b>1 of 7</b> |

| GENERAL DESCRIPTION:<br>This is a one story, stucco and wood sided, single family residence. It has an attached garage. It has a tile roof and was vacant at the time of inspection. | Inspection Tag Posted:<br><b>Garage.</b> |

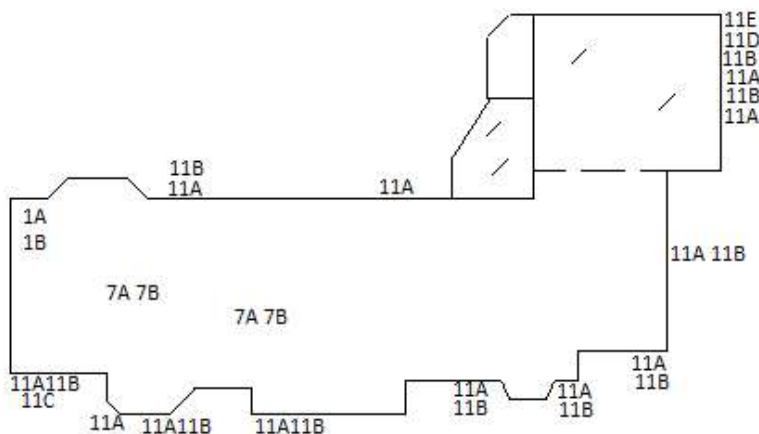
Evidence of DRYWOOD TERMITES as indicated by 1A on the diagram. Evidence noted in or near: SUBFLOOR.
- RECOMMENDATION: 1A

Drywood termite pellets as indicated by 1B on the diagram.

| FINDING: | Evidence of DRYWOOD TERMITES as indicated by 7A on the diagram. Evidence noted in or near: ATTIC FRAMING. |
| FINDING AND RECOMMENDATION: 7B | Drywood termite pellets as indicated by 7B on the diagram.<br><br>Remove or cover pellets in visible and accessible areas. NOTE: It is common for additional pellets to sift down over a period of time due to normal household vibrations. This estimate is to cover the pellets one time only. |

| FINDING: | Evidence of DRYWOOD TERMITES as indicated by 11A on the diagram. Evidence noted in or near: EAVES, RAFTERS. |
| FINDING: | DRYWOOD TERMITE DAMAGE as indicated by 11B on diagram. The damage was noted in or near: EAVES, RAFTERS. |
| FINDING: | Evidence of DRYWOOD TERMITES as indicated by 11C on the diagram. Evidence noted in or near: SIDING. |

FINDING:                                      Evidence of DRYWOOD TERMITES as indicated by 11D on the diagram. Evidence noted in or near: GARAGE DOOR JAMB.

FINDING:                                      DRYWOOD TERMITE DAMAGE as indicated by 11E on diagram. The damage was noted in or near: GARAGE DOOR JAMB.

Fumigate the structure with a fumigant lethal to DRYWOOD TERMITES (Sulfuryl Fluoride). See the occupants fumigation notice for further details. This company is not responsible for delays or schedule changes due to inclement weather or other agencies, nor is it responsible for damage to roof or plants as a result of the fumigation. Refer to the occupant's fumigation notice/preparation sheet (sent separately) for additional information.
- ITEM NO. 1B

Remove or cover pellets in visible and accessible areas. NOTE: It is common for additional pellets to sift down over a period of time due to normal household vibrations. This estimate is to cover the pellets one time only.

| RECOMMENDATION: 11B | Remove and replace damaged wood as necessary with today's available widths and grades. |
| RECOMMENDATION: 11B | Cut off termite damage and repair with appropriate wood filler. |

RECOMMENDATION: 11E                      Cut off termite damage and repair with appropriate wood filler.
