# ***Cornerstone Inspection***

## **Property Inspection Report**

***2138 Callender Road, Arroyo Grande, CA 93420***  
***Inspection prepared for: Scott and Tina Dye***  
***Real Estate Agent: Jim Settle - Century 21 Hometown Realty***

***Date of Inspection: 6/5/2017 Time: 1:00 PM Size: 1800***  
***Order ID: 2150***

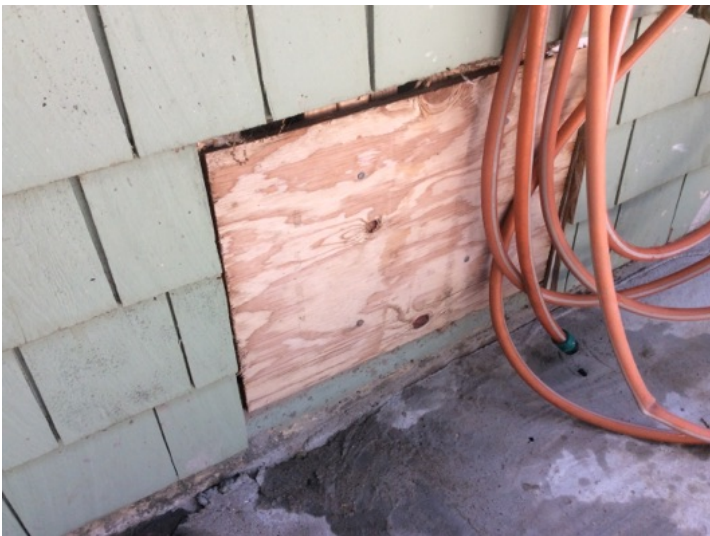
3.2. The house wall finish is generally in acceptable condition but has unfinished portions and repairs that should be serviced.

The house wall finish is generally in acceptable condition but has a unfinished repair that should be serviced.

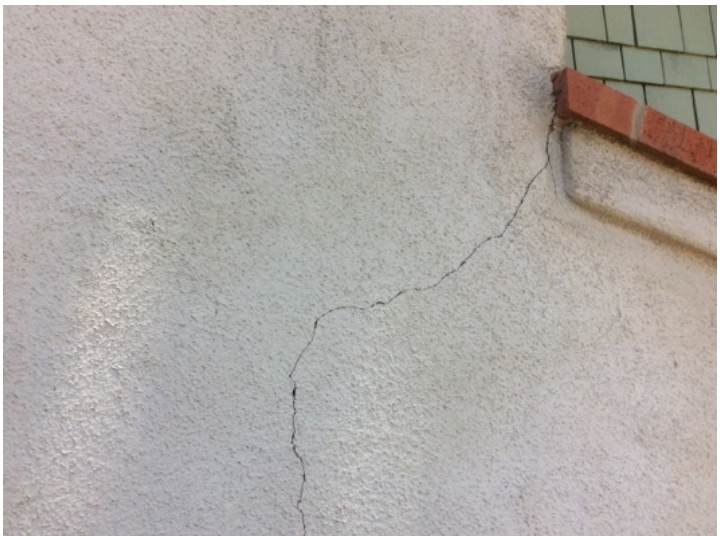
3.4. There are small cracks in the stucco around some of the windows and doors that result from movement, and are quite common. Stress fractures can reappear after they have been repaired, and particularly if they have not been repaired correctly.

There are small cracks in the stucco around some of the windows and doors that result from movement, and are quite common. Stress fractures can reappear after they have been repaired, and particularly if they have not been repaired correctly.

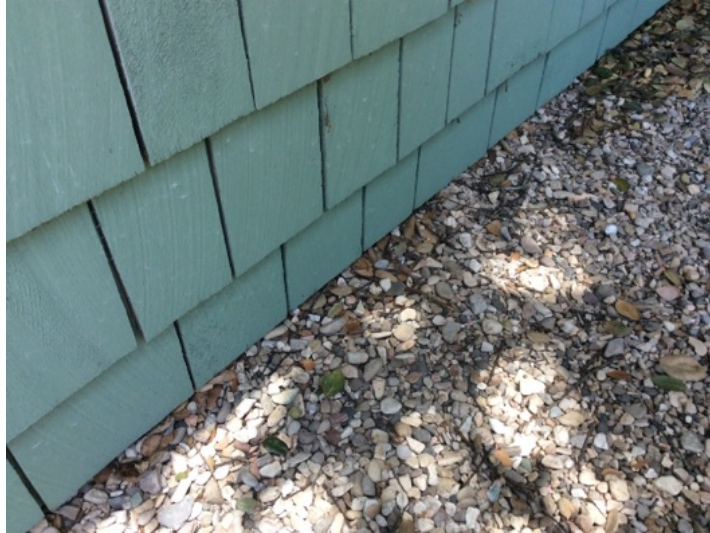
3.6. There are areas where the wooden siding is close to or touching the ground and is subject to moisture damage. These areas should be monitored closely and sealed frequently to prevent moisture damage.

There are areas where the wooden siding is close to or touching the ground and is subject to moisture damage. These areas should be monitored closely and sealed frequently to prevent moisture damage.

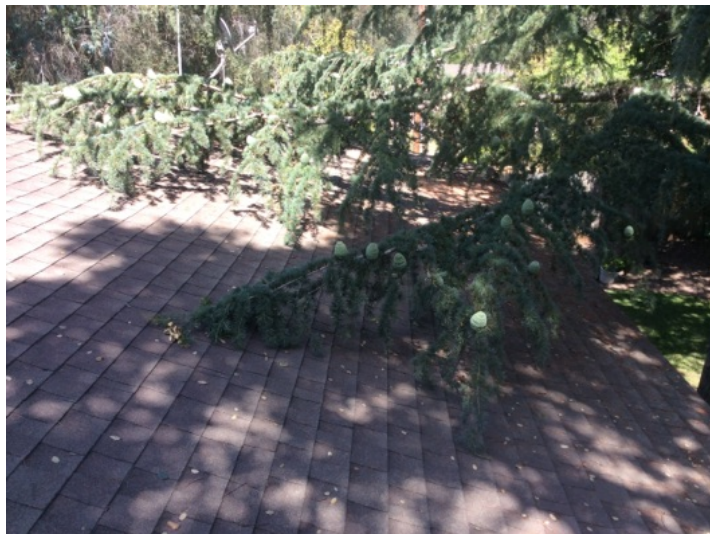
9.1. There are tree limbs overgrowing the residence that should be trimmed or monitored, to insure that they do not impact or damage the roof or its components.

There are tree limbs overgrowing the residence that should be trimmed or monitored, to insure that they do not impact or damage the roof or its components.

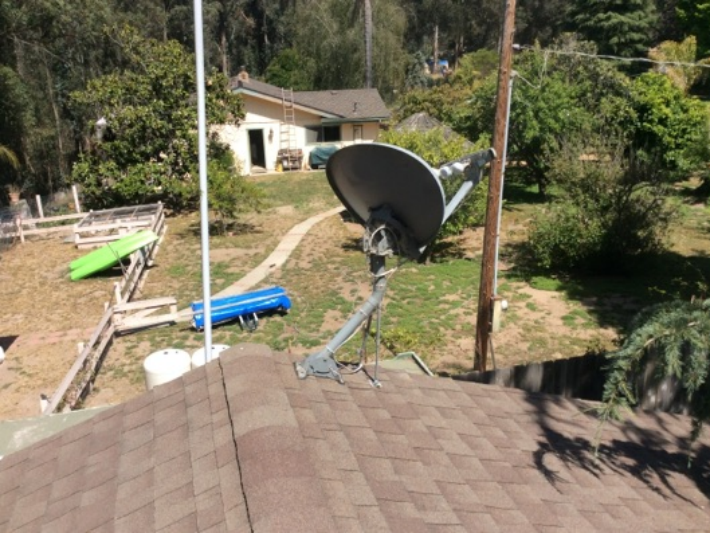
2.5. The roof includes a satellite dish that has been installed by bolting through the roof, which can be a common point of leaks and should be monitored.

The roof includes a satellite dish that has been installed by bolting through the roof, which can be a common point of leaks and should be monitored.

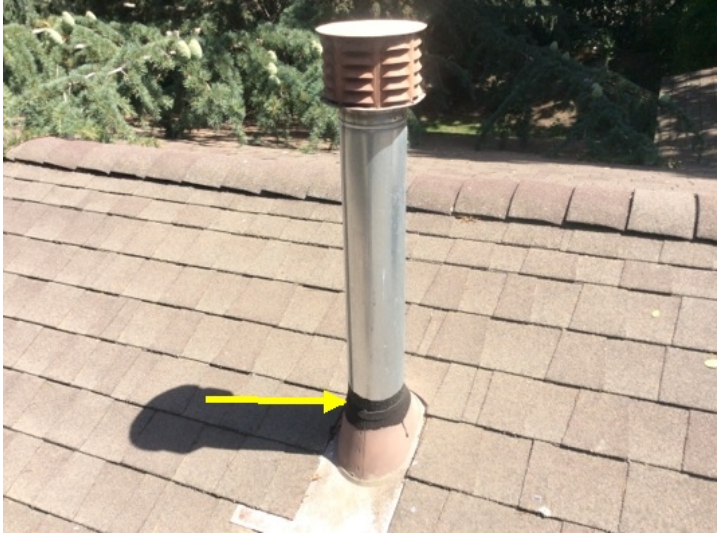
2.6. A rain-collar is missing on a heat vent which you may wish to have installed.

A rain-collar is missing on a heat vent which you may wish to have installed.

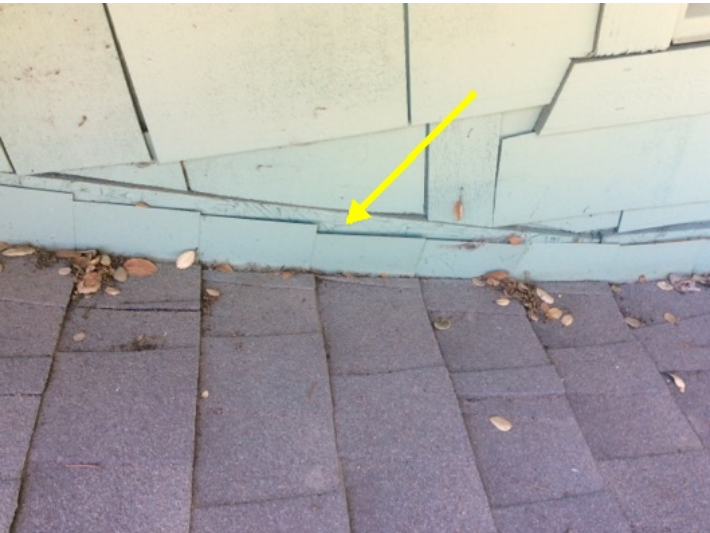
2.7. There is flashing but no counter flashing where a portion of the roof abuts the house, and moisture intrusion would be possible. Therefore, this connection will need to be monitored and serviced as necessary.

There is flashing but no counter flashing where a portion of the roof abuts the house, and moisture intrusion would be possible. Therefore, this connection will need to be monitored and serviced as necessary.

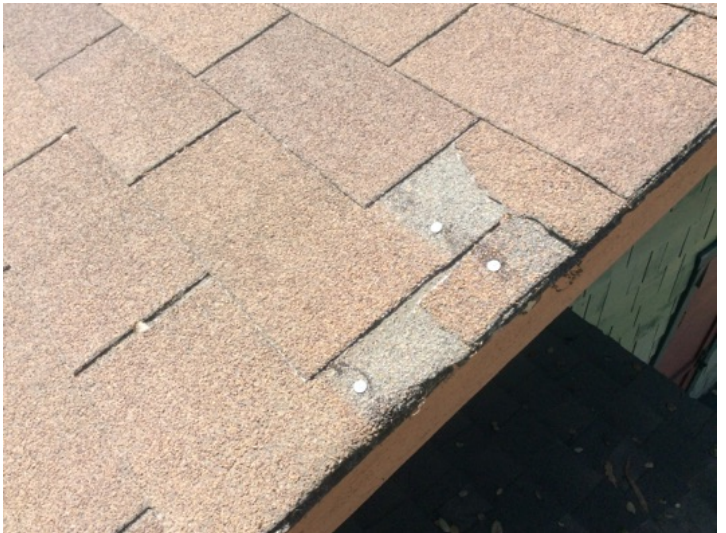
2.9. The roof has one or more damaged or missing shingles that should be repaired by a licensed roofing contractor.

The roof has one or more damaged or missing shingles that should be repaired by a licensed roofing contractor.

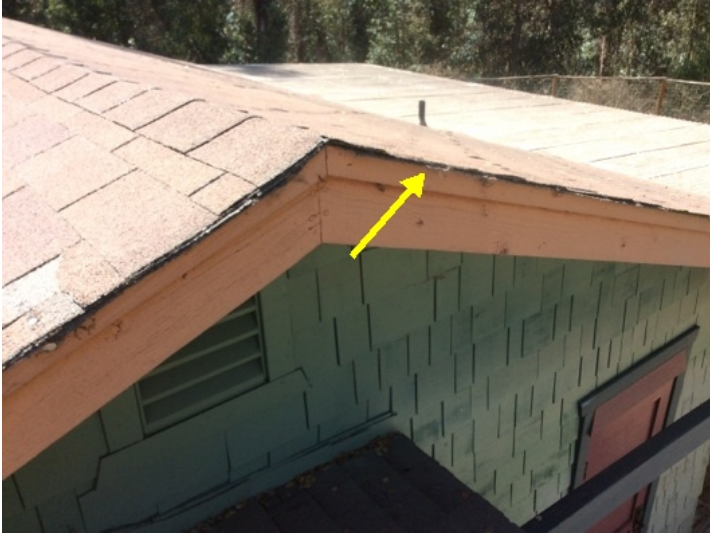
2.8. There is no drip edge at portions of the eaves, or edge of the roof, which is recommended to protect the wood sheathing.

There is no drip edge at portions of the eaves, or edge of the roof, which is recommended to protect the wood sheathing.

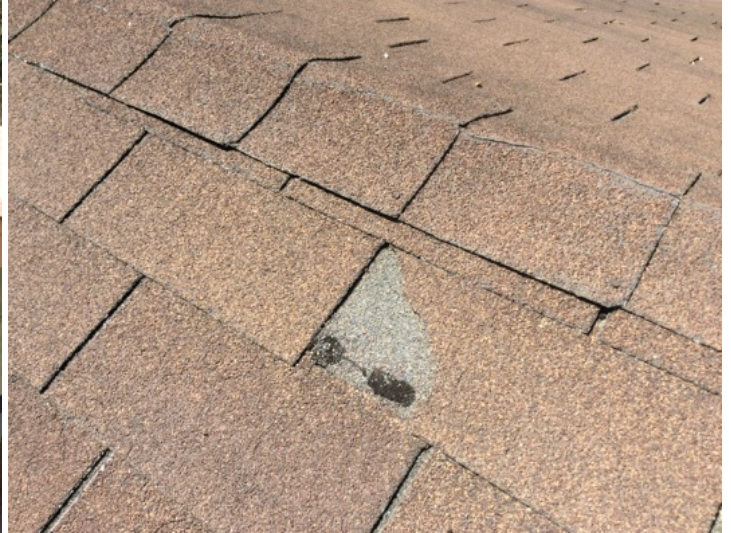
The roof has one or more damaged or missing shingles that should be repaired by a licensed roofing contractor.

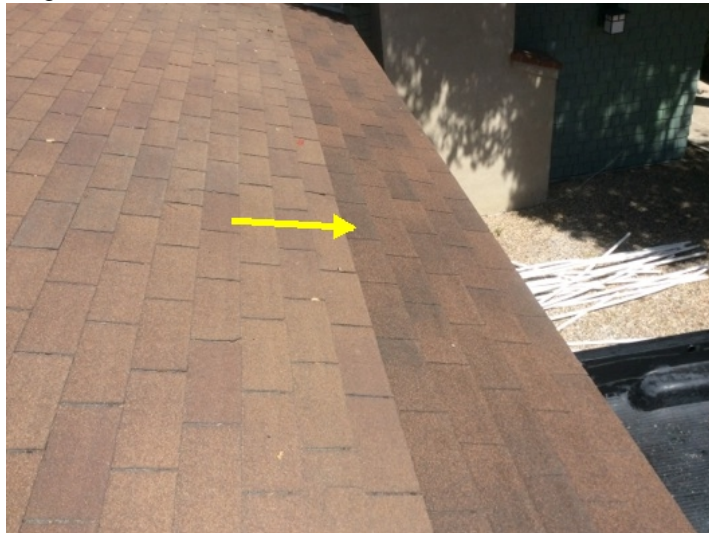
2.4. We observed repairs done to the roof that should be explained by the sellers as to why these repairs were needed.

We observed repairs done to the roof that should be explained by the sellers as to why these repairs were needed.

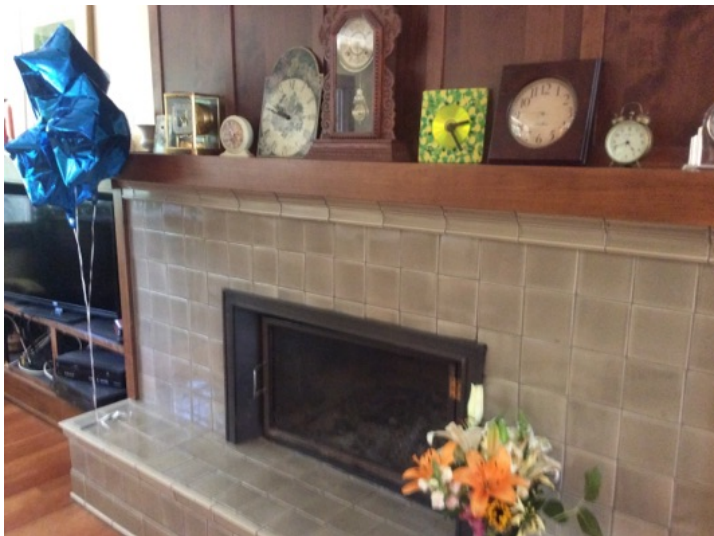
1.9. The wooden fireplace mantle is closer to the opening than current standards would permit, which typically require twelve inches of clear space between them. However, this distance can vary depending on the distance that the mantle projects, and you may wish to have a specialist evaluate.

The wooden fireplace mantle is closer to the opening than current standards would permit, which typically require twelve inches of clear space between them. However, this distance can vary depending on the distance that the mantle projects, and you may wish to have a specialist evaluate.

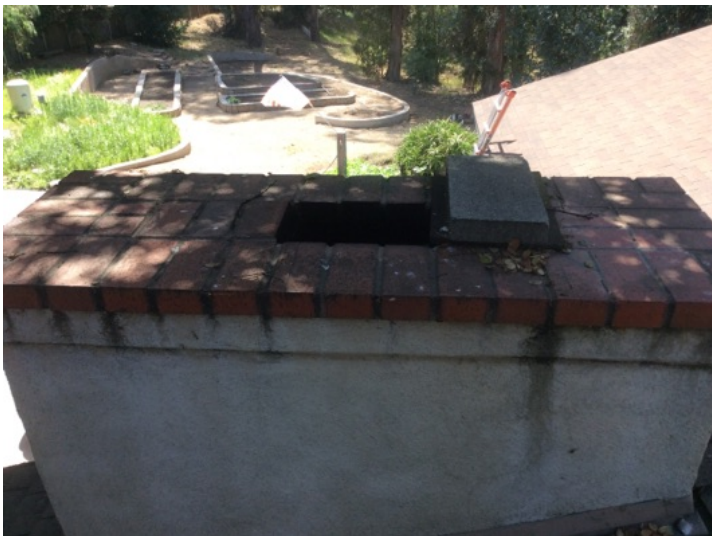
The mortar on the crown is not contoured correctly to shed water, which is its intended purpose, and should be serviced.

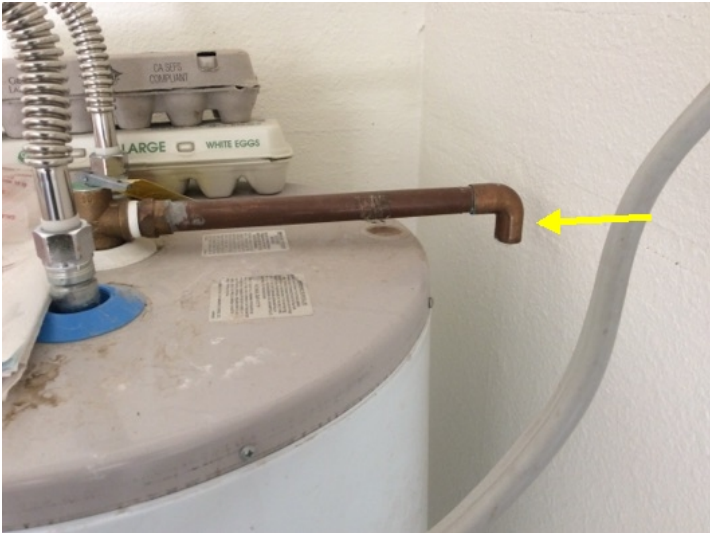
5.9. The pressure relief valve on the water heater does not have a discharge pipe. One should be installed to terminate no more than 24 inches above grade and no closer than 6 inches to it and be directed down towards the ground.

The pressure relief valve on the water heater does not have a discharge pipe. One should be installed to terminate no more than 24 inches above grade and no closer than 6 inches to it and be directed down towards the ground.

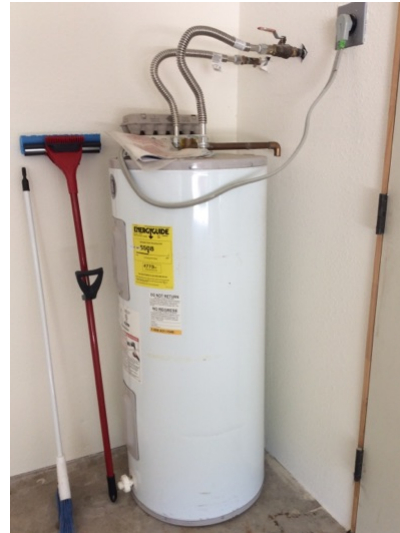
5.10. The water heater is not correctly secured, and needs to be seismically strapped and braced in accordance with local standards.

The water heater is not correctly secured, and needs to be seismically strapped and braced in accordance with local standards.

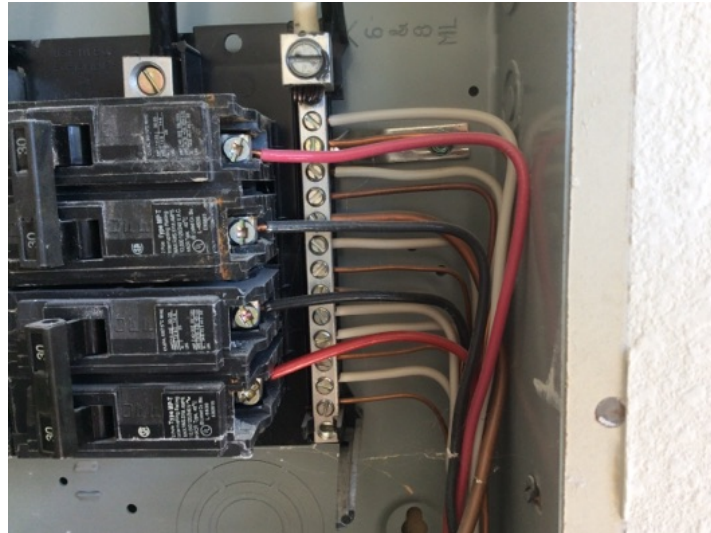
2.8. The neutral and ground wires are together on the same buss bar and should be separate. The ground wires should be bonded to the panel and the neutral wires should be separate and "floating" from the panel. We recommend that a licensed electrician evaluate and service the sub panel.

The neutral and ground wires are together on the same buss bar and should be separate. The ground wires should be bonded to the panel and the neutral wires should be separate and "floating" from the panel. We recommend that a licensed electrician evaluate and service the sub panel.

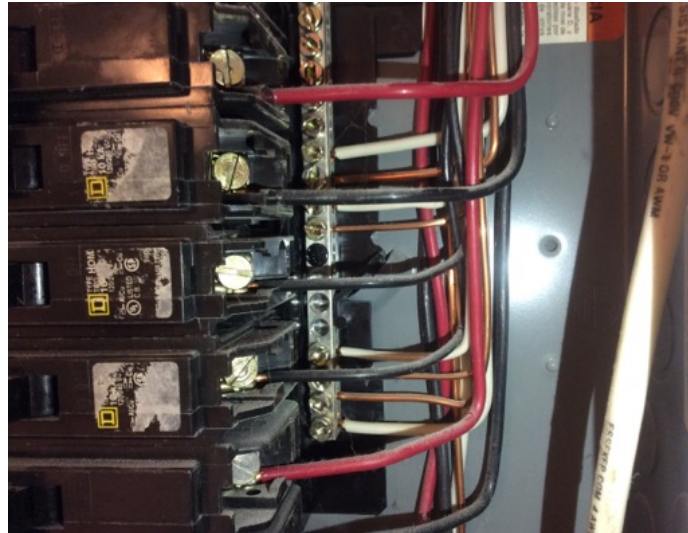
The neutral and ground wires are together on the same buss bar and should be separate. The ground wires should be bonded to the panel and the neutral wires should be separate and "floating" from the panel. We recommend that a licensed electrician evaluate and service the sub panel.

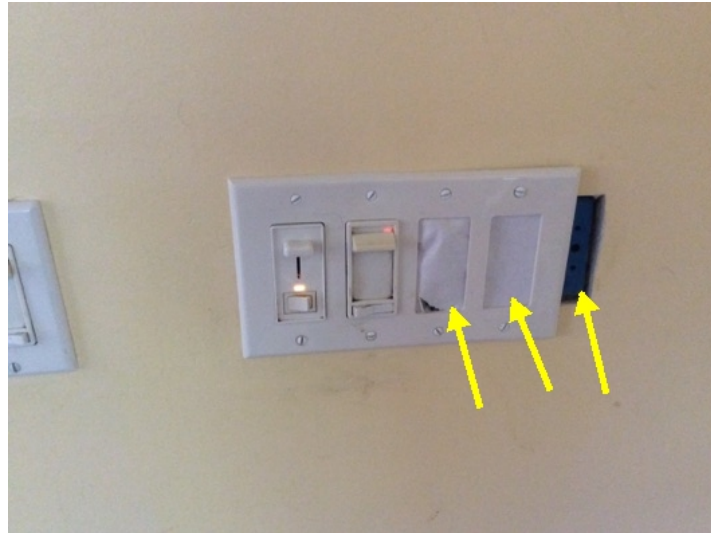
4.3. There is an improper outlet covers that does not fully cover the junction box and should be serviced.

There is an improper outlet covers that does not fully cover the junction box and should be serviced.

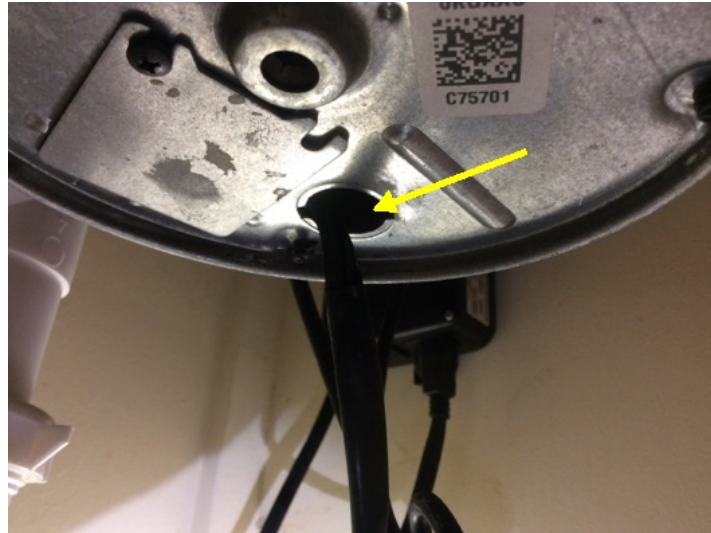
The electrical connection to the garbage disposal is substandard. The approved appliance cord is missing its protective clamp.

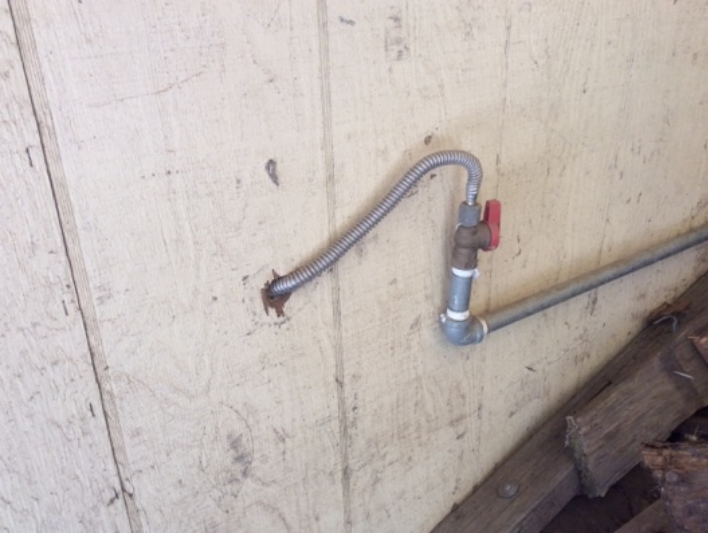
The gas control valve is located on the exterior and is required to be located adjacent the dryer within the laundry room and its connector passes through the exterior wall which is not permitted by current standards and should be serviced.

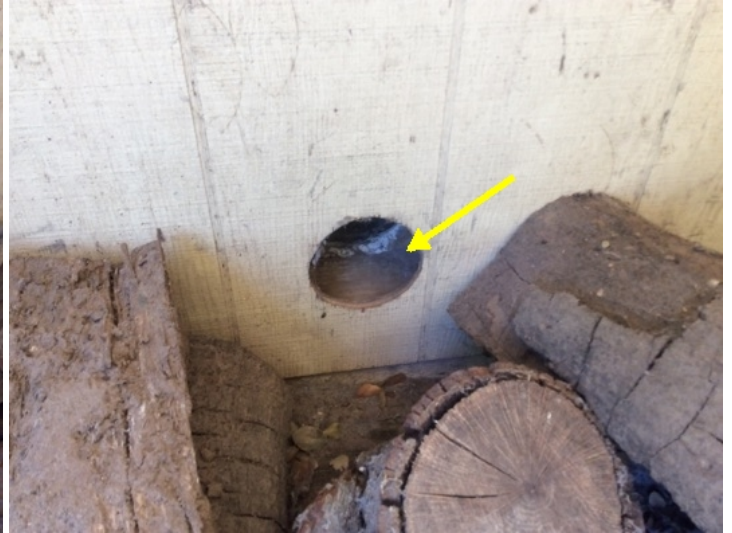
The back-draft on the exterior dryer vent cover is missing, incomplete or non functional and should be repaired or replaced.

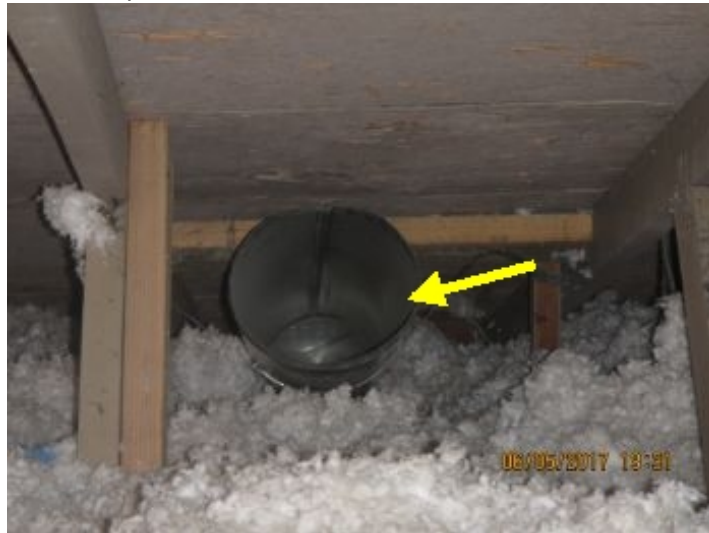
Some of the ducts do not appear to be connected and may have been part of a previous system. They permit air from the attic to transfer to the interior. We recommend an HVAC contractor evaluate and service as required.

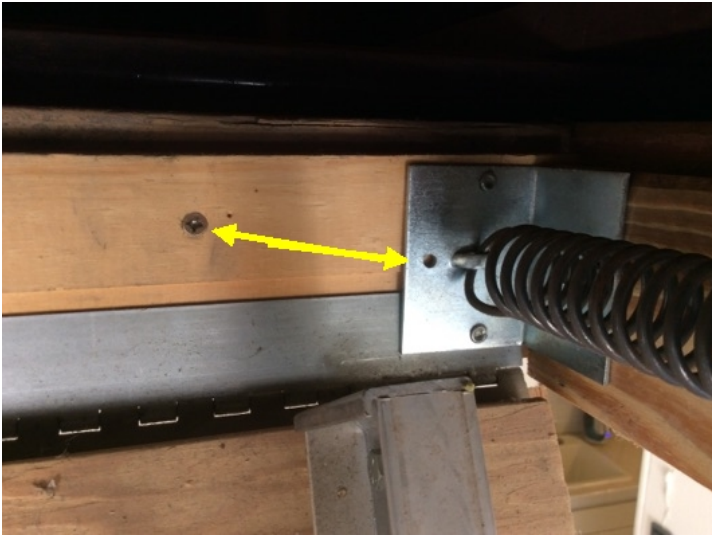
The pull down ladder is not installed according to the manufacturers requirements that calls for nails, not screws, be installed through the brackets. We recommend servicing to meet this standard.

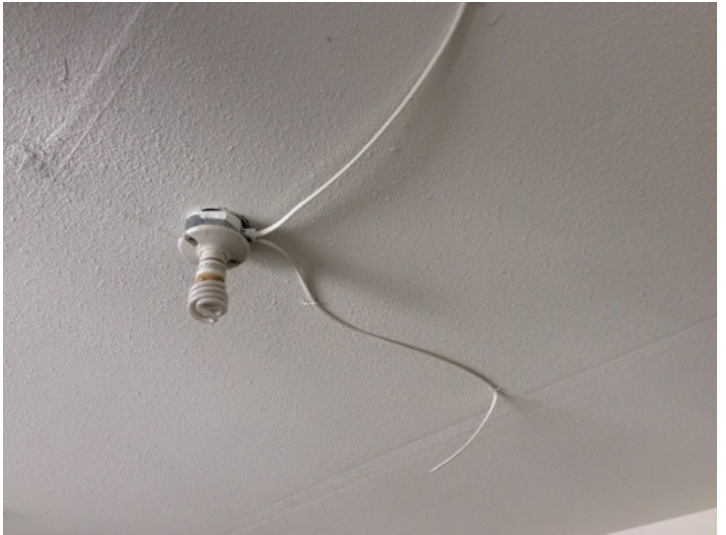
There is exposed romex that should be protected by installing the romex inside the wall cavity, or properly wired into conduit.
