Home Inspection Services Home Inspection Report

Address: 6620 Atascadero Ave, Atascadero - 3/30/18

Inspector: John Ramsey, CCI 3321 Via Del Sueno Atascadero, CA 93422 (805) 801-7129

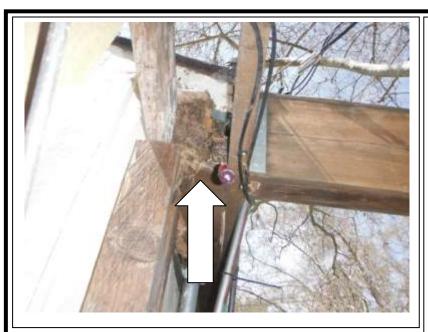
Moisture and/or bug type damage & deterioration found at exterior areas such as eaves, fascia and/or trim.
 (Refer to the termite report for locations and extent).
 eastside - See example at photo page)

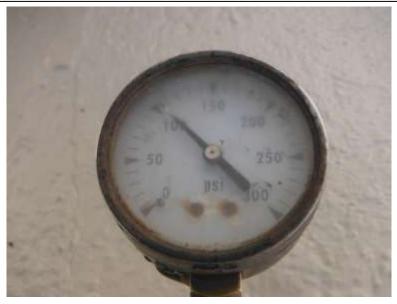
2. Excessive water pressure (above the maximum of 80 psi, currently at:100 psi). Recommend the adjustment or repair of the pressure regulator. 2 - See example at photo page)

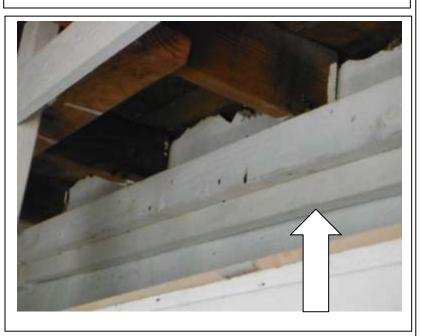
3. Garage roof framing is overspanned & ledger boards improperly installed @upgrades recommended - See example at photo page)

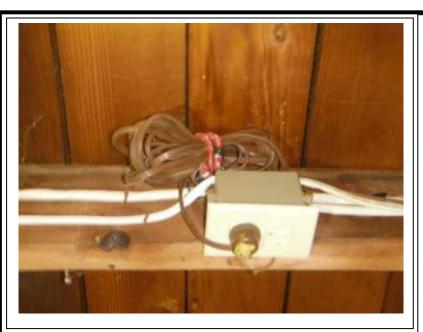
4.
■ Extension cord improperly used as permanent electrical wiring: ②⑤ @ garage light - See example at photo page)

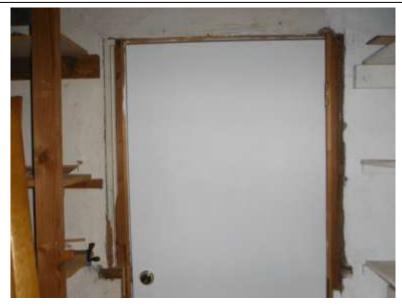
5. Door from garage into the house or living space missing trim ① - See example at photo page)

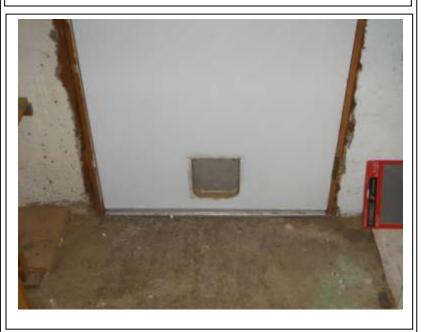
6. ■ A Pet door improperly installed in the garage fire door to the living space. ① 5 - See example at photo page)

■ Self closer is missing at garage fire door to the living space. ①

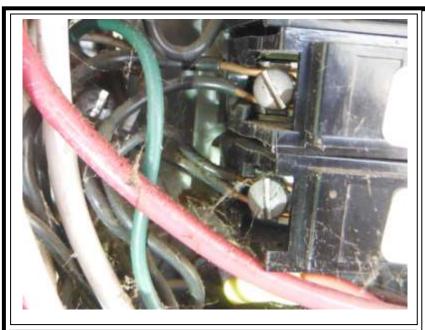
7. Improper installation of two wires on single wire rated circuit breaker 1. MAIN ELECTRICAL PANEL – 2 places - See example at photo page

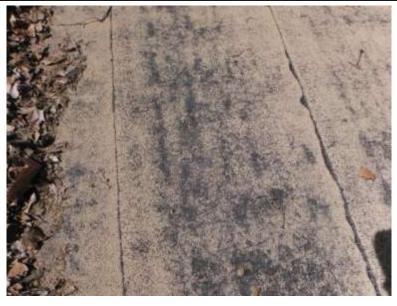
8. Roof is weathered and deteriorated. Roof is weathered and deteriorated. Roof garage bonus room - See example at photo page) X 2

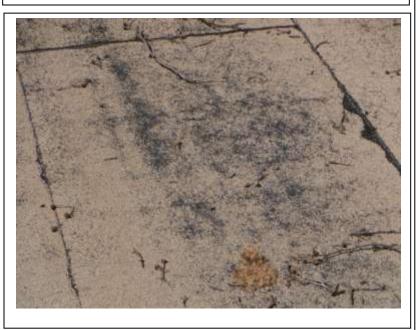
9. Roof is weathered and deteriorated. @@ garage
 8 bonus room - See example at photo page) X 2

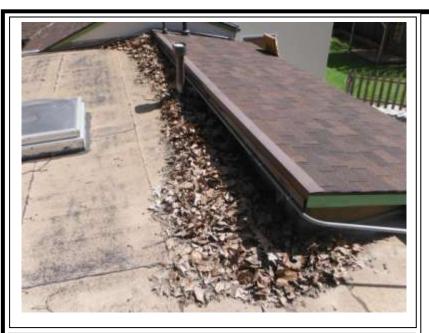
10. Debris covers portions of roof. Not fully visible.

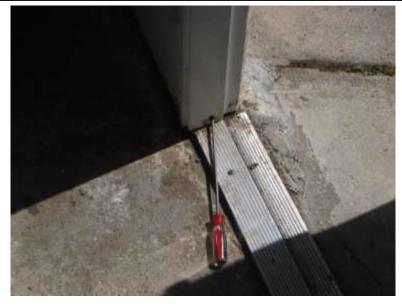
11. Moisture damage found at laundry room & living room exterior doors / jambs. 20: - See example at photo page)

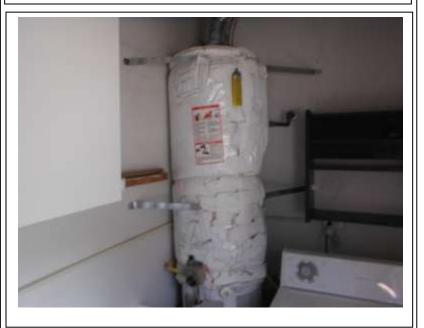
12. Water heater thermal blanket covers ID & safety placard, S - See example at photo page)

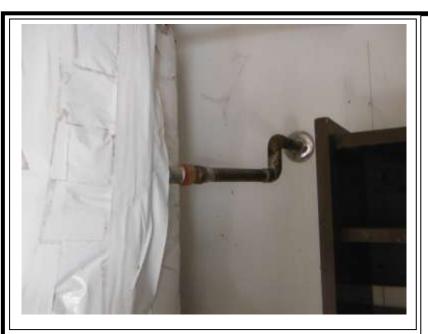
13. WATER HEATER TPR (TEMPERATURE PRESSURE RELIEF)

VALVE INSTALLED pipe improperly flows uphill from TPR

valve. 12 - See example at photo page)

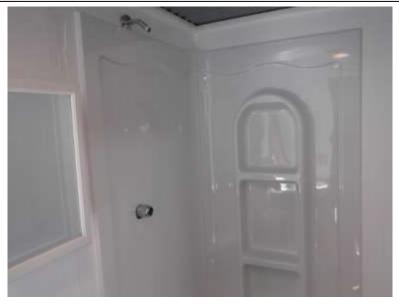
14. Bonus room bathroom shower under construction and not finished – missing faucethandle, shower hed, enclosure doors / curtain - See example at photo page)

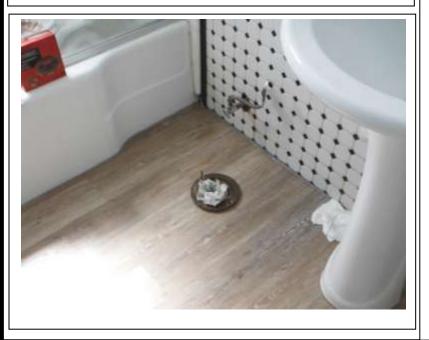
15. Toilet was not installed at time of inspection :
hall bathroom - See example at photo page

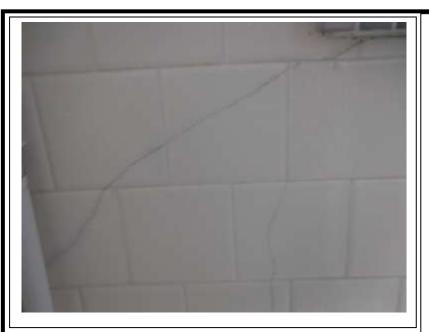
16. Cracked tiles found both sides of window 20: in hall bathroom shower enclosure - See example at photopage)

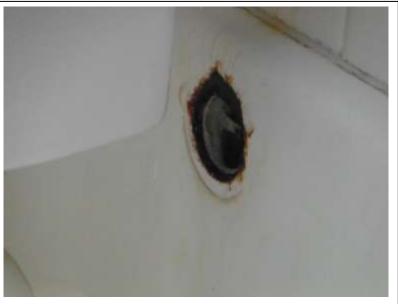
17. Tub overflow cover missing 43: A hall bathroom - See example at photo page
