WOOD DESTROYING PESTS AND ORGANISMS INSPECTION REPORT

Building No. 714	Street Camellia Drive	City Paradise	ZIP 95969	Date of Inspection 04/04/2018	Number of Pages 4
---------------------	--------------------------	------------------	--------------	----------------------------------	----------------------

HOUSE DETECTIVE TERMITE CONTROL INC

HOME INSPECTION REPORT

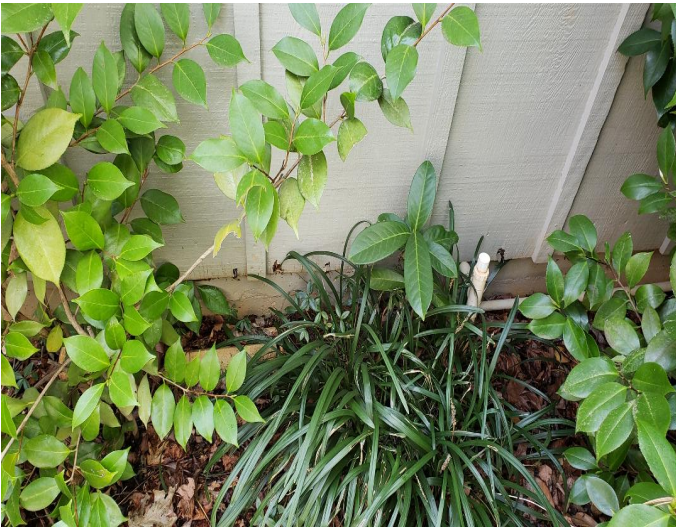
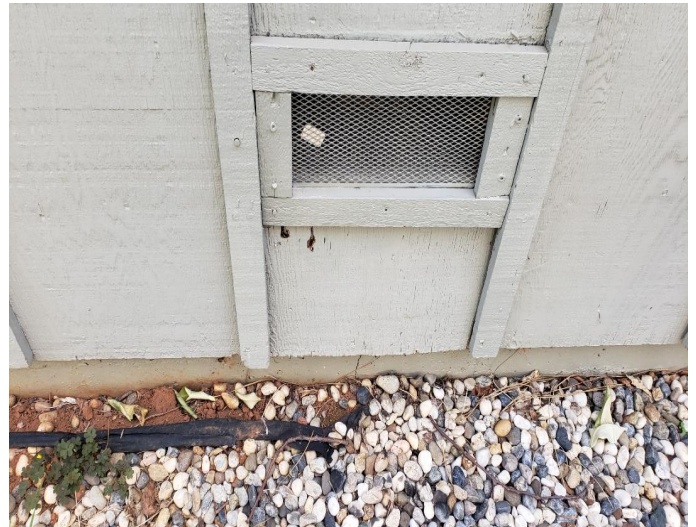
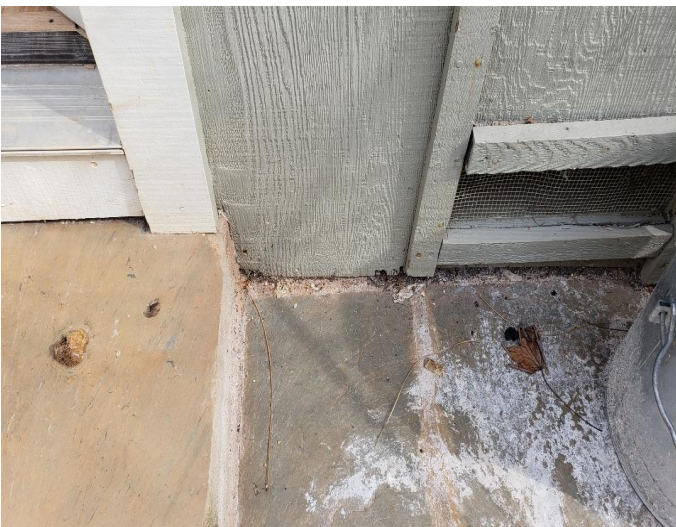
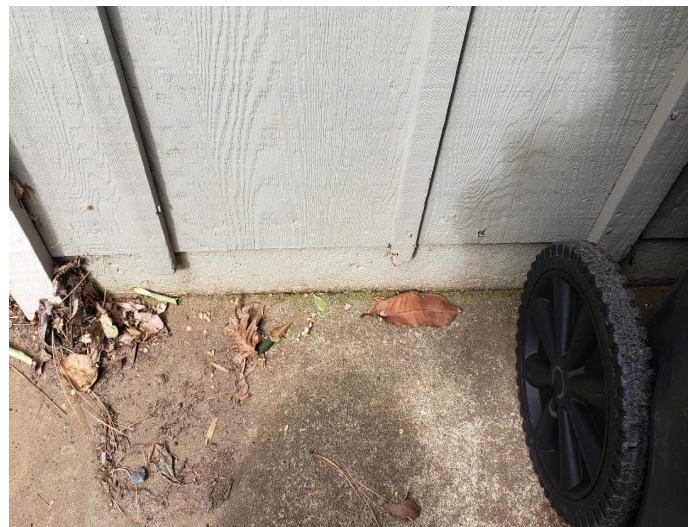
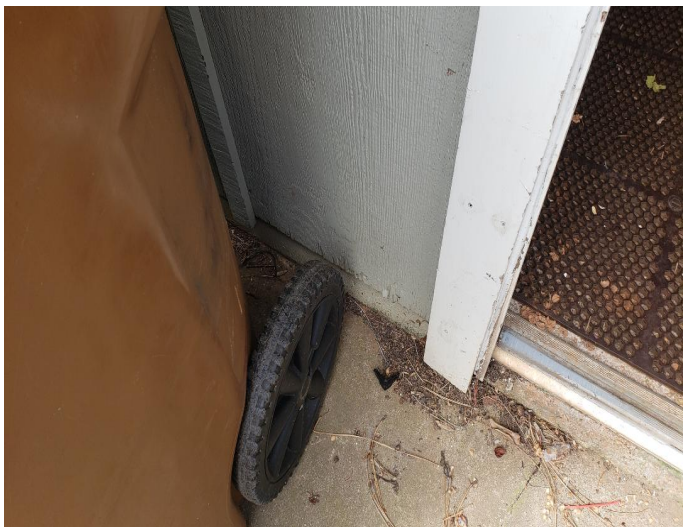
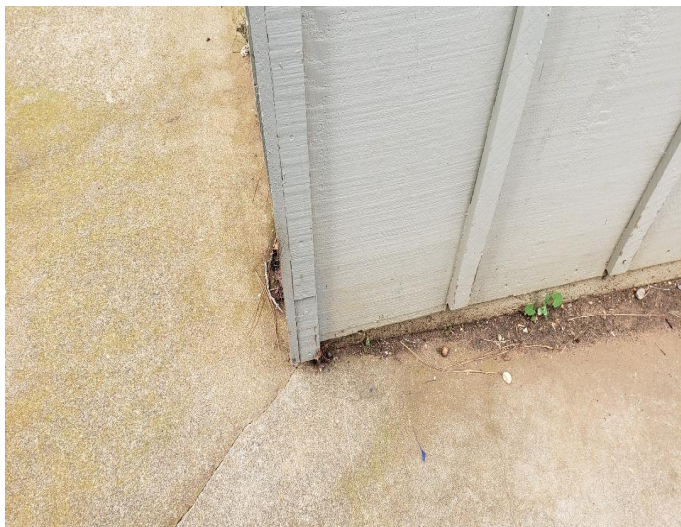
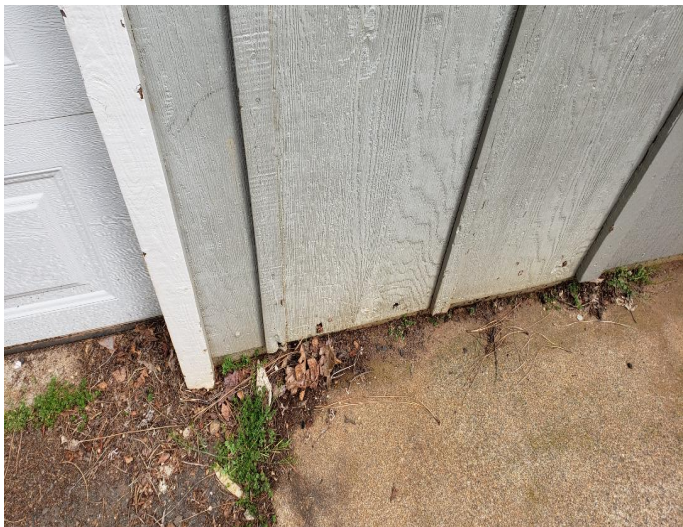
FINDING: Fungus damage was found to areas of lower siding and trim on the main house and garage.

3A - Damaged siding and trim.

3A - Damaged siding.

RECOMMENDATION: Remove the damaged wood members and replace with new material. Prime paint only.

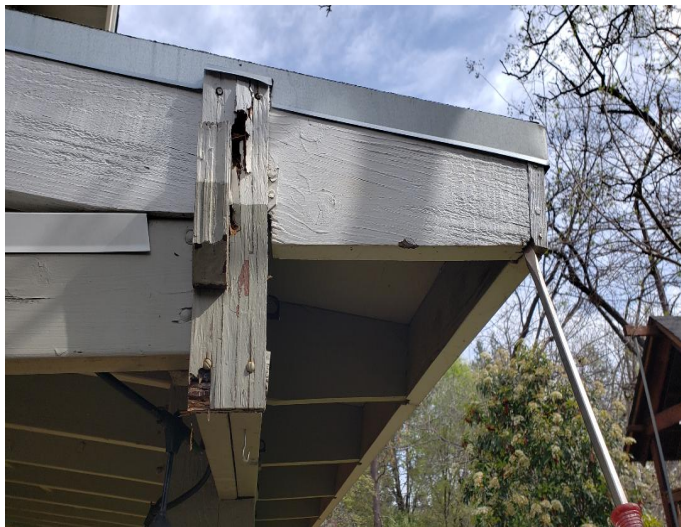
FINDING: Fungus damage was found to the patio joist and trim.

3B - Damaged patio joist and trim.

RECOMMENDATION: Remove the damaged wood members and replace with new material. Prime paint only.

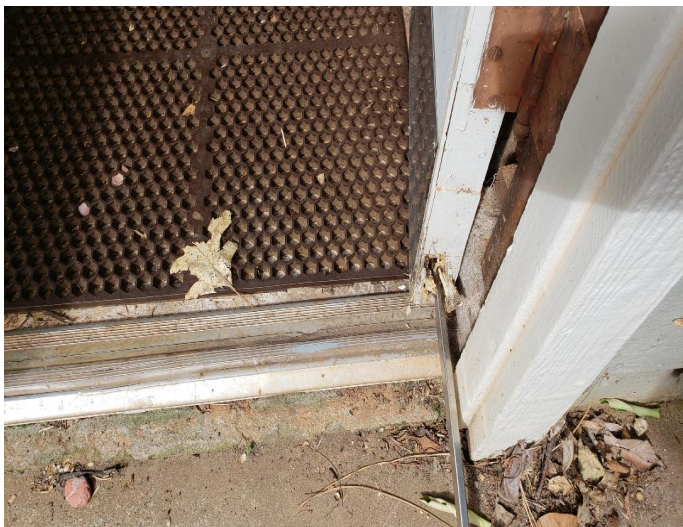
FINDING: Fungus damage was found to the garage door.

3C - Damaged garage door.

RECOMMENDATION: Remove the damaged wood members and replace with new material. Prime paint only.

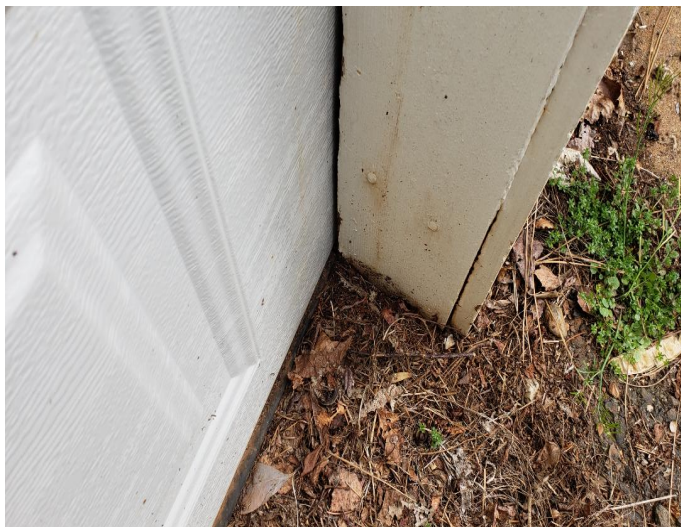
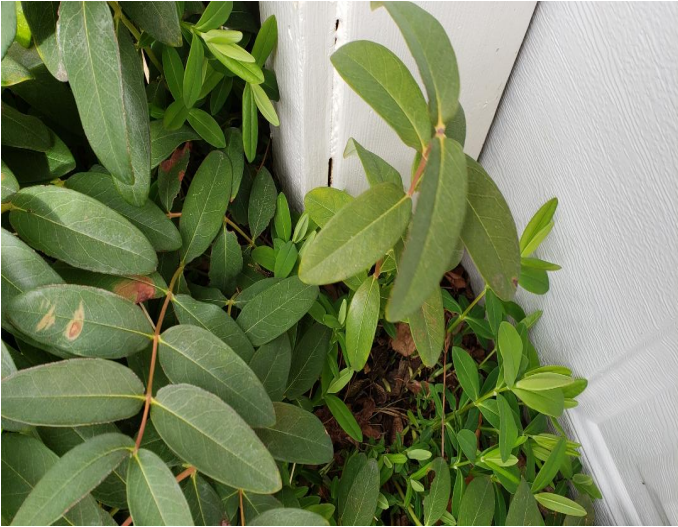
FINDING: Fungus damage was found to the front garage door jambs.

3D - Damaged garage door jambs.

RECOMMENDATION: Remove the damaged wood members and replace with new material. Prime paint only.

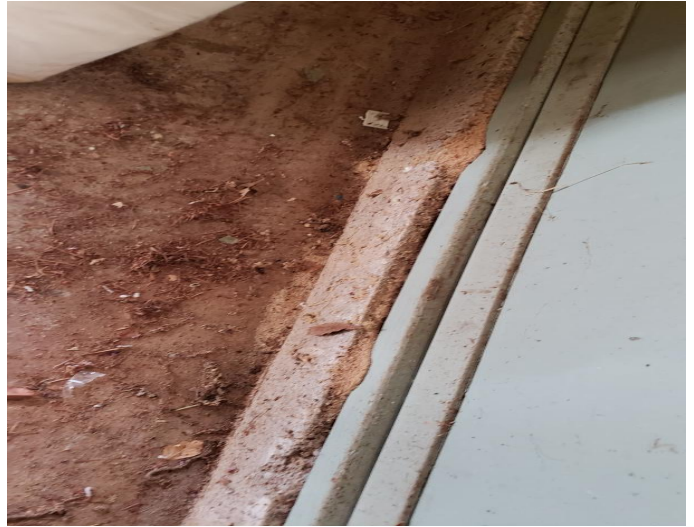
FINDING: Carpenter ant frass was found in the garage.

3E - Carpenter ants in the garage.

RECOMMENDATION: We recommend the owner/agent engage the services of a licensed general pest control company to eliminate the carpenter ants as needed.

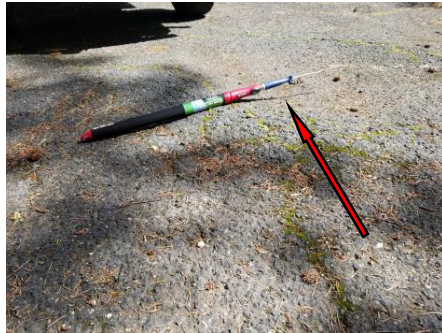
Notice uneven asphalt under pole

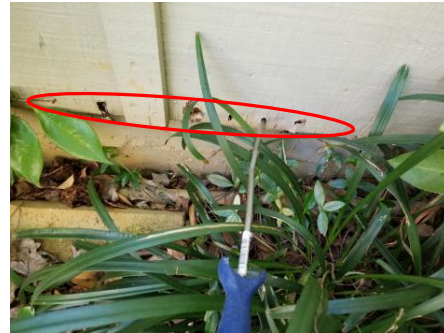
Dry rot at bottom of siding

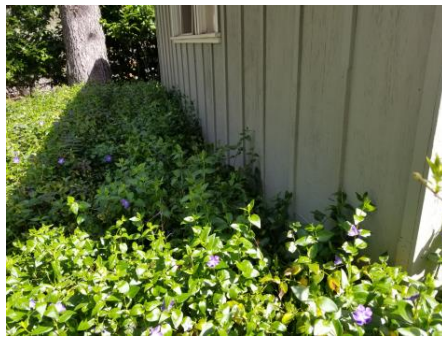
Recommend trimming vegetation

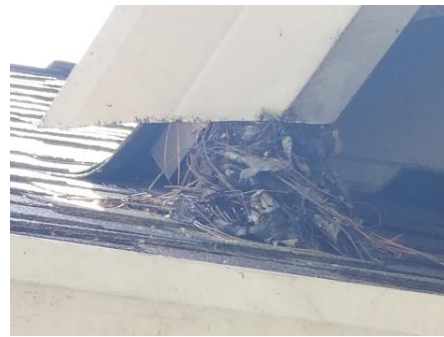
Upper gutter full of debris

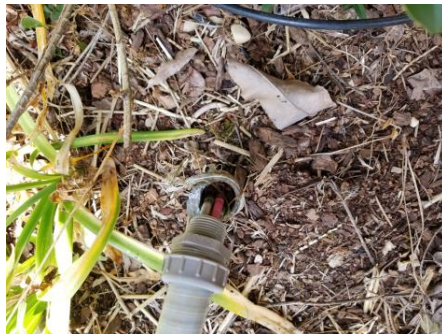
Recommend repairing elec. Conduit in garden area

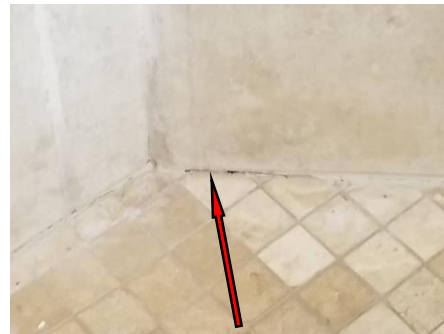
Shower tile needs re grouting in master bath

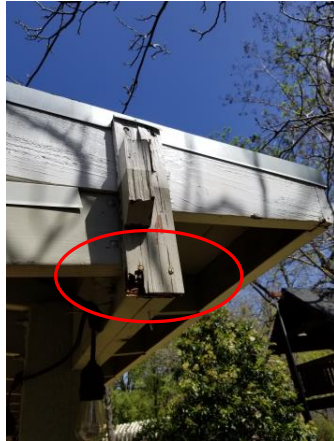
Dry rot at patio cover trim

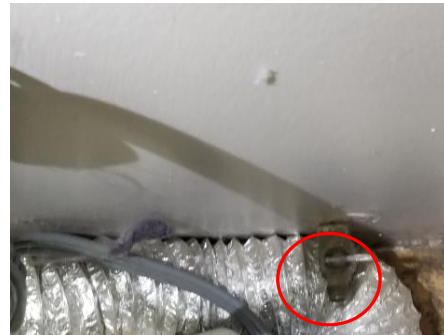
GAS VALVES: Gas cap missing- SAFETY HAZARD.

Safety Issue: Gas valve needs cap

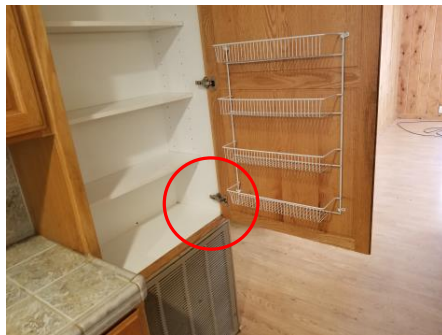
Loose hinge

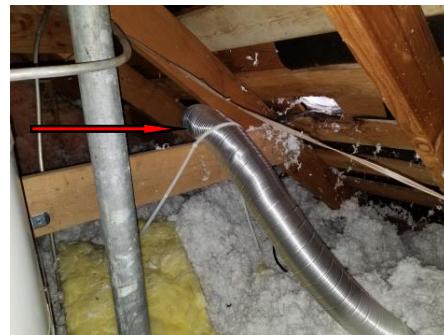
Vent pipe not directed outside

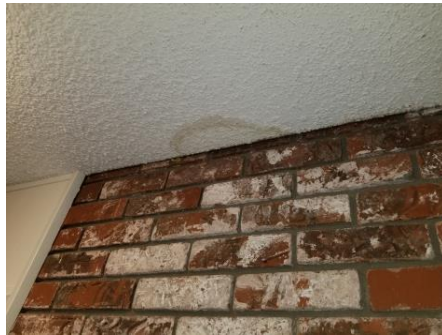
Ceiling stain upstairs in hall

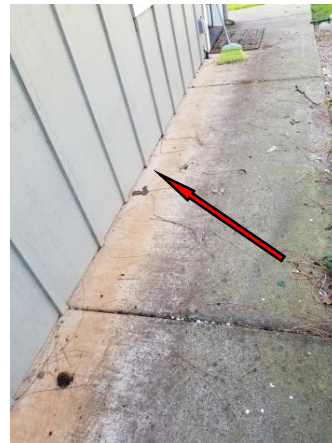
Siding too close to concrete

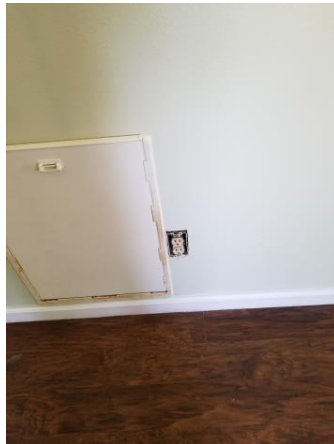
Outlet cover missing in guest home Shop.

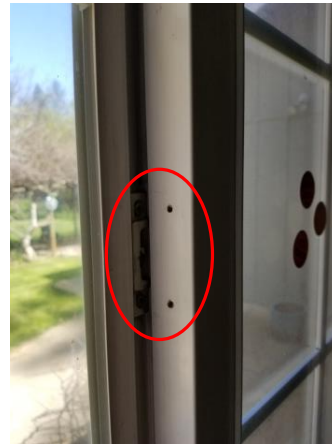
Window lock missing in guest home

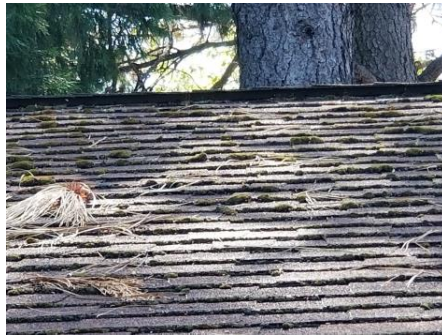
Moss build up on guest home roof

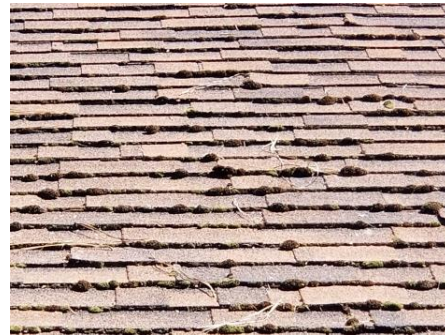
Moss build up on garage

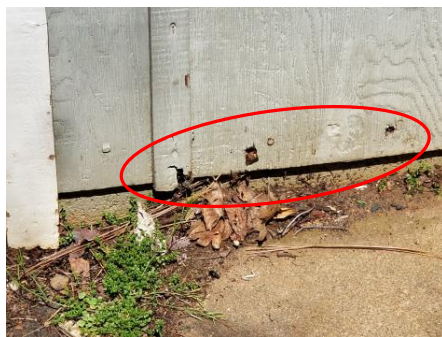
Dry rot on garage siding and trim

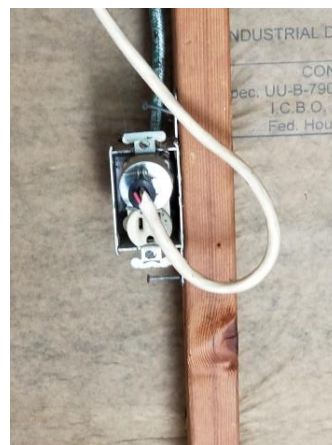
Missing outlet cover in garage
