REPORT OF COMPACTION GROUTING

Posgay Residence
Lot 1, Tract 30383
Rancho Palos Verdes, California

July 19, 1979

Job No. 079-817

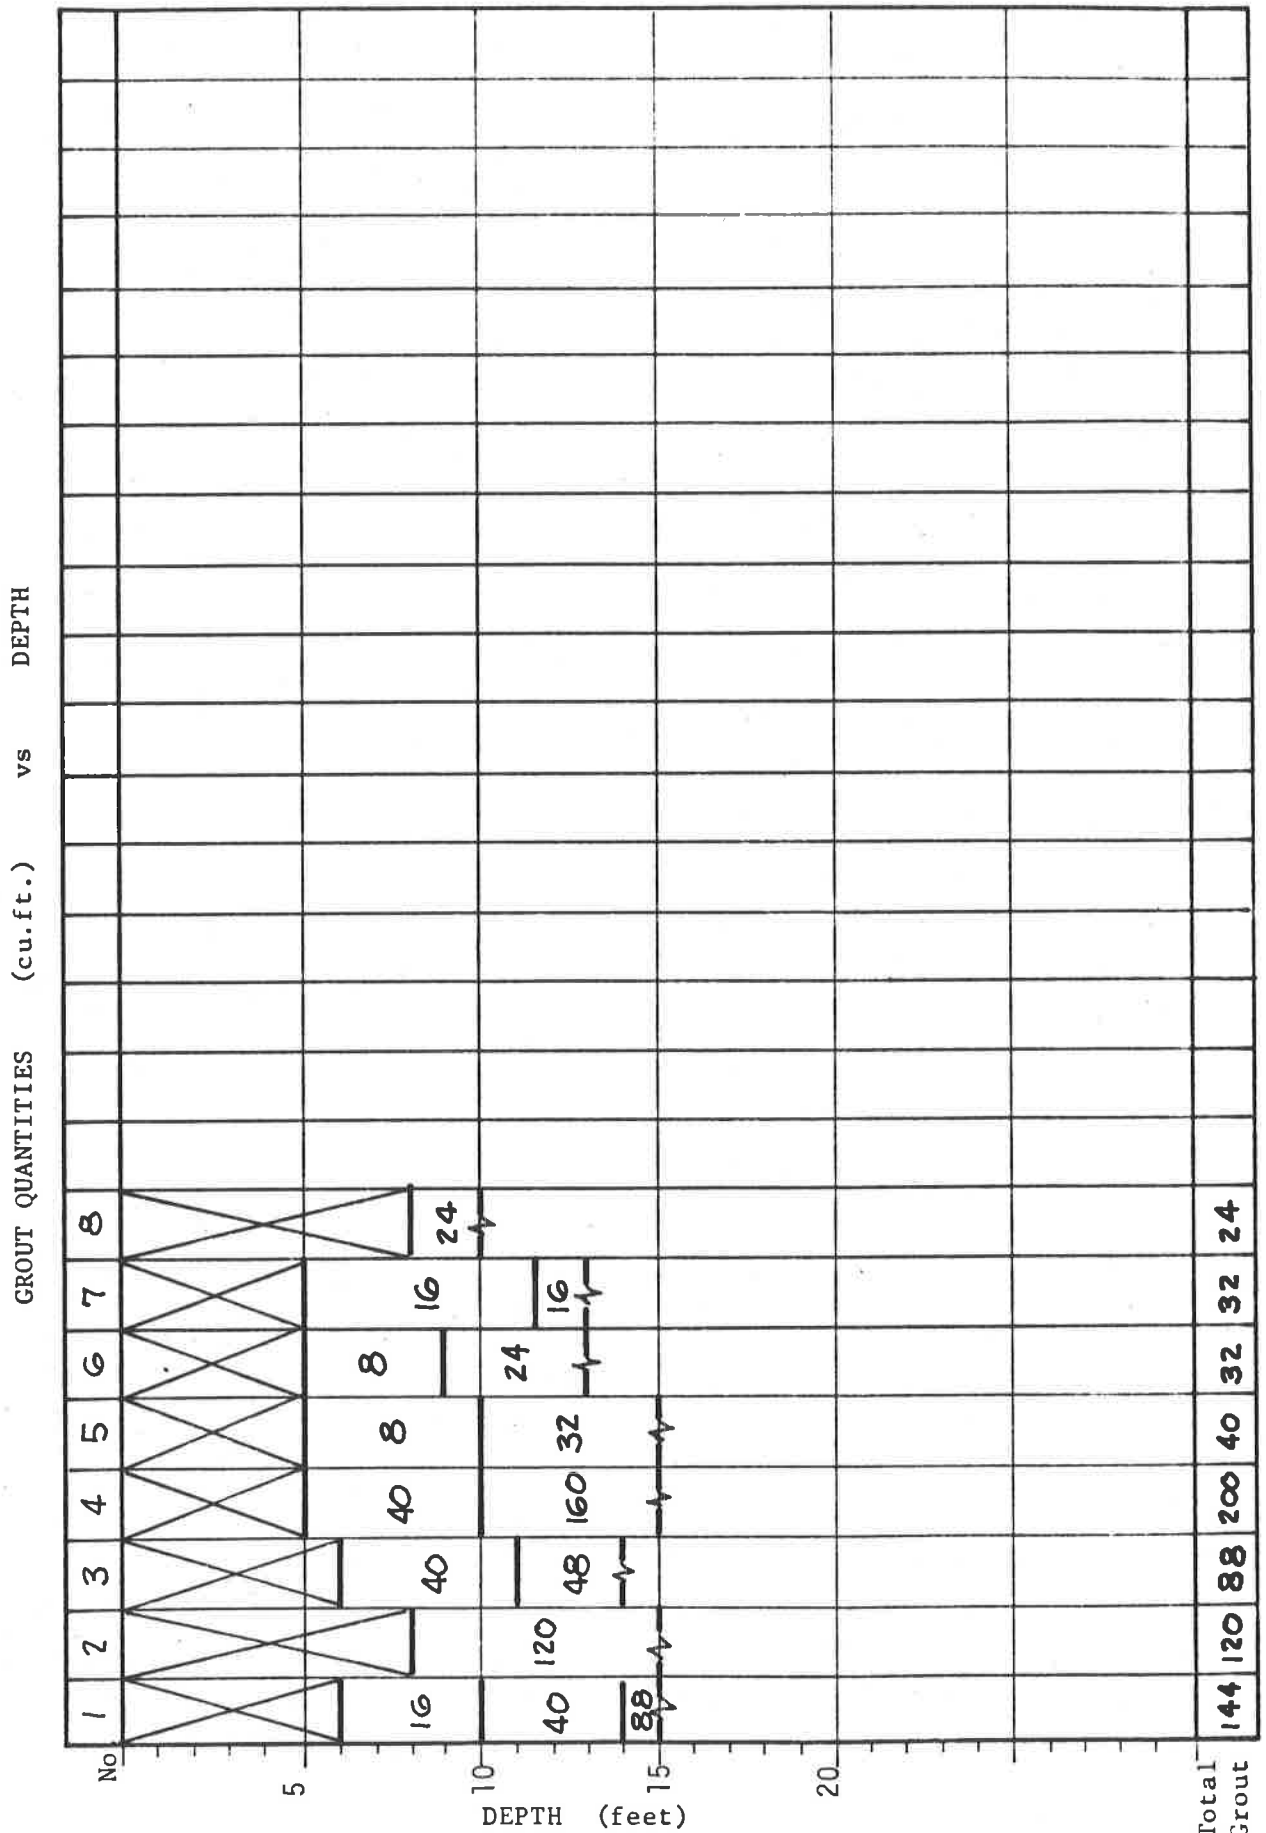
Total Grout

Using a five-foot effective radius around each grout point as the area compacted, the total area affected by the grouting computes to approximately 628 square feet. For the 680 cubic feet of grout injected, a calculated average layer of grout 1.08 feet thick was emplaced in this area. Subtracting the average lift at the surface from this figure shows that--theoretically--about 0.9 feet of grout was applied to compacting the compressible soil. This figure shows there obviously was potential for future settlement in these areas. The amount of grout injected yields a calculated average increase in soil density of 7 percent over the area treated, excluding the upper five feet.

TOTAL GROUT VOLUME 680 c.f.

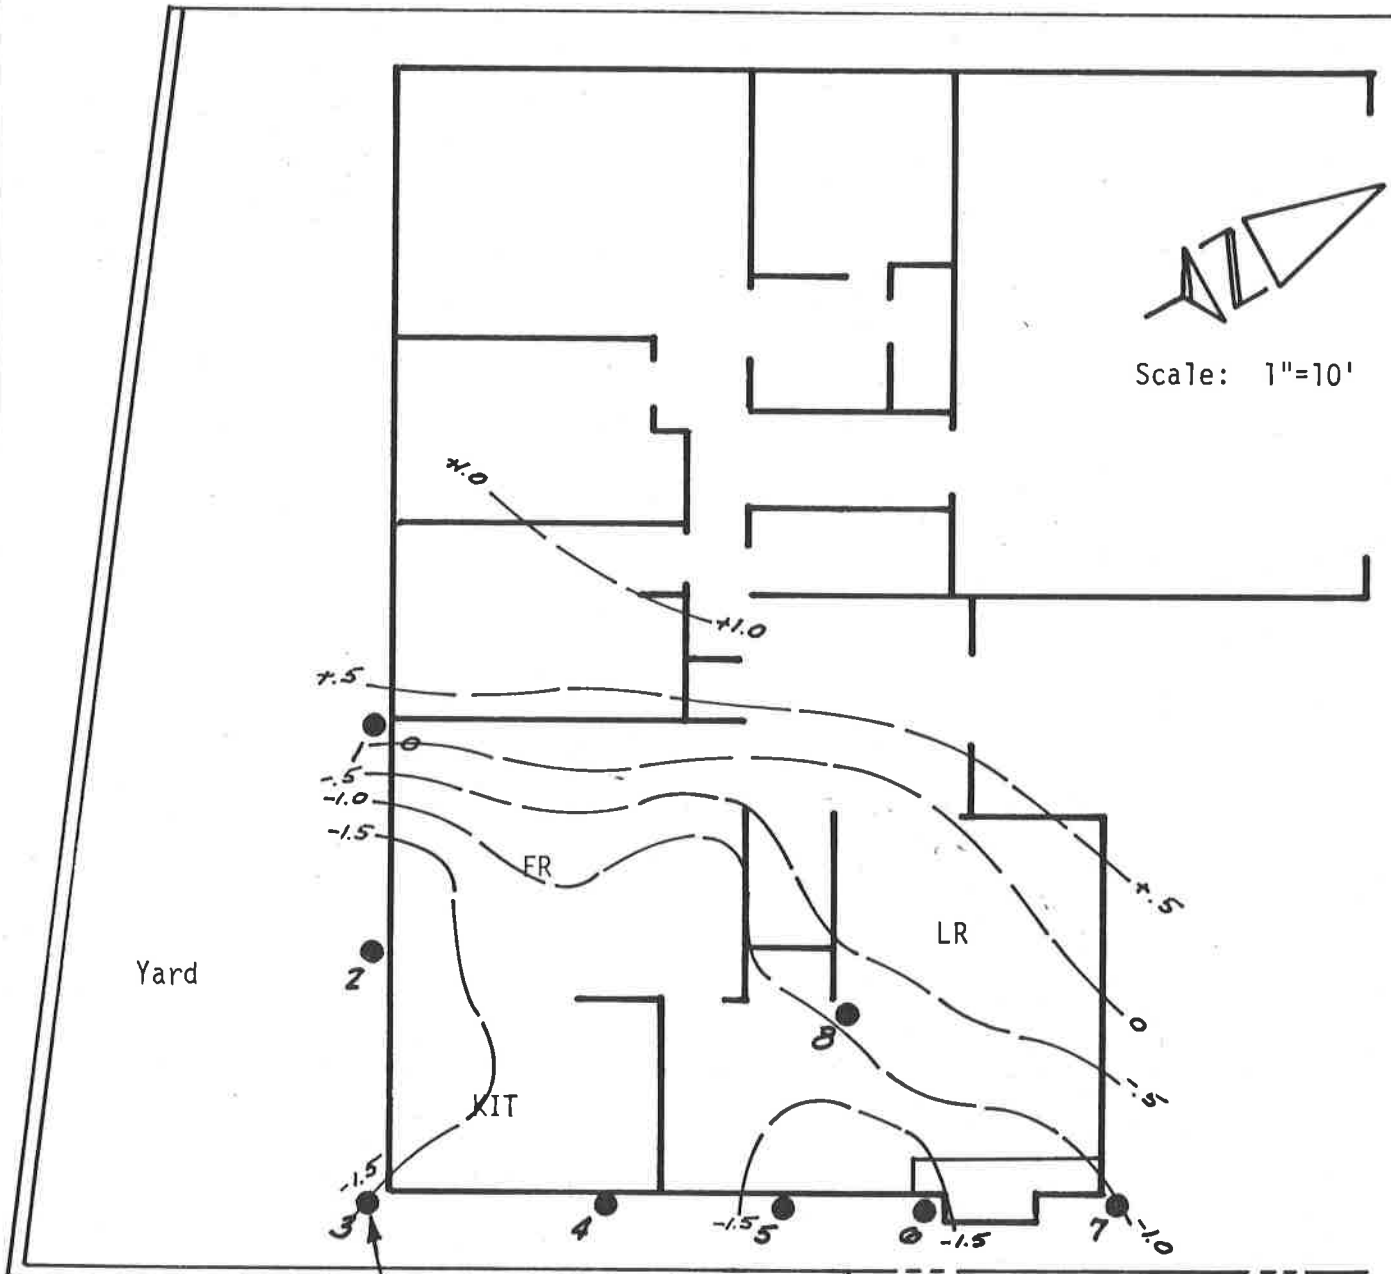
LOCATION OF GROUT POINTS

Low slump, sand-cement grout was injected at eight points in the area to be treated (see attached plan, page A-1). The location of these points was adjusted in some cases from the originally planned program to conform more closely to requisite structural support or due to soil response as grout emplacement progressed.

The southwest corner of the house was raised substantially by the grout injections. Level surveys of the floor area before and after completion of the work indicates as much as 2.5 inches of lift. The final slab elevation contours in the area of treatment are plotted on the attached plan and show major improvement over pre-grouting conditions. Care was
