WOOD DESTROYING PESTS AND ORGANISMS INSPECTION REPORT

Building No. 10540	Street Fairway Dr.	City Kelseyville	Zip 95451	Date of Inspection 04/27/18	Page 1 of 12

Registration # PR5770		Report # 10008			
Ordered by: Timothy Toye & Associates Janice Hodges 16360 Hwy. 175 Cobb, CA 95426		Property Owner and/or Party of Interest: Dawn & Mike Drew 10540 Fairway Dr., Kelseyville, CA 95451		Report sent to: Timothy Toye & Associates Janice Hodges 16360 Hwy. 175, Cobb, CA 95426	
COMPLETE REPORT <input checked="" type="checkbox"/> LIMITED REPORT <input type="checkbox"/> SUPPLEMENTAL REPORT <input type="checkbox"/> REINSPECTION REPORT <input type="checkbox"/>					
General Description: One-story, single family dwelling, wood siding, unoccupied, unfurnished, attached porch and deck, current weather: Windy.				Inspection Tag Posted: Subarea Other Tags Posted: None	
An inspection has been made of the structure(s) shown on the diagram in accordance with the Structural Pest Control Act. Detached porches, detached steps, detached decks and any other structures not on the diagram were not inspected. Diagram is not to scale. Locations are only approximate.

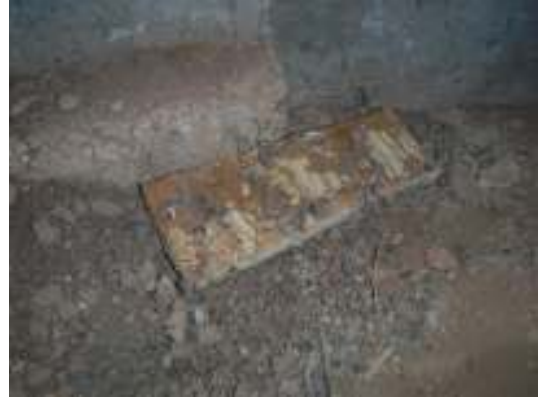
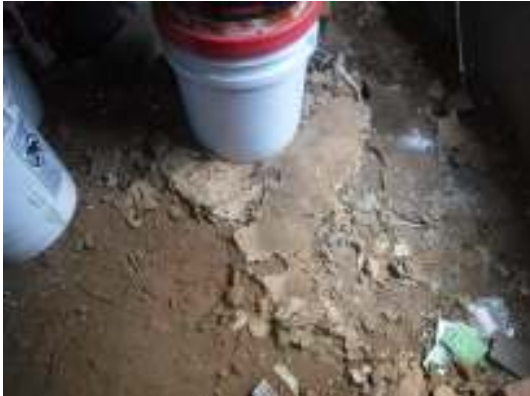
1C:

FINDING: Cellulose debris (wood, paper products) with evidence of subterranean termites was noted in the subarea.
RECOMMENDATION: Remove the cellulose debris of a rakable size. Treat the subarea with a 0.06% solution of TERMIDOR, a registered termiticide, in accordance with the manufacturer's label.
A THREE YEAR GUARANTEE WILL BE GIVEN ON THE TREATED AREA.
NOTE: A DISCOUNT OF \$200.00 WILL BE GIVEN IN THE WORK COMPLETION IF OTHERS REMOVE THE CELLULOSE DEBRIS FROM IN THE SUBAREA.

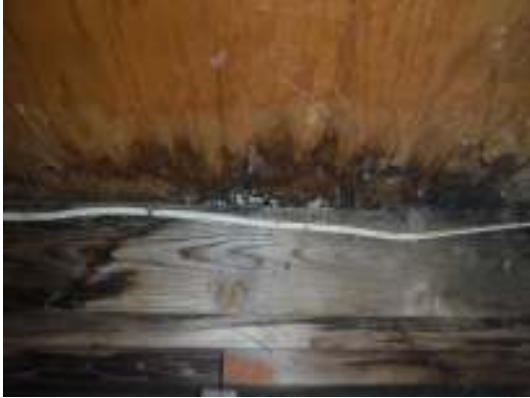
1B:

FINDING: Surface fungus was noted on the flooring in the subarea. It appears an old sliding glass door may have been located in this location which could have caused the fungus.
RECOMMENDATION: Scrape off the fungus. If no further damage is exposed, chemically treat the infected wood members with TIMBOR a registered fungicide in accordance with the manufacturers label.
A ONE YEAR GUARANTEE WILL BE GIVEN ON THE TREATED WOOD MEMBERS.

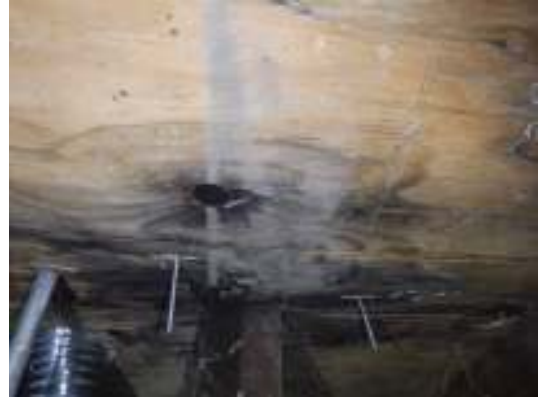
1D:

FINDING: Fungus has damaged the flooring in the subarea. This damage is located directly below the dryer and hall bath vanity.
RECOMMENDATION: Remove the vanity. Remove the damaged flooring. If no further damaged is exposed, replace with new material. Re-install the vanity as needed.

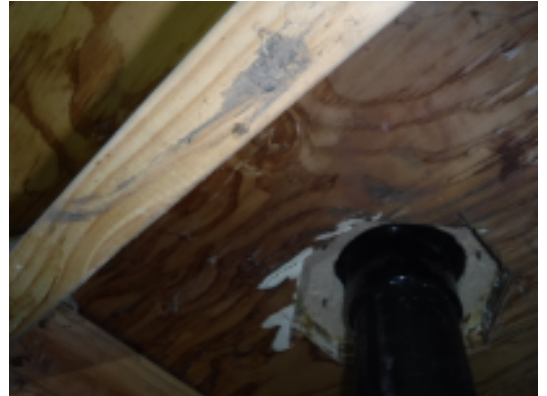
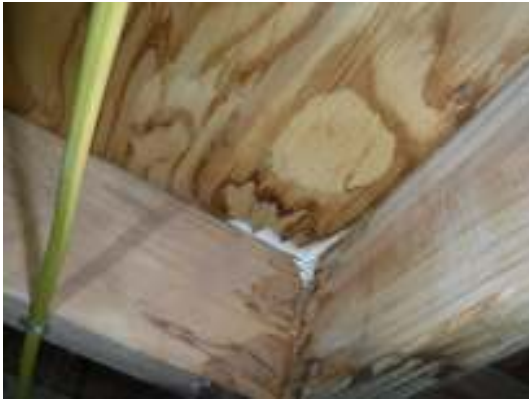
1E:

Surface fungus was noted on the flooring under the hall bath in the subarea.

Scrape off the fungus. If no further damage is exposed, chemically treat the infected wood members with TIMBOR a registered fungicide in accordance with the manufacturers label. A ONE YEAR GUARANTEE WILL BE GIVEN ON THE TREATED WOOD MEMBERS.

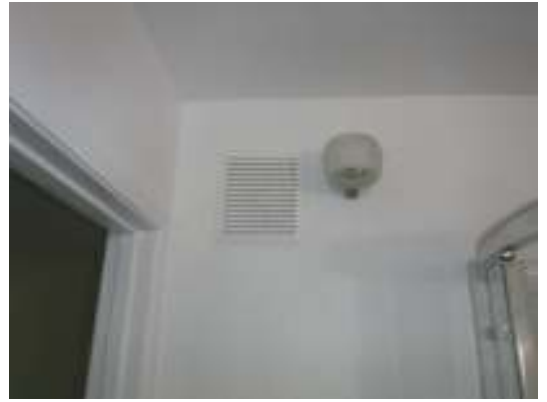
2C:

A switch could not be found to test the exhaust fan in the hall bathroom.

The owner is to supply a switch and/or let this company know of the location. All further findings will be listed in a supplemental report.

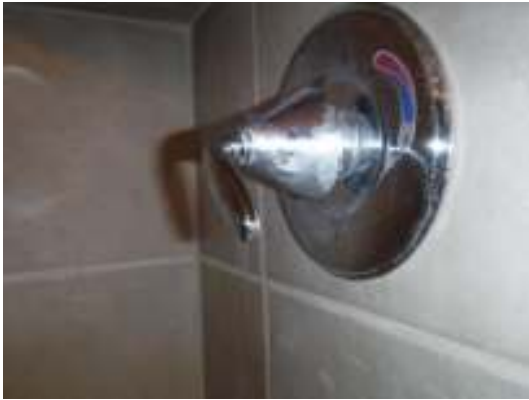
2A:

A plumbing leak was noted at the shower/tub faucet in the master bath.

Repair the plumbing leak as needed.

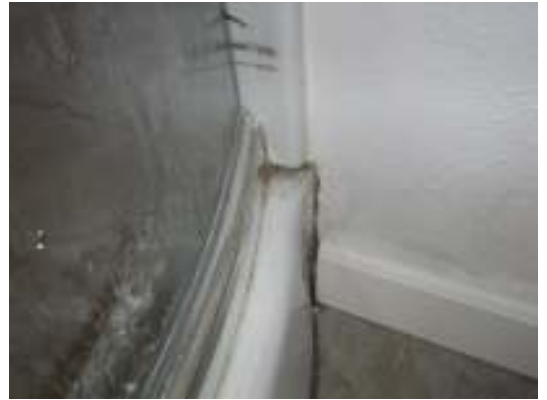
2D:

A leak was noted at the glass enclosure of the shower in the hall bath.

Seal the glass enclosure to correct the leak as needed.

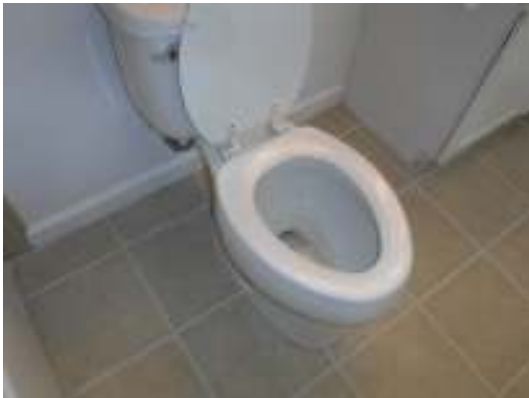
2B:

The toilet was noted to be loose in the master bathroom.

Remove the toilet. If no damage or other conditions are found, reset the toilet on a new wax seal as needed.

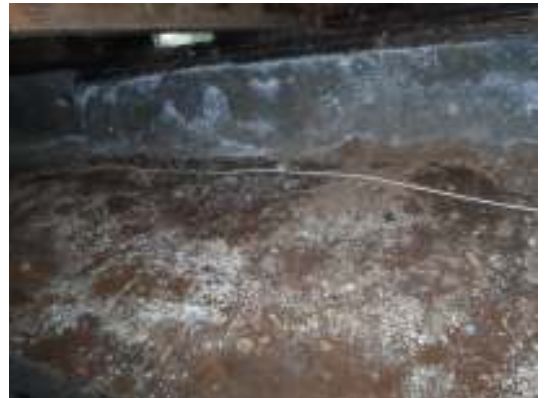
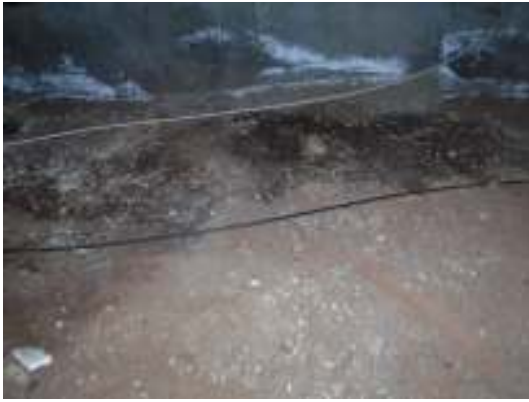
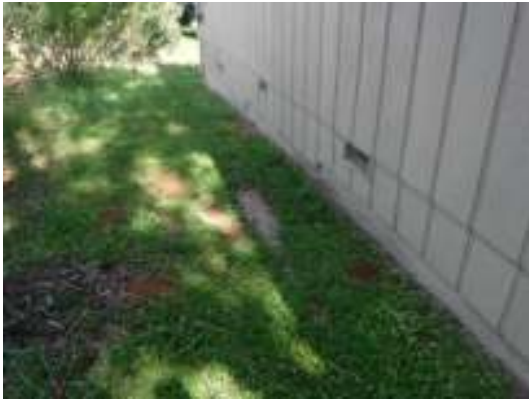
2E:

The soil was noted to be slightly damp in the subarea. This appears to have been caused by lack of the proper gutter along the left side of the structure.

Install the proper gutter and downspout along the left side of the structure as needed.

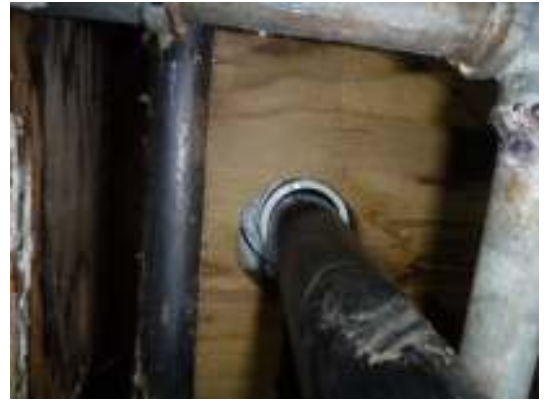
2G:

The hall bath shower drain was noted to be leaking in the subarea.

Replace the shower drain as needed.

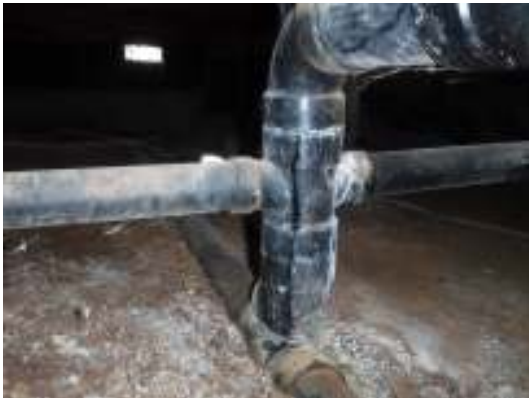
2F:

A plumbing leak was noted at the drain line in the subarea causing an excessive moisture condition.

Repair the leak as needed.
