Property Inspection Report

2505 Rodman Dr, Baywood-Los Osos, CA 93402
Inspection prepared for: Ken Kellett
Real Estate Agent: -

Date of Inspection: 4/6/2018 Time: 10:00 AM
Age of Home: 1995 Size: 2059
Order ID: 3322

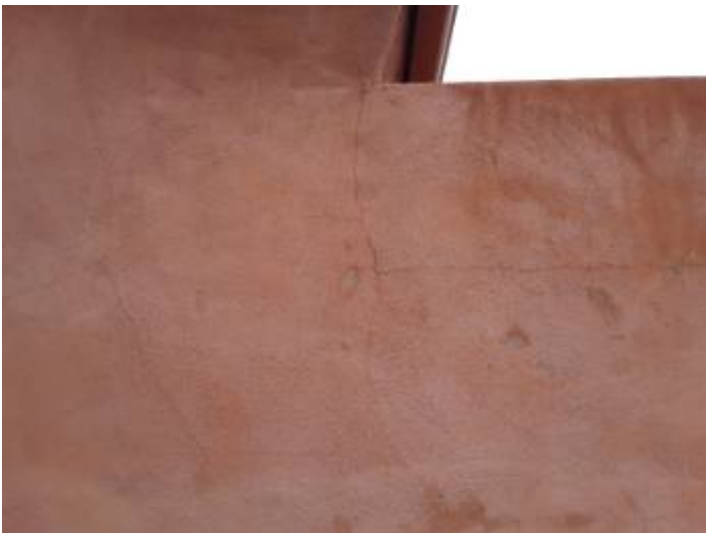
3.6. The spider-like cracks in the smooth stucco, or which is sometimes referred to as being a steel-trowel finish, are commonplace and not indicative of structural damage. However, you could have a specialist confirm this.

The spider-like cracks in the smooth stucco, or which is sometimes referred to as being a steel-trowel finish, are commonplace and not indicative of structural damage. However, you could have a specialist confirm this.

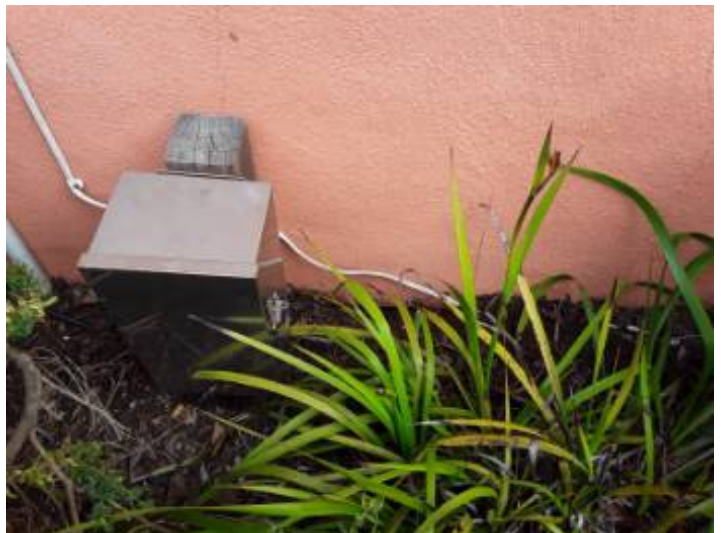
The soil is too high against the home at various areas around the home which should be serviced.

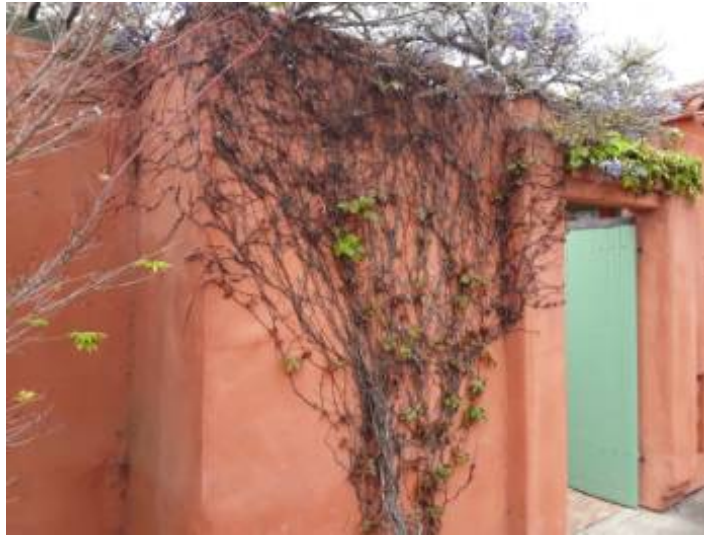
3.2. Vines, shrubs or bushes are growing on the house walls and although they are attractive they can introduce pests and rodents and accelerate deterioration. Therefore, you may wish to consider having them removed or cut back to 12 inches away from the home.

Vines, shrubs or bushes are growing on the house walls and although they are attractive they can introduce pests and rodents and accelerate deterioration. Therefore, you may wish to consider having them removed or cut back to 12 inches away from the home.

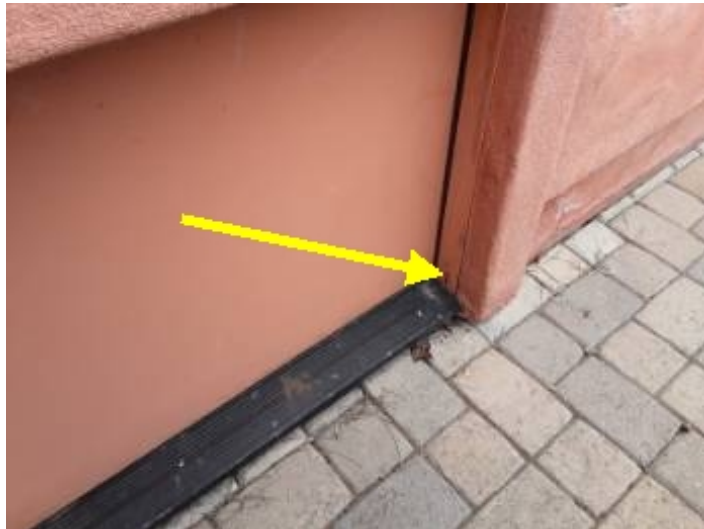
- 5.1. There is damage to the wood trim that should be evaluated by a termite inspector.

There is damage to the wood trim that should be evaluated by a termite inspector.

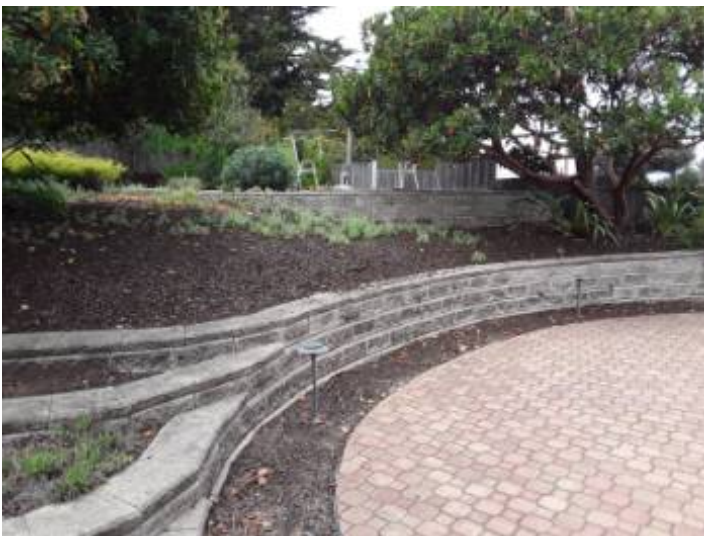
9.2. The stacked masonry yard walls, though functional, have no value as retaining walls and will need to be periodically monitored for movement.

The stacked masonry yard walls, though functional, have no value as retaining walls and will need to be periodically monitored for movement.

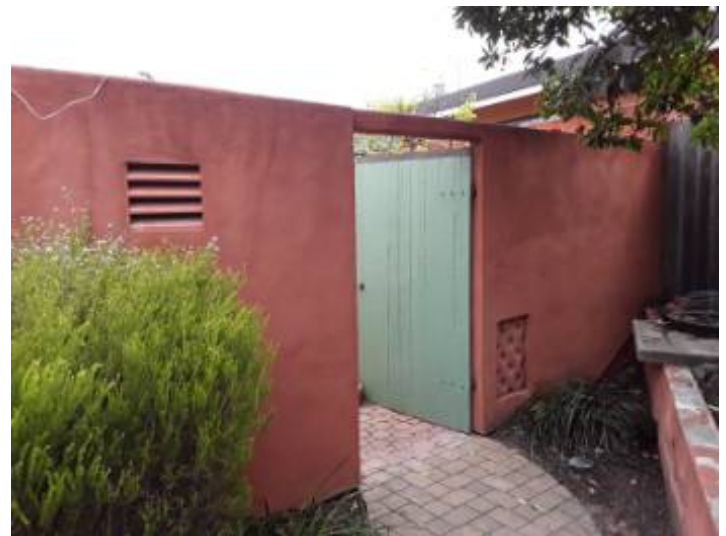
9.3. Some of the yard walls are wood-framed and finished with stucco. Such walls must be kept sealed and monitored, because if moisture penetrates them the wood framing can deteriorate without being apparent.

Some of the yard walls are wood-framed and finished with stucco. Such walls must be kept sealed and monitored, because if moisture penetrates them the wood framing can deteriorate without being apparent.

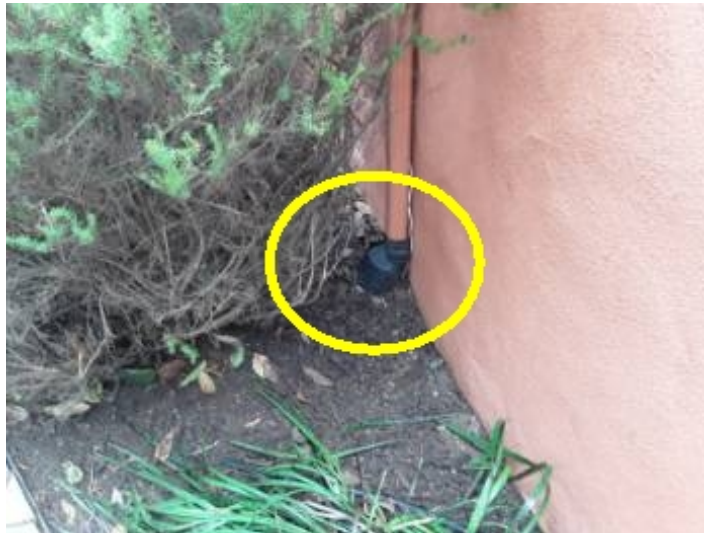
1.2. We have noted that the downspouts enter into underground drains, but we cannot confirm their termination points. It should be verified that they are clear, and the termination points be verified.

We have noted that the downspouts enter into underground drains, but we cannot confirm their termination points. It should be verified that they are clear, and the termination points be verified.

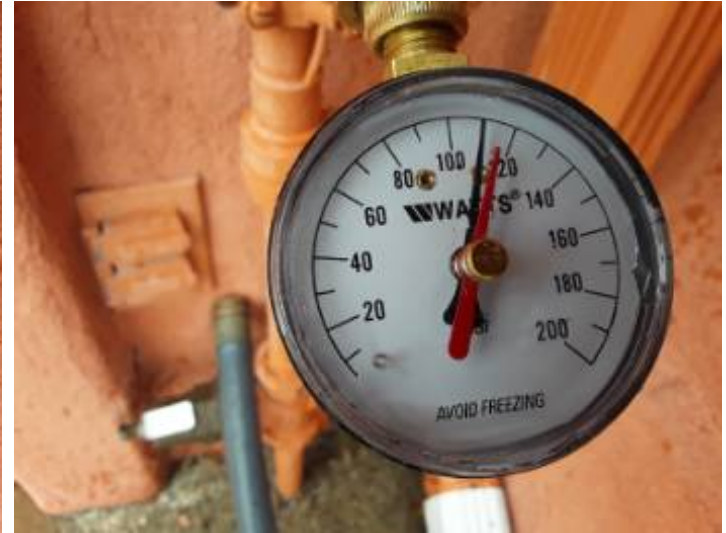
Page 12 Item: 1	Water Supply Comments	1.3. The pressure inside the residence is above 80 PSI and will stress components of the system. A licensed plumber should reduce the pressure at the regulator to sixty pounds per square inch, which is optimum. However, the regulator may have failed and would need to be replaced.
-----------------	-----------------------	--

1.3. The pressure inside the residence is above 80 PSI and will stress components of the system. A licensed plumber should reduce the pressure at the regulator to sixty pounds per square inch, which is optimum. However, the regulator may have failed and would need to be replaced.

The pressure inside the residence is above 80 PSI and will stress components of the system. A licensed plumber should reduce the pressure at the regulator to sixty pounds per square inch, which is optimum. However, the regulator may have failed and would need to be replaced.

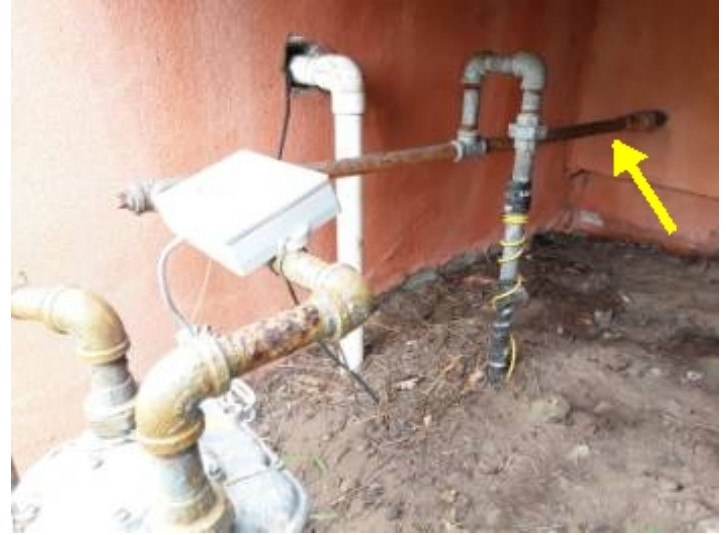
2.2. The gas lines at the meter are rusted and should be painted to prevent further corrosion.

The gas lines at the meter are rusted and should be painted to prevent further corrosion.

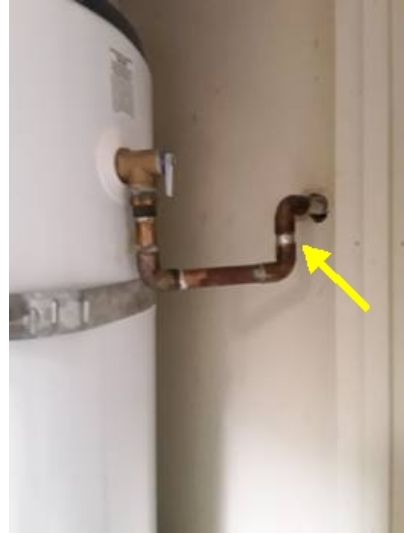
The discharge pipe from the pressure relief valve has been incorrectly plumbed uphill. This is not permissible and the discharge pipe should be correctly plumbed.

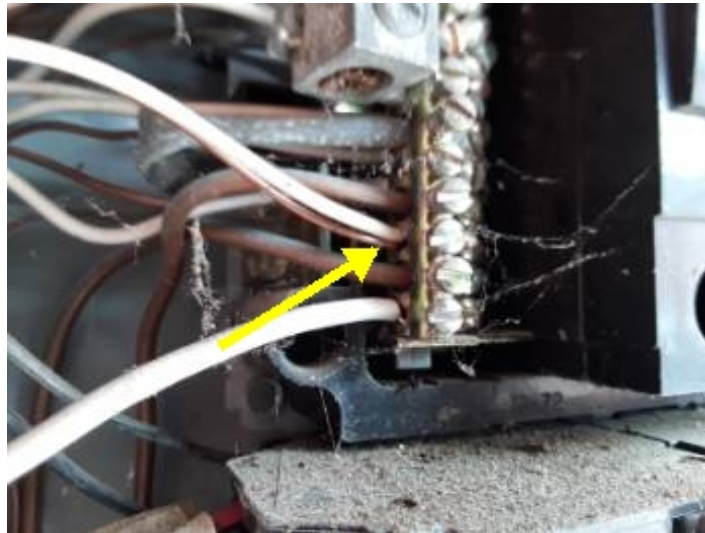
1.10. Neutral and ground wires have been improperly installed into one slot on the grounding buss bar which should be evaluated and corrected by a licensed electrical contractor.

Neutral and ground wires have been improperly installed into one slot on the grounding buss bar which should be evaluated and corrected by a licensed electrical contractor.

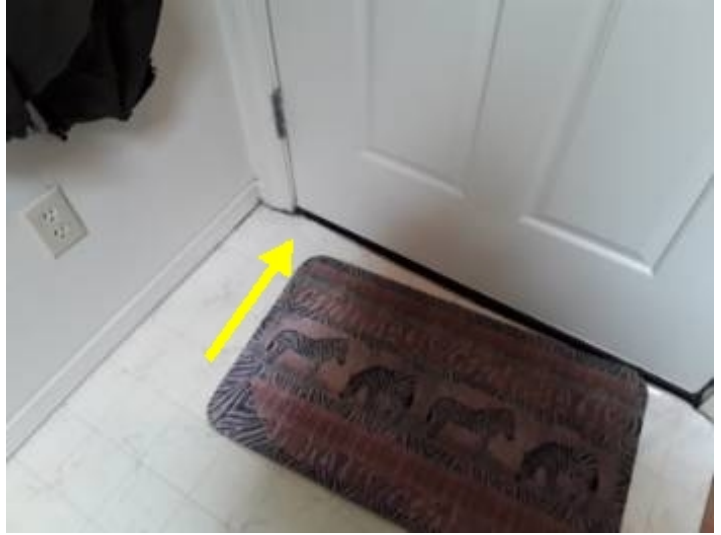
- 3.1. This bedroom is located adjacent to the main entry.
- 3.2. The floor is moisture damaged at the exterior doors and should be evaluated by a termite inspector.

The floor is moisture damaged at the exterior doors and should be evaluated by a termite inspector.

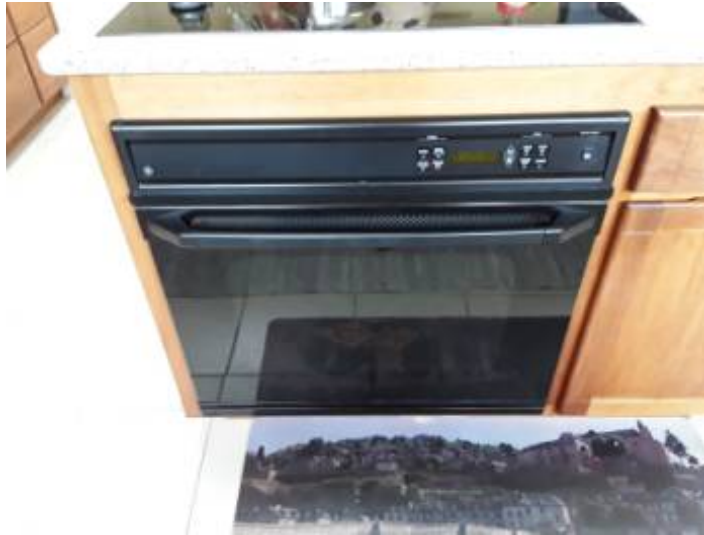
10.1. The electrical oven is not functional.

The electrical oven is not functional.

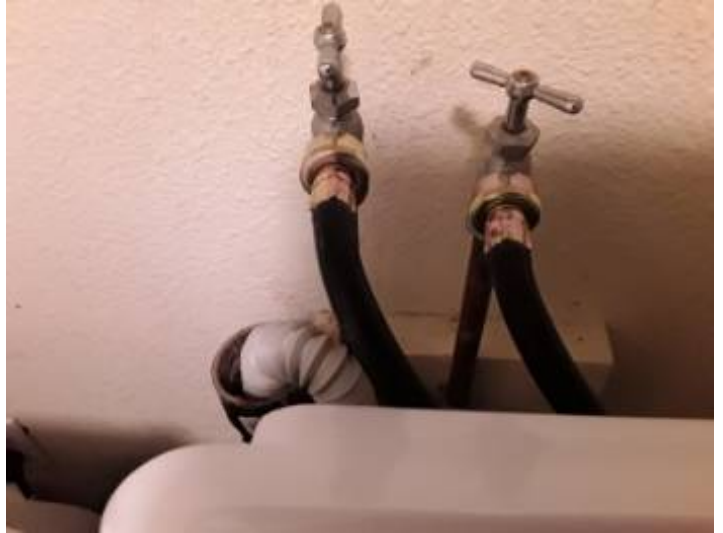
The water supply to washing machines is commonly left on, and over time, the rubber hoses that are commonly used to supply water can become stressed and burst. For this reason we recommend replacing all rubber supply hoses with metal-braided ones that are more resilient.

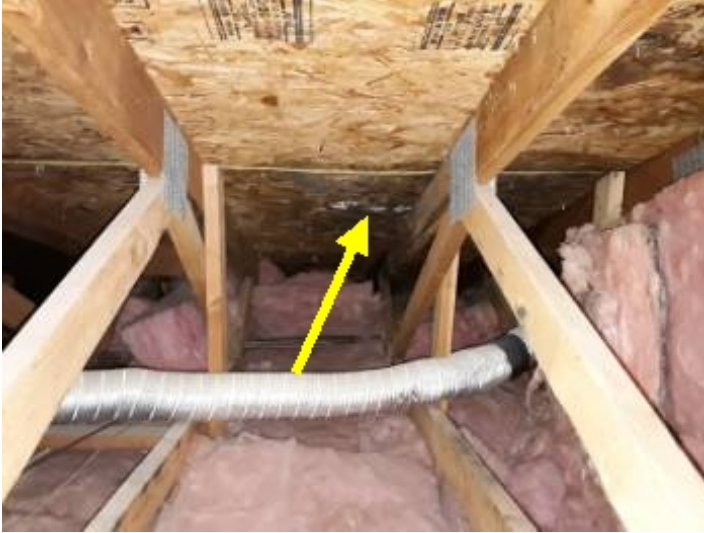
The are water stains on the ceiling that implies that a leak has occurred. Since it was not raining during our inspection, we were unable to determine if the leak is currently leaking, or, it is an old leak that has been repaired. You should ask the sellers for information regarding this issue.

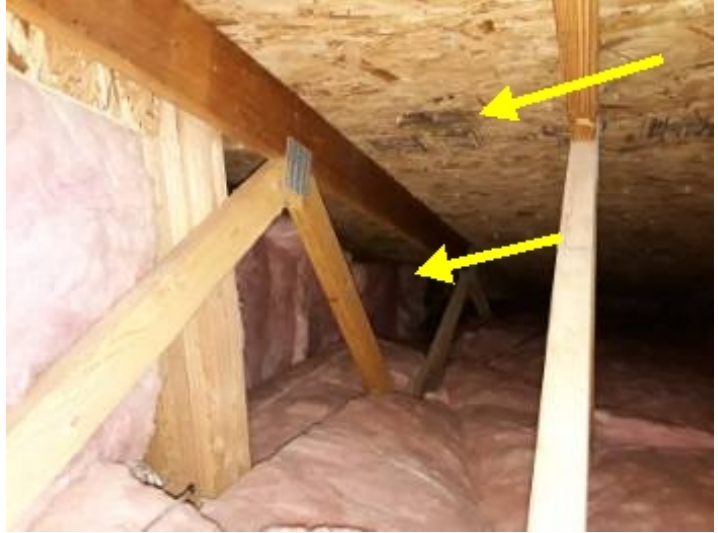
The are water stains on the ceiling that implies that a leak has occurred. Since it was not raining during our inspection, we were unable to determine if the leak is currently leaking, or, it is an old leak that has been repaired. You should ask the sellers for information regarding this issue.

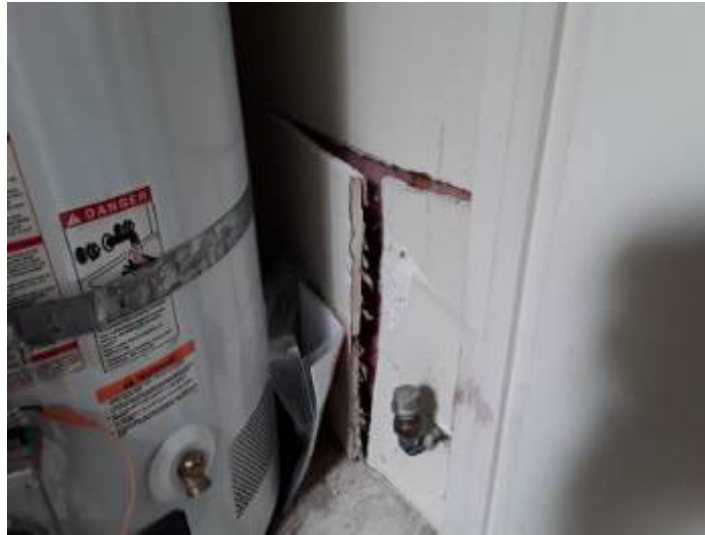
Page 34 Item: 1	Double-Car Garage	1.9. The voids in the garage firewall must be repaired, in order to maintain the necessary firewall separation between the garage and the residence.
-----------------	-------------------	--

The voids in the garage firewall must be repaired, in order to maintain the necessary firewall separation between the garage and the residence.
