L.A. PRIVATE EYES ENGINEERS

December 5, 2018
Job No. 12TI18

Subject: **Limited Geotechnical Inspection**
7080 Via Del Mar
Lot 19, Tract 37818
Los Angeles, California

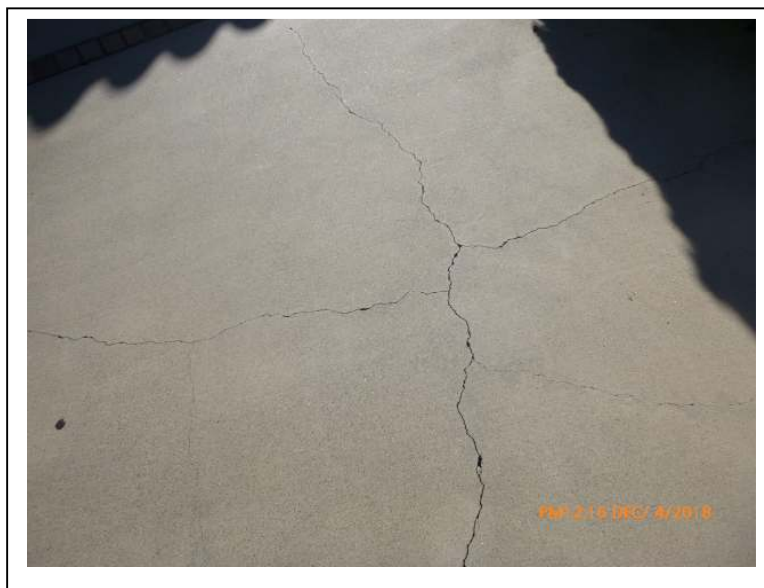
- The driveway and garage slabs contain a few cracks.

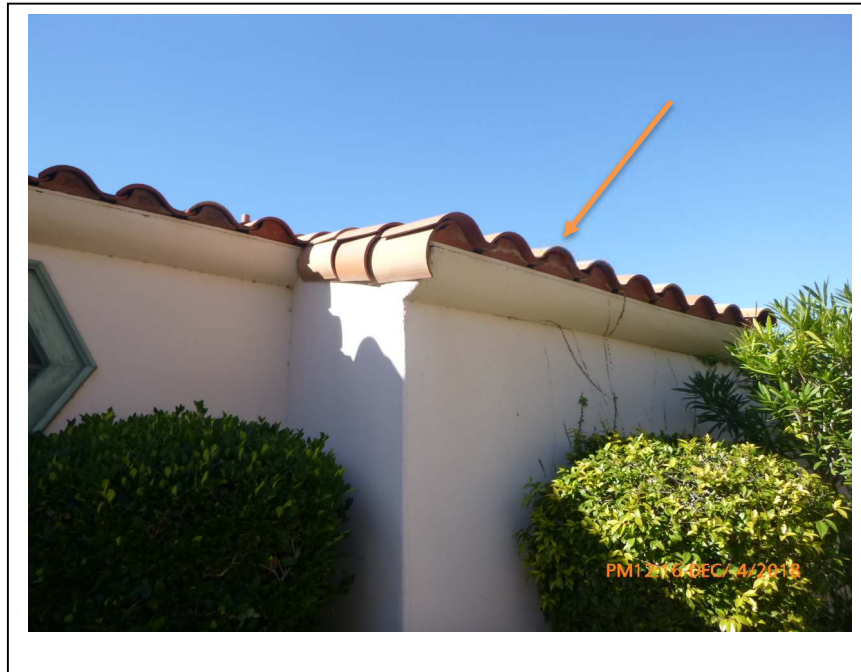
- The structure is missing roof gutters and downspouts. This condition is not desirable as rain water can accumulate next to the building and cause settlement.

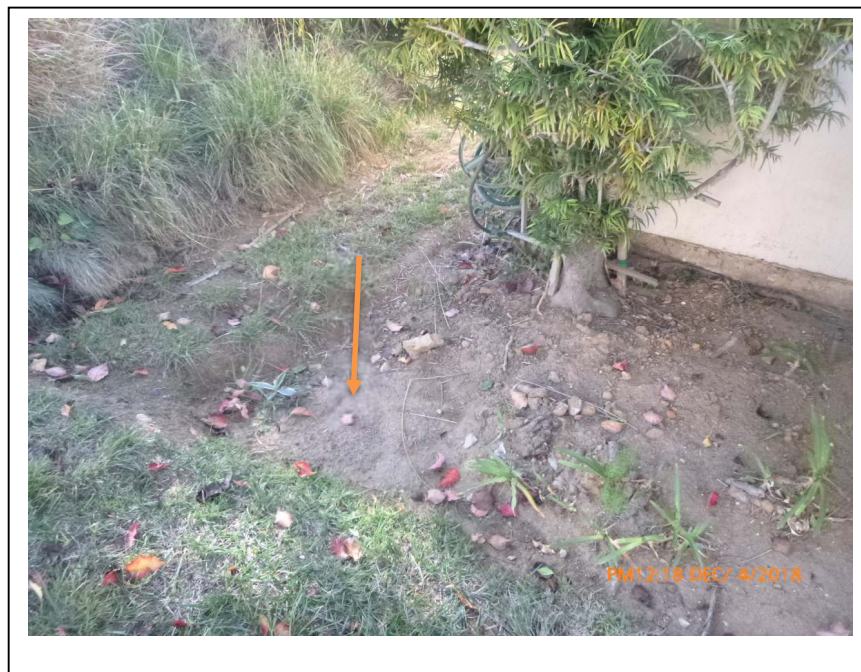
- In absence of drainage devices, rain and/or irrigation water can pond in the low lying areas around the building

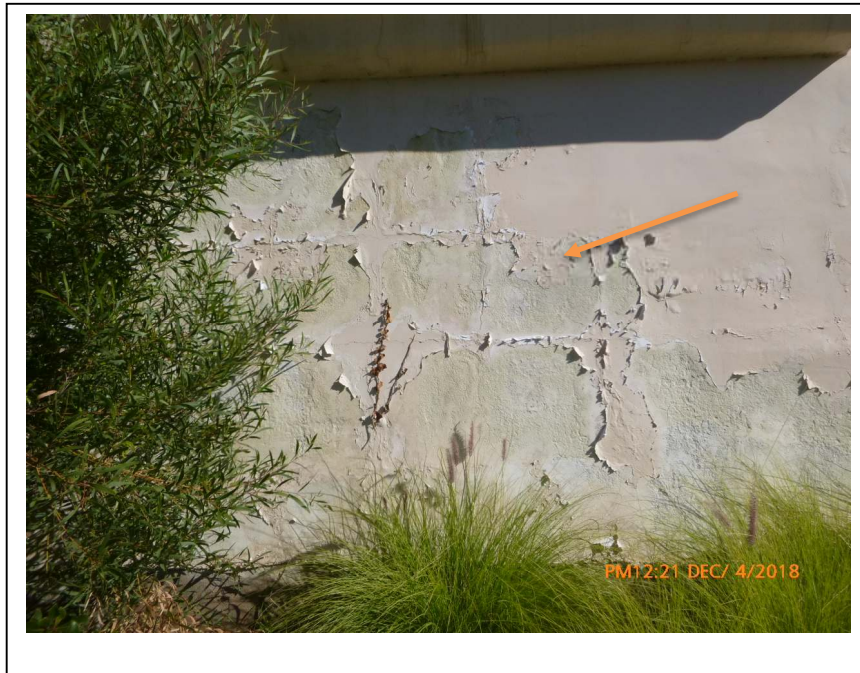
- Some of the exterior walls of the building and retaining walls are covered with vegetation and could not be thoroughly inspected. Where visible, water damage was noted on the face of some of the walls. This may be due to lack of a waterproofing membrane behind the wall.

If the noted condition of the retaining walls from a waterproofing view point is not acceptable to you, for most effective results, we recommend the backfill behind walls to be excavated and a French-drain (Fig 8) to be installed. Should this method of repair not be economically feasible, waterproof the walls by first sand blasting their face and then apply couple of coats of a suitable concrete sealant over the wall. Again keep in mind that this method of repair is not as effective as waterproofing the walls from their backside.

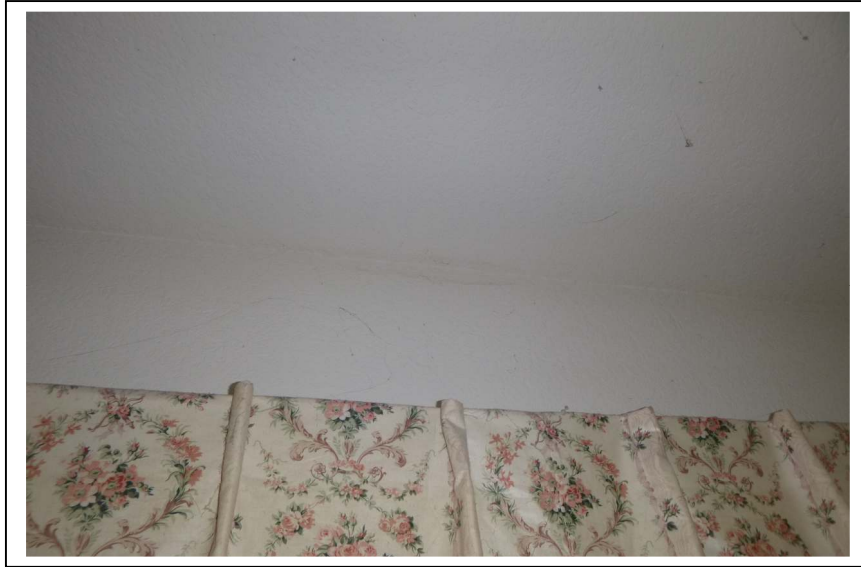
- Stains were noted on the ceiling in some areas. Water damage was noted to the ceiling of the lower level laundry room. The noted water damage may be due to a leak from a bathroom above this area. Make sure that there are no more leaks.

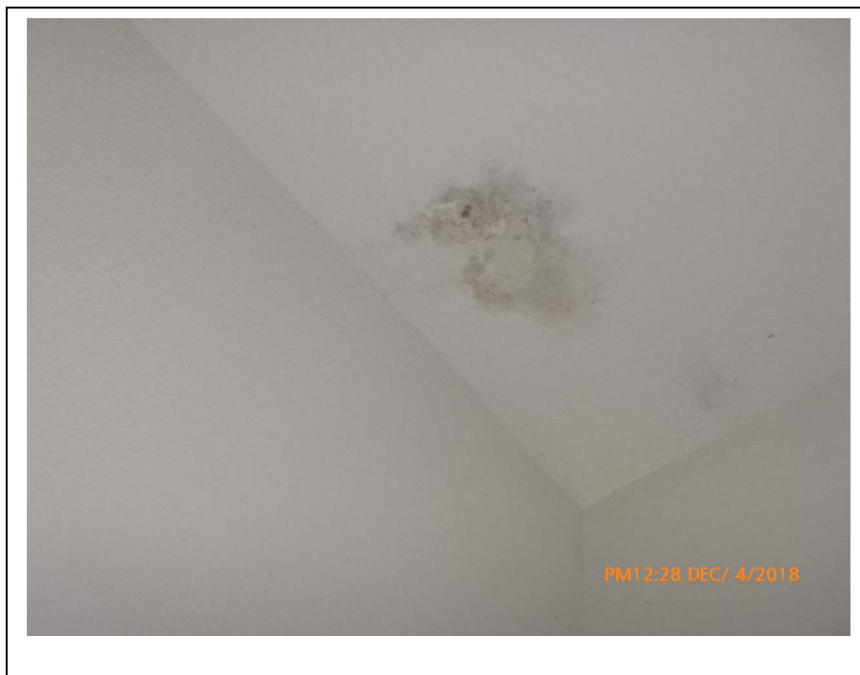
- Dark to black stains were noted on the ceiling to the southwest of the upper living room; this may be due to a roof leak. Have a qualified roofer check the roof to ensure that there is no potential for future leaks. In addition, due to water intrusion into the building envelop, we recommend you have a mold and termite inspection performed at this property as soon as possible.

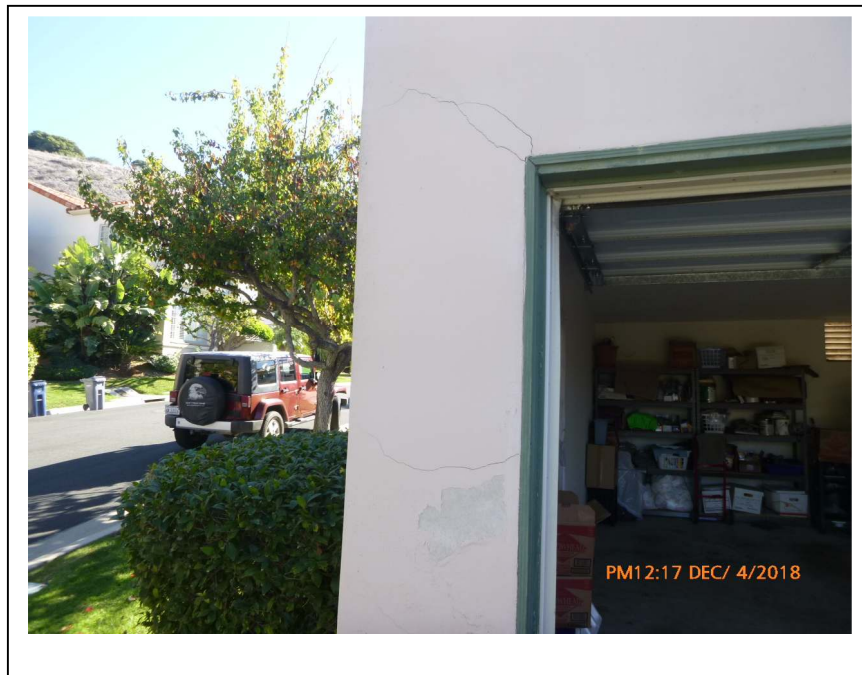
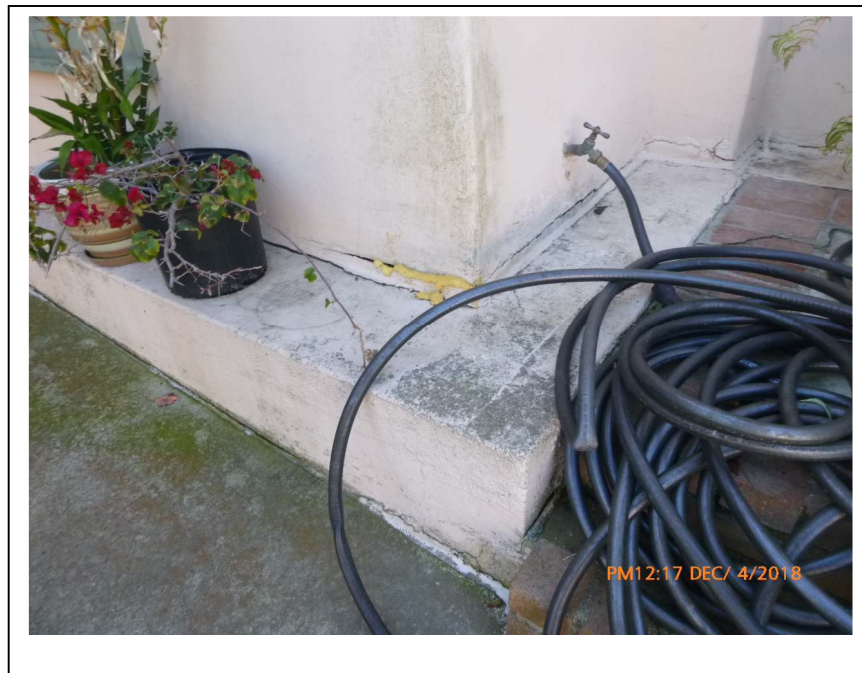
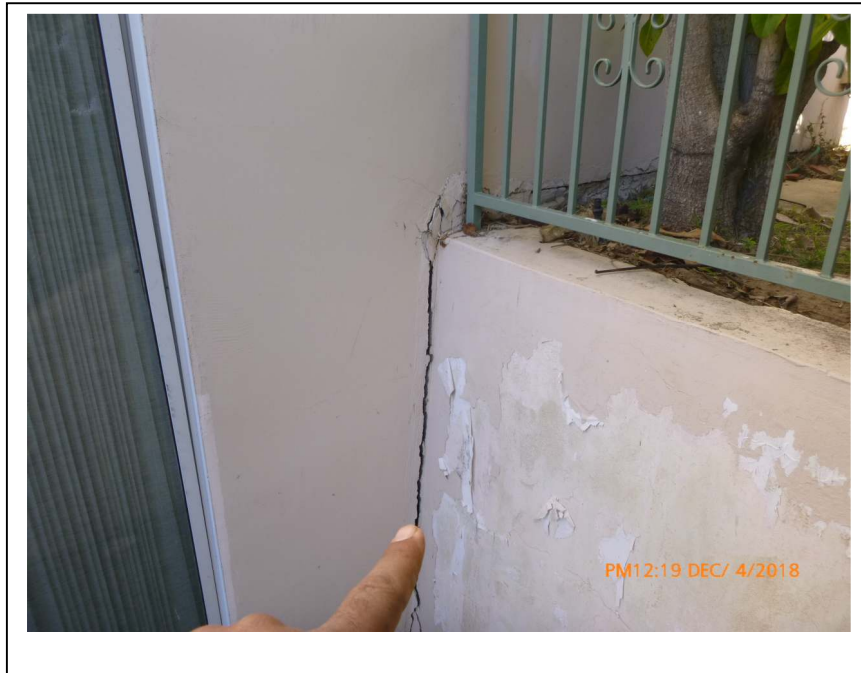
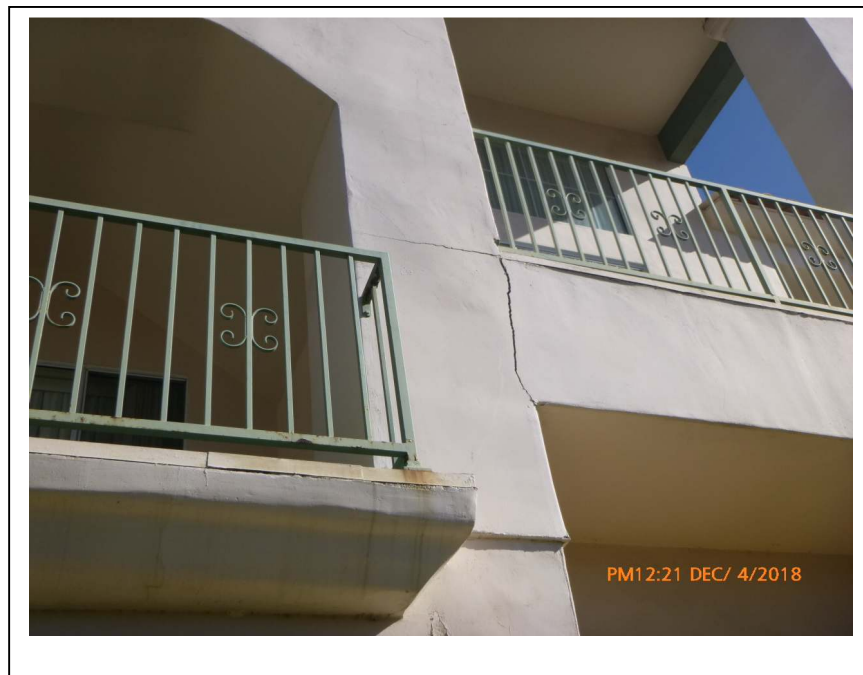
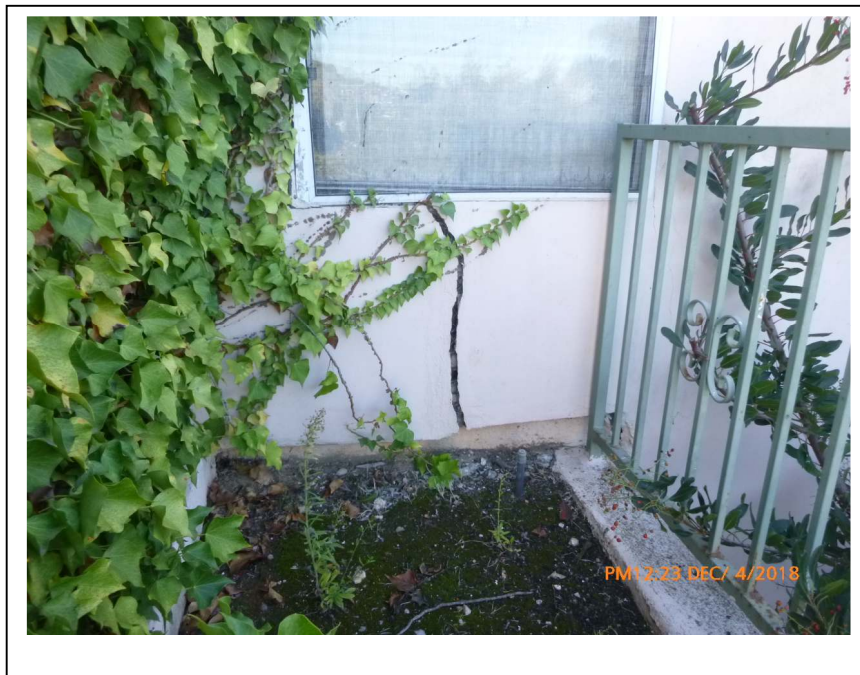
- Cracks were noted on the exterior of the building.

- To keep cracking of the structures and their foundations to a minimum, the differential movement across a horizontal distance of 30 feet should usually not exceed about 1 inch. Based on our measurements, the structure has settled differentially by up to about 5 inches. This amount of movement is excessive and in opinion is the main cause of the noted distress cracking.

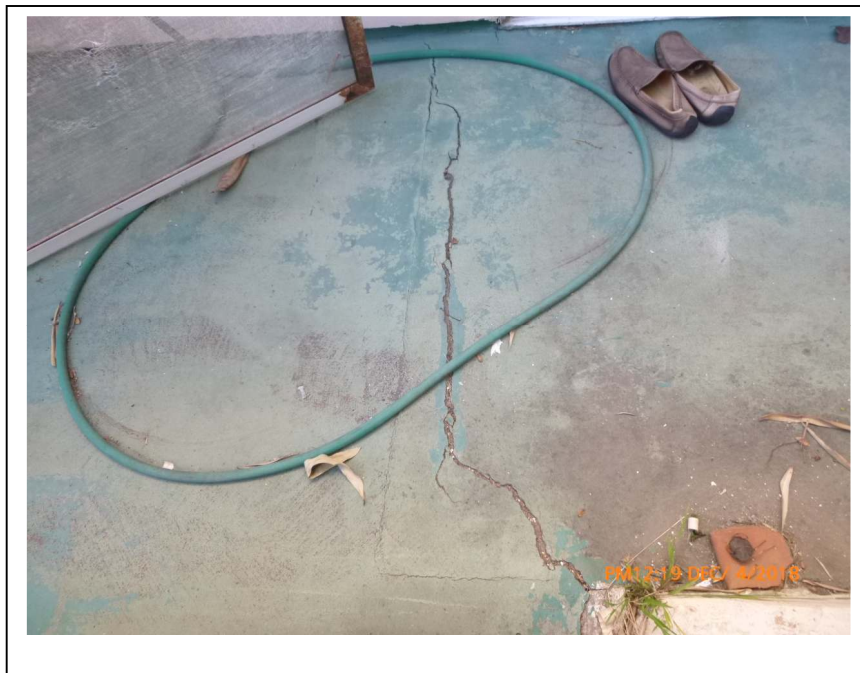
- View of a crack in the southerly slab to the south of the house.

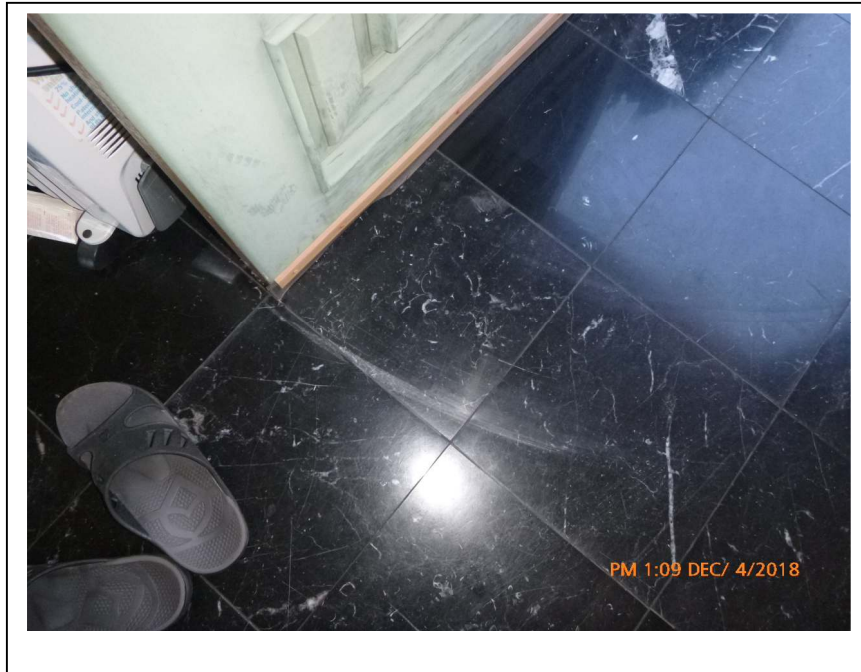
- The front door apparently rubs against the floor.

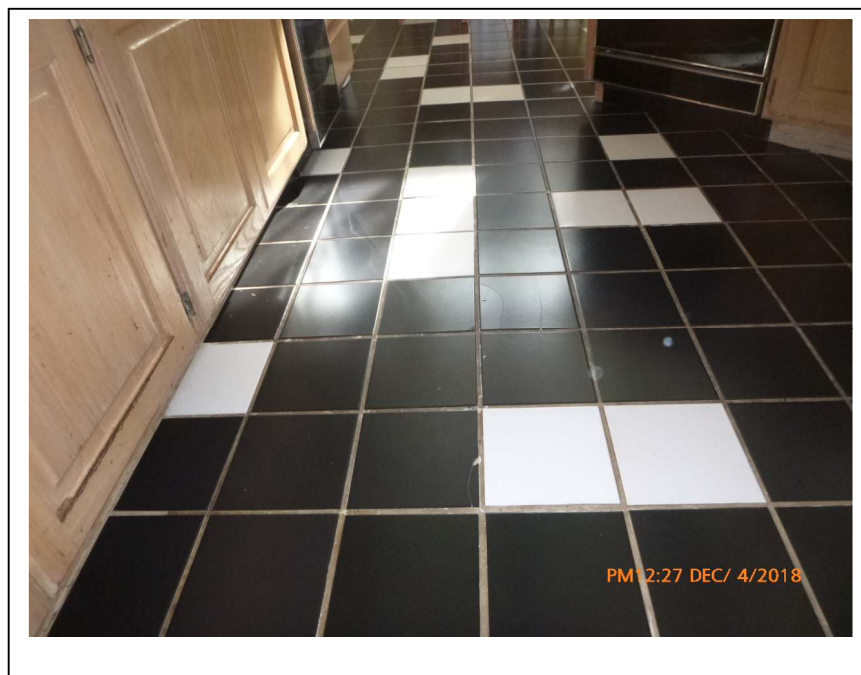
- Hairline cracks were noted in the lower level kitchen.

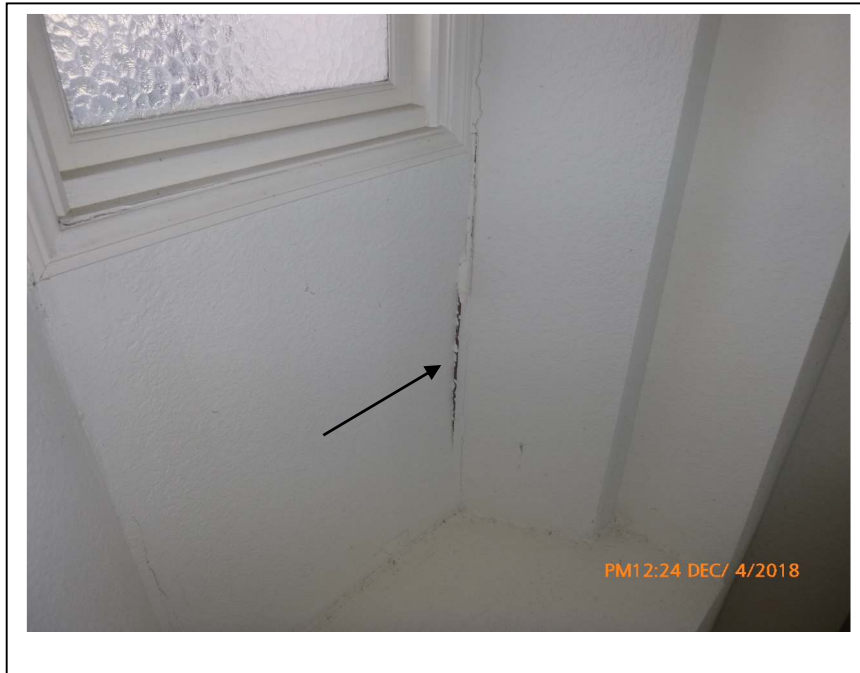
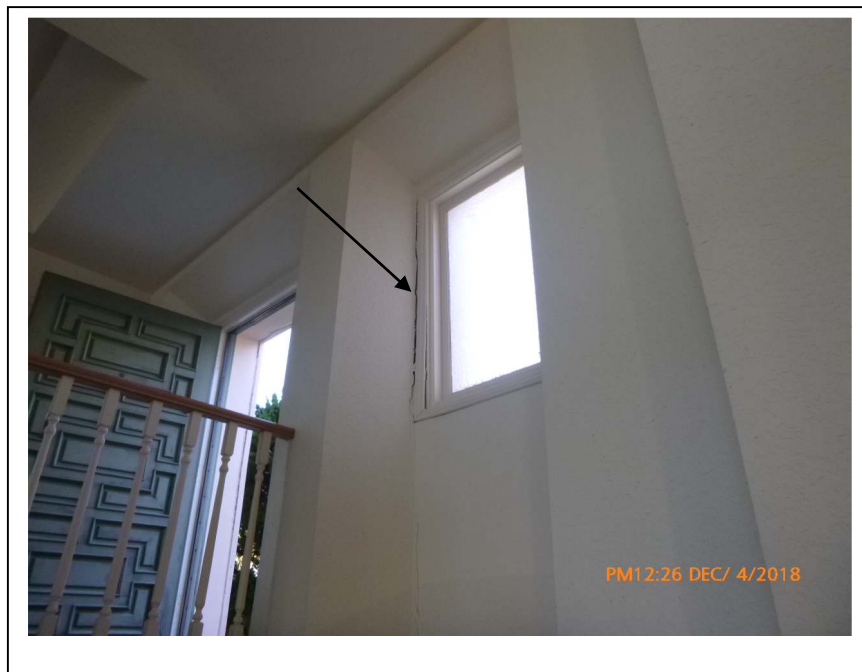
- Numerous cracks were noted within the interior of the structure.

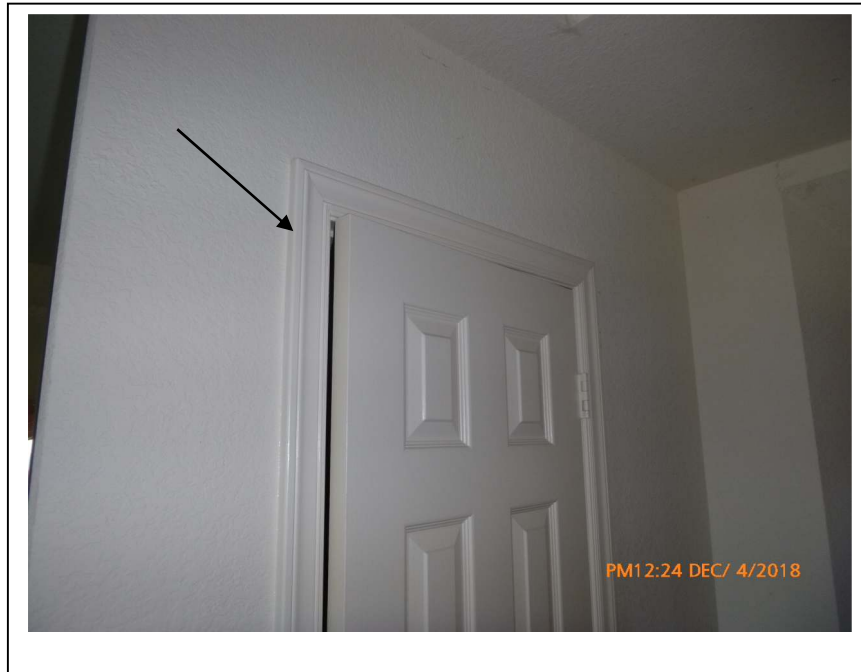
- Some of the doors above-referenced either out of square or do not operate properly any longer.

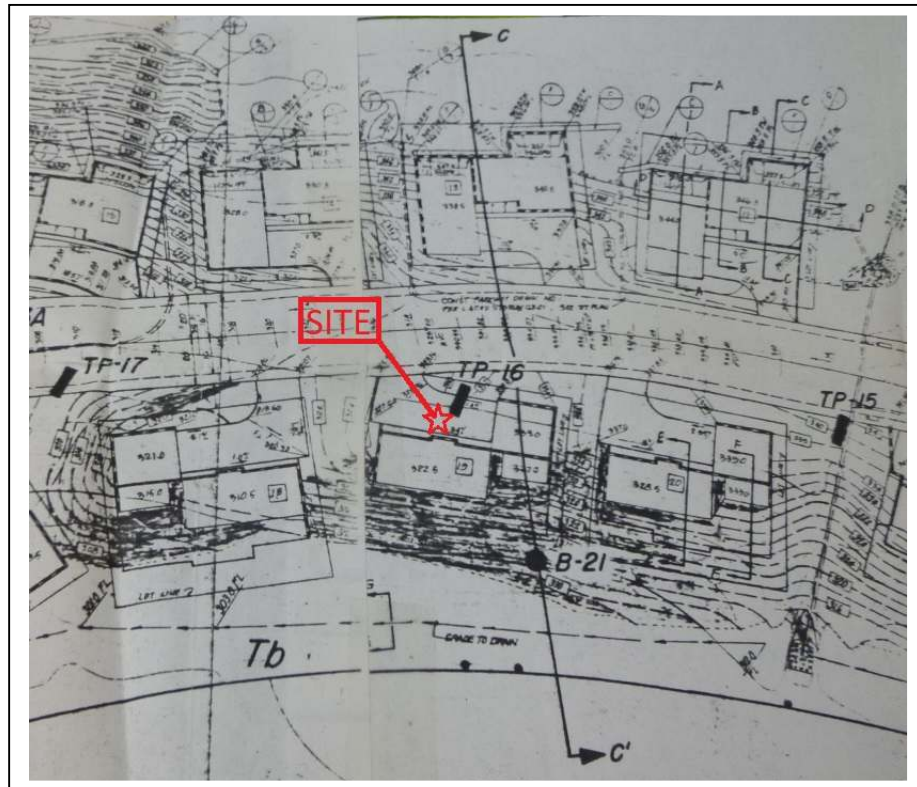
Fig 5-Grading Plan

- In order to develop a level building pad, the lot was graded by removing the loose topsoil overlying the underlying bedrock before placing fill soils on the underlying bedrock. The limits of the fill soils within the site area are depicted on Fig 4-Grading Plan. The fill soils

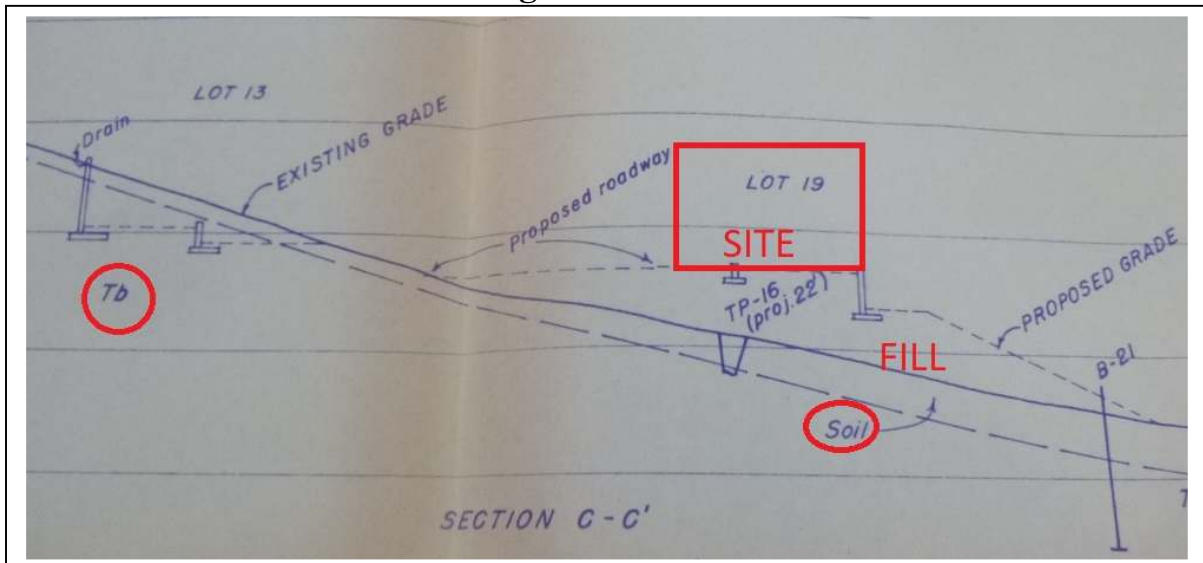
Fig 6-Section

at the site range anywhere from about 23 to 30 feet deep. The thickness of the fill soils at the site are shown on Fig 5-Section.

- The fill soils were placed under observation of Moore & Taber and are reported to have been compacted. The fill soils were placed at a time when strict grading ordinances were not in effect; as such they may not have been compacted to the current standards. As a result, they do not appear to have been properly compacted as they have settled causing settlement of portions of the structure as discussed in the following sections.

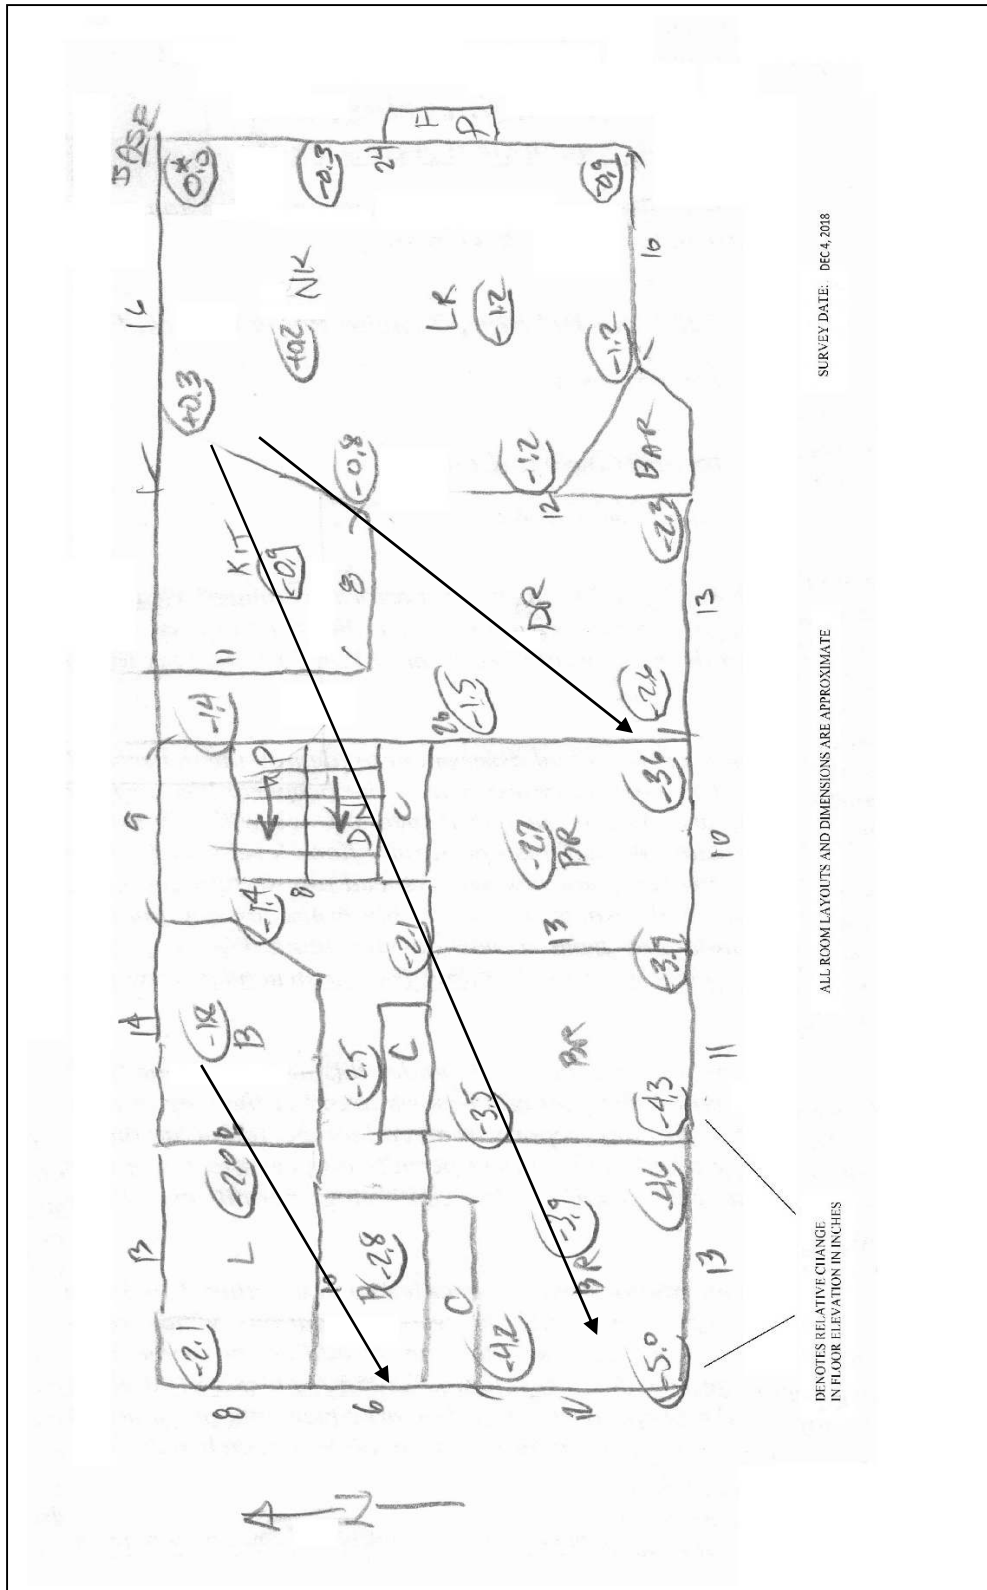
Fig 7-Floor Level Survey Results

- We checked the levelness of the structure by performing a floor-level survey on its lower level interior floors using a water-level (manometer). The results of our measurements are presented in Figure 6-Floor Level Survey Results. The readings take into consideration the variation in the thickness of various floor coverings in the house.

As recommended by other consultants for the adjoining properties, we also recommend the settled portions of the structure to be underpinned with drilled caissons that extend through unsuitable soils into the underlying firm soils. In order to determine the depth of the caissons, a subsurface investigation is needed. Such an investigation would be required by the City before issuing a permit for the installation of the caissons. This method of repair is code compliant but is expensive.

As an alternative, the settled portions of the structure can be underpinned by installing helical piers or vibratory push pipes; however; these methods of repair are not code compliant and are only intended to improve the existing adverse conditions. The later methods of repair are less expensive than installing drilled caissons. A subsurface investigation is also required for installation of the helical piers or push pipes. After installation of the recommended underpins, the settled portions of the structure should be jacked against the existing foundations so that shimming plates and or dry packing can be installed. Upon completion of the releveling process, the foundations should be retrofitted by a qualified seismic retrofit contractor.
