# Inspection Report

**Property Address:**  
1327 S Helberta Ave  
Redondo Beach CA 90277

**Ferguson Home Inspections**

<b>Date:</b> 1/5/2021	<b>Time:</b> 09:00 AM	<b>Report ID:</b> 01052021Helberta
<b>Property:</b> 1327 S Helberta Ave Redondo Beach CA 90277	<b>Customer:</b> Bob Crowe	<b>Real Estate Professional:</b> Bilge Coskun

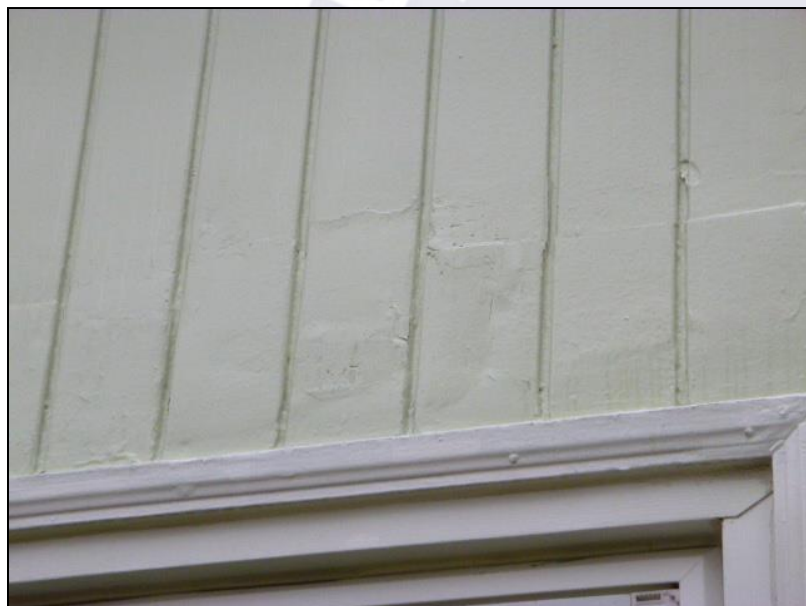
1.3 Item 1(Picture)

**1.3 (1)** Patched areas, open seams and deterioration noted at various wood siding areas. Suggest review with a licensed termite company and/or a licensed contractor for repair/replacement costs as needed.

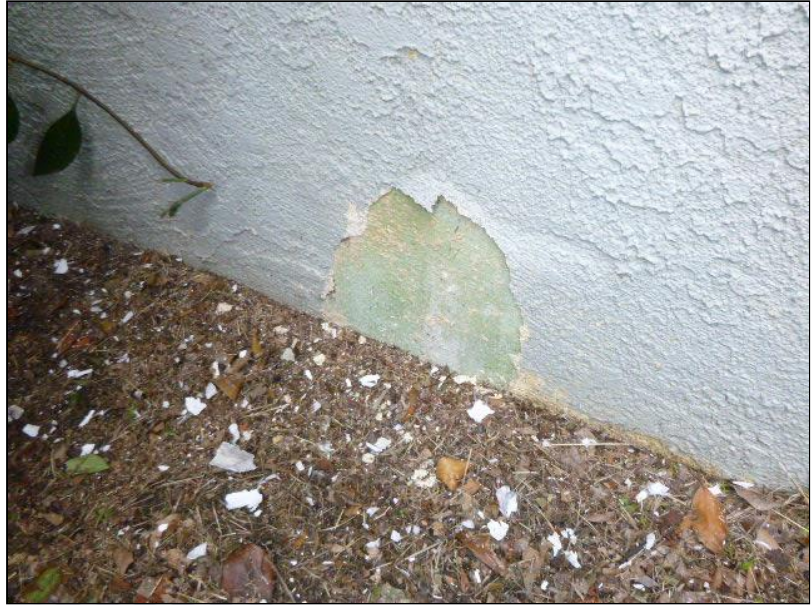
1.3 Item 4(Picture)

**1.3 (2)** Deteriorated and blistering stucco noted at various areas. See the Lot/Drainage comments and review with a licensed contractor to repair as needed and divert water away from the foundation areas.

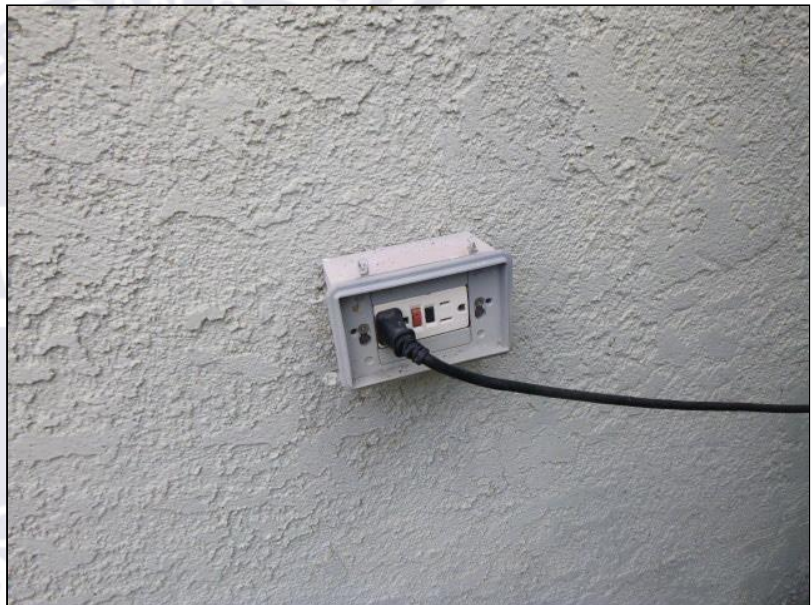
1.7 Item 1(Picture)

**1.7 (1)** The exterior outlet(s) are missing the weather cover(s). Suggest installation for safety and as required.

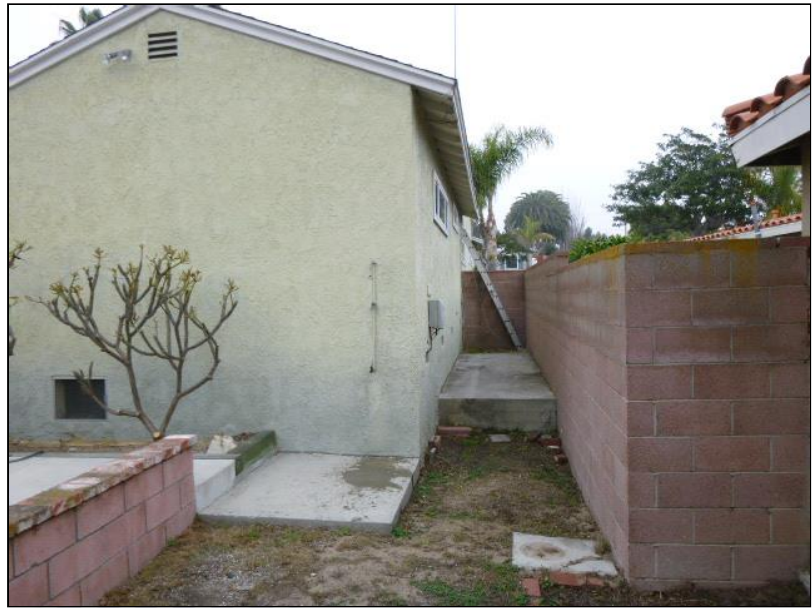
1.8 Item 1(Picture)

**1.8** Suggest installation of gutters throughout all eave areas and installation of an area drainage system to divert the water away from the foundation to the street as an upgrade.

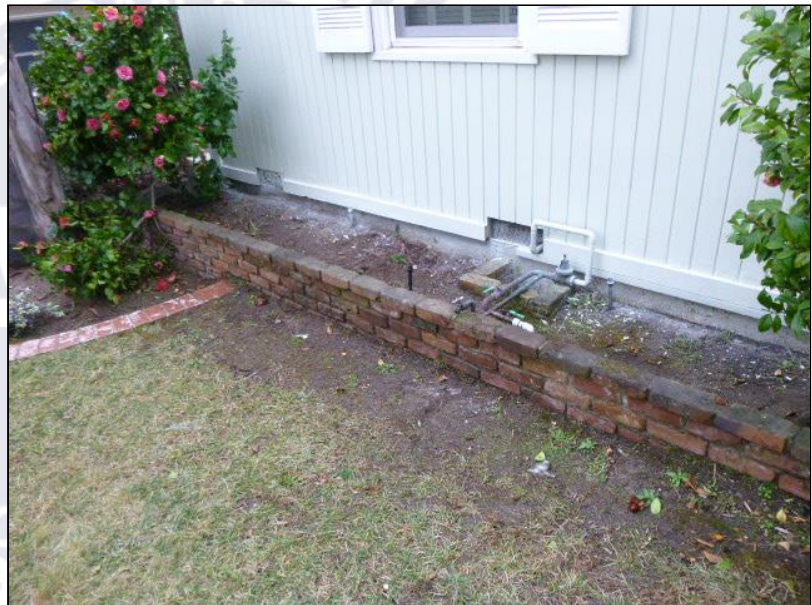
1.10 Item 1(Picture)

**1.10** No drain holes noted in the planter(s). Suggest installing drain holes to prevent ponding during the rainy season.

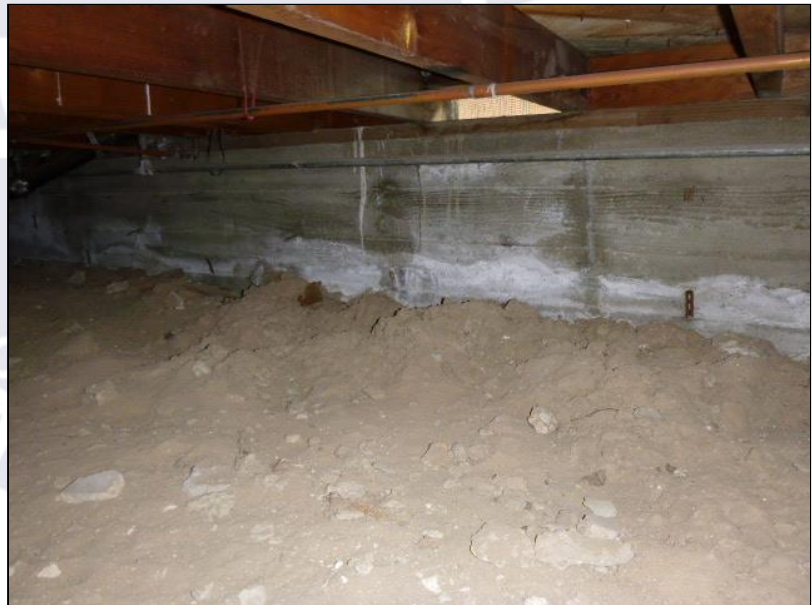
3.0 Item 1(Picture)

**3.0** White efflorescence (powder substance) on foundation footings indicates prior, and possibly ongoing, excessive moisture build up at the exterior of the foundation. Ongoing water intrusion at the foundations can, in some cases, cause the steel in the foundations to rust, called spawling, which can lead to horizontal cracking of the foundation ( currently there are no major cracks visible at the foundation ). Any future cracking/damaged can be an expensive repair as the foundation is now structurally weak and susceptible to horizontal movement. Suggest review of the Lot/Grade and drainage systems, including rain gutters, to reduce and prevent further and future water buildup at the exterior of the dwellings foundations.

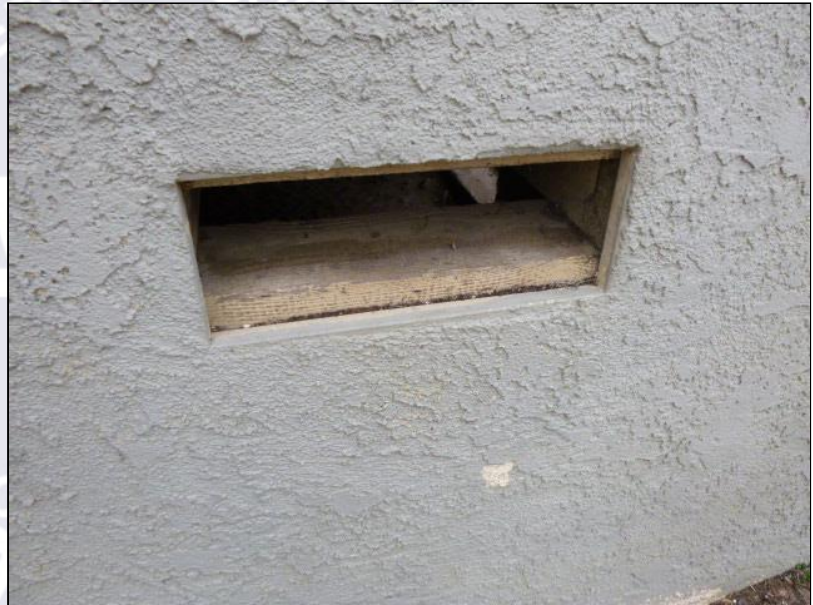
4.2 Item 1(Picture)

**4.2** Loose, missing or deteriorated vent screens noted. Suggest re-screening missing and/or deteriorated vent screens as needed to prevent rodent and insect intrusion .

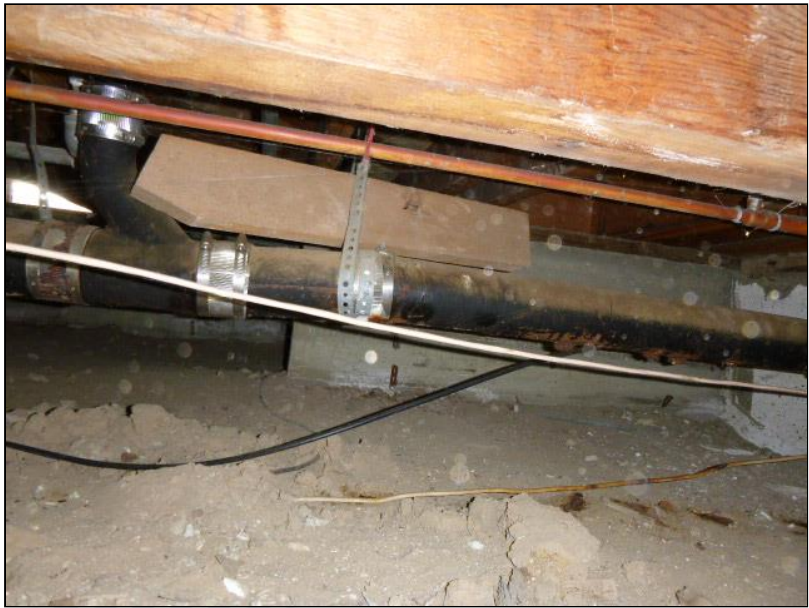
4.4 Item 6(Picture)

**4.4 (2)** Inadequate slope noted at various drains in the crawl area, suggest review with a licensed plumber for costs to re-slope the drains as required/ needed.

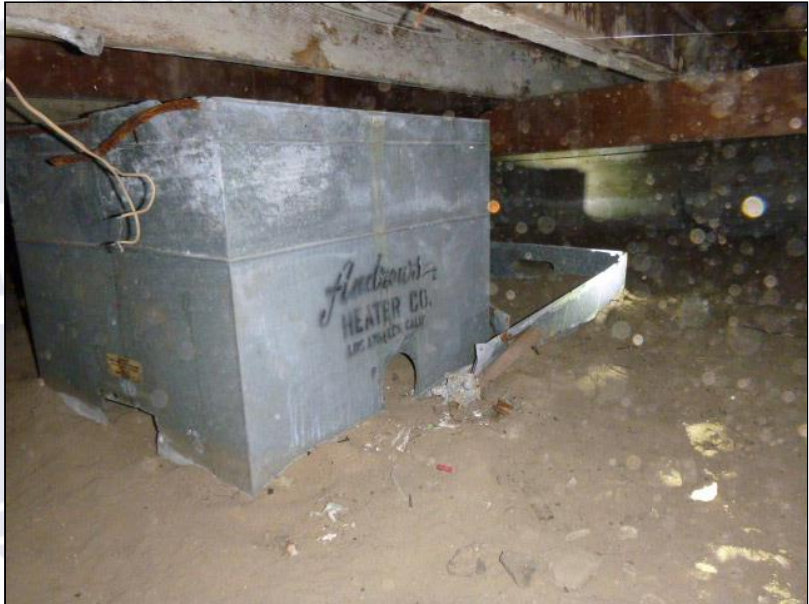
4.5 Item 1(Picture)

**4.5 (1)** The original gas floor heating system is abandoned as noted at the crawl area.

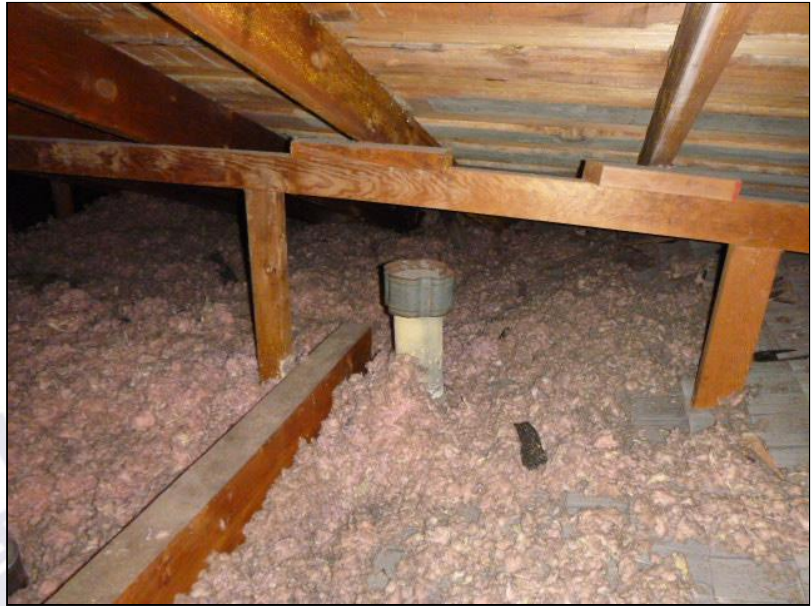
6.6 Item 1(Picture)

**6.6** The kitchen oven vent currents exits/terminates in the rear attic. Suggest review with a licensed contractor for costs to repair/extend the vent through the roof as required.

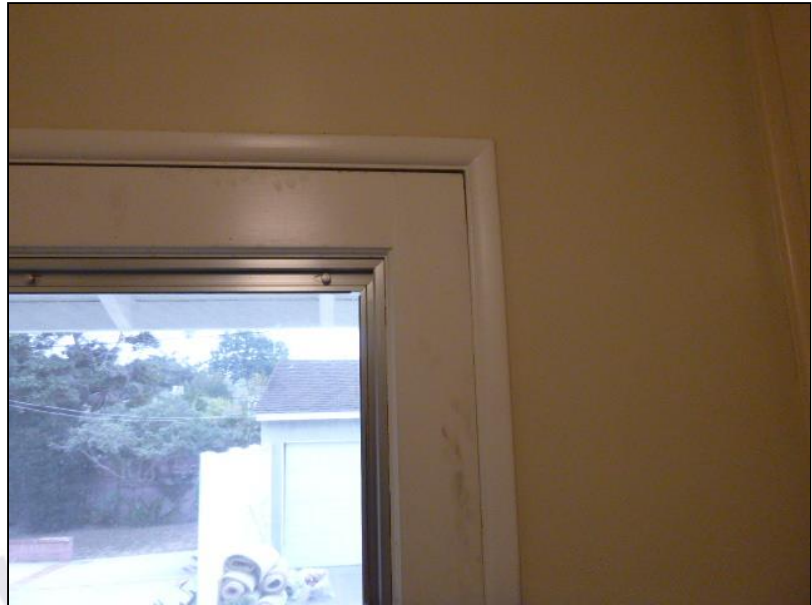
7.3 Item 1(Picture)

**7.3** The door to the exterior impacts on the impacts/sticks on the jamb when operating, suggest repair as needed.

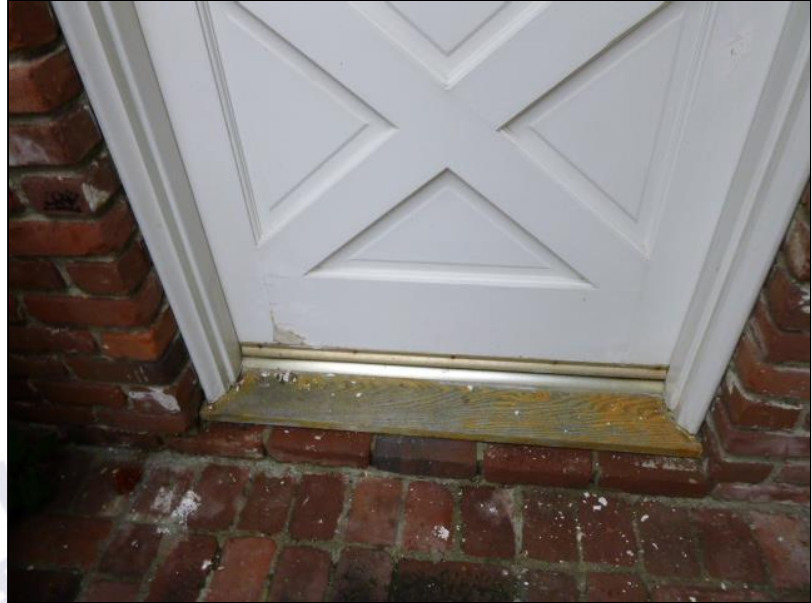
8.4 Item 1(Picture)

**8.4 (1)** The front door and threshold are weathered and deteriorated, suggest repairs/maintenance as needed.

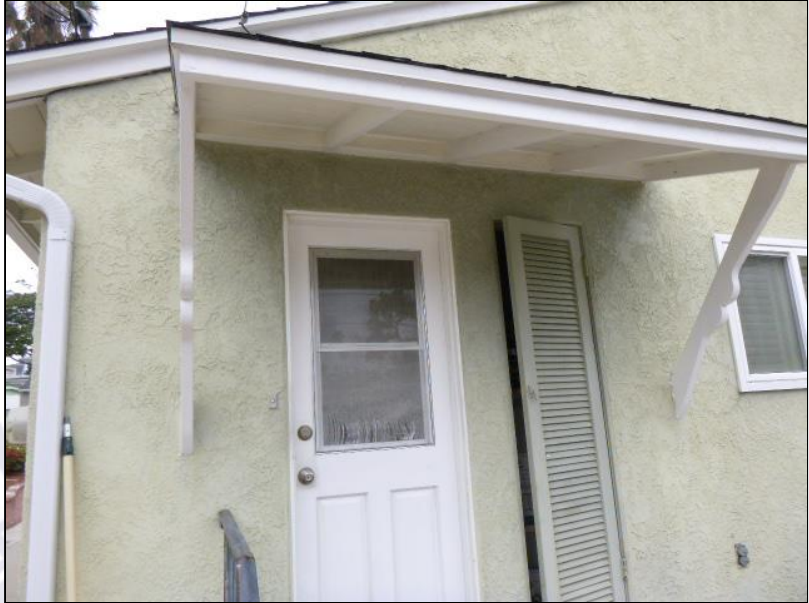
9.3 Item 1(Picture)

**9.3** No light fixture installed at this area as required, this is a possible safety hazard. Suggest review with a licensed electrician for installation costs for a light fixture to enhance safety.

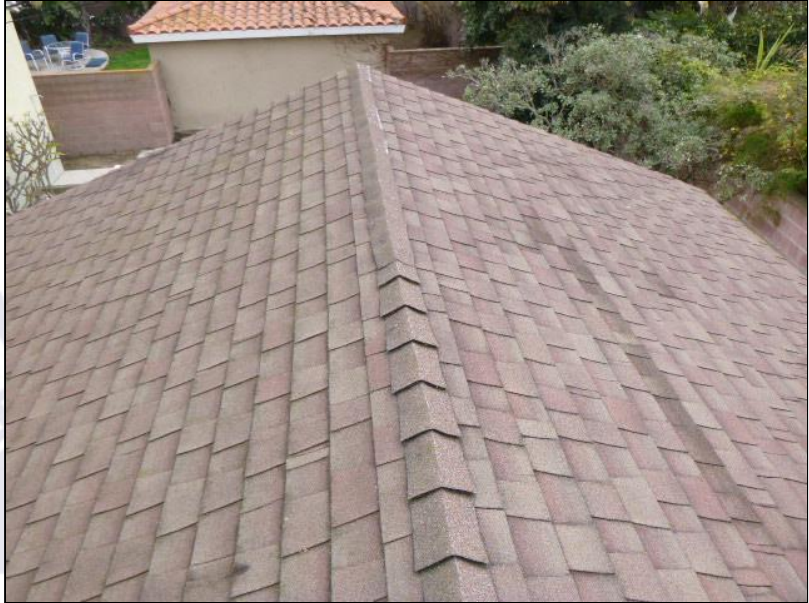
10.1 Item 1(Picture)

**10.1 (1)** The roof shows normal wear for its age and type, suggest periodic review with a licensed roofer for maintenance as needed.

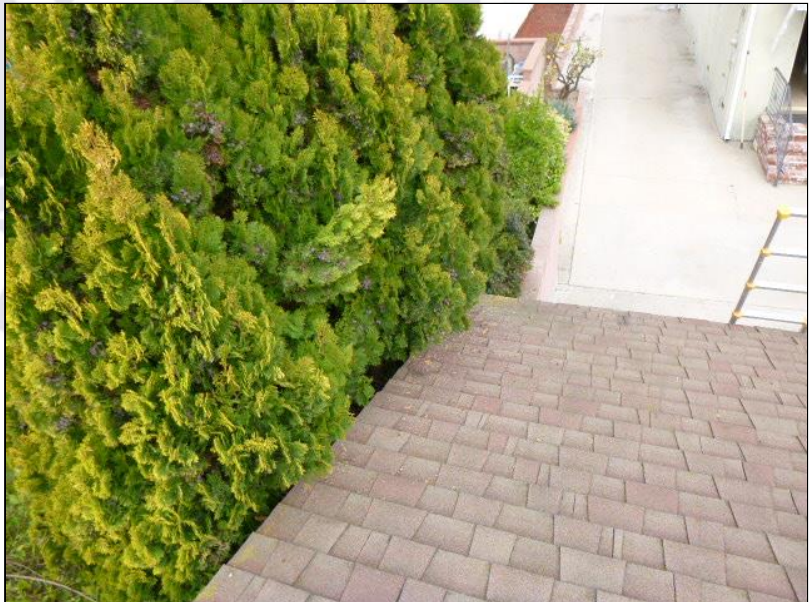
10.1 Item 2(Picture)

**10.1 (2)** The tree limbs that are in contact with roof or hanging near roof should be trimmed to prevent damaging the roof. Suggest trimming as needed.

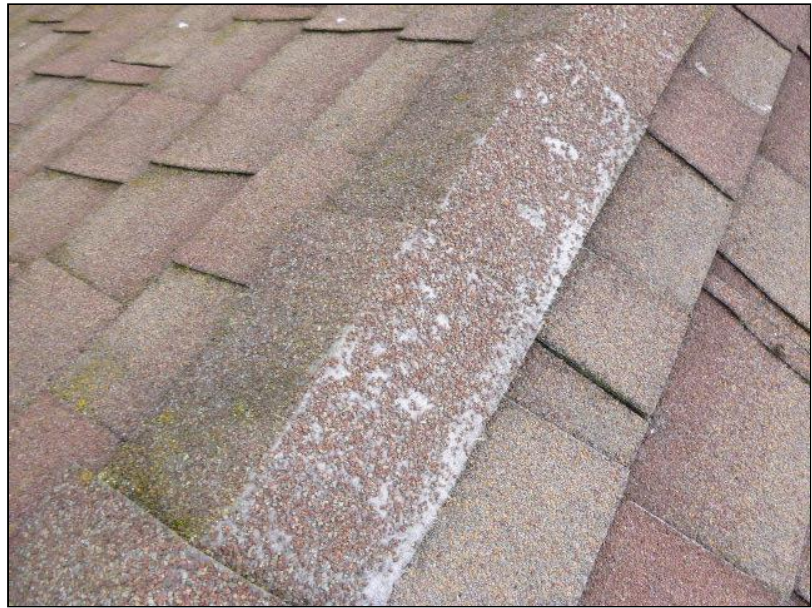
10.1 Item 3(Picture)

**10.1 (3)** Deteriorated ridge caps noted at the pitched roof, suggest review by licensed roofer for replacement costs and replace as needed.

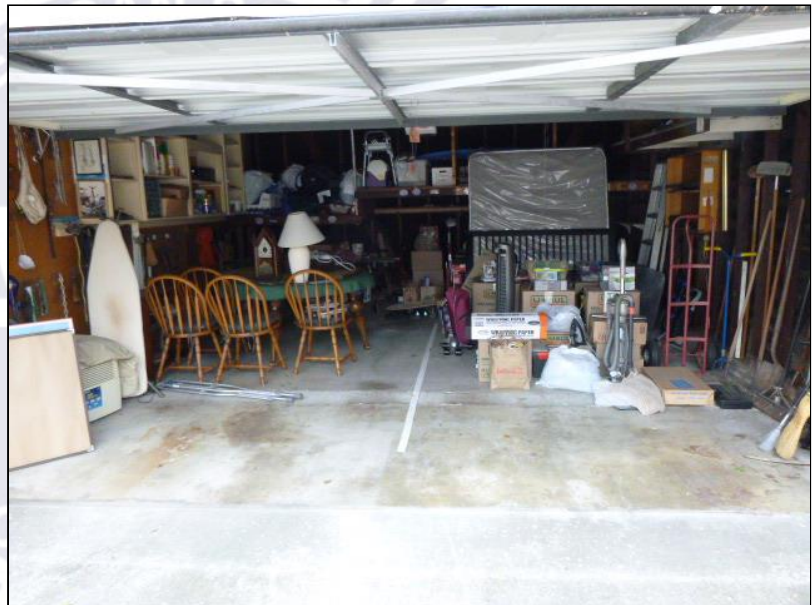
10.3 Item 1(Picture)

**10.3 (1)** Access within this area was blocked or severely limited at the time of the inspection. An inspection of this area can be performed by appointment and at an additional cost when the area is made accessible.

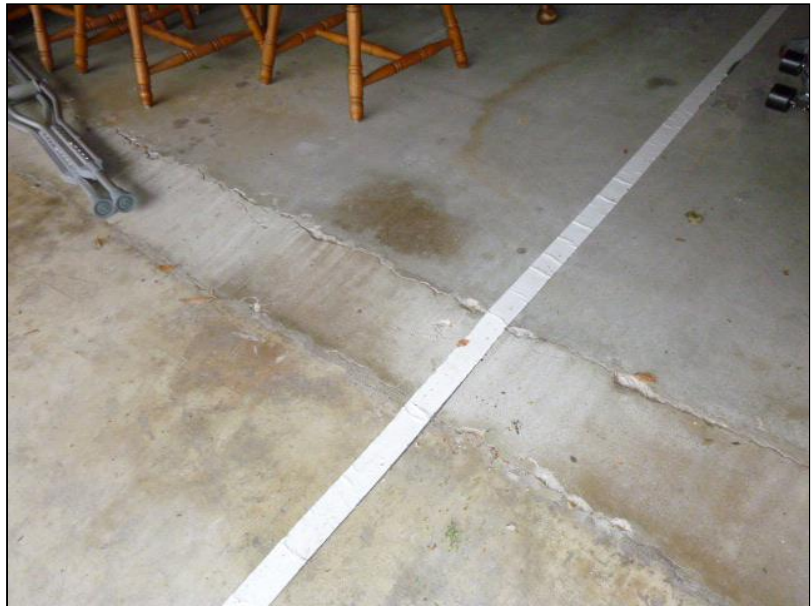
10.3 Item 2(Picture)

**10.3 (2)** Patched and repaired areas of the garage slab were noted. Suggest review with the seller on the cause and any repairs needed. Suggest repair/replace as needed.

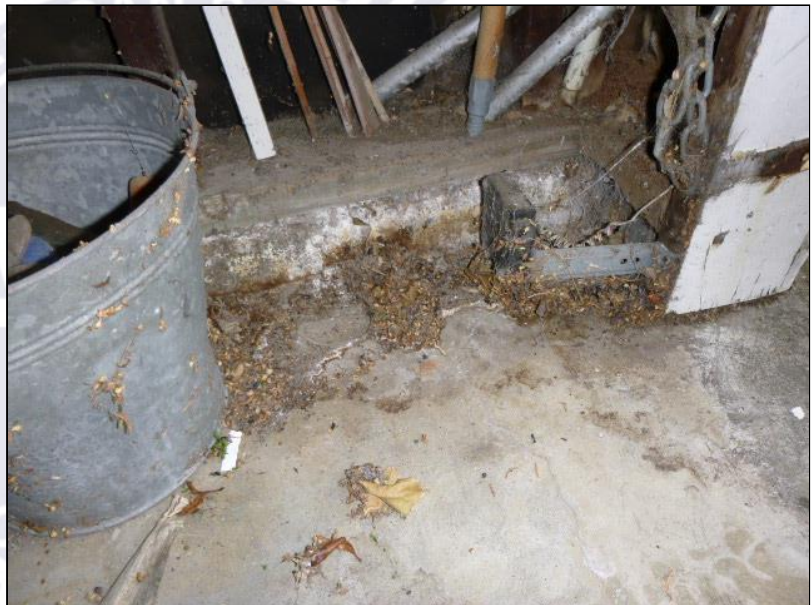
10.4 Item 1(Picture)

**10.4 (1)** Evidence of previous and possible ongoing water intrusion noted at the main door, see the driveway comments and repair/replace as needed.

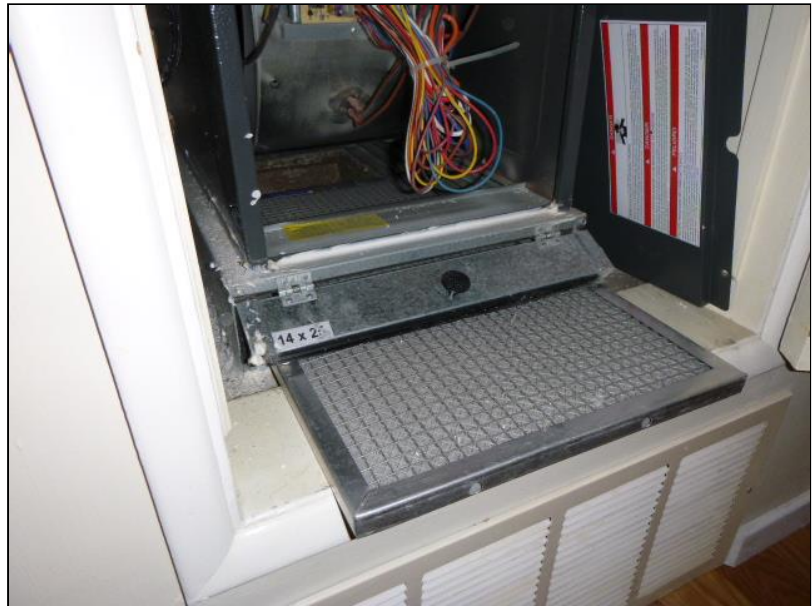
11.0 Item 3(Picture)

**11.0 (2)** Suggest replacing/cleaning the filter(s) as needed.

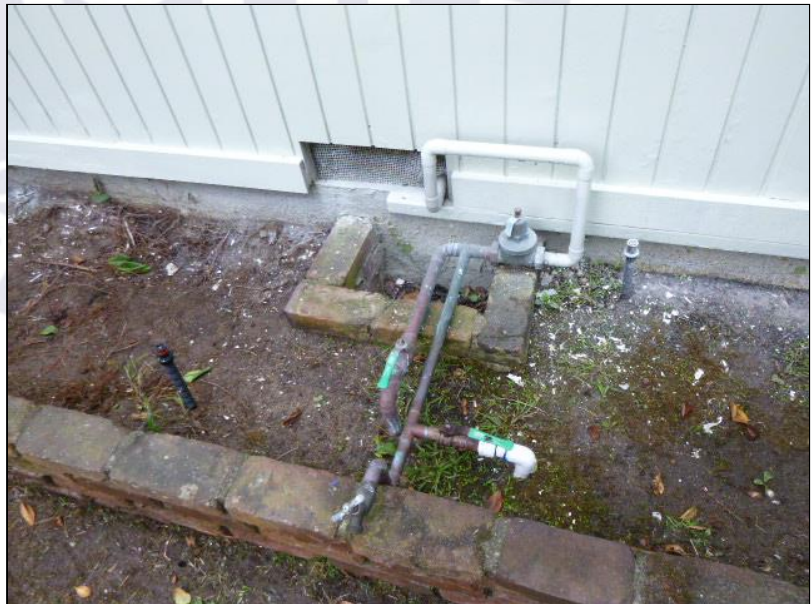
13.0 Item 1(Picture)

**13.0 (1)** Suggest repair/replace the faulty pressure regulator due to excessively high water pressure as tested. This will reduce water pressure below 80 PSI to relieve stress on all plumbing joints and fittings.

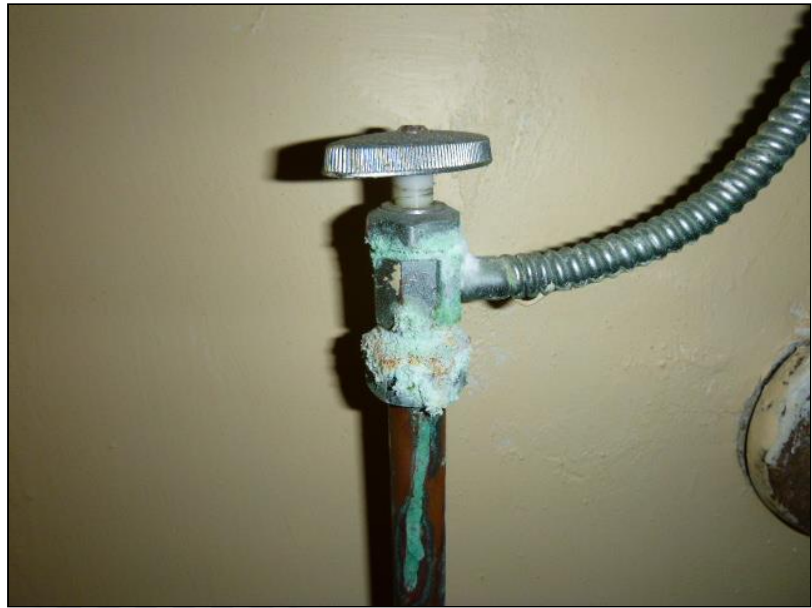
13.0 Item 2(Picture)

**13.0 (2)** Corroded plumbing and fittings noted at various areas within the dwelling. Suggest further review by a licensed plumber for repair/replacement costs as needed to prevent future leakage, pin hole leaks and possible stains/damage to the interior of the dwelling.

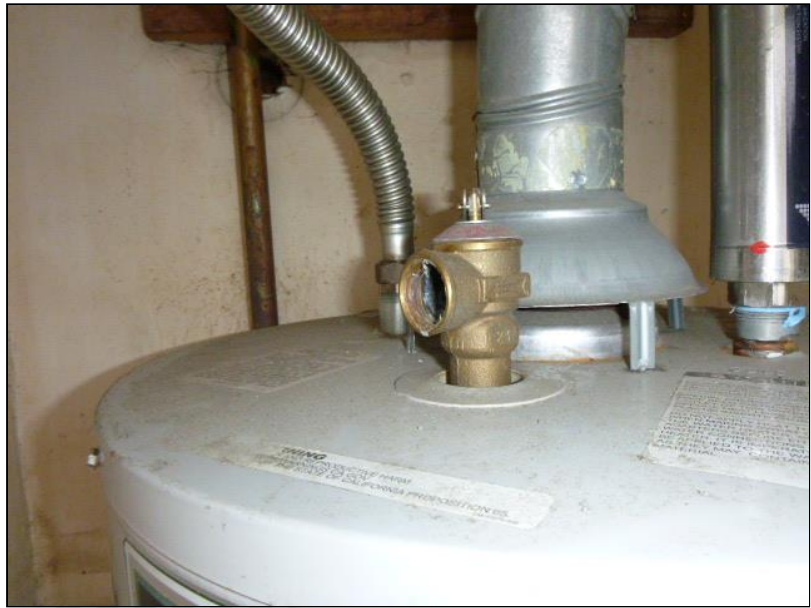
15.0 Item 4(Picture)

**15.0 (4)** No discharge pipe connected to the TP&R valve, this is a potential safety hazard. Suggest review by a licensed plumber for costs to install the TP discharge drain down to within 4-6 inches of the exterior grade/deck as required for safety.

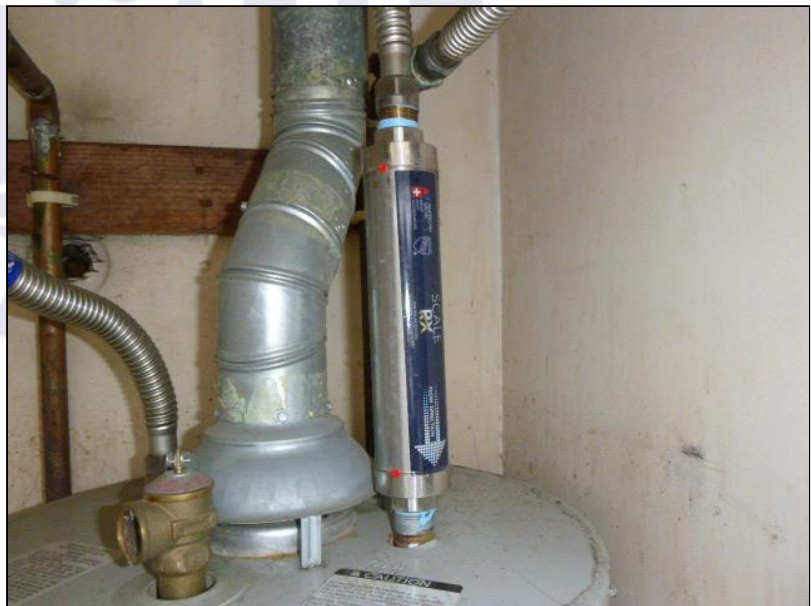
15.0 Item 5(Picture)

**15.0 (6)** An in-line water filter/de-scaling system was noted. Suggest periodic review and replacement of the system as needed to prevent blockages and restrictions on the hot water system.

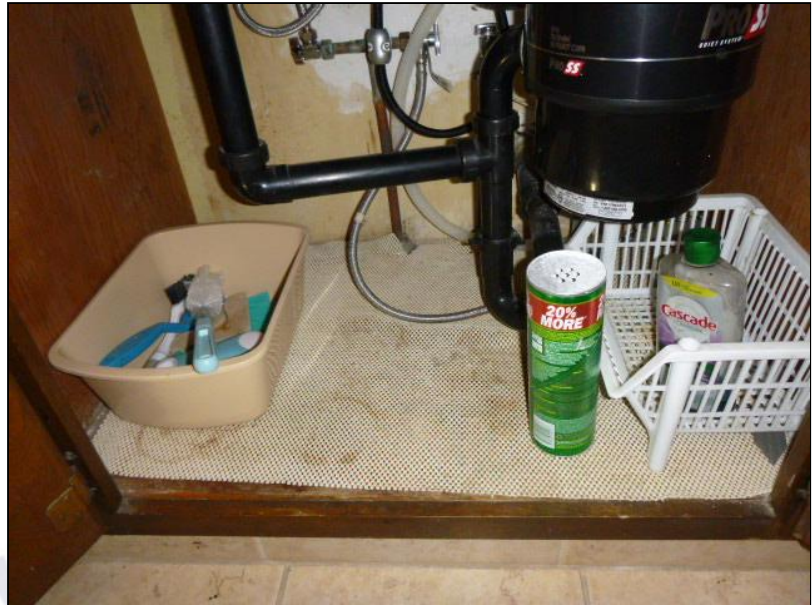
16.6 Item 1(Picture)

**16.6** The base cabinet under the sink is deteriorated/stained from previous leaks, suggest repair/replace as needed.

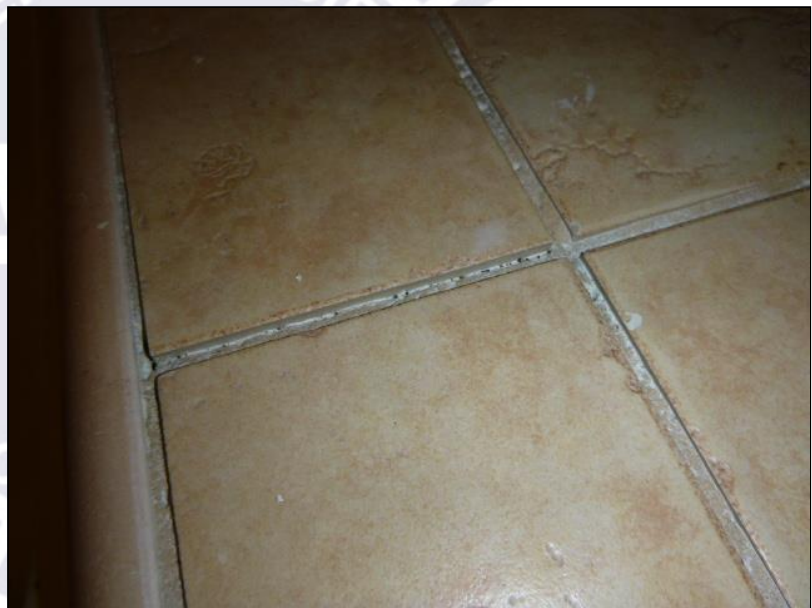
16.7 Item 1(Picture)

**16.7** Deteriorated and missing grout noted at various areas of the tile countertop, suggest repair/replace as needed.

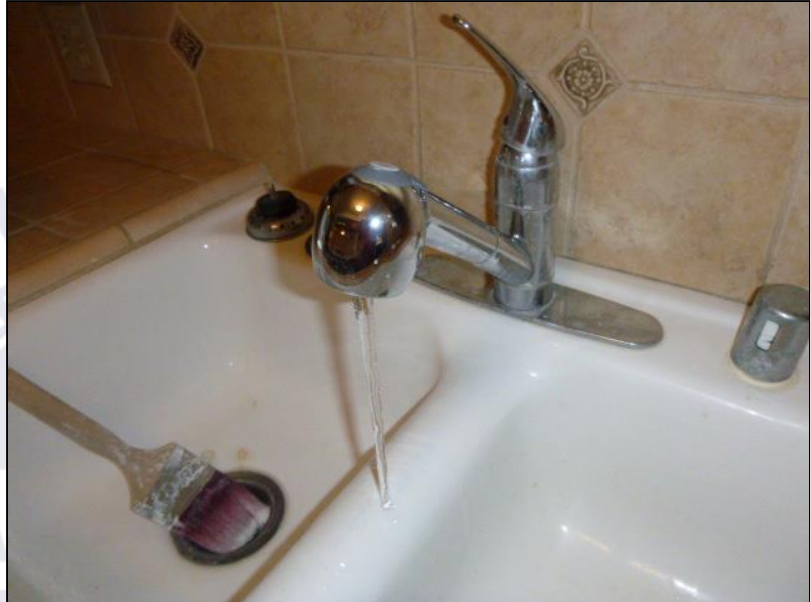
16.10 Item 1(Picture)

**16.10** Poor water flow noted at the sink faucet, suggest review with a licensed plumber for repair/replacement costs as needed.

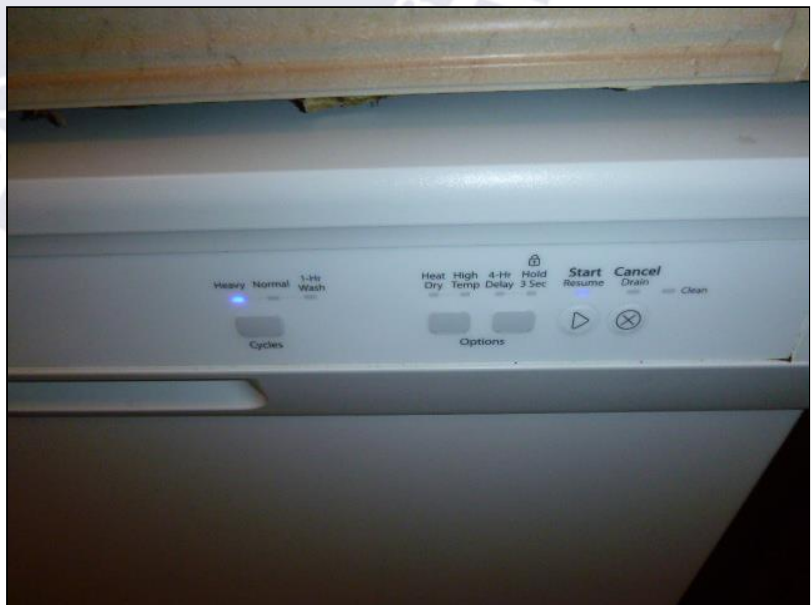
16.12 Item 1(Picture)

**16.12 (1)** The inspector was unable to select between the multiple washing cycles as needed, Suggest review with a licensed appliance contractor for repair/replacement costs as needed.

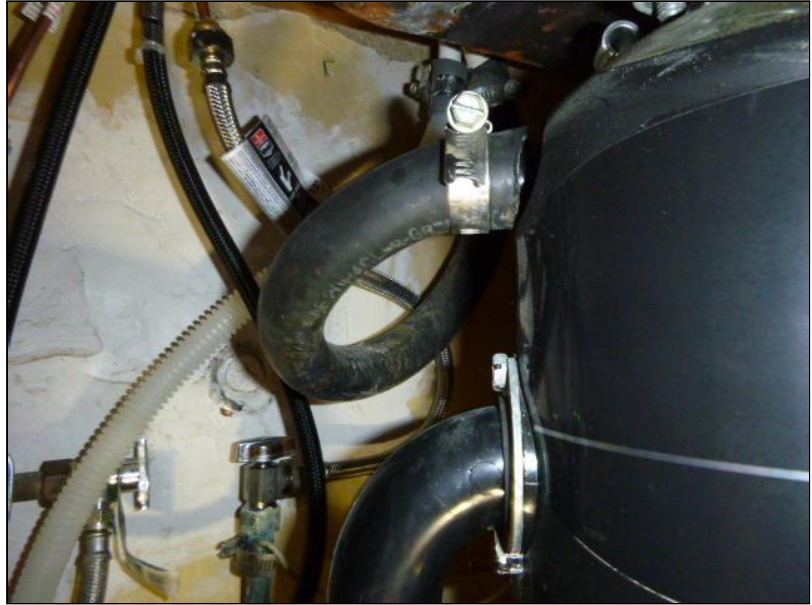
16.12 Item 2(Picture)

**16.12 (2)** Suggest review with a licensed plumber for costs to reduce the length of the drain from the air gap to the disposal as this has created a trap in the drainage system.

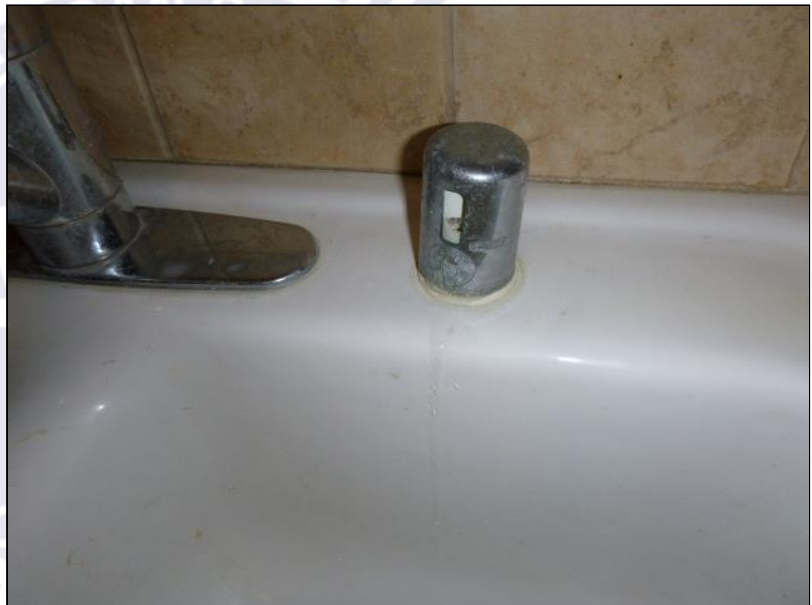
16.12 Item 3(Picture)

**16.12 (3)** The dishwasher partially drains over countertop/sink through air gap as there appears to be a blockage in the drain line. Suggest review by a licensed plumber and repair as needed.

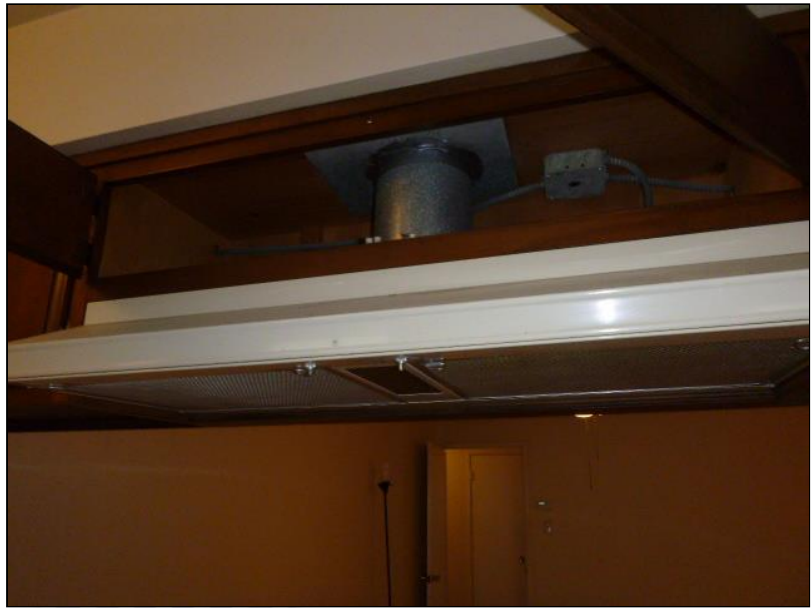
16.15 Item 1(Picture)

**16.15** (1) The light bulbs at the vent hood were inoperable at the time of the inspection, suggest replacing the bulbs as needed.

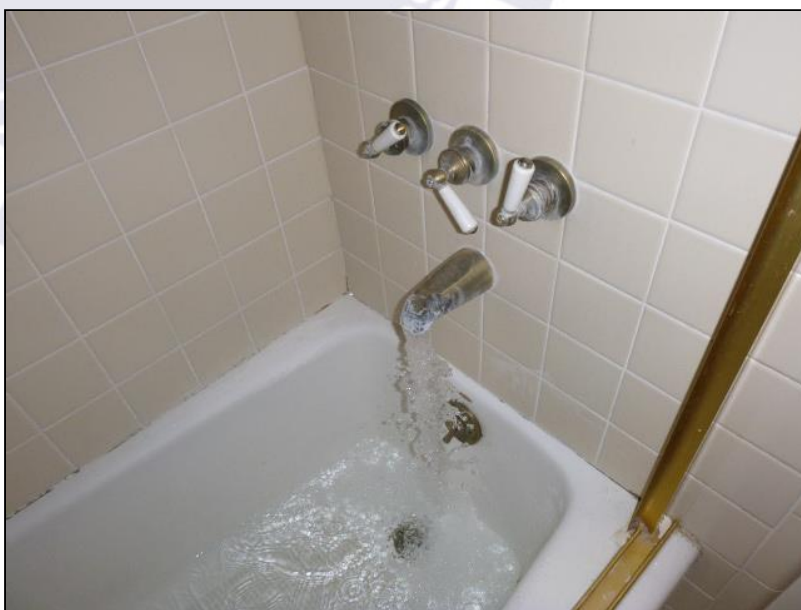
17.10 Item 1(Picture)

**17.10** The existing tub faucet is not a low-flow system as required. Suggest review with a licensed plumber for costs to replace the existing tub faucet with a low flow faucet (2.2 gallons per minute) as required by the State of California as of January 1st, 2017. See the plumbing system comments for further details and a link to the State of California plumbing ordinance.

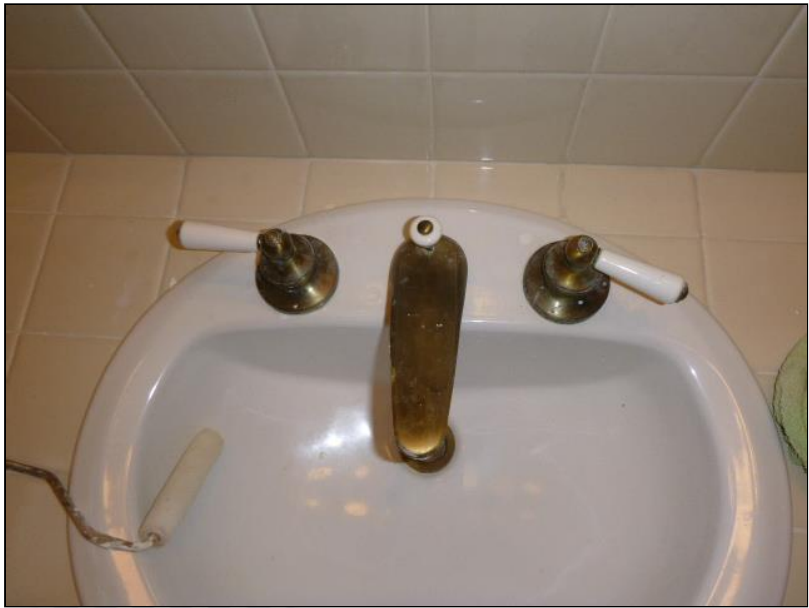
17.15 Item 1(Picture)

**17.15** The sink faucet handles are not set square, suggest repair as needed.

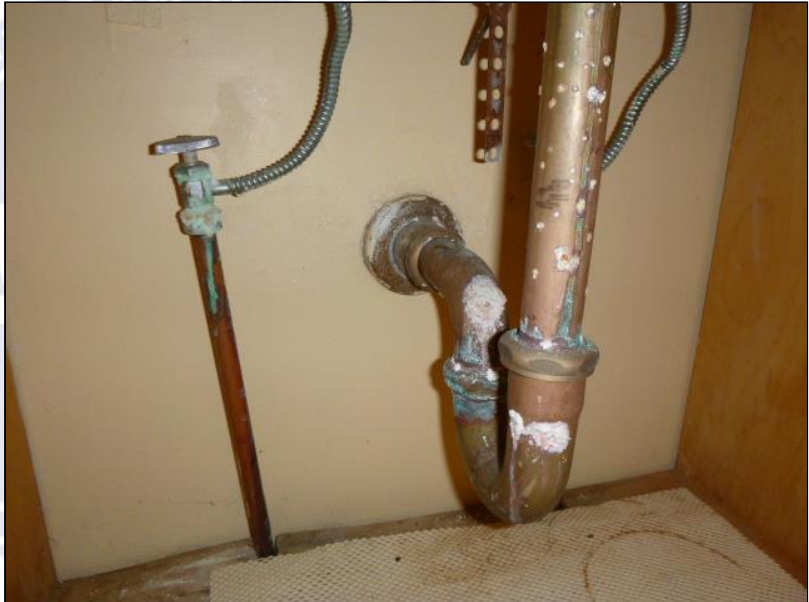
17.16 Item 1(Picture)

**17.16** (1) Corrosion noted at the sink drain and angle valve(s), no leaking noted at the time of the inspection. Suggest review by a licensed plumber and repair/replace as needed.

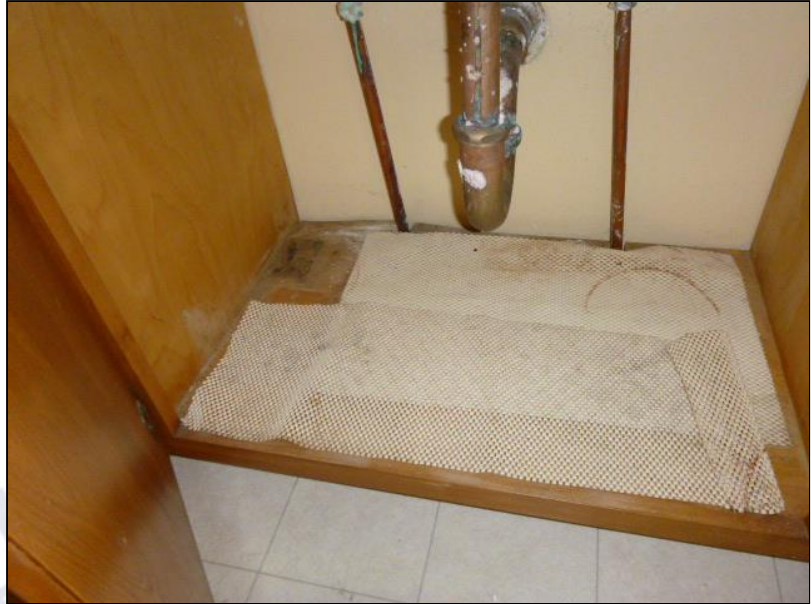
17.18 Item 1(Picture)

**17.18** The base cabinet under the sink is deteriorated/stained from previous leaks, suggest repair/replace as needed.

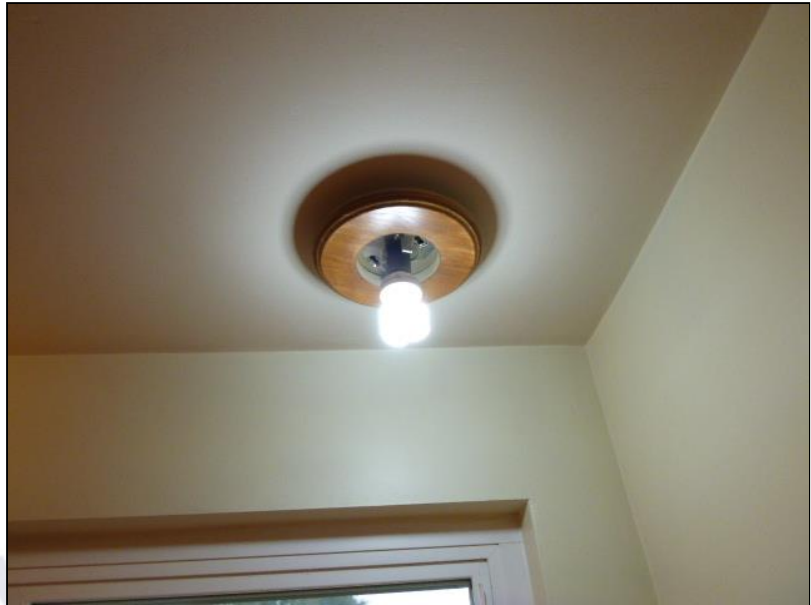
18.6 Item 1(Picture)

**18.6** The cover globe(s) are missing at light fixture(s) at the time of the inspection. Suggest replacing the missing cover globe(s) for safety.

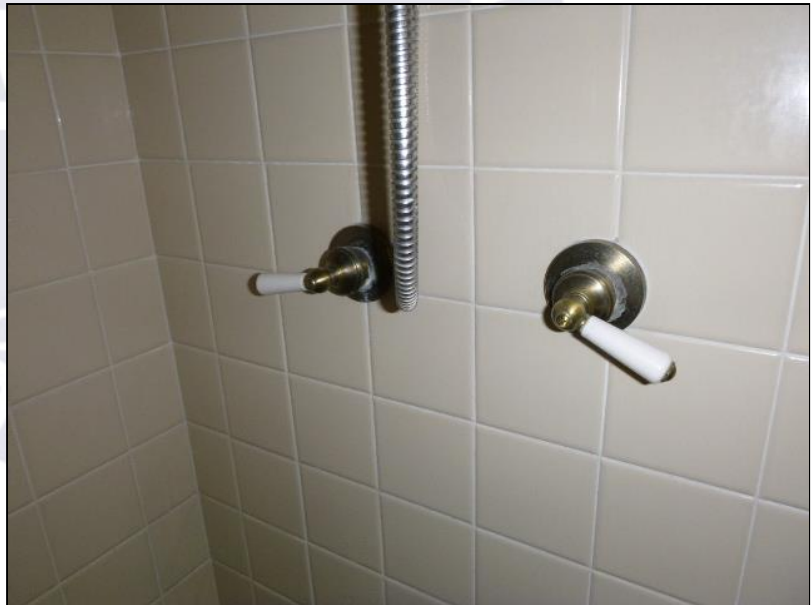
18.11 Item 1(Picture)

**18.11** The hot shower faucet handle is difficult to operate and sticks when trying to rotate. Suggest review by licensed plumber and repair as needed.

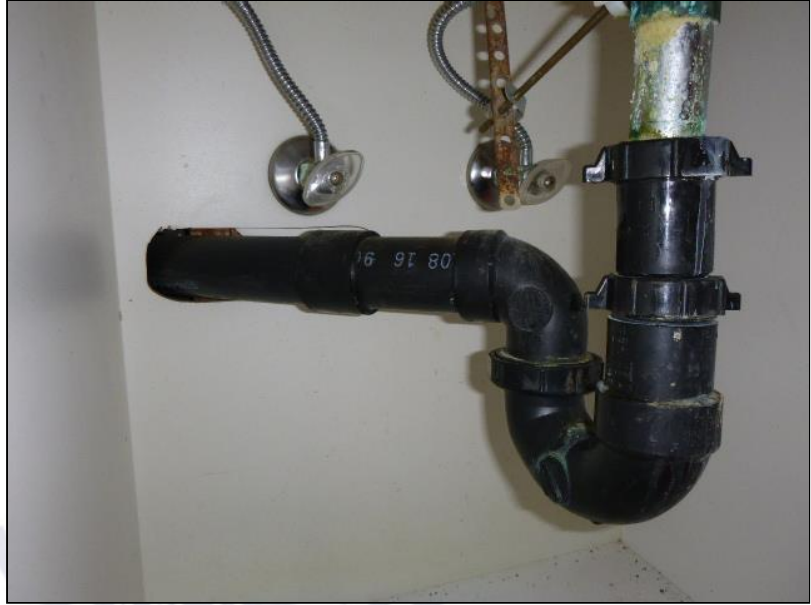
18.14 Item 1(Picture)

**18.14** Corrosion noted at the sink drain and angle valve(s), no leaking noted at the time of the inspection. Suggest review by a licensed plumber and repair/replace as needed.

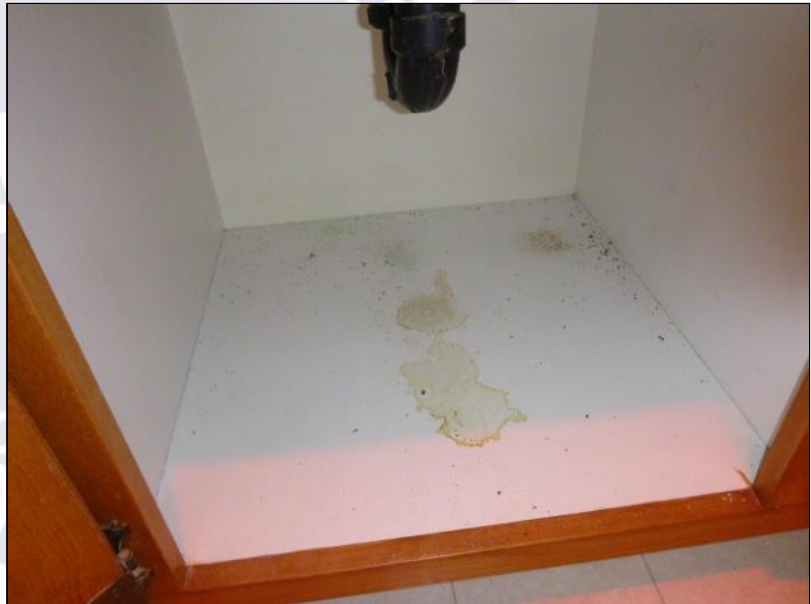
18.16 Item 1(Picture)

**18.16** The base cabinet under the sink is deteriorated/stained from previous leaks, suggest repair/replace as needed.

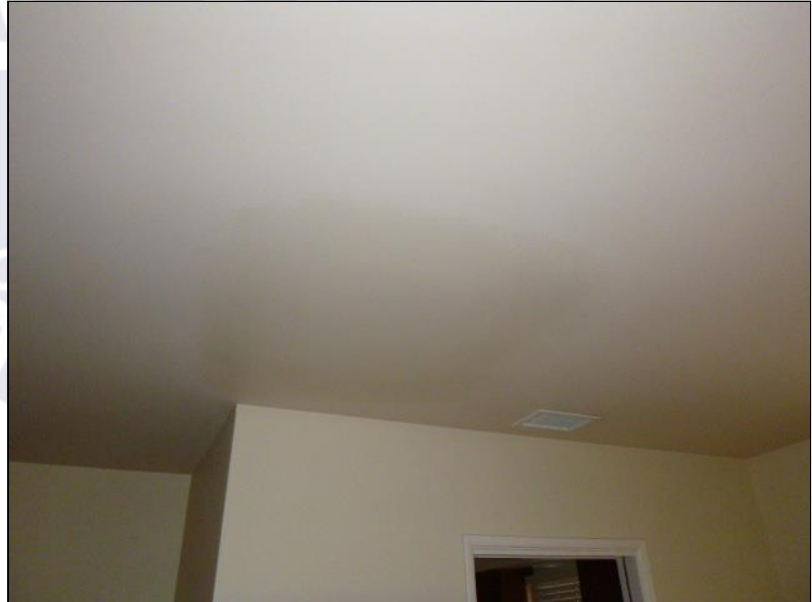
21.2 Item 1(Picture)

**21.2** Patched and uneven areas of the ceiling noted, suggest review with the seller on the cause and any repairs needed. Suggest repair as needed.

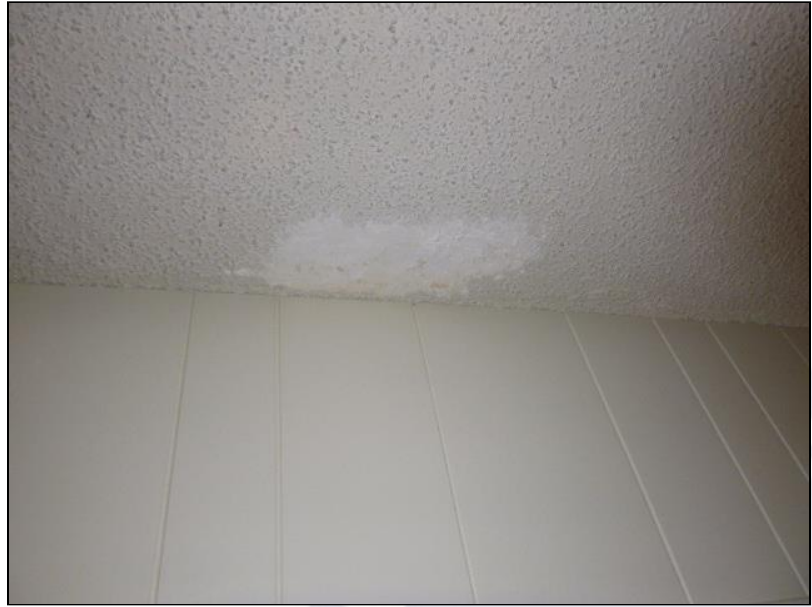
22.2 Item 1(Picture)

**22.2 (1)** Patched and uneven areas of the ceiling noted, suggest review with the seller on the cause and any repairs needed. Suggest repair as needed.

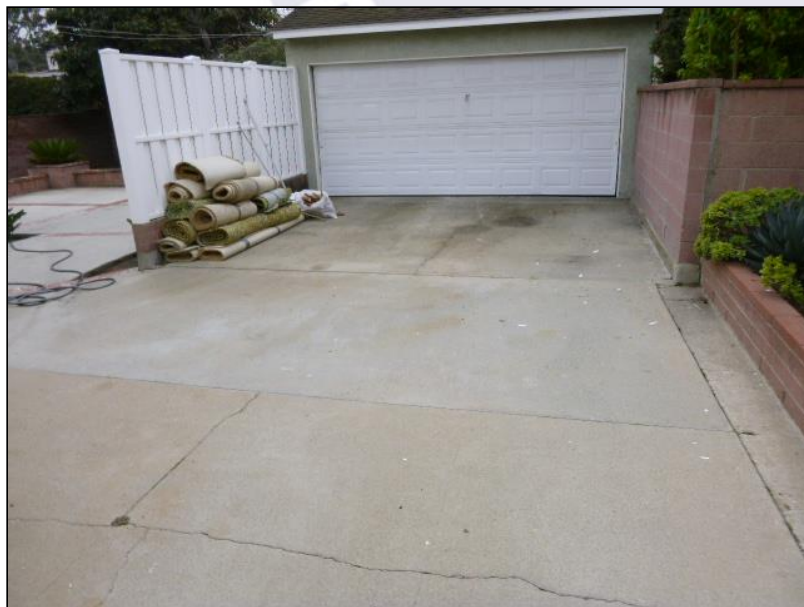
1.0 Item 1(Picture)

The driveway slopes toward the main garage door, during heavy rains water may intrude into the garage area. Suggest review with a licensed contractor for installation costs to re-grading, swale or drain installation to divert water away from the garage and the main garage door.
