# Inspection Report

**Property Address:**  
1327 S Helberta Ave  
Redondo Beach CA 90277

**Ferguson Home Inspections**

<b>Date:</b> 1/5/2021	<b>Time:</b> 09:00 AM	<b>Report ID:</b> 01052021Helberta
<b>Property:</b> 1327 S Helberta Ave Redondo Beach CA 90277	<b>Customer:</b> Bob Crowe	<b>Real Estate Professional:</b> Bilge Coskun

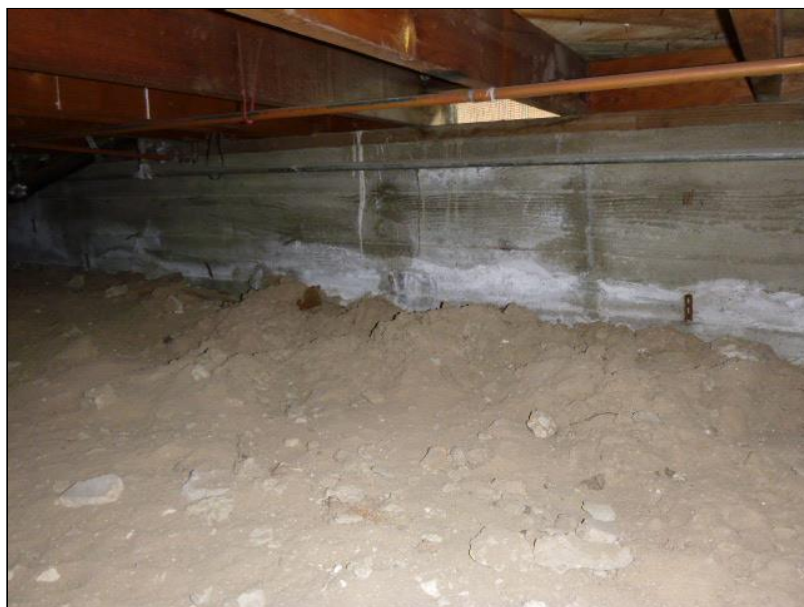
3.0 Item 1(Picture)

**3.0** White efflorescence (powder substance) on foundation footings indicates prior, and possibly ongoing, excessive moisture build up at the exterior of the foundation. Ongoing water intrusion at the foundations can, in some cases, cause the steel in the foundations to rust, called spawling, which can lead to horizontal cracking of the foundation ( currently there are no major cracks visible at the foundation ). Any future cracking/damaged can be an expensive repair as the foundation is now structurally weak and susceptible to horizontal movement. Suggest review of the Lot/Grade and drainage systems, including rain gutters, to reduce and prevent further and future water buildup at the exterior of the dwellings foundations.

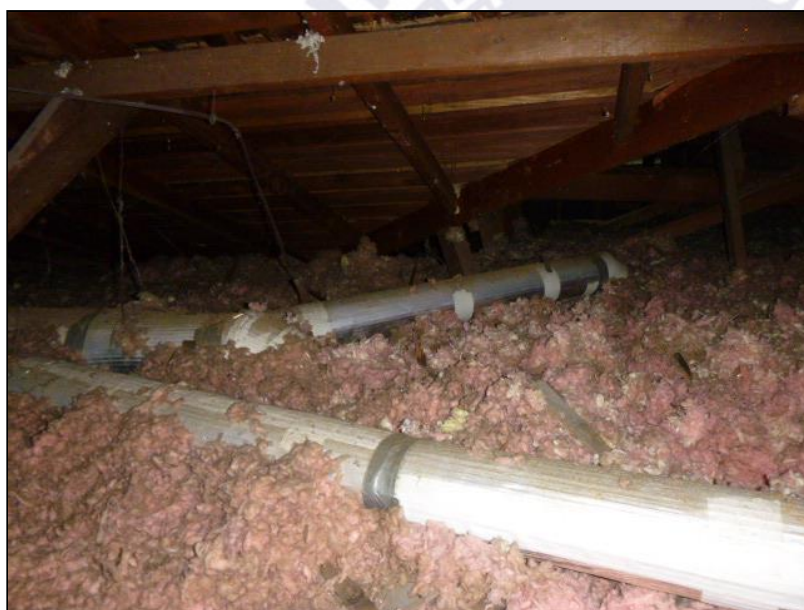
6.4 Item 2(Picture)

**6.4 (2)** Generally a certification of the existing ducting is required when replacing the heating to determine and confirm no leakage will occur which can/will result in the asbestos insulation being damaged and blown through the dwelling/attic area. Suggest review with the sellers and the heater installation company for confirmation of this requirement and/or costs to replace the existing asbestos ducting as required.

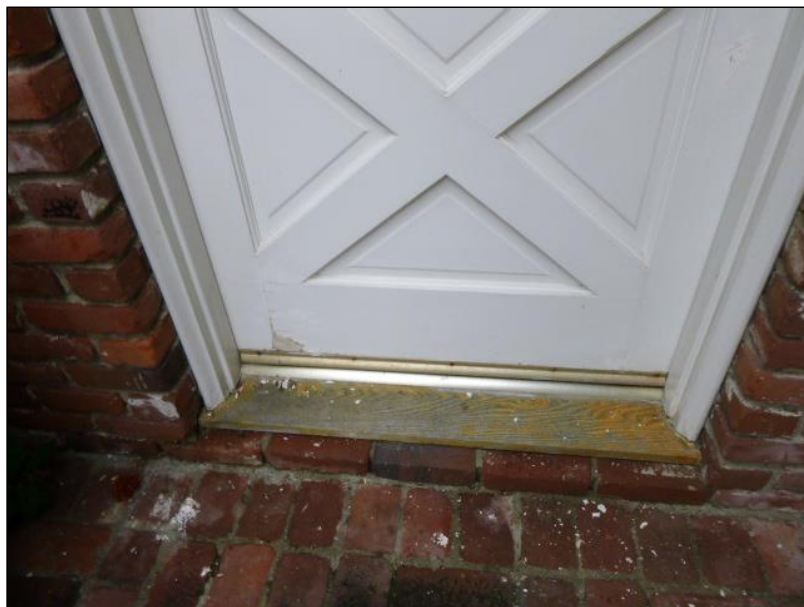
8.4 Item 1(Picture)

**8.4 (1)** The front door and threshold are weathered and deteriorated, suggest repairs/maintenance as needed.

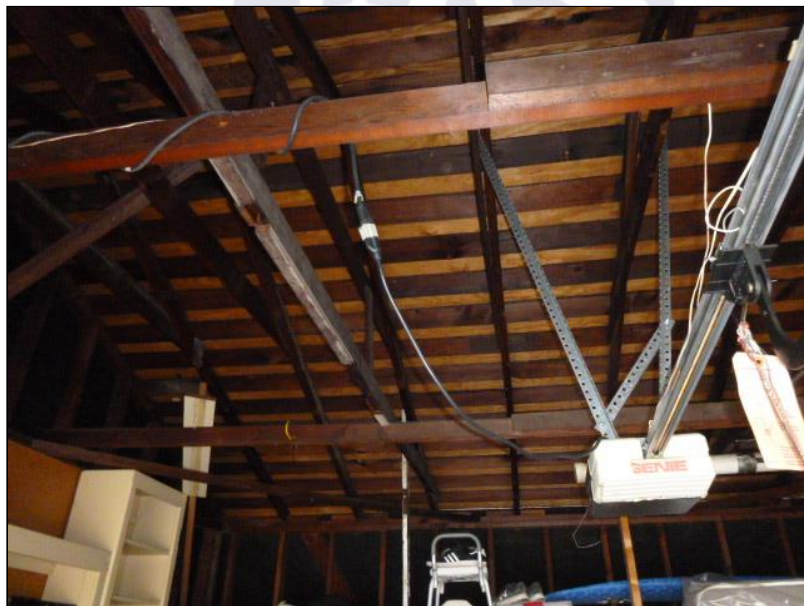
10.6 Item 1(Picture)

**10.6 (1)** Unreasonable resistance was required to stop the main garage door in motion, this is a safety concern. Suggest adjusting door opener so the safety reverse operates as required. The US Product Safety Commission recommends these devices be checked monthly.

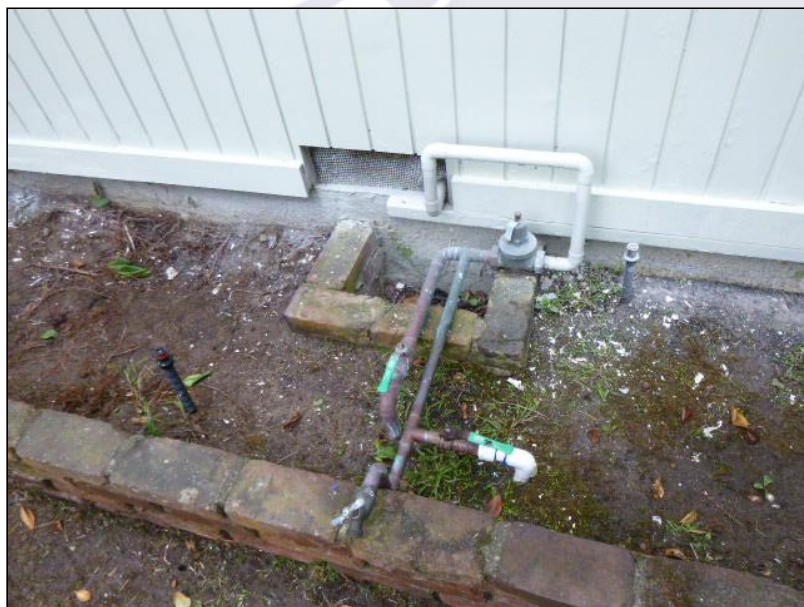
13.0 Item 1(Picture)

**13.0 (1)** Suggest repair/replace the faulty pressure regulator due to excessively high water pressure as tested. This will reduce water pressure below 80 PSI to relieve stress on all plumbing joints and fittings.

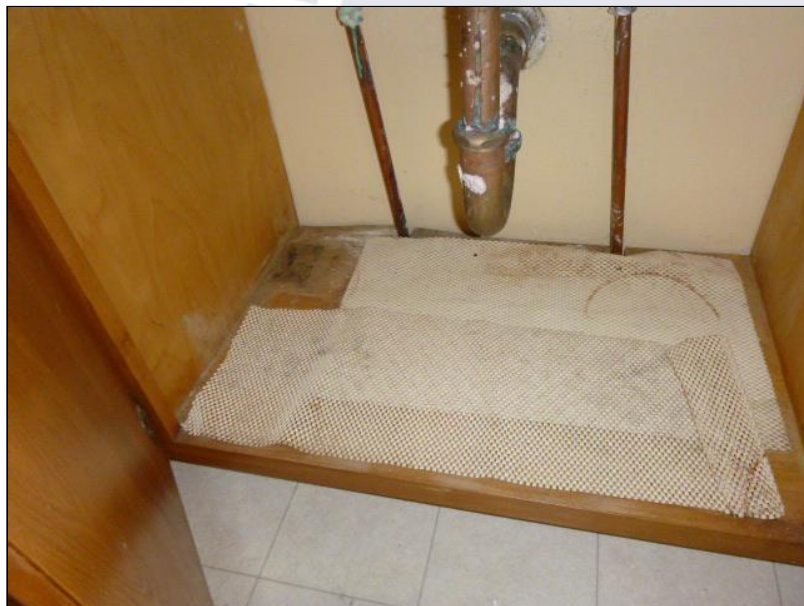
17.18 Item 1(Picture)

**17.18** The base cabinet under the sink is deteriorated/stained from previous leaks, suggest repair/replace as needed.

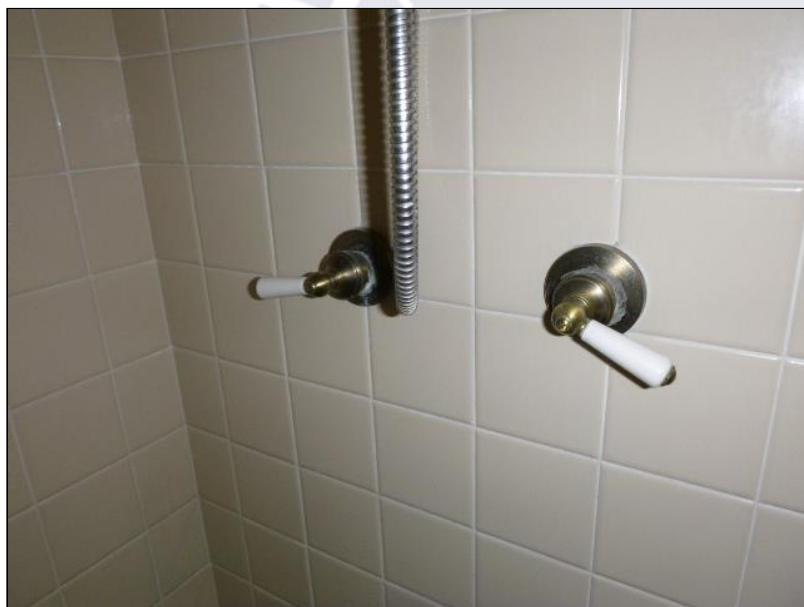
18.11 Item 1(Picture)

**18.11** The hot shower faucet handle is difficult to operate and sticks when trying to rotate. Suggest review by licensed plumber and repair as needed.
