# Inspection Report

5709 Sunmist Dr  
Rancho Palos Verdes, CA 90275

Thursday, August 27, 2020

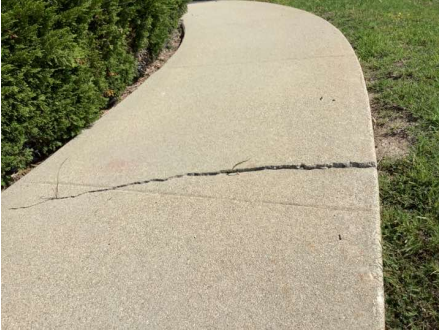
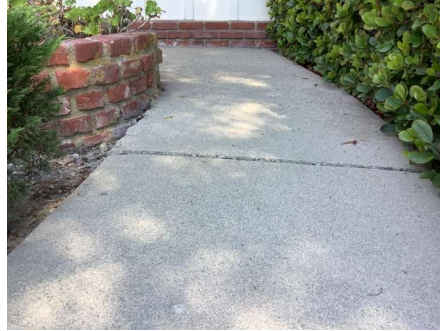
**SC s-26:** Uneven sections are observed in the walkway surface. This condition poses a trip hazard. We recommend correcting the condition(s) noted for safety reasons.

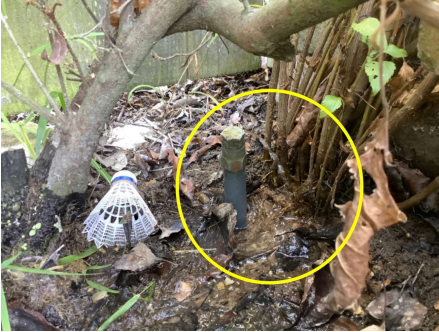
**CR s-31:** Testing of the yard irrigation system is beyond the scope of this inspection. However, one or more of the sprinklers leaks at the left side of the building. We suggest that all leaking, malfunctioning or damaged sprinklers should be repaired or replaced.

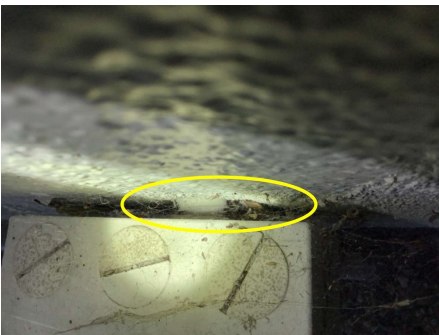
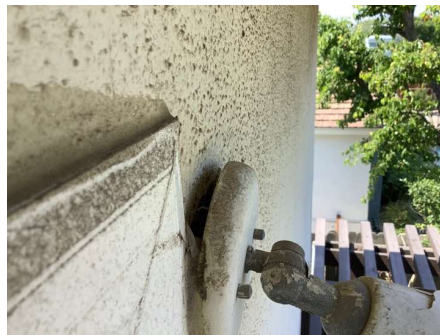
**FE CR s-38:** There is a gap(s) in the exterior cladding at joints with dissimilar materials, a utility, pipe or vent penetration. This can permit water entry and result in damage to the cladding and underlying building elements. We suggest that open joints or gaps in the siding should be caulked and sealed.

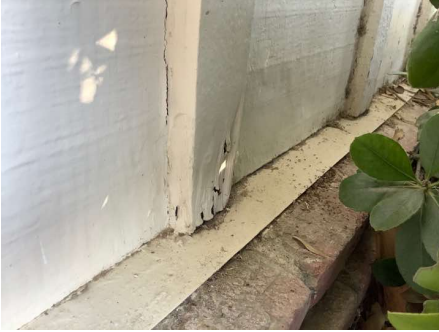
**CR s-40:** Sections of the siding are deteriorated. We suggest a qualified technician should repair or replace any deteriorated siding. NOTE: Review of a current pest control operator's report, if available is recommended to determine what action might be appropriate. If no current report is available, a report should be ordered from a qualified, licensed pest control operator.

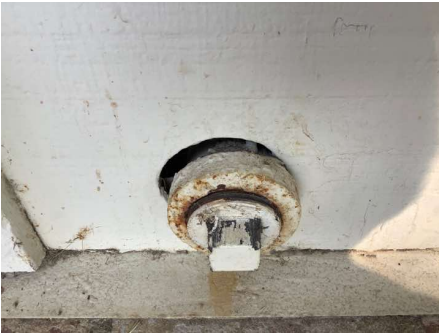
**CR s-41:** There is a gap(s) in the exterior cladding at joints with dissimilar materials, a utility, pipe or vent penetration. This can permit water entry and result in damage to the cladding and underlying building elements. We suggest that open joints or gaps in the siding should be caulked and sealed.

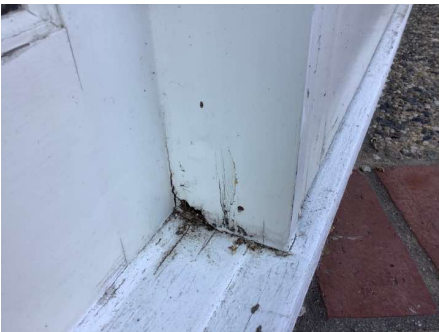
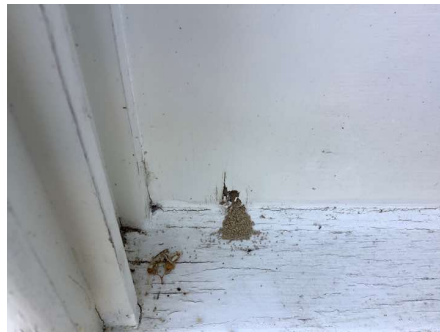
**FE CR s-42:** The exterior door is deteriorated on the left rear of the building. We suggest deteriorated doors should be repaired or replaced as necessary. NOTE: Review of a current pest control operator's report, if available is recommended to determine what action might be appropriate. If no current report is available, a report should be ordered from a qualified, licensed pest control operator.

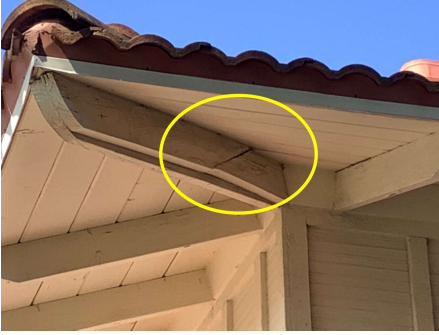
**CR s-44:** On the front of the building one or more of the rafter tails are damaged. We suggest a qualified technician should evaluate this condition and make repairs or modifications as necessary.

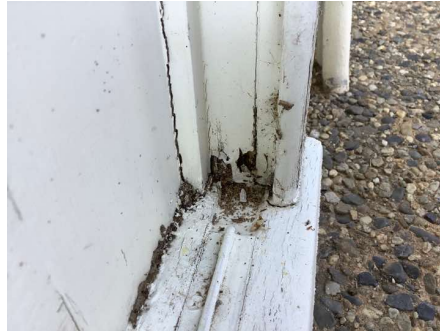
**CR s-46:** Some of the exterior trim is damaged and/or deteriorated on the left rear of the building. We have NOT listed every instance of trim damage. We suggest having a qualified contractor examine all exterior trim for deterioration, damage or missing parts, and repair or replace as necessary. Regular routine maintenance is recommended. NOTE: Review of a current pest control operator's report, if available is recommended to determine what action might be appropriate. If no current report is available, a report should be ordered from a qualified, licensed pest control operator.

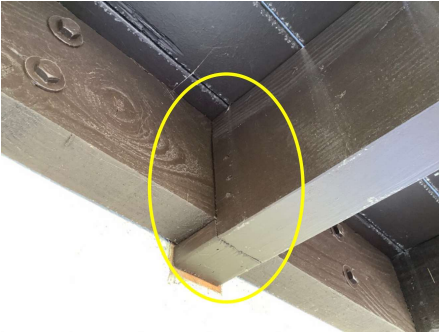
**SC CR s-49:** The deck/balcony support and connections are minimal or inadequate by industry standards for deck/balcony design and construction. This can allow damage of the deck, especially under heavy loads and/or seismic activity. We suggest a qualified technician evaluate the deck and make repairs or modifications as necessary.

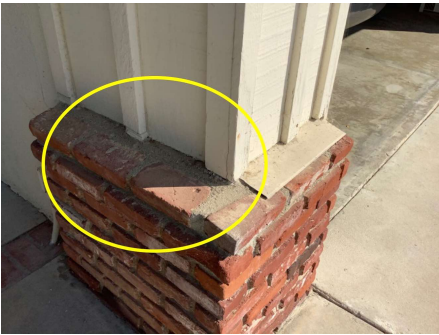
**CR s-50:** No flashing is installed at the veneer on the left front of the building. We suggest a qualified technician could install flashings to ensure that the area remains watertight.

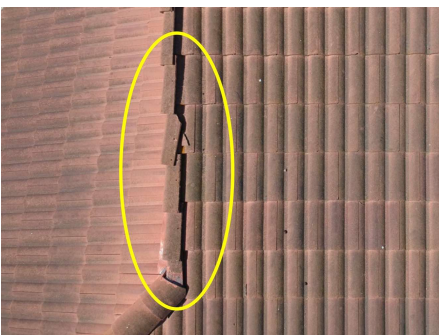
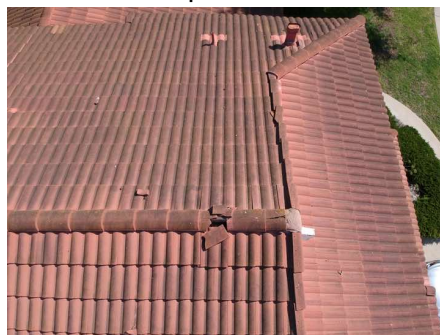
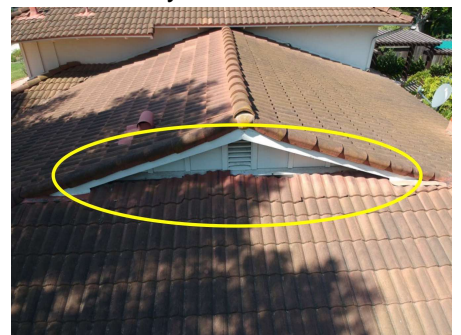
**CR s-58:** There are a number of cracked, damaged or dislodged tiles on the roof. We suggest a qualified roofer should evaluate the entire roof and make repairs or modifications as necessary.

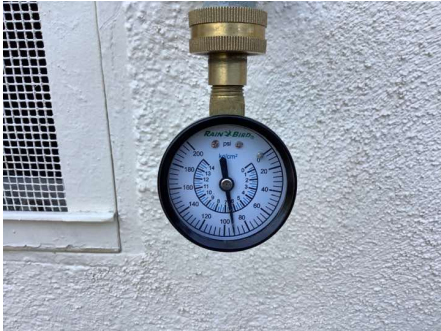
**CR s-92:** System pressure as measured by a gauge at an exterior hose bibb-was excessive at 90 p.s.i. Excessive pressure can result in damage or failure to valves, seats and washers, and fixture supply lines. We suggest the pressure regulator should be adjusted by a qualified plumber to keep pressure below 80 p.s.i. or the regulator should be replaced.

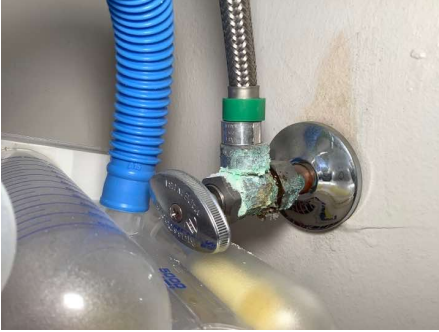
Master bathroom left wash basin

**CR s-98:** In the area(s) listed below the water supply shutoff valves are noticeably corroded, but are not leaking at this time. We recommend replacing any corroded valve before leaks are discovered.

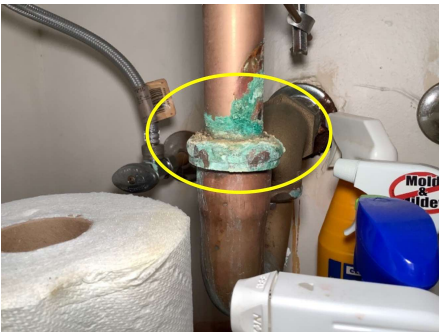
Master bathroom right wash basin

**CR s-100:** In the area(s) listed below the drain pipe(s) are leaking. We suggest all leaking drain lines should be repaired or replaced. A qualified plumber should do the work.

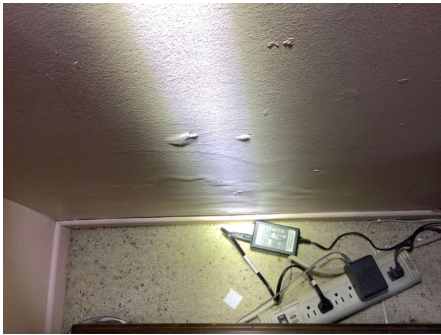
Living room

**FE CR s-178:** In the area(s) listed below there are water stains and/or minor surface damage to the wall and ceiling. We suggest the source of the moisture should be identified and eliminated. The surface could be refinished as necessary.

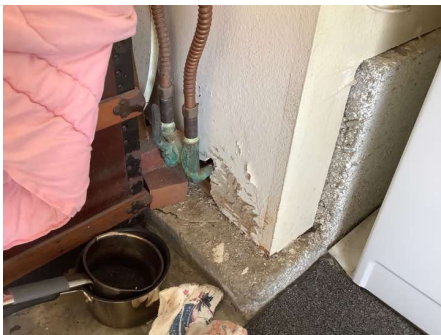
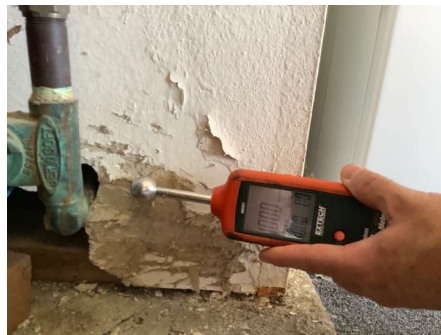
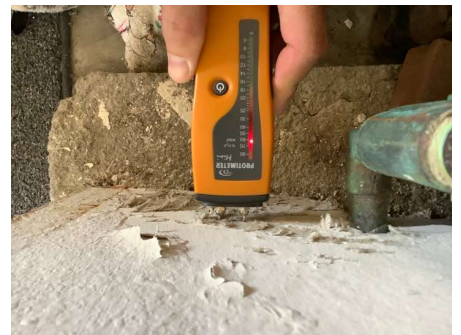
**Garage**

**FE CR s-179:** In the area(s) listed below when tested with a moisture meter, staining and/or active moisture was confirmed at the wall and ceiling indicating an active leak. We suggest the source of the leak should be identified and necessary repairs performed before any attempt is made to restore surface appearance. Restoration of surface appearance may require extensive patching and/or replacement of some of the surface materials.

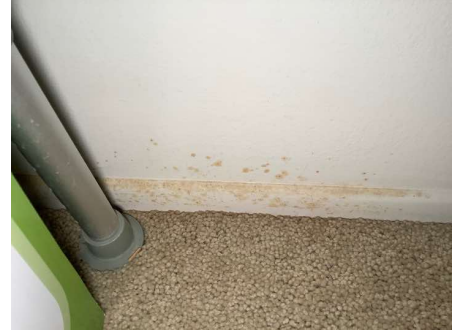
Garage

**FE s-180:** In the area(s) listed below there is surface growth and/or an earthy odor on the walls. This may indicate the presence of mold, fungus or other microbial organisms. The identification of molds, fungus and other microbial organisms is outside the scope of this inspection. We suggest a qualified environmental specialist should be retained to evaluate the surfaces and make further recommendations. Testing and remediation of mold growth can only be accomplished by a qualified environmental specialist. If strict protocol is not followed, spores can be released into the interior of the building and may create a health hazard for those with low tolerances to such organisms.

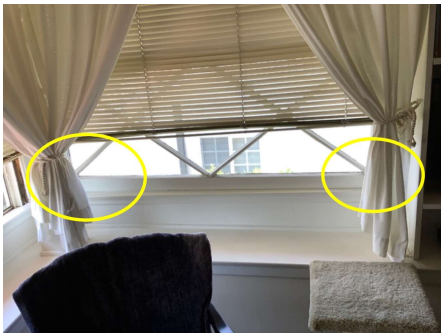
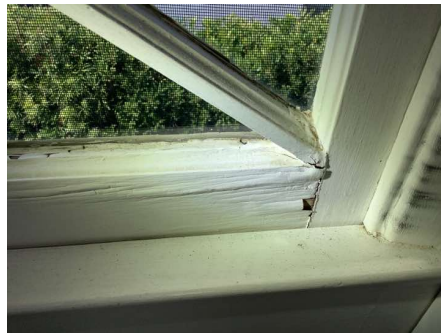
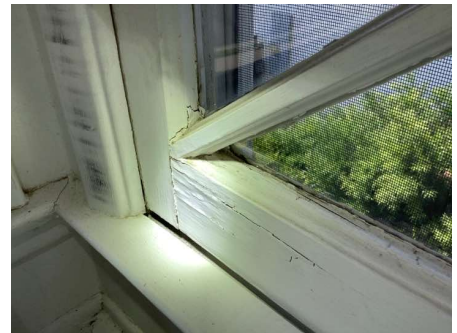
Right front bedroom

**FE CR s-181:** In the area(s) listed below there are water stains and/or damage at the wall or sill near the window(s). The leaks that caused the damage may still exist. We suggest a qualified technician should identify and repair all leaks. If damage to finished surfaces and underlying materials are discovered during the course of repairs, repairs should be made as necessary.

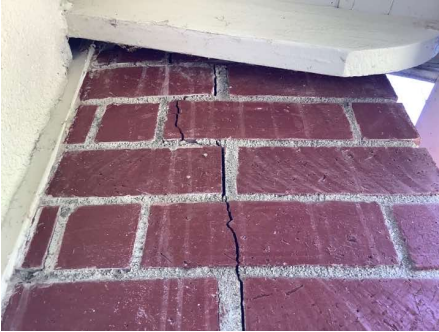
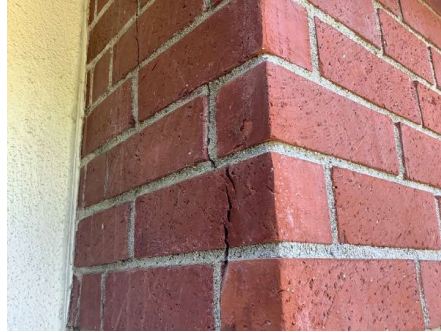
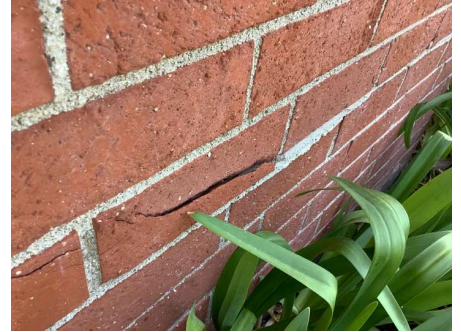
**FE CR s-232:** There are cracks in the chimney brick and/or mortar. We recommend the entire fireplace and chimney should be evaluated by a qualified fireplace technician to determine what corrective action is necessary.

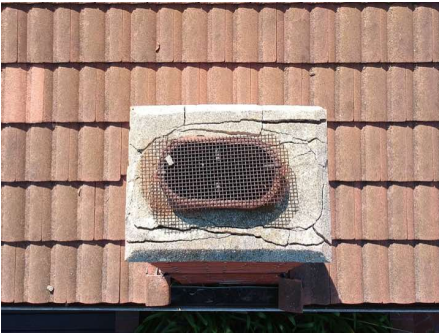
**FE CR s-233:** The mortar chimney cap is significantly cracked, damaged or deteriorated. This can promote damage to the chimney. We suggest a qualified mason repair the mortar cap as necessary.

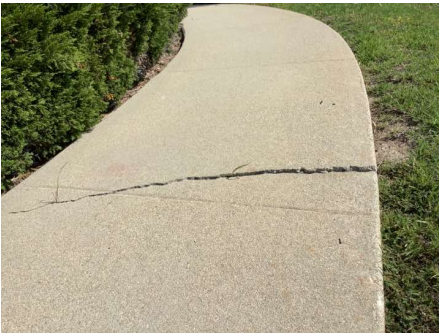
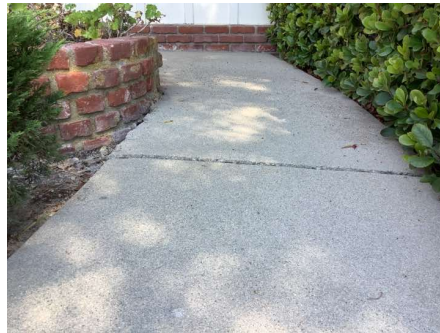
**SC 26:** Uneven sections are observed in the walkway surface. This condition poses a trip hazard. We recommend correcting the condition(s) noted for safety reasons.

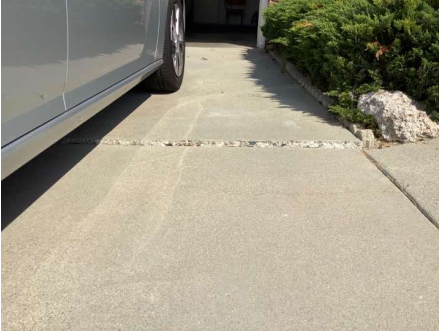
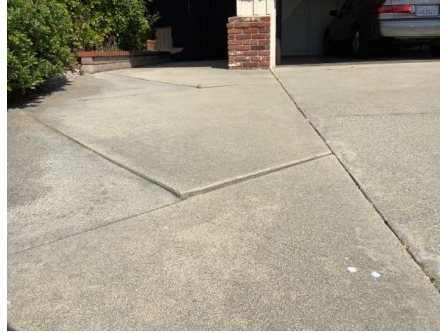
**SC 27:** Uneven sections were observed in the driveway surface. This condition poses a trip hazard. We recommend correcting the condition(s) noted for safety reasons.

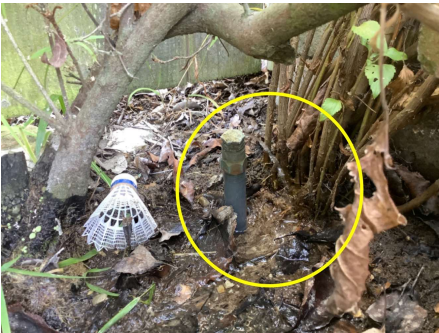
**CR 31:** Testing of the yard irrigation system is beyond the scope of this inspection. However, one or more of the sprinklers leaks at the left side of the building. We suggest that all leaking, malfunctioning or damaged sprinklers should be repaired or replaced.

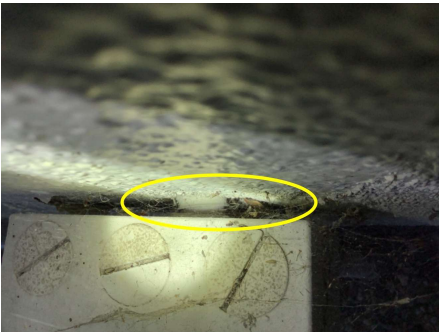
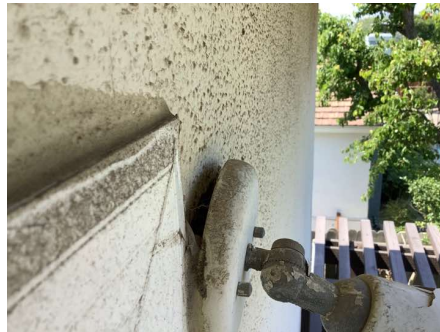
**FE CR 38:** There is a gap(s) in the exterior cladding at joints with dissimilar materials, a utility, pipe or vent penetration. This can permit water entry and result in damage to the cladding and underlying building elements. We suggest that open joints or gaps in the siding should be caulked and sealed.

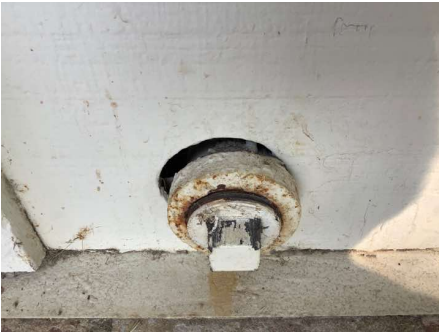
**CR 41:** There is a gap(s) in the exterior cladding at joints with dissimilar materials, a utility, pipe or vent penetration. This can permit water entry and result in damage to the cladding and underlying building elements. We suggest that open joints or gaps in the siding should be caulked and sealed.

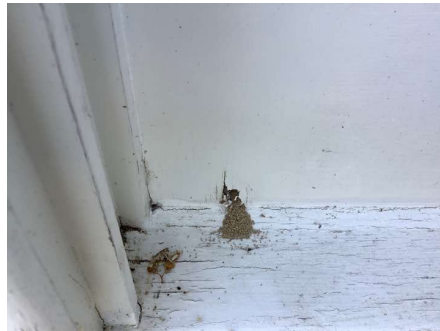
**FE CR 42:** The exterior door is deteriorated on the left rear of the building. We suggest deteriorated doors should be repaired or replaced as necessary. **NOTE:** Review of a current pest control operator's report, if available is recommended to determine what action might be appropriate. If no current report is available, a report should be ordered from a qualified, licensed pest control operator.

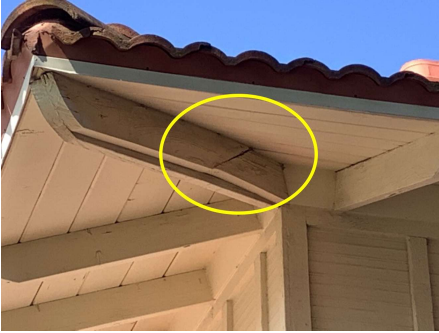
**CR 44:** On the front of the building one or more of the rafter tails are damaged. We suggest a qualified technician should evaluate this condition and make repairs or modifications as necessary.

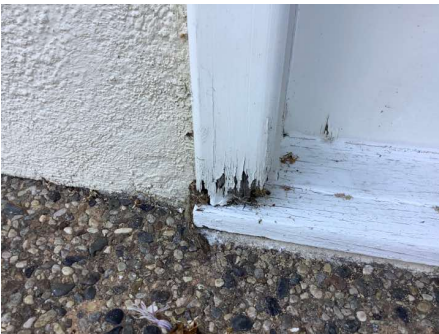
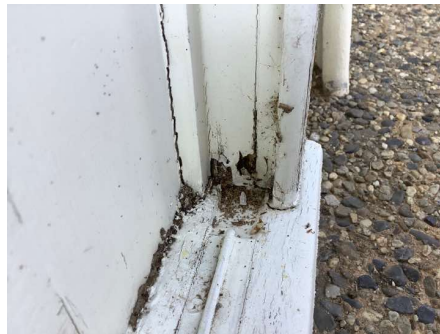
**CR 46:** Some of the exterior trim is damaged and/or deteriorated on the left rear of the building. We have NOT listed every instance of trim damage. We suggest having a qualified contractor examine all exterior trim for deterioration, damage or missing parts, and repair or replace as necessary. Regular routine maintenance is recommended. NOTE: Review of a current pest control operator's report, if available is recommended to determine what action might be appropriate. If no current report is available, a report should be ordered from a qualified, licensed pest control operator.

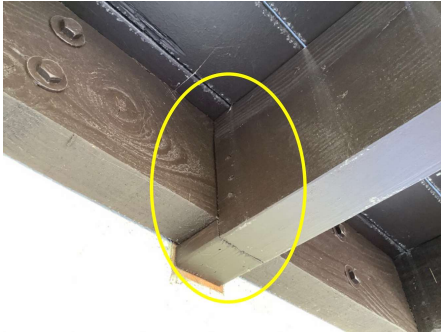
**SC CR 49:** The deck/balcony support and connections are minimal or inadequate by industry standards for deck/balcony design and construction. This can allow damage of the deck, especially under heavy loads and/or seismic activity. We suggest a qualified technician evaluate the deck and make repairs or modifications as necessary.

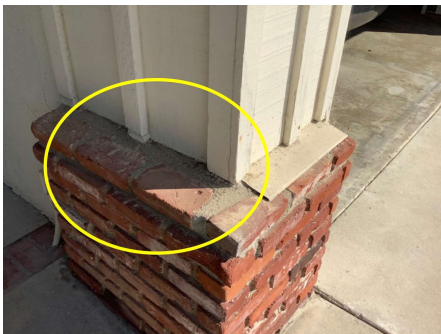
**CR 50:** No flashing is installed at the veneer on the left front of the building. We suggest a qualified technician could install flashings to ensure that the area remains watertight.

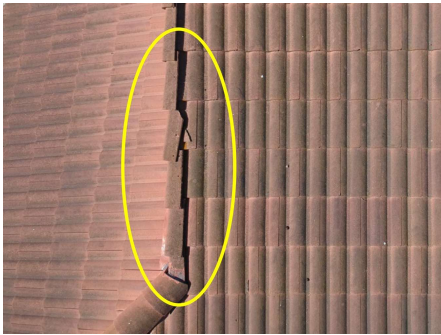
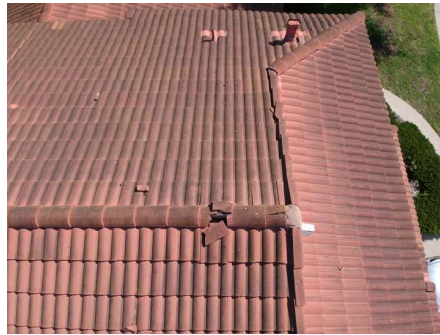
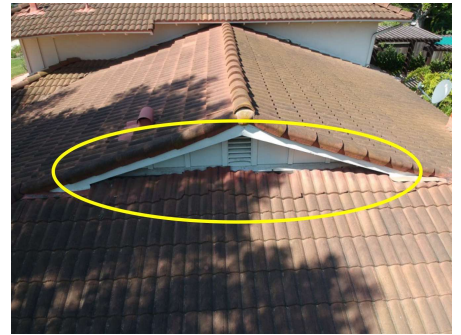
**CR 58:** There are a number of cracked, damaged or dislodged tiles on the roof. We suggest a qualified roofer should evaluate the entire roof and make repairs or modifications as necessary.

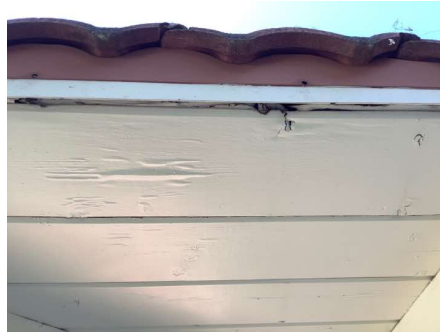
**FE 60:** There are water stains on the underside of the eaves at the front of the building. These visible conditions strongly indicate an active leak. We suggest the source of the water penetration should be located and appropriate repairs made to prevent more damage to the eaves.

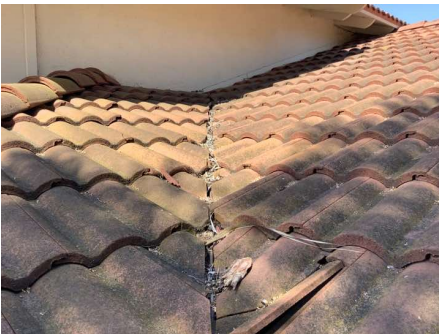
**FE CR 62:** The valleys are obstructed by an accumulation of debris. The debris can promote moisture penetration of the roofing system. We suggest regular maintenance and clearing of all debris from the valleys is recommended as part of routine roof maintenance.

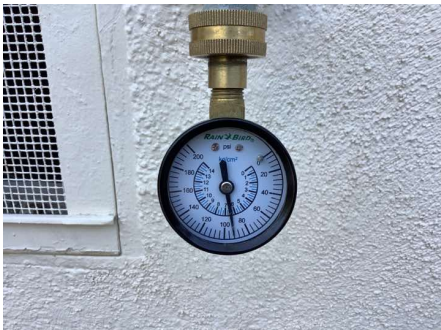
**CR 92:** System pressure as measured by a gauge at an exterior hose bibb-was excessive at 90 p.s.i. Excessive pressure can result in damage or failure to valves, seats and washers, and fixture supply lines. We suggest the pressure regulator should be adjusted by a qualified plumber to keep pressure below 80 p.s.i. or the regulator should be replaced.

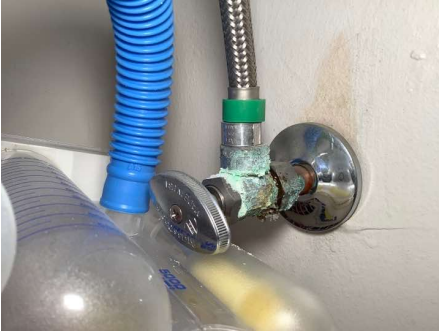
**CR 98:** In the area(s) listed below the water supply shutoff valves are noticeably corroded, but are not leaking at this time. We recommend replacing any corroded valve before leaks are discovered.  
Master bathroom left wash basin

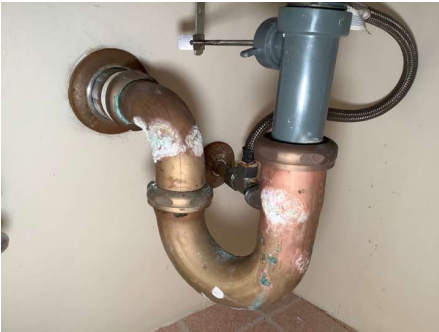
**CR 99:** In the area(s) listed below although no active leak was observed, there is/are corroded and/or deteriorated drain line(s) with a limited useful life. We suggest considering replacing such drains before leaks occur.  
Upper floor hallway bathroom wash basin

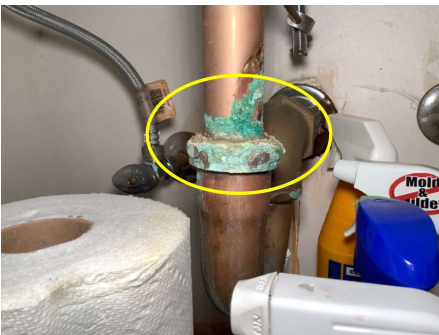
**CR 100:** In the area(s) listed below the drain pipe(s) are leaking. We suggest all leaking drain lines should be repaired or replaced. A qualified plumber should do the work.  
Master bathroom right wash basin

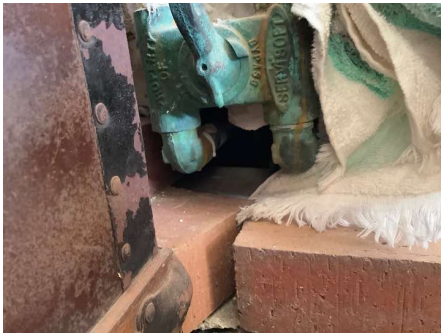
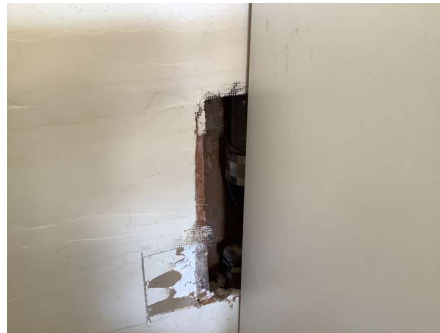
**CR 168:** There are holes/damage in the fire-resistive barrier between the garage and interior or attic. This condition can allow more rapid spread of smoke and flames in the event of a fire. We suggest all voids should be repaired per current industry standards.

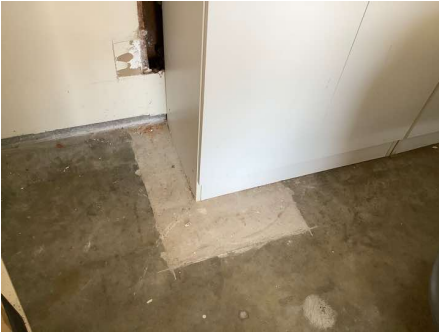
**FE CR 171:** Prior repairs have been made in the garage slab. Inquiries should be made with the sellers as to the reason for the repairs. If concerns remain, we suggest a qualified technician should evaluate this condition and make repairs or modifications as necessary.

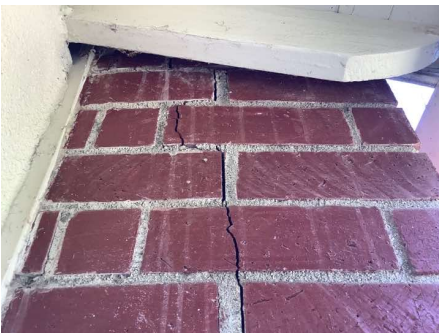
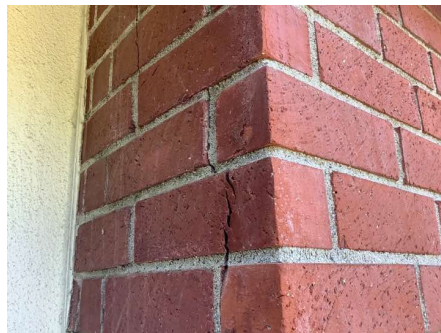
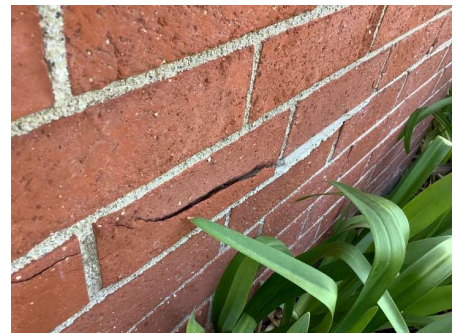
**FE CR 232:** There are cracks in the chimney brick and/or mortar. We recommend the entire fireplace and chimney should be evaluated by a qualified fireplace technician to determine what corrective action are necessary.

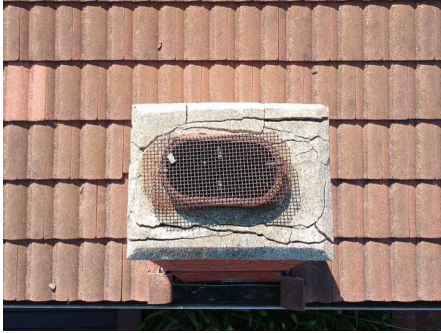
**FE CR 233:** The mortar chimney cap is significantly cracked, damaged or deteriorated. This can promote damage to the chimney. We suggest a qualified mason repair the mortar cap as necessary.
