# Integrity inspections

## Home Inspection Report

**28006 Pontevedra Dr.**

Inspected on Tue, Jan 26 2021 at 9:27 AM

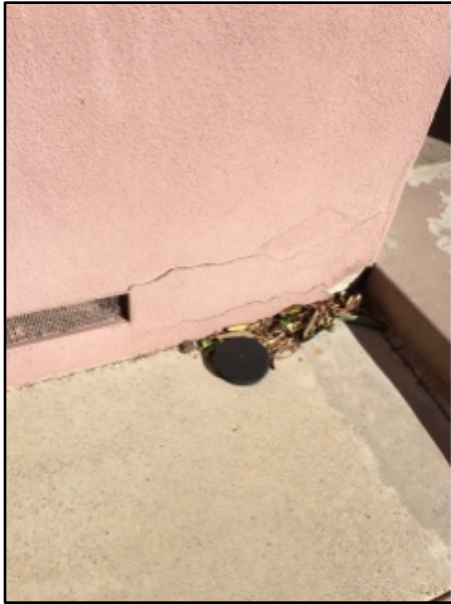
Figure 2-1

Comment 2:  
Cracks on exterior walls.

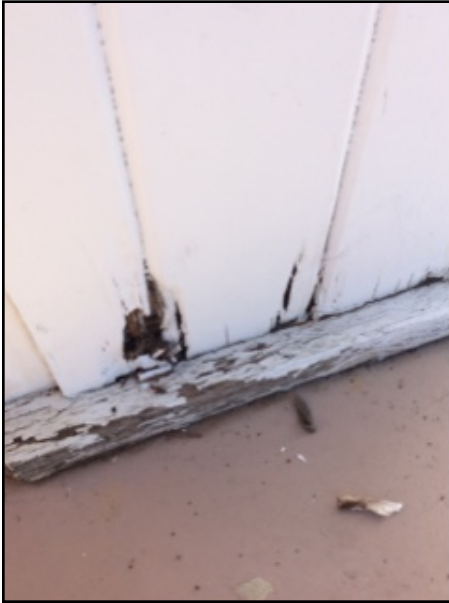
Figure 3-1

Moisture damage to exterior wood at patio .

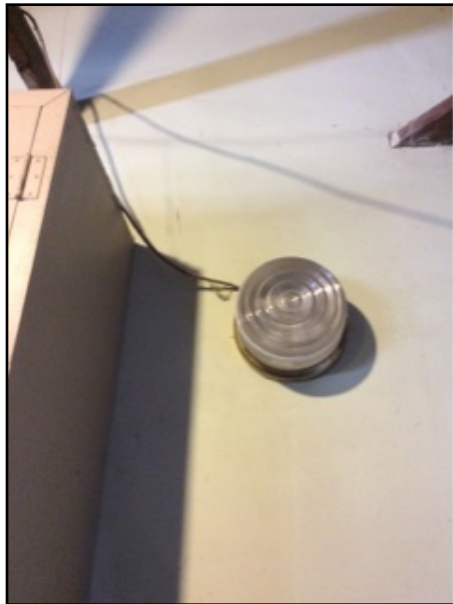
Figure 6-1

Comment 6:  
Light not working. Improper wiring off light

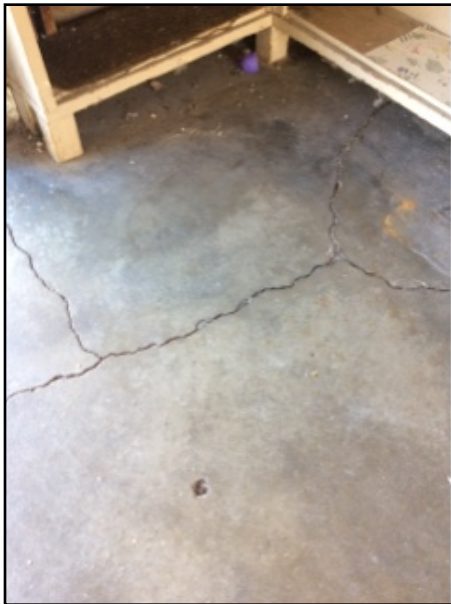
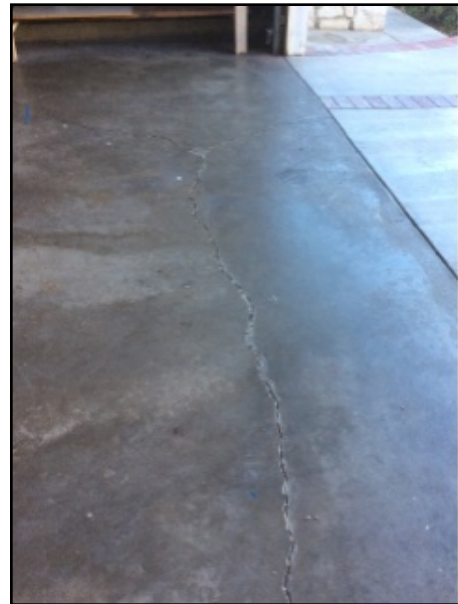
Comment 8:  
Cracks on garage floor if concerned suggest further evaluation.

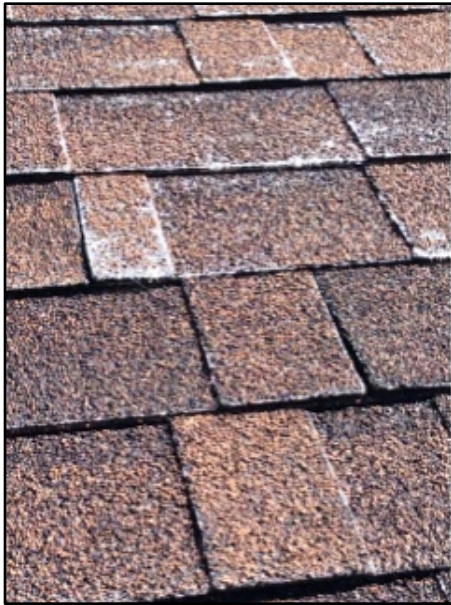
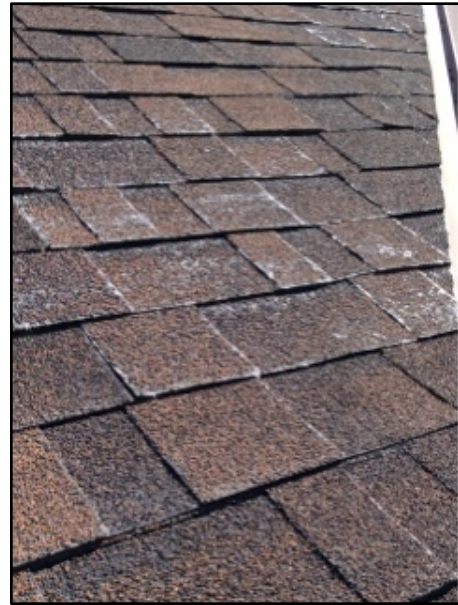
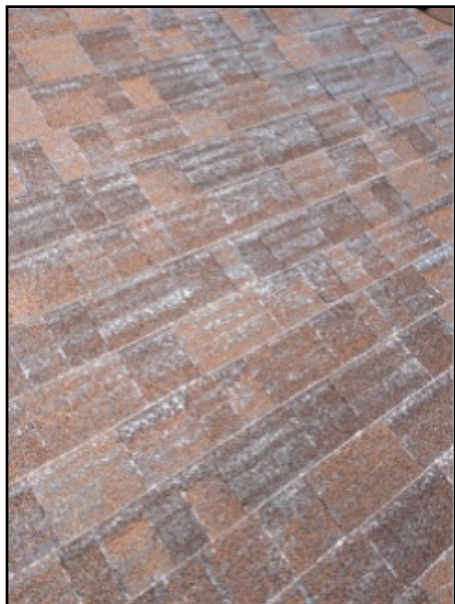
Comment 9:  
Shingles starting to wear. If concerned suggest further evaluation

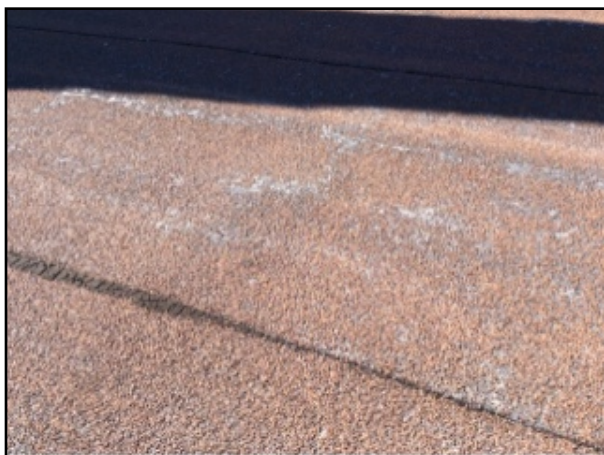
Figure 10-1

Comment 10:  
Roll roofing starting to wear.

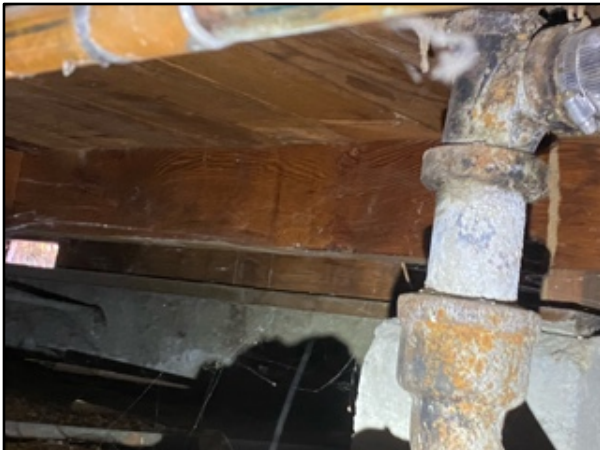
Figure 25-1

Comment 25:  
Some corrosion on piping. Older piping

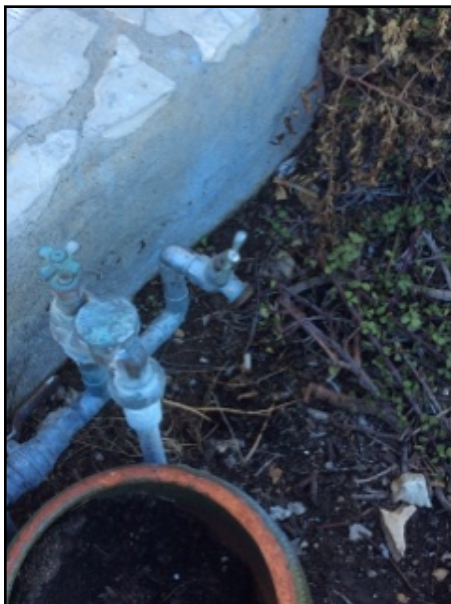
Figure 27-1

Comment 27:  
Constant dripping at exterior front faucet .

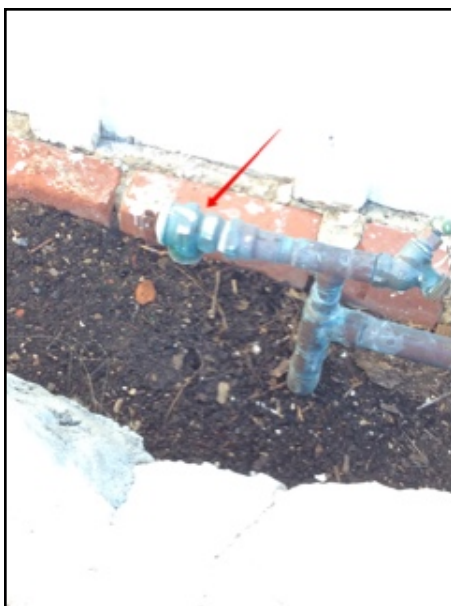
Figure 28-1

Comment 28:  
TPR valve at main line dripping .

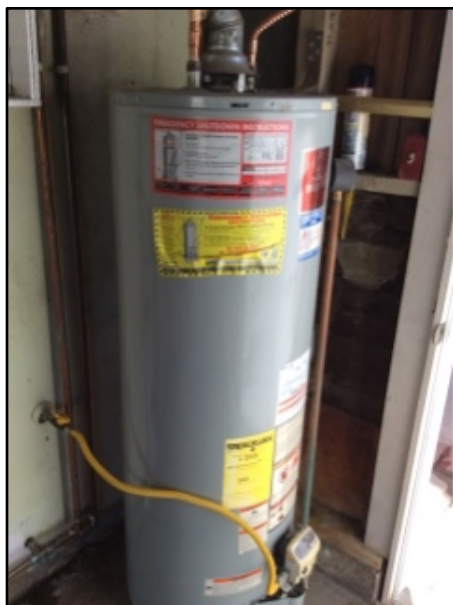
Figure 29-1

Manufacturer:	State
Water Heater Location :	Garage
Fuel:	Natural Gas
Capacity:	50 gal
Temp & Pressure Relief Valve:	Present With Blow Off Leg
Fuel Disconnect:	Condition: Satisfactory
Seismic Straps Installed:	Within Sight of Equipment
	No
	Condition: Repair

Water heater needs two straps one on top one third and one on bottom one third. Attached to studs in the wall with 3/4" X 3" lag bolts

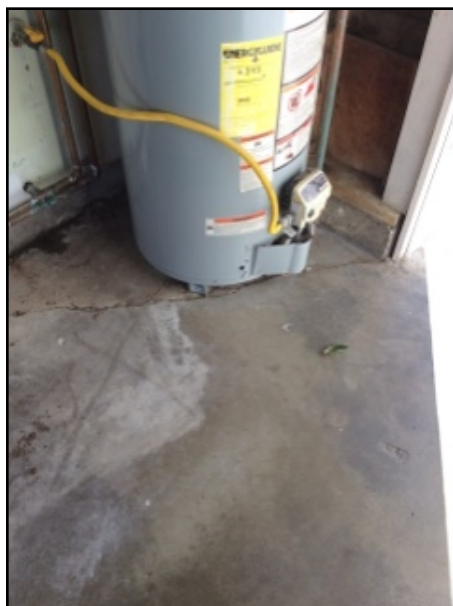
Figure 30-1

Comment 30:  
Gas flame needs to be 18" off ground.

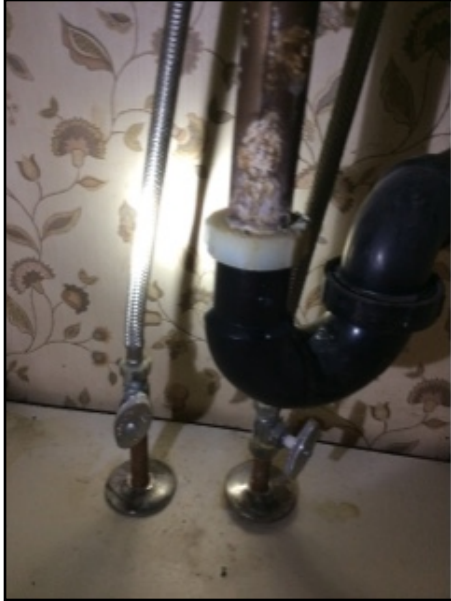
Figure 33-1

Comment 33:  
Rust/Corrosion on pipes.

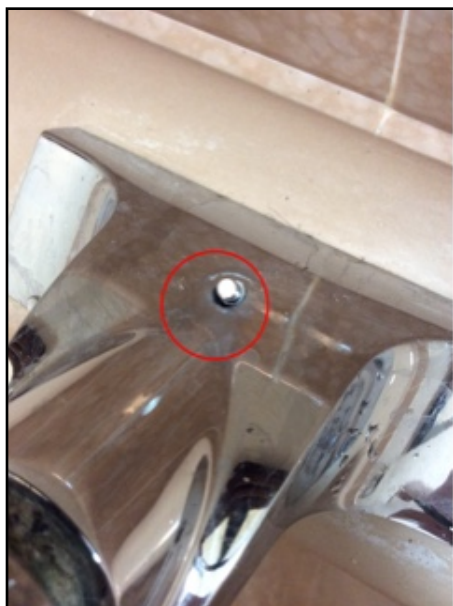
Figure 34-1

Comment 34:  
Drain stopper missing knob on lever handle .

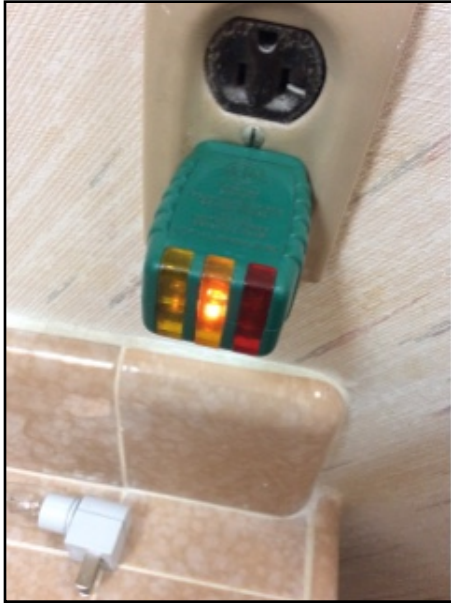
Figure 35-1

Comment 35:  
Has a weak ground suggest further .

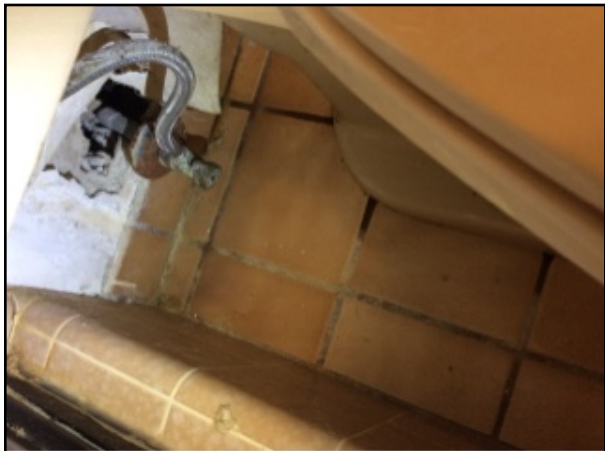
Figure 37-1

Comment 37:  
Opening in wall behind toilet .

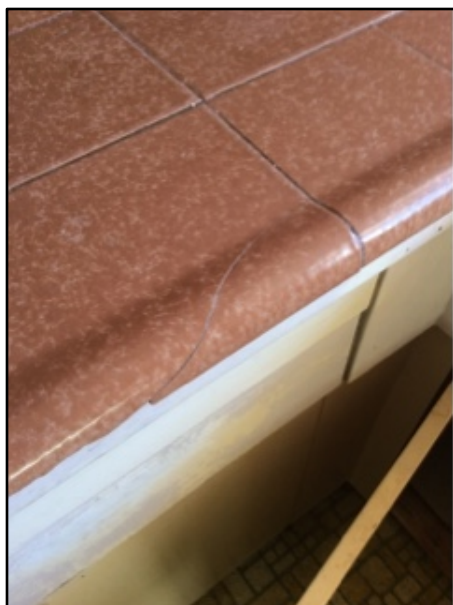
Figure 40-1

Comment 40:  
Cracked/worn/damaged tiles.

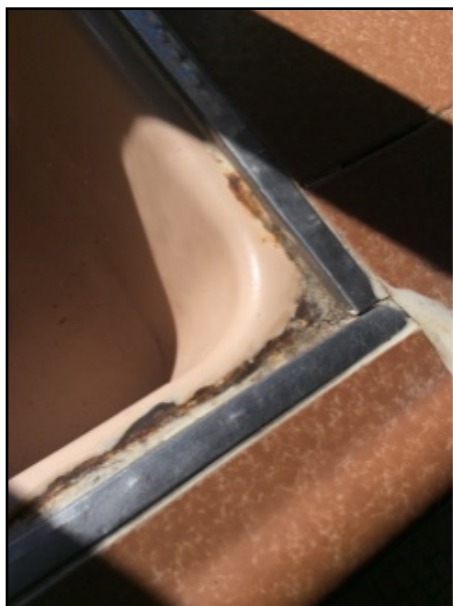
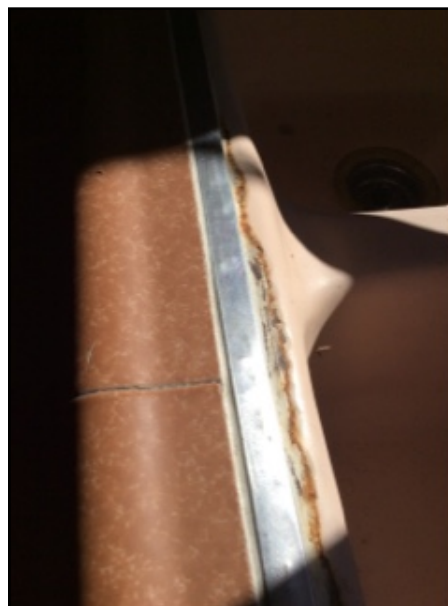
Comment 41:  
Older sink/rusted suggest replacing .

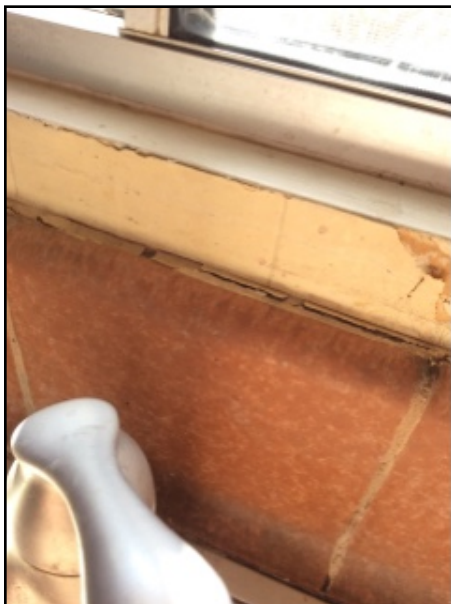
Figure 43-1

Comment 43:  
Need sealing at splash guard .

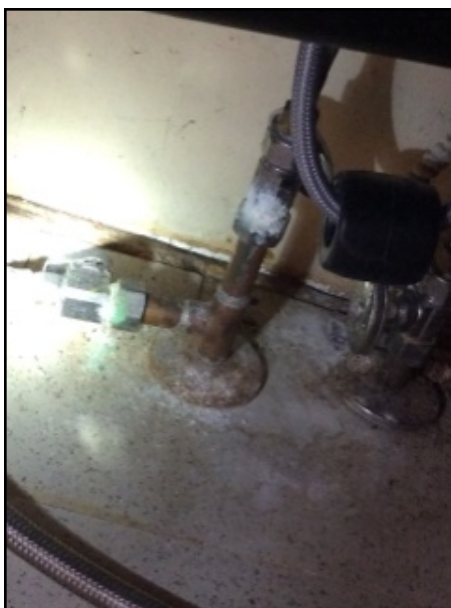
Figure 44-1

Comment 44:  
Oxidation/hard water residue on pipes possibly suggest small pin hole leaks.

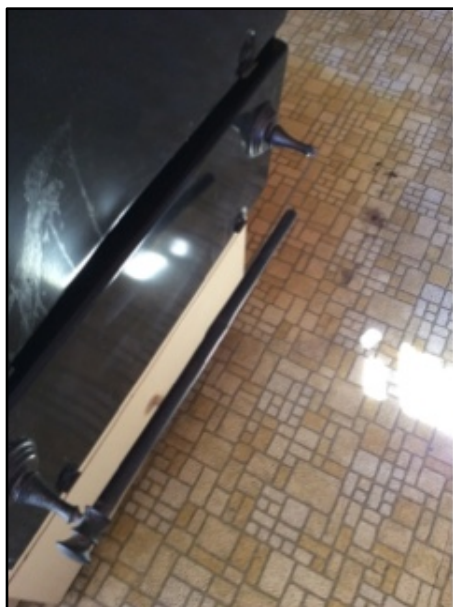
Figure 45-1

Broken broiler handle. Oven handle loose

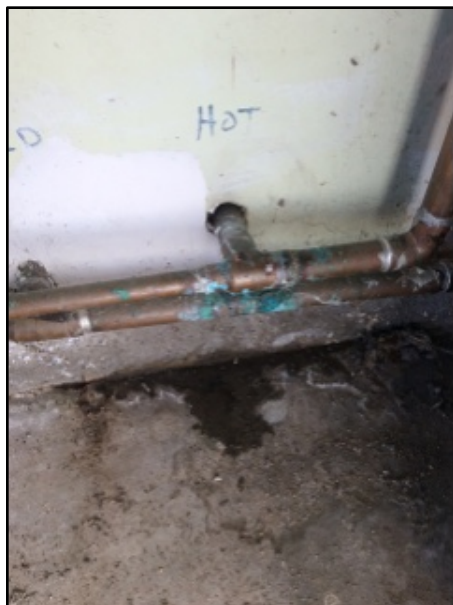
Figure 49-1

Comment 49:  
Oxidation on pipes and appear to be leaking suggest further evaluation .

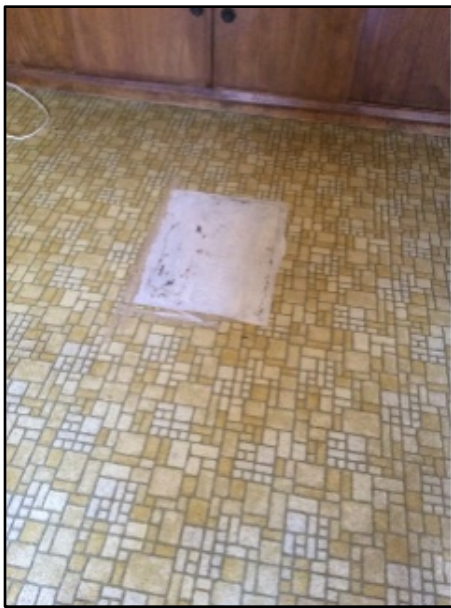
Figure 50-1

Comment 50:  
Repair done on flooring in dining room .

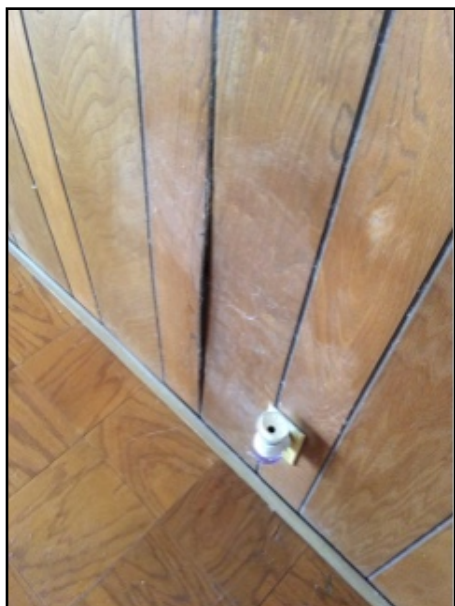
Figure 51-1

Comment 51:  
Paneling coming away from wall.

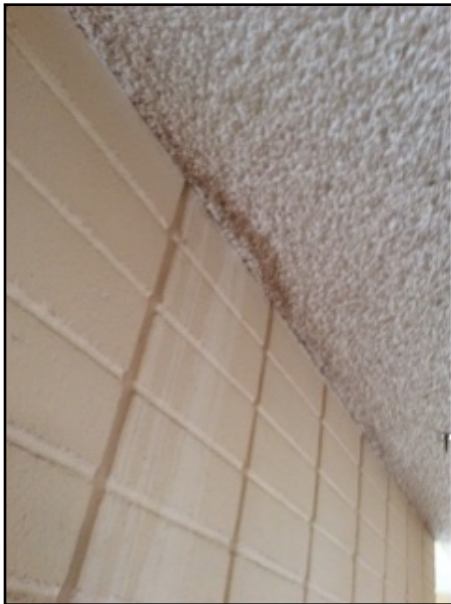
Figure 52-1

Moisture stains suggest prior or present leak suggest further explanation .

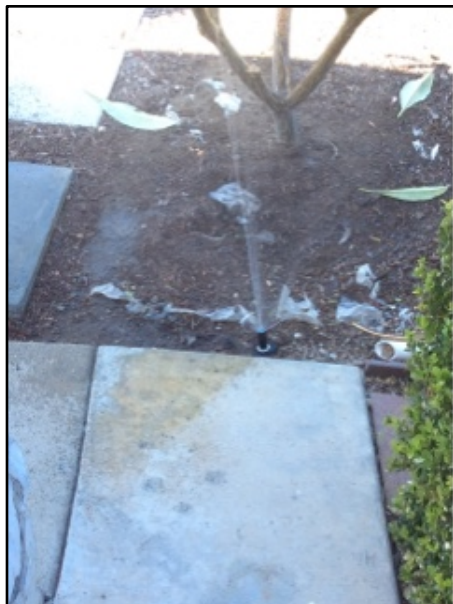
Figure 55-1

Comment 55:  
Damaged sprinkler heads.

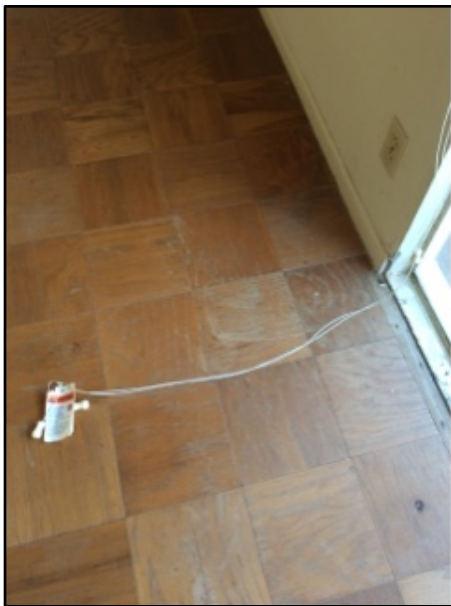
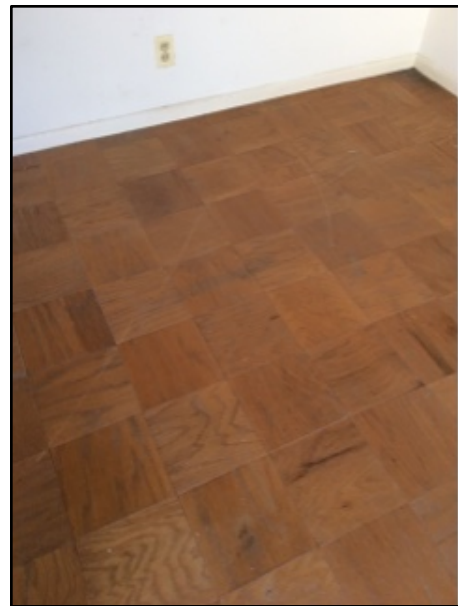
Comment 56:  
Flooring worn .

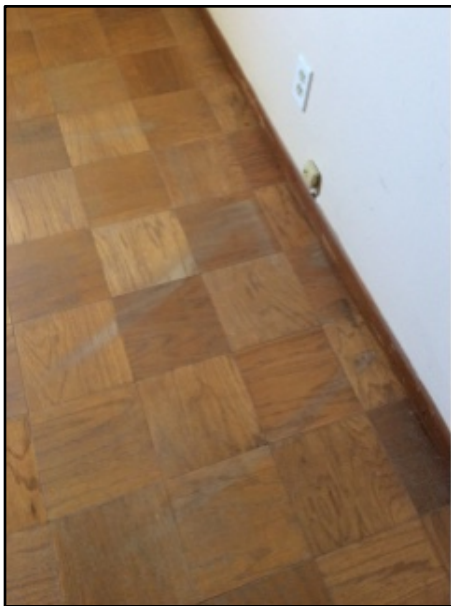
Figure 59-1

Comment 59:  
Flooring worn.

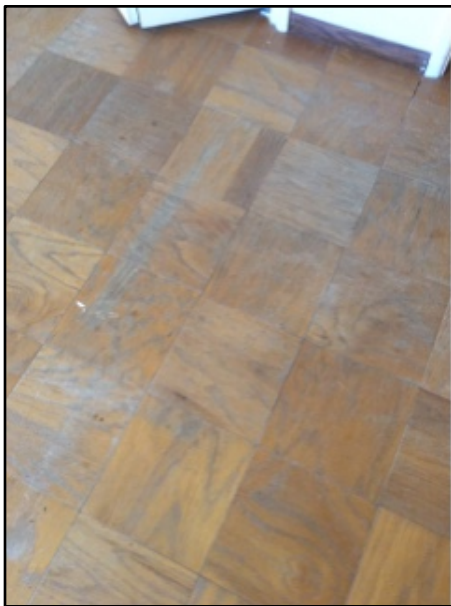
Figure 62-1

Comment 62:  
Flooring worn.

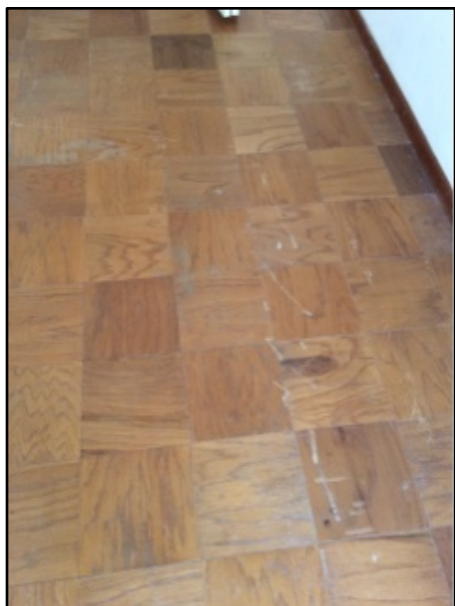
Figure 66-1

Comment 66:  
Flooring worn.

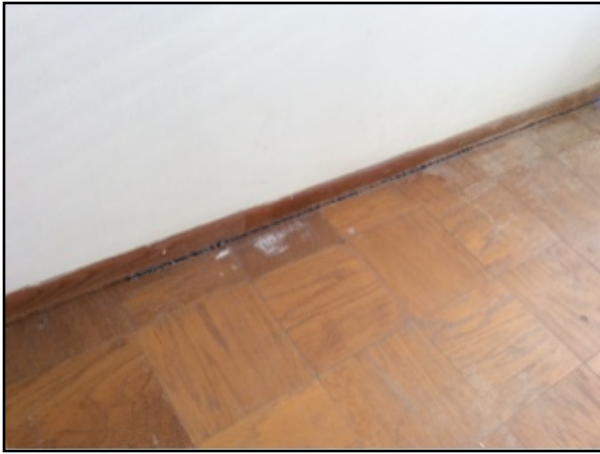
Figure 67-1

Comment 67:  
Possible old separation that was filled in suggest further evaluation .

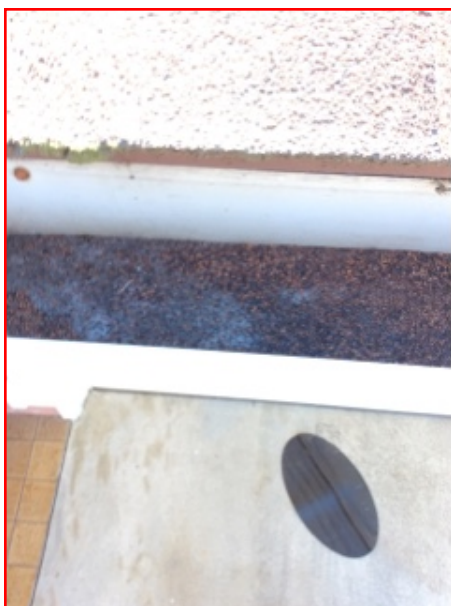
Figure 12-1

10) Suggest cleaning rain gutters.

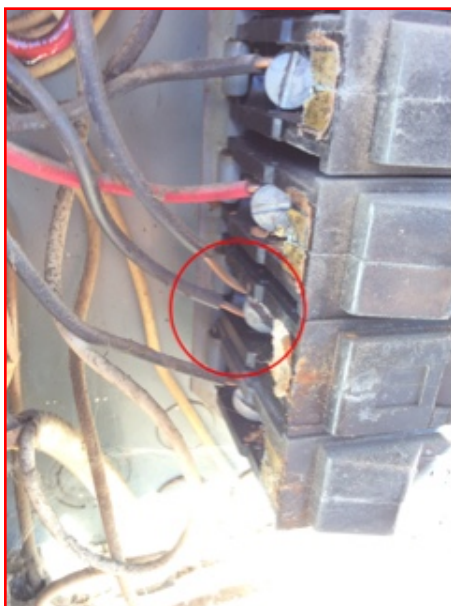
Figure 19-1

17) 2 wires on a 1 wire breaker.
