WOOD DESTROYING PESTS AND ORGANISMS INSPECTION REPORT

Building Address: 4687 Virginia Av., Oroville, CA 95966		Date of Inspection 02/01/2019	Number of Pages 8
John Moss Pest Control 6595 Perry Rd. Magalia CA 95954 Phone: (530) 228-1568 Fax: (530) 873-3276			Report # W10802
			Lic. Registration # PR 6242
			Escrow #
Ordered by: Keller Williams Chico Area Alisha Fickert 2080 E. 20th St. 170 Chico, CA 95928 624-2111 - Cell	Property Owner and/or Party of Interest: Keller Williams Chico Area Alisha Fickert 2080 E. 20th St. 170 Chico, CA 95928 624-2111 - Cell	Report Sent to: Keller Williams Chico Area Alisha Fickert 2080 E. 20th St. 170 Chico, CA 95928 624-2111 - Cell	
COMPLETE REPORT <input checked="" type="checkbox"/> LIMITED REPORT <input type="checkbox"/> SUPPLEMENTAL REPORT <input type="checkbox"/> REINSPECTION REPORT <input type="checkbox"/>			
General Description: Single story raised foundation (crawl space) occupied and furnished single family residence		Inspection Tag Posted: Water Heater

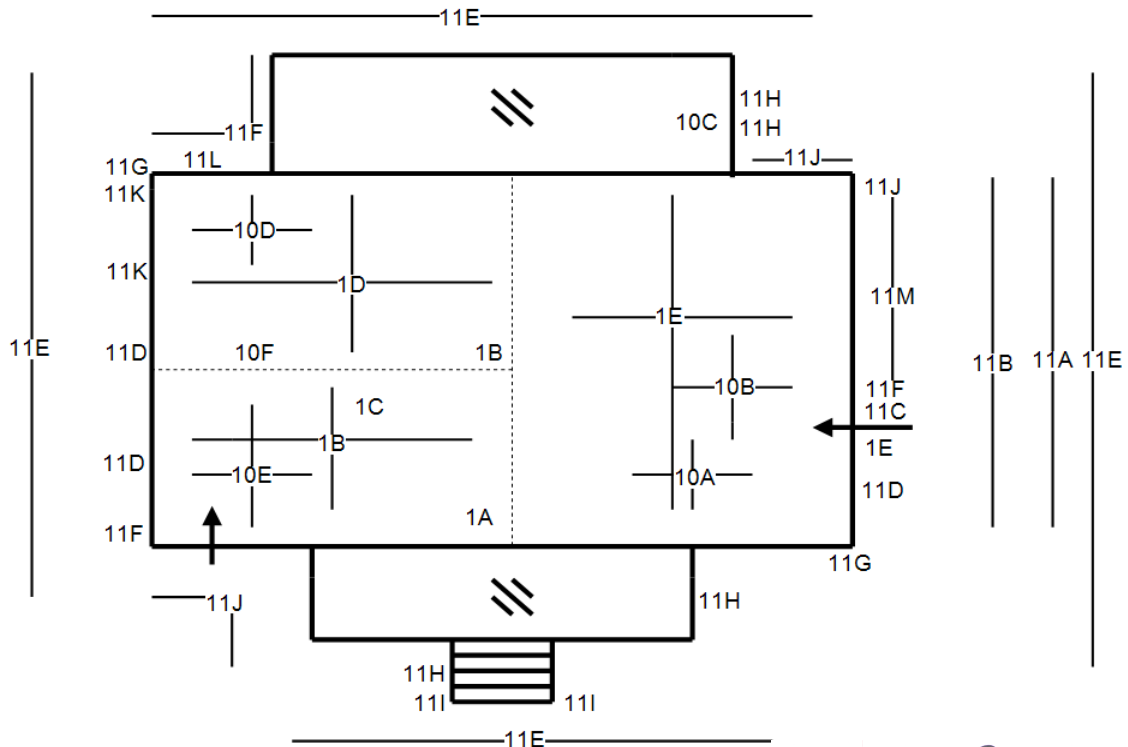
This Diagram is not to scale

- 10B PRICE: Not Estimated (Further Inspection)
FINDINGS: Inaccessible areas due to people sleeping in the area preventing inspection.
RECOMMENDATION: Owner to make area accessible for inspection. Contact John Moss Pest Control for a supplemental report after area is opened for inspection.

- 10C PRICE: Not Estimated (Further Inspection)
FINDINGS: Stains were noted at time of inspection to the sink shelf. John Moss Pest Control does not guarantee the presence or absence of any leaks or hidden damage from same.
RECOMMENDATION: Interested parties should engage the services of a licensed contractor to further inspect the area and/or repair as necessary.

- 10D PRICE: Not Estimated (Further Inspection)
FINDINGS: Inaccessible areas due to stored items preventing inspection.
RECOMMENDATION: Owner to make area accessible for inspection. Contact John Moss Pest Control for a supplemental report after area is opened for inspection.

- 10E PRICE: Not Estimated (Further Inspection)
FINDINGS: Inaccessible areas due to loose dogs preventing inspection.
RECOMMENDATION: Owner to make area accessible for inspection. Contact John Moss Pest Control for a supplemental report after area is opened for inspection.

- 10F PRICE: \$175.00 (Section II)
FINDINGS: The toilet in the bathroom indicated on the diagram is rocking on its drain flange.
RECOMMENDATION: Remove the toilet and inspect adjacent wood members. If no further damage is found reset the commode with a new wax seal.

- 11A PRICE: \$1,200.00 (Section I)
FINDINGS: Wood decay fungi damage (Dry Rot) found at time of inspection to the rafter tails and sheathing as indicated on the diagram.
RECOMMENDATION: Replace or repair visible dry-rot damaged wood members as necessary.

- 11B PRICE: Not Estimated (Further Inspection)
FINDINGS: Inaccessible areas at the carport siding and window trim preventing inspection.
RECOMMENDATION: Owner to make area accessible for inspection. Contact John Moss Pest Control for a supplemental report after area is opened for inspection.

- 11C PRICE: Not Estimated (Further Inspection)
FINDINGS: The subarea access covers are not removable without damage.
RECOMMENDATION: Repair or replace the covers to prevent entry and secure to the structure.

- 11D PRICE: \$400.00 (Section I)
FINDINGS: Wood decay fungi damage (Dry Rot) found at time of inspection to the window trim and siding as indicated on the diagram.
RECOMMENDATION: Replace or repair visible dry-rot damaged wood members as necessary.

- 11E PRICE: Not Estimated (Section II)
FINDINGS: There is weathered and peeling paint with areas of exposed barewood as indicated in the area on the diagram.
RECOMMENDATION: Repaint the areas of peeling paint and barewood as necessary. Color/Sheen will not be an exact match.

- 11F PRICE: \$900.00 (Section I)
FINDINGS: Wood decay fungi damage (Dry Rot) found at time of inspection to the trim and siding as indicated on the diagram.
RECOMMENDATION: Replace or repair visible dry-rot damaged wood members as necessary.

- 11G PRICE: \$250.00 (Section I)
FINDINGS: Wood decay fungi damage (Dry Rot) found at time of inspection to the corner trim as indicated on the diagram.
RECOMMENDATION: Replace or repair visible dry-rot damaged wood members as necessary.

- 11H PRICE: \$200.00 (Section I)
FINDINGS: Wood decay fungi damage (Dry Rot) found at time of inspection to the rail as indicated on the diagram.
RECOMMENDATION: Replace or repair visible dry-rot damaged wood members as necessary.

- 11I PRICE: \$100.00 (Section I)
FINDINGS: Wood decay fungi damage (Dry Rot) and earth to wood contact found at time of inspection to the post as indicated on the diagram.
RECOMMENDATION: Replace or repair visible dry-rot damaged wood members as necessary. Break the earth to wood contact.

- 11J PRICE: Not Estimated (Section II)
FINDINGS: There is vegetation touching the building as indicated in the area on the diagram. This condition is can be conducive to wood destroying pests.
RECOMMENDATION: Trim or remove vegetation as needed.

- 11K PRICE: \$300.00 (Section I)
FINDINGS: Wood decay fungi damage (Dry Rot) found at time of inspection to the siding as indicated on the diagram.
RECOMMENDATION: Replace or repair visible dry-rot damaged wood members as necessary.

- 11L PRICE: Not Estimated (Further Inspection)
FINDINGS: The shingles are damaged as indicated in the area on the diagram.
RECOMMENDATION: Interested parties should engage the services of a licensed contractor to further inspect the area and/or repair as necessary.

- 11M PRICE: \$750.00 (Section I)
FINDINGS: Wood decay fungi damage (Dry Rot) found at time of inspection to the trim and siding as indicated on the diagram. This is a visual inspection only.
RECOMMENDATION: Replace or repair visible dry-rot damaged wood members as necessary.
