A2Z Building Inspection  
A2Z Building Inspection  
San Pedro , Ca 90731

601-603 Garnet St  
Redondo Beach , Ca 90277

Page 1 of 29  
01/26/20 04:59:59 PM

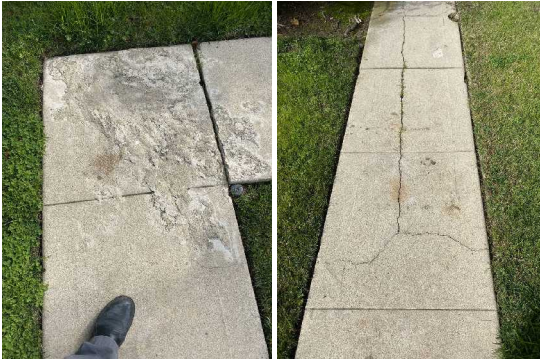
1. ☐☐☐☒☐ Walkways: Concrete - Concrete pitted and chipped, Cracked

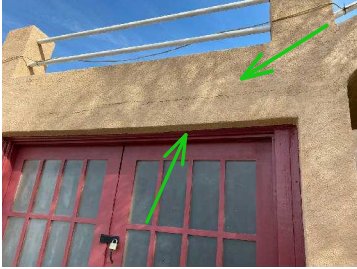
14. ☐☐☐☒☐ Exterior Surface: Stucco - Stress cracks

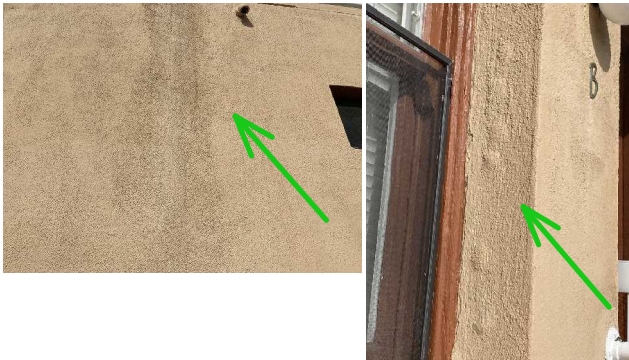
East Exterior Surface

49. ☐ ☐ ☐ ☒ ☐ Type: Stucco - Stucco shows previous cracks that have been repaired and painted. stucco has blistering around windows.

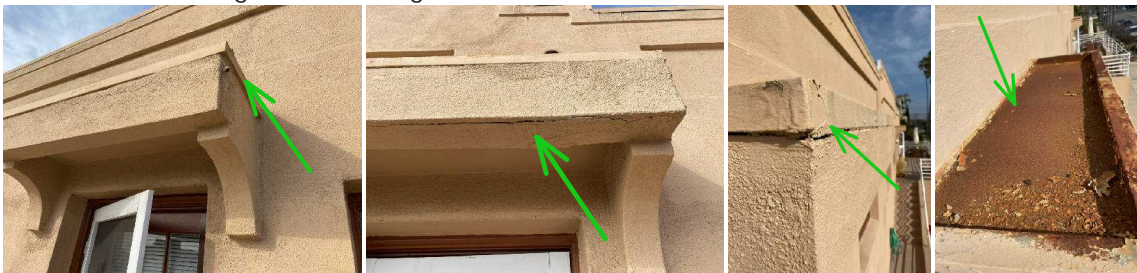
50. ☐ ☐ ☐ ☐ ☒ Main Entry: Metal, Wood, stucco - Valances above front doors have cracks, plugged or missing drain holes causing water damage.

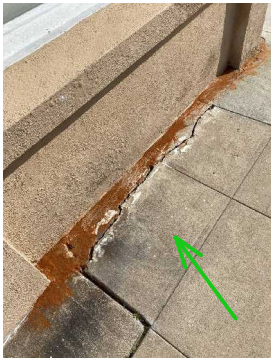
3. ☐ ☐ ☐ ☒ ☐ Differential Movement: Crack with displacement - Concrete cracked around front edge of building

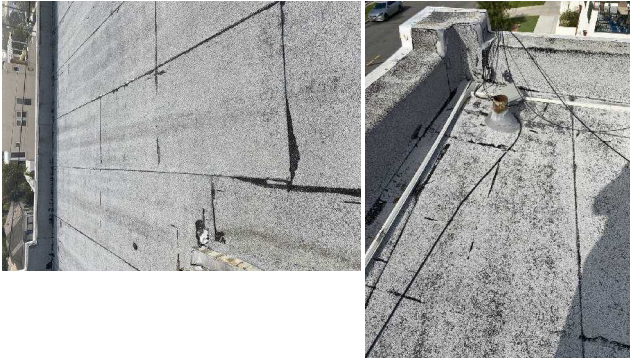
1. Method of Inspection: On roof
2. ☒ ☐ ☐ ☐ ☐ Unable to Inspect: 10%
3. ☐ ☐ ☐ ☒ ☐ Material: Rolled roof material - Roof shows signs of deterioration

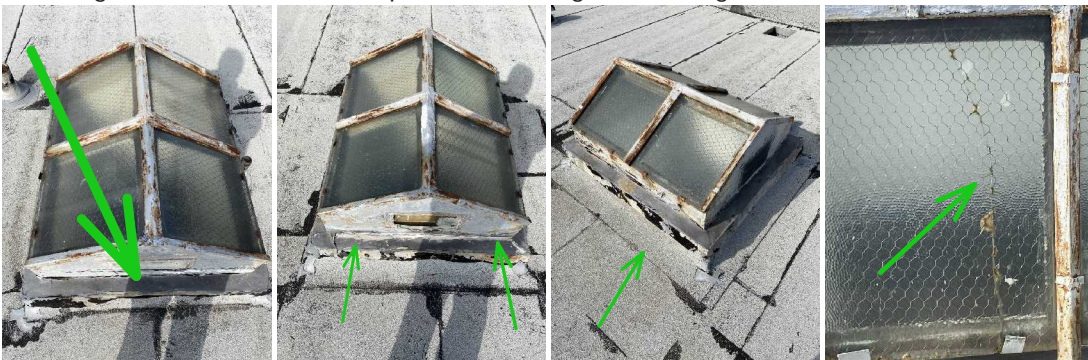
7. ☐ ☐ ☐ ☐ ☒ Skylights: Glass -  
Flashing needs to be resealed possible leakage. Broken glass

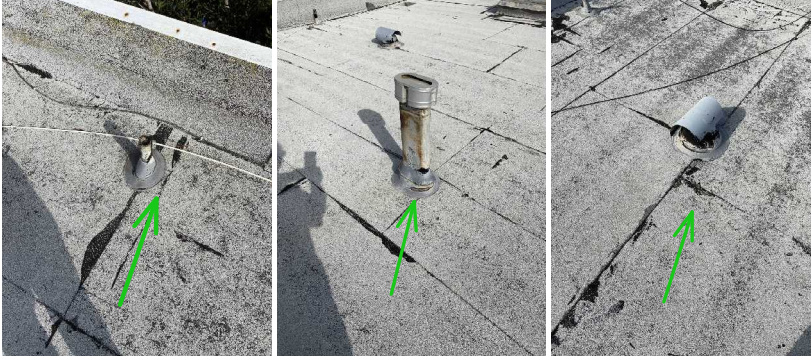
8. ☐☐☐☒☐ Plumbing Vents: Cast Iron - vents should be resealed to prevent leaks

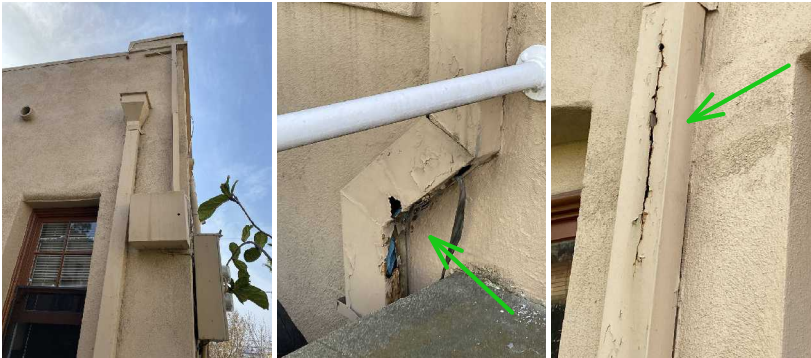
12. ☐☐☐☒☐ Downspouts: Galvanized - Some of the downspouts show rust holes and peeling paint.

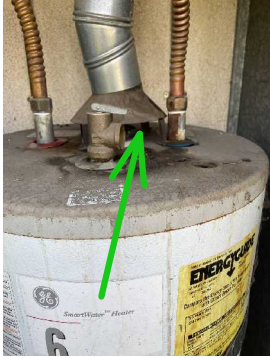
21. ☐☐☐☐☒ TPRV and Drain Tube: Copper - Missing drain tube

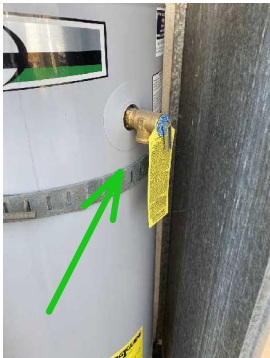
23. Manufacturer: A.O. Smith  
24. Model Number: G6 in Dash UT4040 in VR 400 Serial Number: 1845112554178  
25. Type: Natural gas Capacity: 40 Gal.  
26. Approximate Age: Unknown Area Served: Unit B  
27. ☒☐☐☐☐ Flue Pipe: Single wall  
28. ☐☐☐☐☒ TPRV and Drain Tube: Copper - Missing drain tube

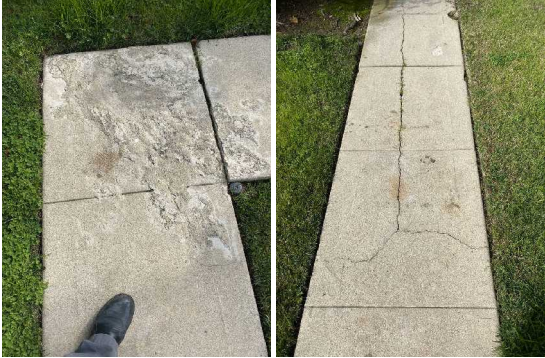
1. Walkways: Concrete - Concrete pitted and chipped, Cracked

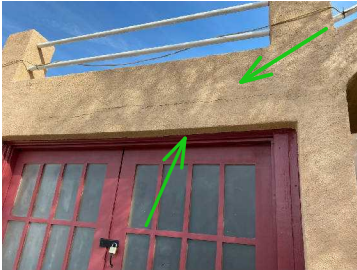
2. 601 A Garage Exterior Surface: Stucco - Stress cracks

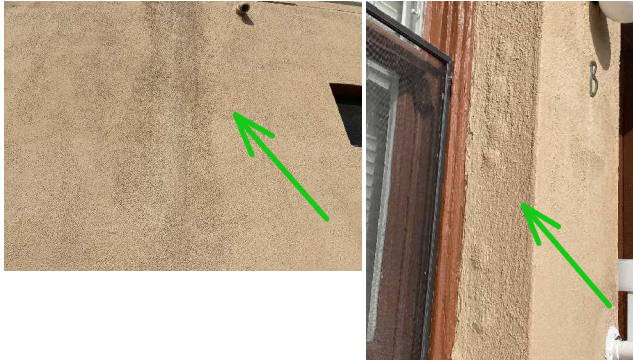
6. East Exterior Surface Type: Stucco - Stucco shows previous cracks that have been repaired and painted. stucco has blistering around windows.

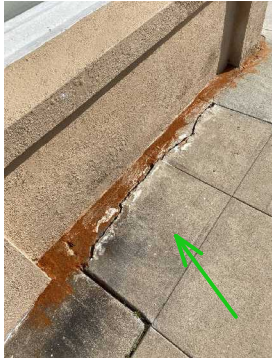
8. Differential Movement: Crack with displacement - Concrete cracked around front edge of building

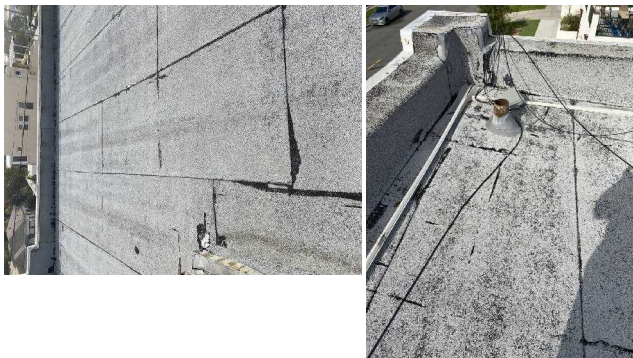
9. Main Roof Surface Material: Rolled roof material - Roof shows signs of deterioration

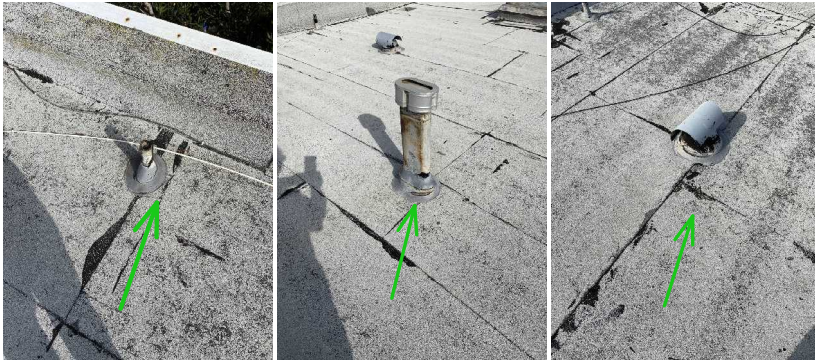
10. Plumbing Vents: Cast Iron - vents should be resealed to prevent leaks

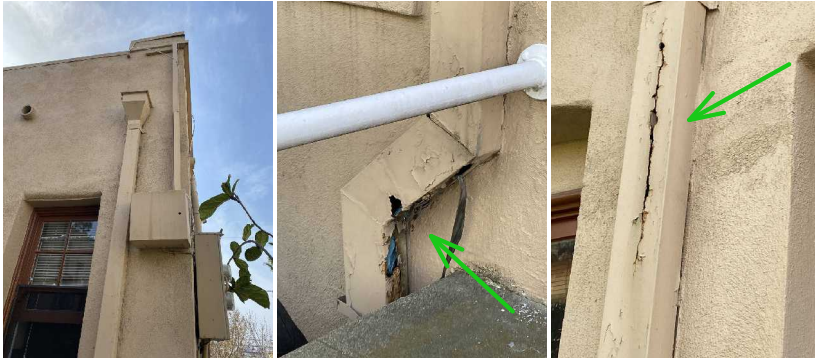
11. Downspouts: Galvanized - Some of the downspouts show rust holes and peeling paint.

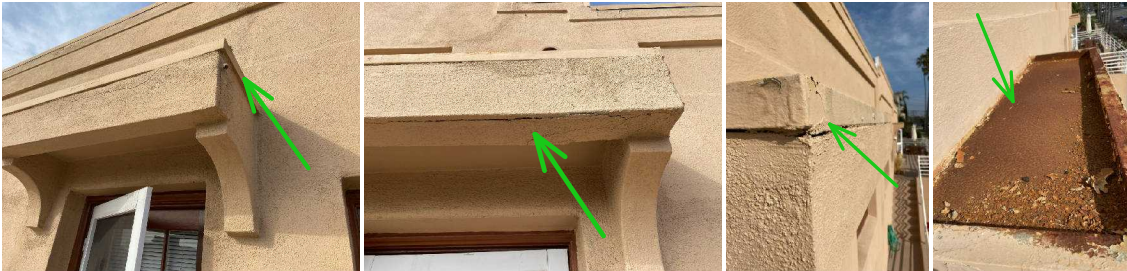
1. Main Entry: Metal, Wood, stucco - Valances above front doors have cracks, plugged or missing drain holes causing water damage.

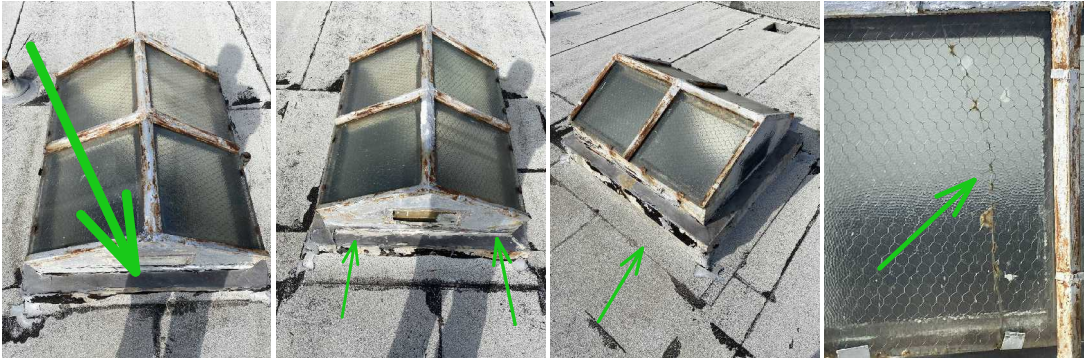
2. Skylights: Glass -  
Flashing needs to be resealed possible leakage. Broken glass

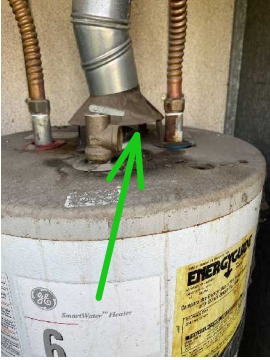
4. Outside back of unit Water Heater TPRV and Drain Tube: Copper - Missing drain tube

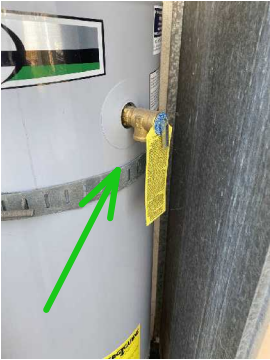
5. Outside back of unit Water Heater TPRV and Drain Tube: Copper - Missing drain tube
