Inspection Report

230 S. Catalina Ave., Unit 106
Redondo Beach, CA 90277

Wednesday, May 31, 2017

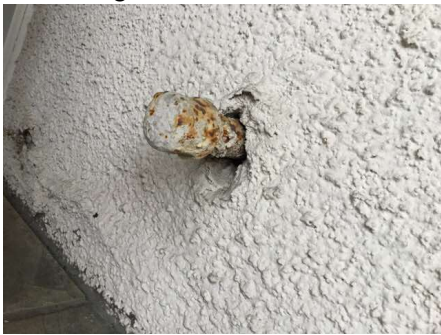
CR s-2: - There is a gap(s) in the exterior cladding at joints with pipe penetration. This can permit water entry and result in damage to the cladding and underlying building elements. We suggest that open joints or gaps in the siding should be caulked and sealed.

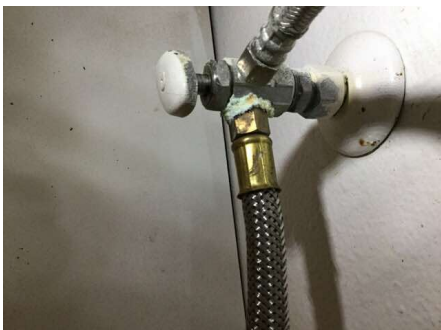
Kitchen sink

CR s-4: - In the area(s) listed below the water supply shutoff valves are noticeably corroded, but are not leaking at this time. We recommend replacing any corroded valve before leaks are discovered.

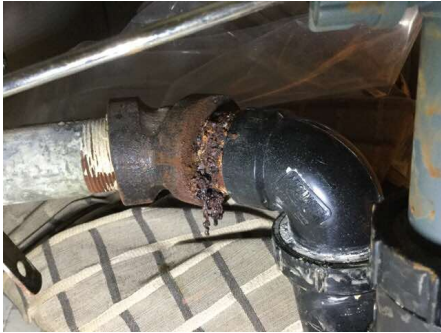
Master bathroom wash basin

CR s-5: - In the area(s) listed below although no active leak was observed, there is/are corroded and/or deteriorated drain line(s) with a limited useful life. We suggest considering such drains before leaks occur.

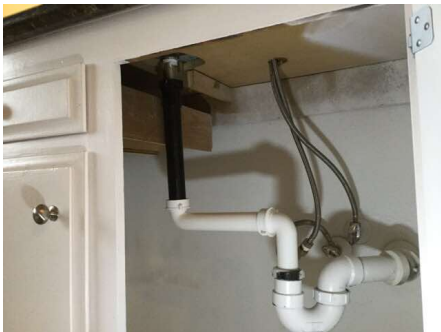
Wet bar sink

CR s-8: - In the area(s) listed below the plumbing fixture tail piece drain is more than 24 inches long before the trap. This can affect proper drain and trap performance. We suggest a qualified Plumber should make repairs or modifications as necessary.

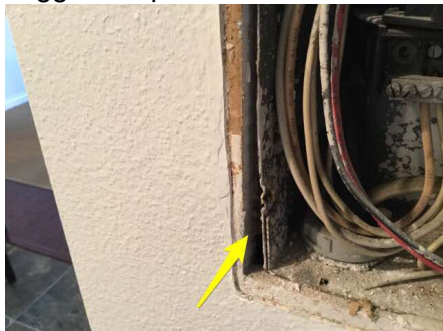
CR s-9: - The subpanel is set back and not mounted flush with the wall. There are gaps more than 1/8 inch around the sides. Both conditions are contrary to industry standards for wood framed construction. We suggest a qualified electrician should evaluate the installation and make repairs or modifications as necessary.

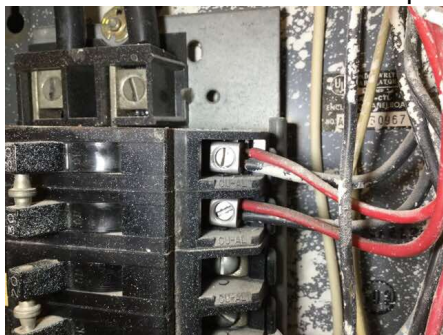
CR s-10: - Multiple wires are installed on several circuit terminals. The connectors do not appear to be designed to accommodate two circuits. This "double tapping" can be a safety hazard. We suggest a licensed electrician should correct all improper double taps.

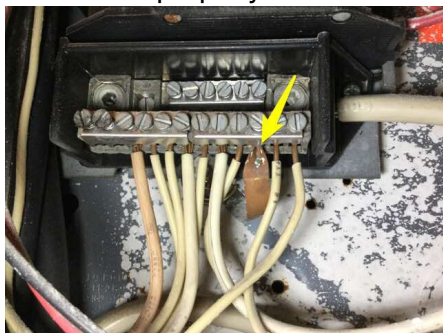
CR s-11: - The neutral and ground conductors are not properly isolated and/or properly grounded in the subpanel. We suggest all neutral conductors in the panel should be isolated from ground and the ground conductors properly bonded to it. A qualified electrician should do the work.

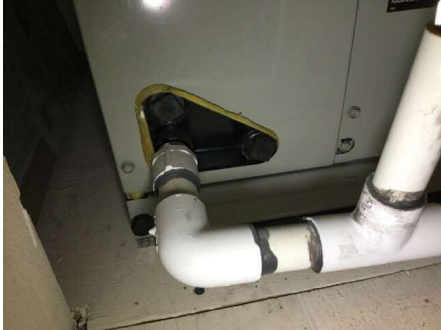
RU s-17: - The the furnace closet the secondary condensate drain from the evaporator coil is capped. If the primary drain line clogs, there is no effective backup drain and this could lead to water damage to the adjacent interior surfaces. We suggest a qualified HVAC technician should install a float switch cutoff.

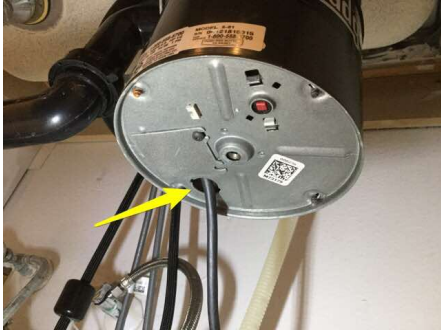
CR s-21: - Wire connections have no strain relief at the bottom of the disposal. This can allow the electric wire to come loose. No bare, exposed metal wiring should be visible under the sink, nor wire splices, any of which could be a shock hazard. We suggest an electrician make repairs.

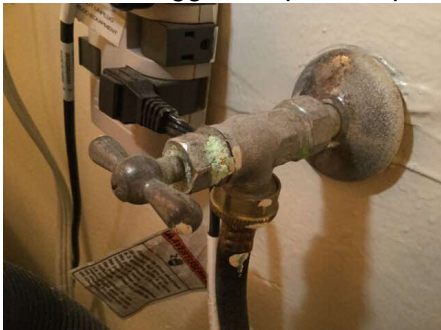
CR s-23: - The laundry hose supply valve connection(s) are heavily corroded, and show signs of previous leaks. We suggest a qualified plumber should replace the corroded connections.

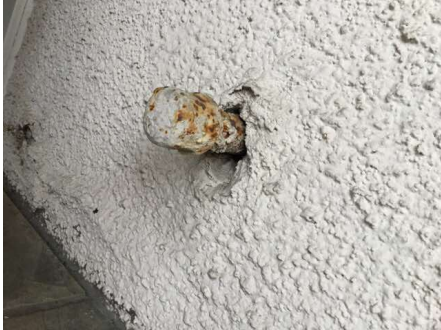
CR 23: - There is a gap(s) in the exterior cladding at joints with pipe penetration. This can permit water entry and result in damage to the cladding and underlying building elements. We suggest that open joints or gaps in the siding should be caulked and sealed.

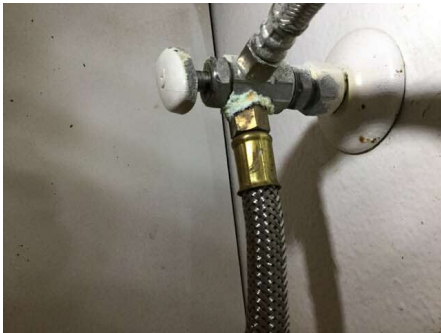
Kitchen sink

CR 35: - In the area(s) listed below the water supply shutoff valves are noticeably corroded, but are not leaking at this time. We recommend replacing any corroded valve before leaks are discovered.

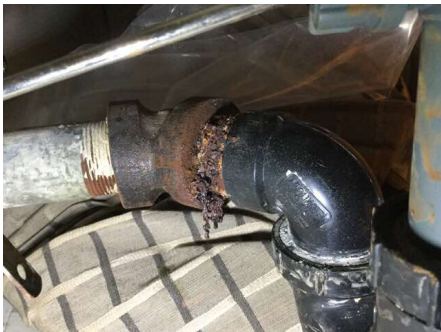
Master bathroom wash basin

CR 36: - In the area(s) listed below although no active leak was observed, there is/are corroded and/or deteriorated drain line(s) with a limited useful life. We suggest considering such drains before leaks occur.

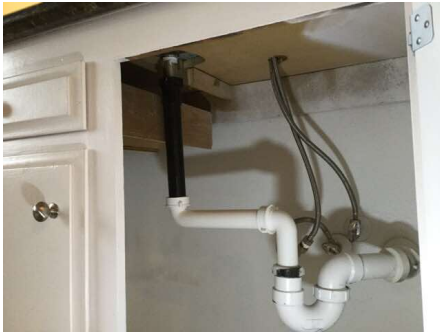
Wet bar sink

CR 39: - In the area(s) listed below the plumbing fixture tail piece drain is more than 24 inches long before the trap. This can affect proper drain and trap performance. We suggest a qualified Plumber should make repairs or modifications as necessary.

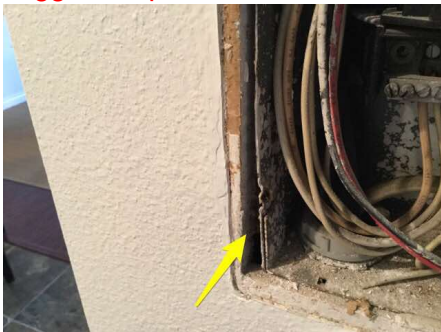
CR 47: - The subpanel is set back and not mounted flush with the wall. There are gaps more than 1/8 inch around the sides. Both conditions are contrary to industry standards for wood framed construction. We suggest a qualified electrician should evaluate the installation and make repairs or modifications as necessary.

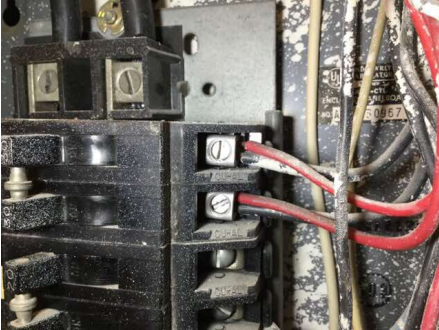
CR 48: - Multiple wires are installed on several circuit terminals. The connectors do not appear to be designed to accommodate two circuits. This "double tapping" can be a safety hazard. We suggest a licensed electrician should correct all improper double taps.

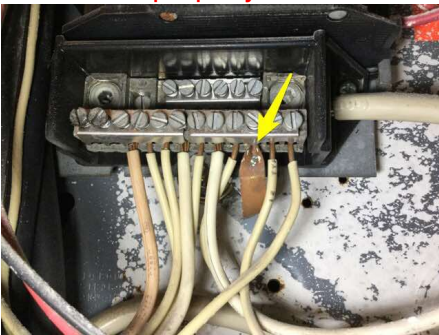
CR 49: - The neutral and ground conductors are not properly isolated and/or properly grounded in the subpanel. We suggest all neutral conductors in the panel should be isolated from ground and the ground conductors properly bonded to it. A qualified electrician should do the work.

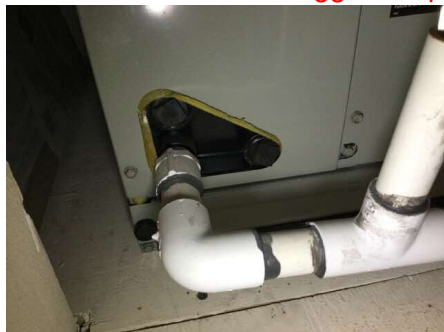
RU 71: - *The the furnace closet the secondary condensate drain from the evaporator coil is capped. If the primary drain line clogs, there is no effective backup drain and this could lead to water damage to the adjacent interior surfaces. We suggest a qualified HVAC technician should install a float switch cutoff.*

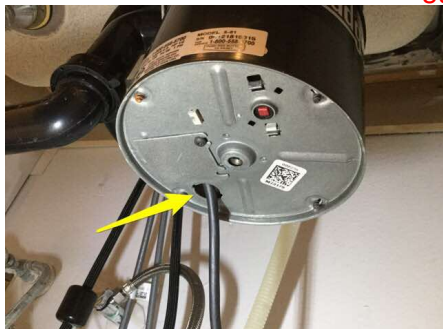
CR 91: - Wire connections have no strain relief at the bottom of the disposal. This can allow the electric wire to come loose. No bare, exposed metal wiring should be visible under the sink, nor wire splices, any of which could be a shock hazard. We suggest an electrician make repairs.

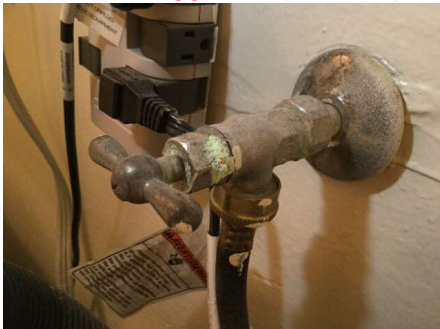
CR 111: - The laundry hose supply valve connection(s) are heavily corroded, and show signs of previous leaks. We suggest a qualified plumber should replace the corroded connections.
