Inspection Report

Property Address:
255 Via Del Salinas
Paso Robles CA 93446

3/28/2018

Murphree Building Inspections

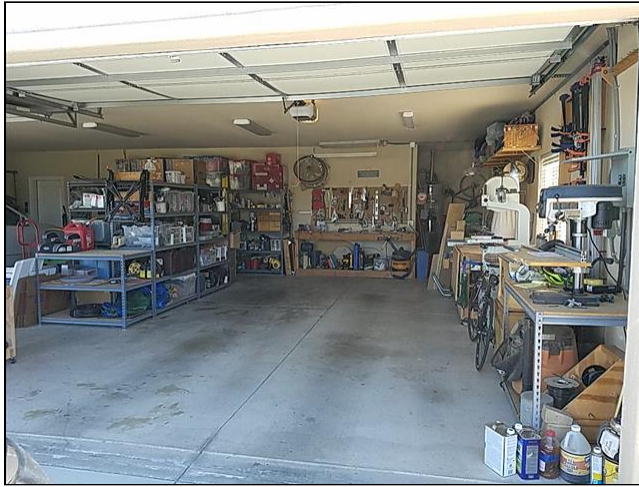
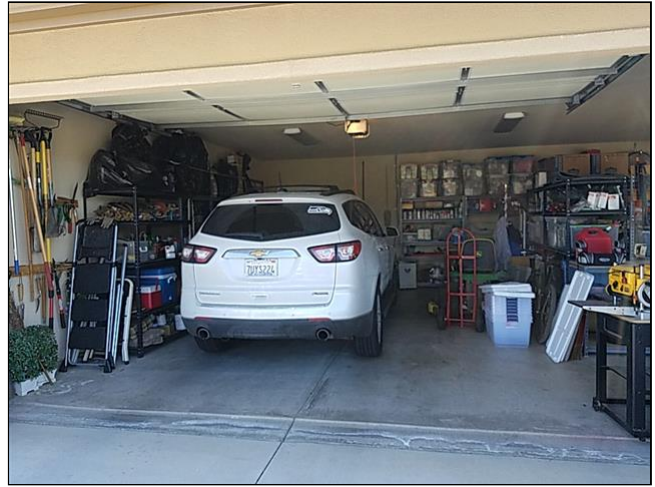
(1) FURTHER EVALUATION

Access impaired to the garage. Storage blocked complete inspection. Recommend further inspection, as needed.

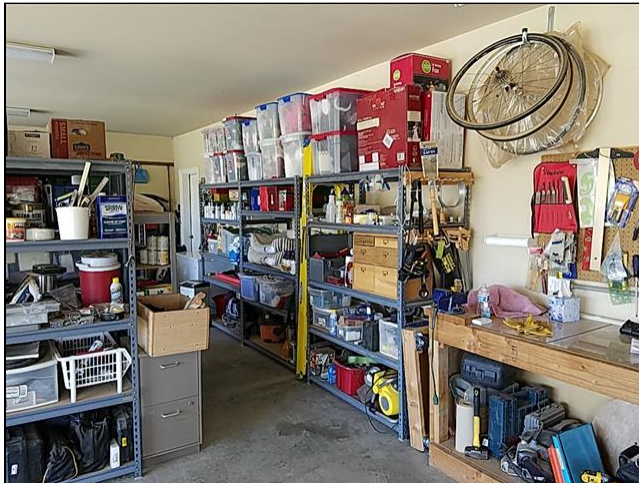
(2) INSTALLATION NEEDED

Free standing shelving across the rear and left side walls should be properly attached to the wall if they are to remain in the home. This will help prevent displacement during seismic activity.

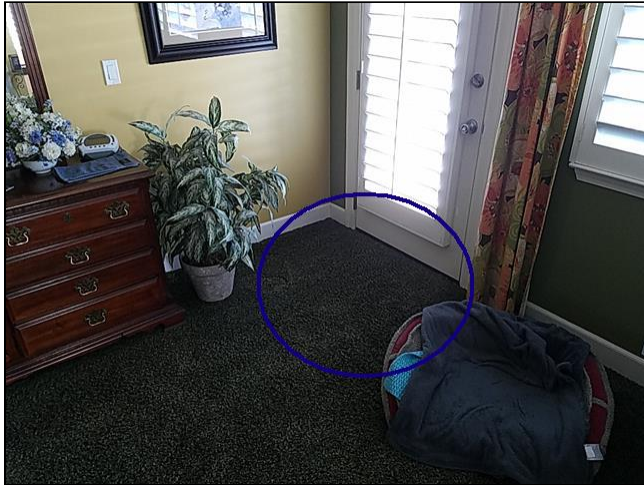
INSTALLATION NEEDED

Carpet at the door off the rear of the master bedroom door is dragging at the bottom of the door. Recommend replacement of the carpet in the door opening area with a lower profile hard flooring that will allow the door to operate smoothly and prevent damage to the door weather stripping.
