October 21, 2016

SPC 7732-01

Subject: LIMITED GEOTECHNICAL REVIEW
1830 Galaxy Drive
Newport Beach, CA 92660

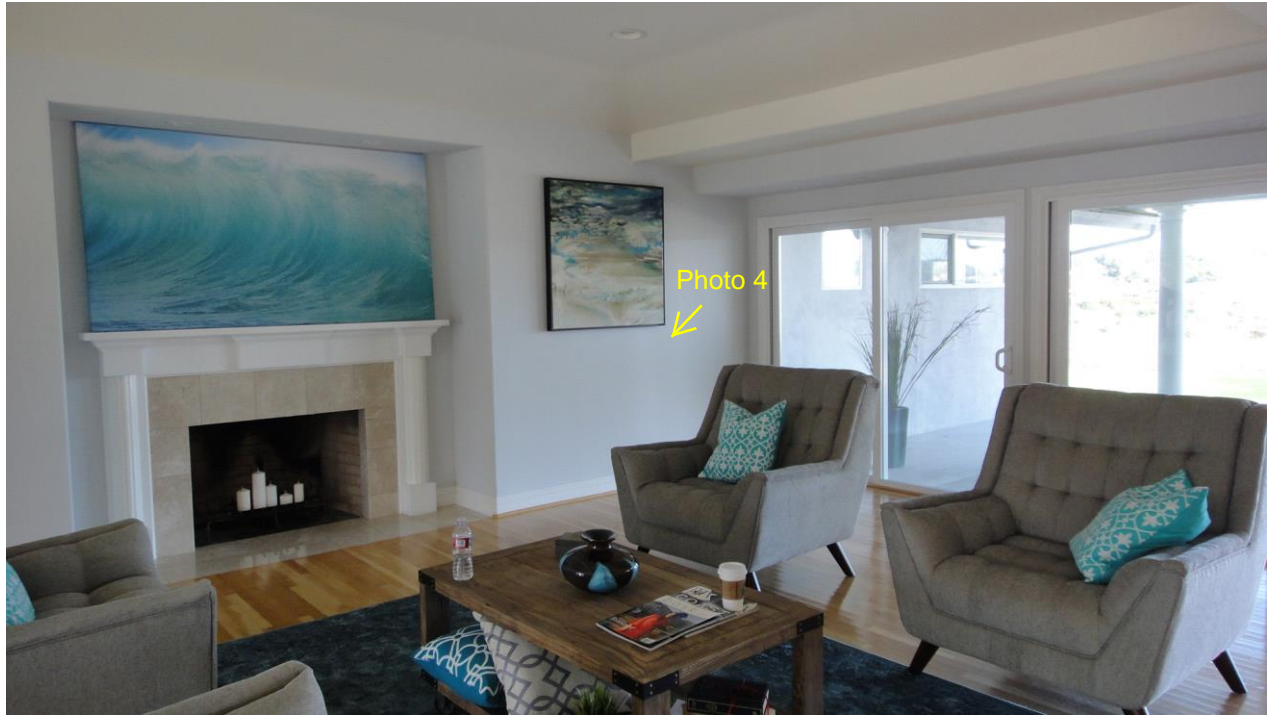
- There is minor, hairline wall cracking in the living room (Photos 3, 4), as well as in a few other locations inside the residence. In the master bedroom, there is wall cracking near a window where a sliding glass door used to be (Photos 5, 6).
- There is wood strip flooring throughout the living room, dining room, and kitchen. Uniform cupping of the floor was observed in all three of these areas (Photos 7, 8).
- At the right side of the kitchen near the refrigerator, there are baseboard and floor separations (Photos 9, 10). These separations are likely related to a past leak in this area.
- No notable signs of floor sloping toward the rear bluff were observed.

- There is minor, hairline wall and ceiling cracking in some areas of the house. The cracking in the master bedroom is located where a sliding glass door once was, and is likely due to methods used to place the drywall and stucco after the door was removed.

Photo 3: A view of the living room. There is some minor hairline wall cracking in the living room as well as in a few other locations inside the residence.

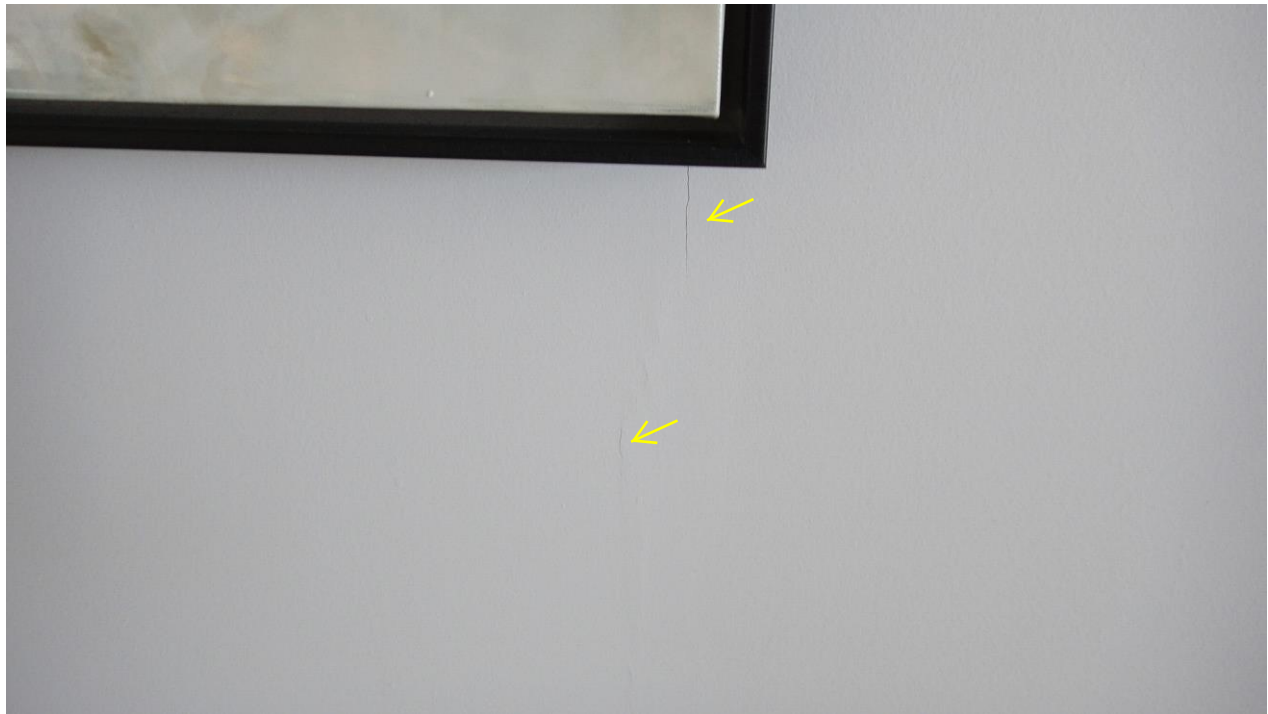
Photo 4: A closer view of the hairline wall cracking.

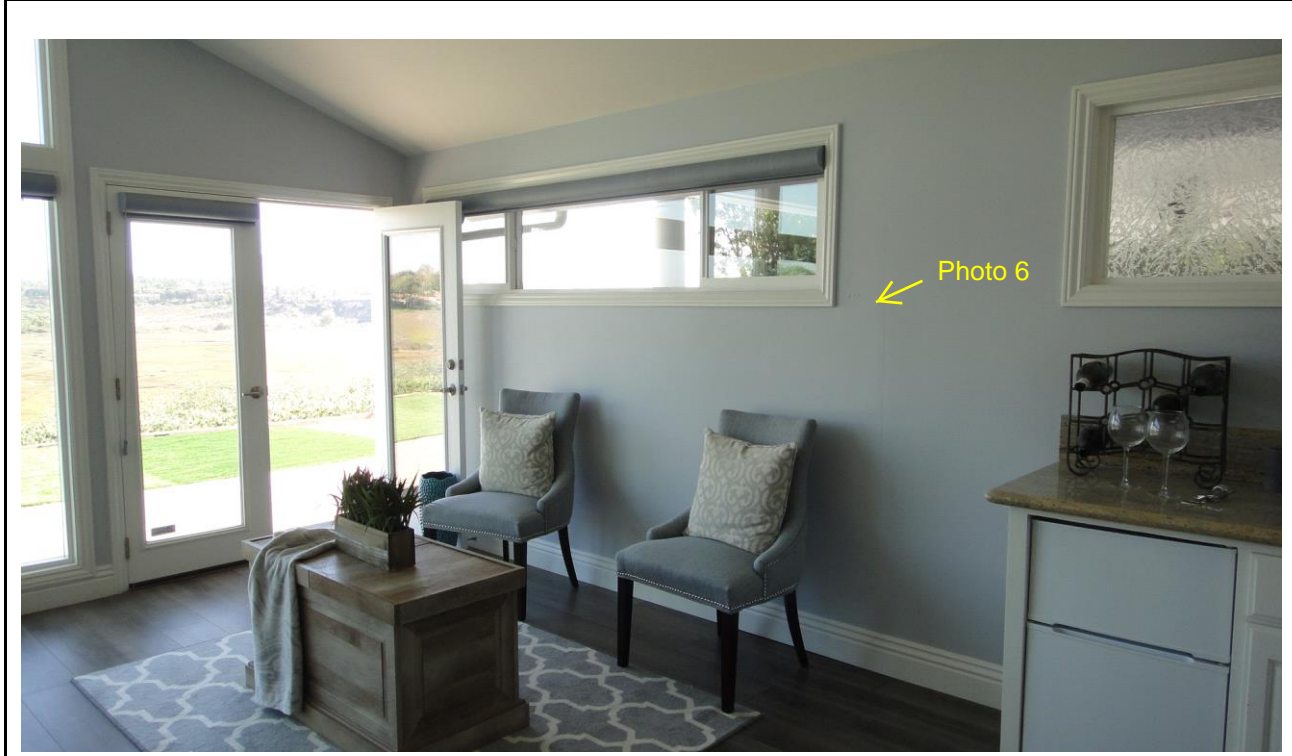
Photo 5: A view of the master bedroom. There is wall cracking at the corner of the window, where there used to be a sliding glass door. DSC00057.JPG

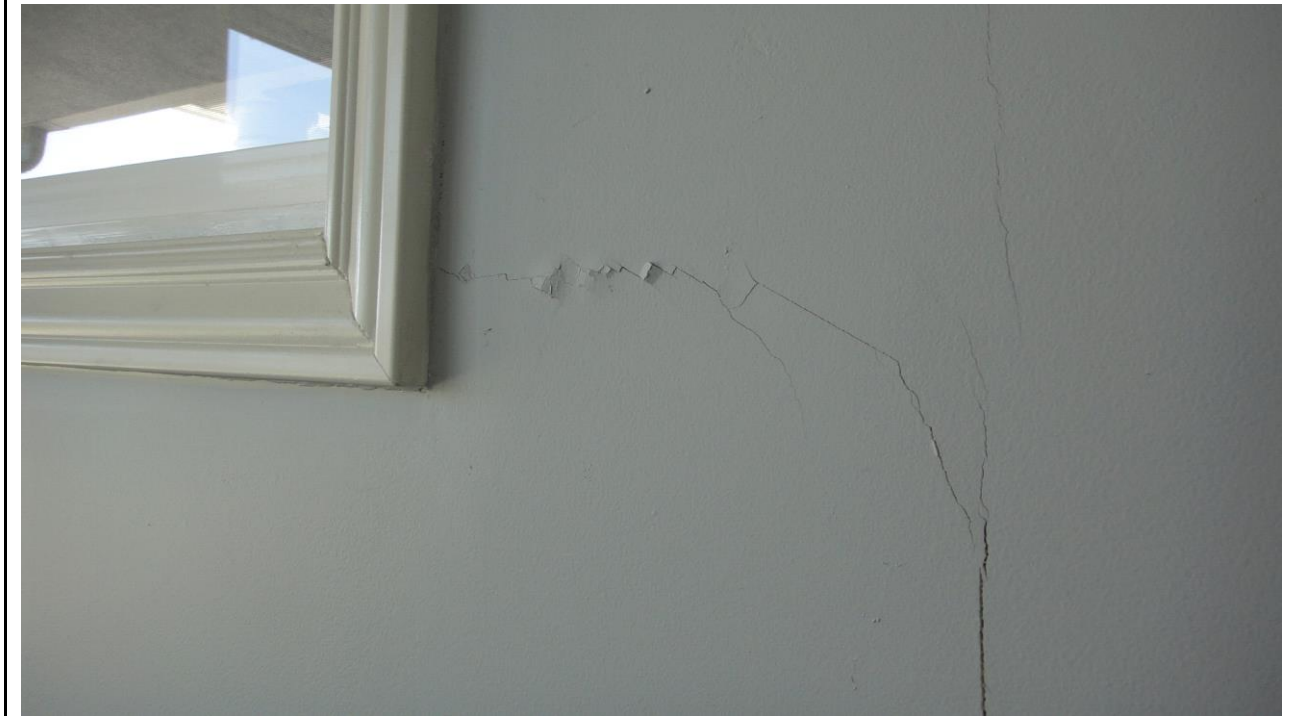
Photo 6: A closer view of the cracking. DSC00060.JPG

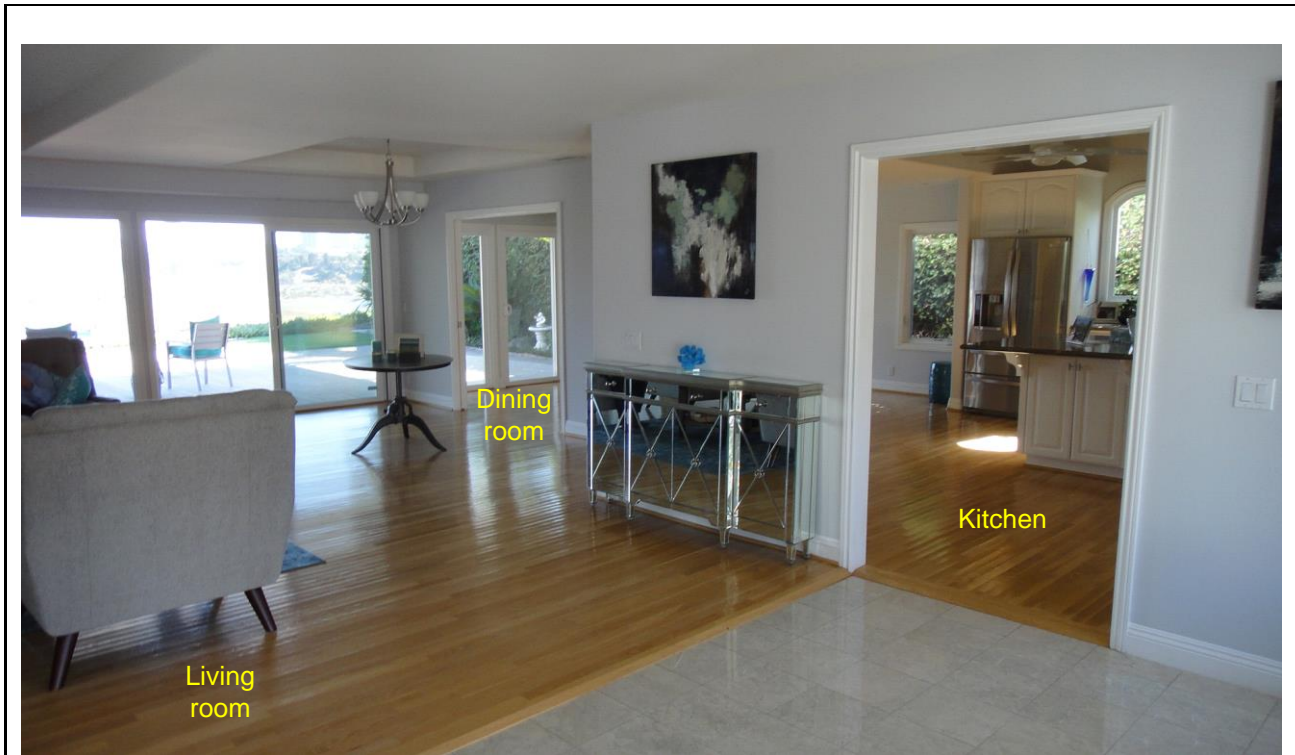
- There is cupping of the wood strip flooring throughout the living room, dining room, and kitchen. In the absence of plumbing leaks, the uniform cupping is likely due to natural soil moisture permeating through the slab. It is unknown what type of moisture barrier was placed over the slab prior to the wood flooring installation.

Photo 7: An overview of the living room, dining room, and kitchen. There is cupping of the strip wood flooring throughout this area.

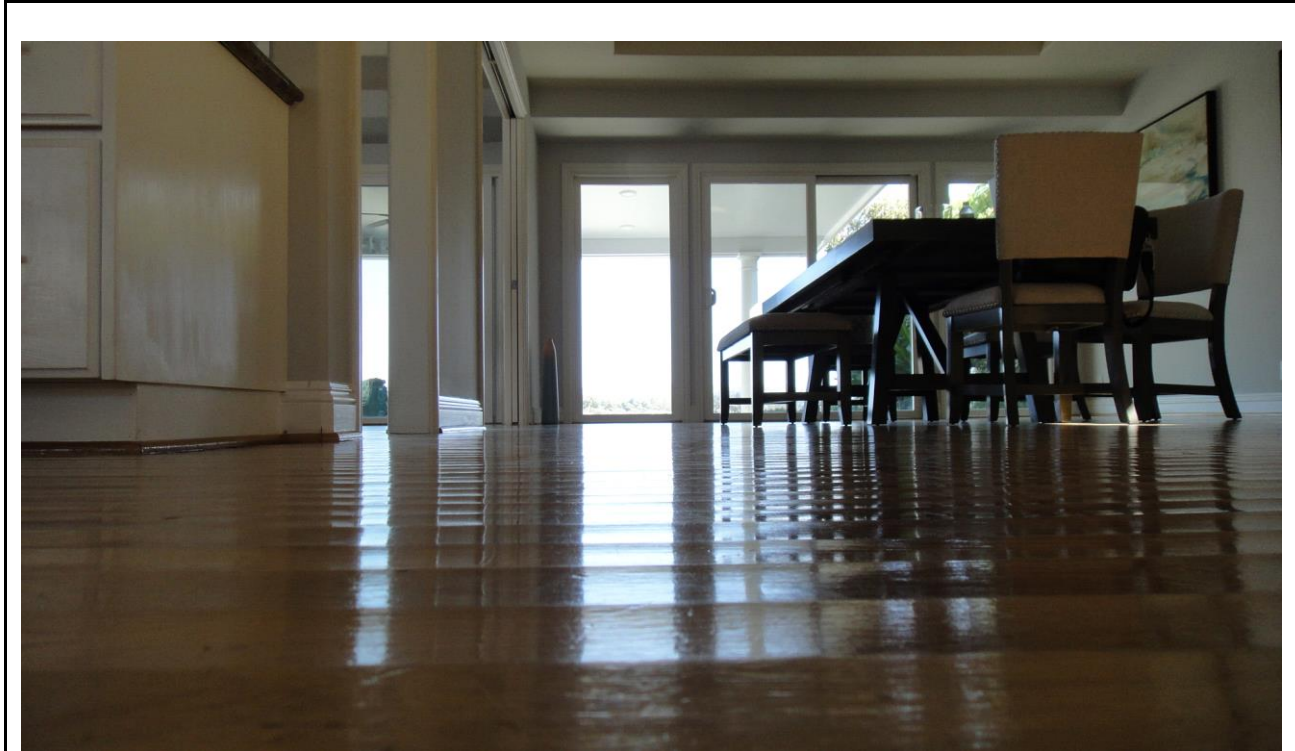
Photo 8: A close-up view of the floor cupping in the kitchen/dining room.

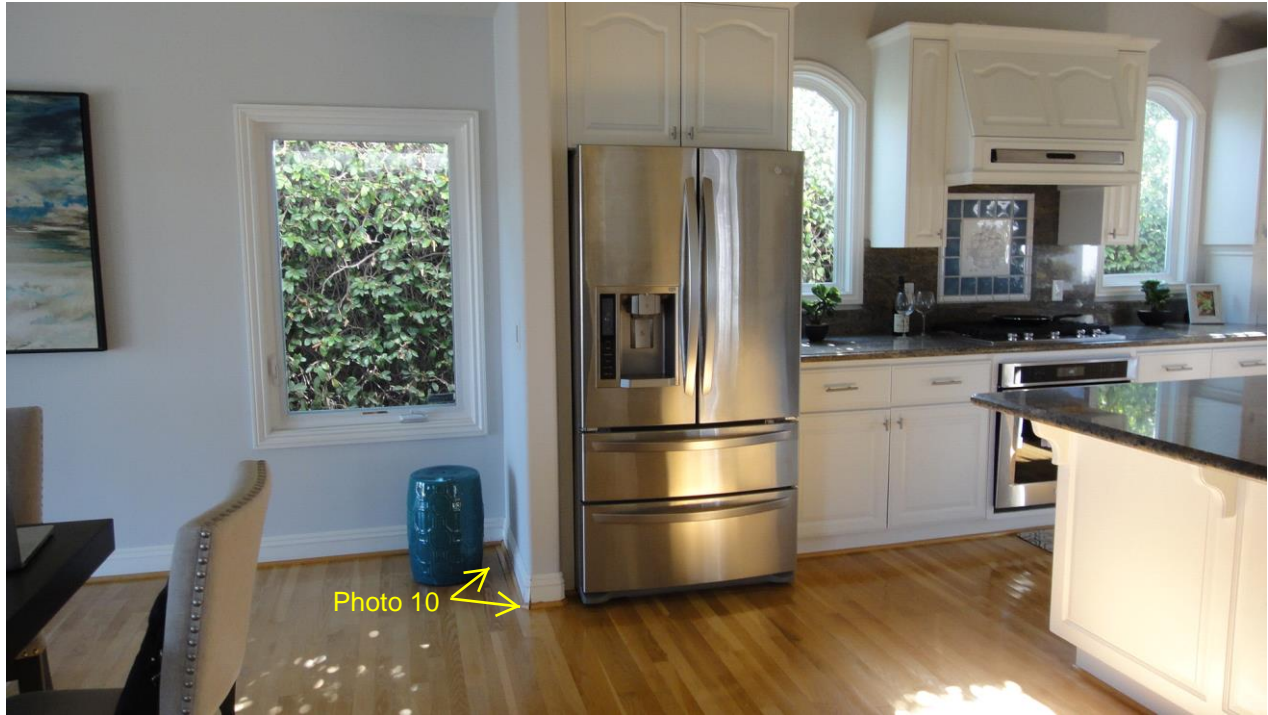
Photo 9: A view of the right side of the kitchen. There are baseboard and floor separations next to the refrigerator, likely due to a past leak. DSC00065.JPG

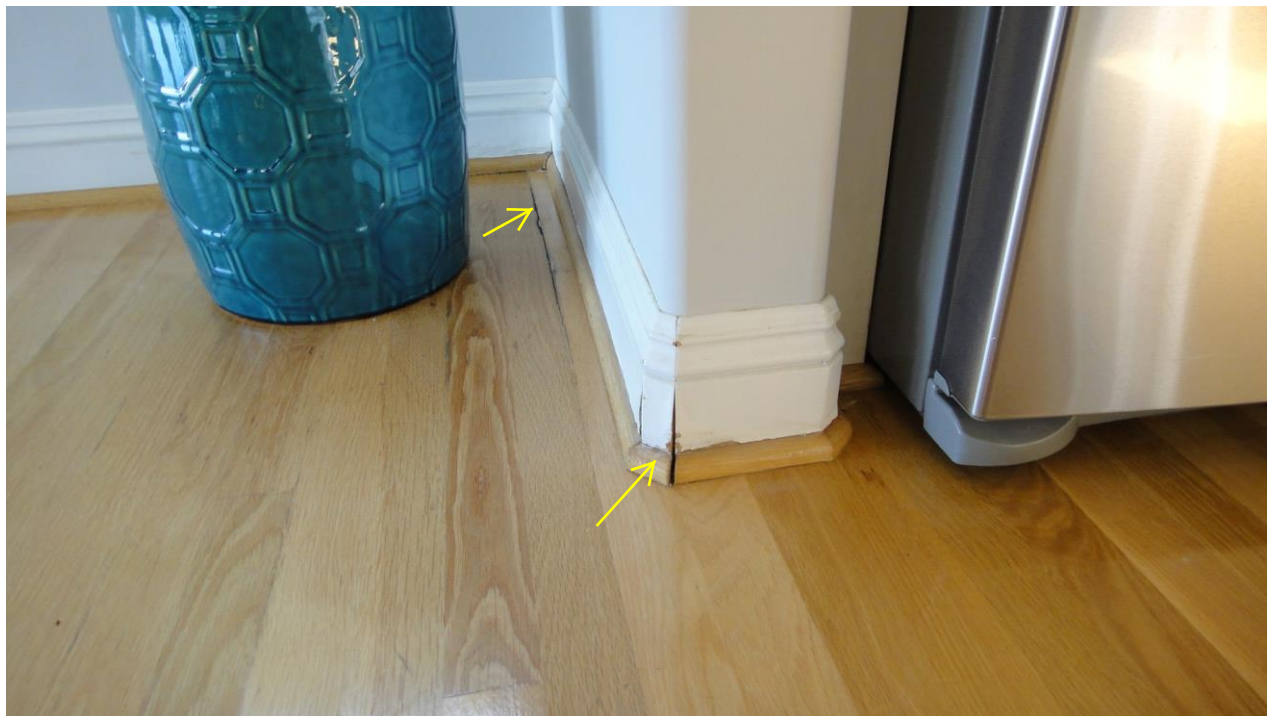
Photo 10: A closer view of the baseboard and floor separations. DSC00066.JPG

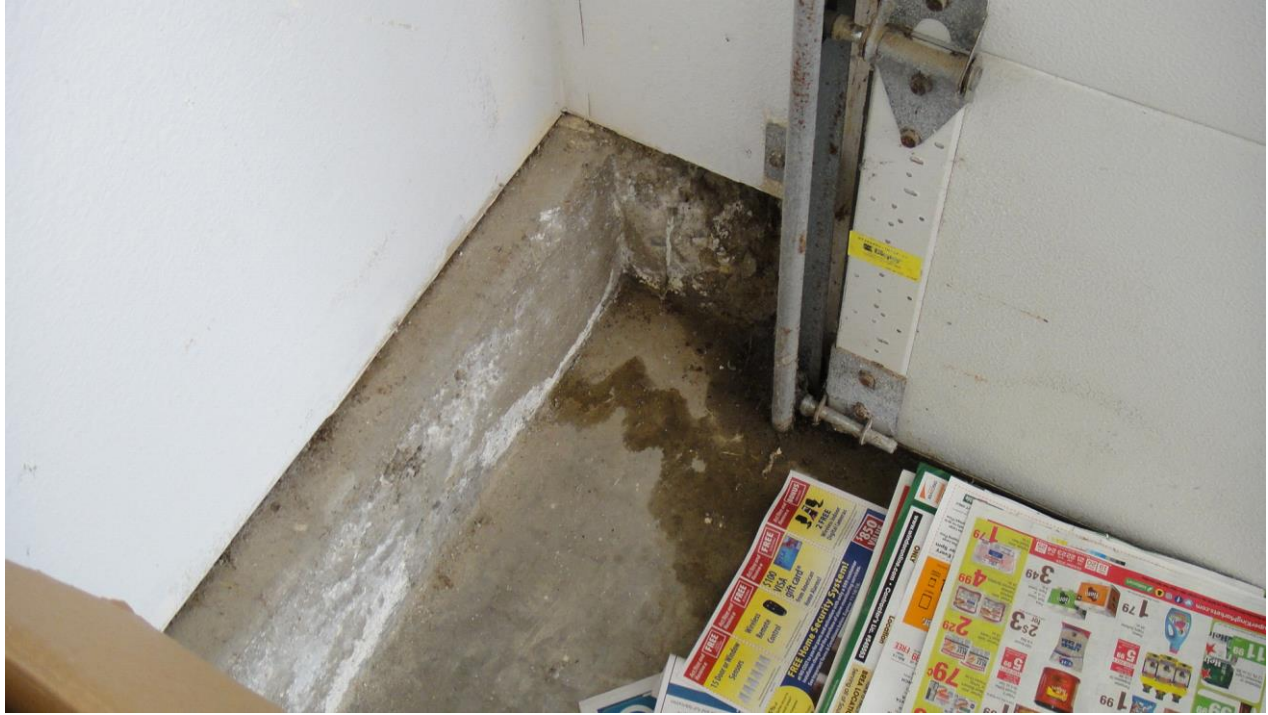
- The garage slab was observed to be in good condition, with only minor, ordinary shrinkage-related cracking. However, there is water intrusion and efflorescence at the front right corner of the garage (Photo 11). The source of moisture appears to be from the raised planter outside of the front right corner of the garage (Photo 12).
- Minor shrinkage cracking of the driveway was observed.

- There is moisture intrusion at the front right corner of the garage. Moisture appears to be entering from the adjacent raised planter, and it is likely that no waterproofing was placed on the garage wall before the planter was constructed.

Photo 11: Water intrusion and efflorescence (white salt deposits) at the front right corner of the garage. DSC05242.JPG

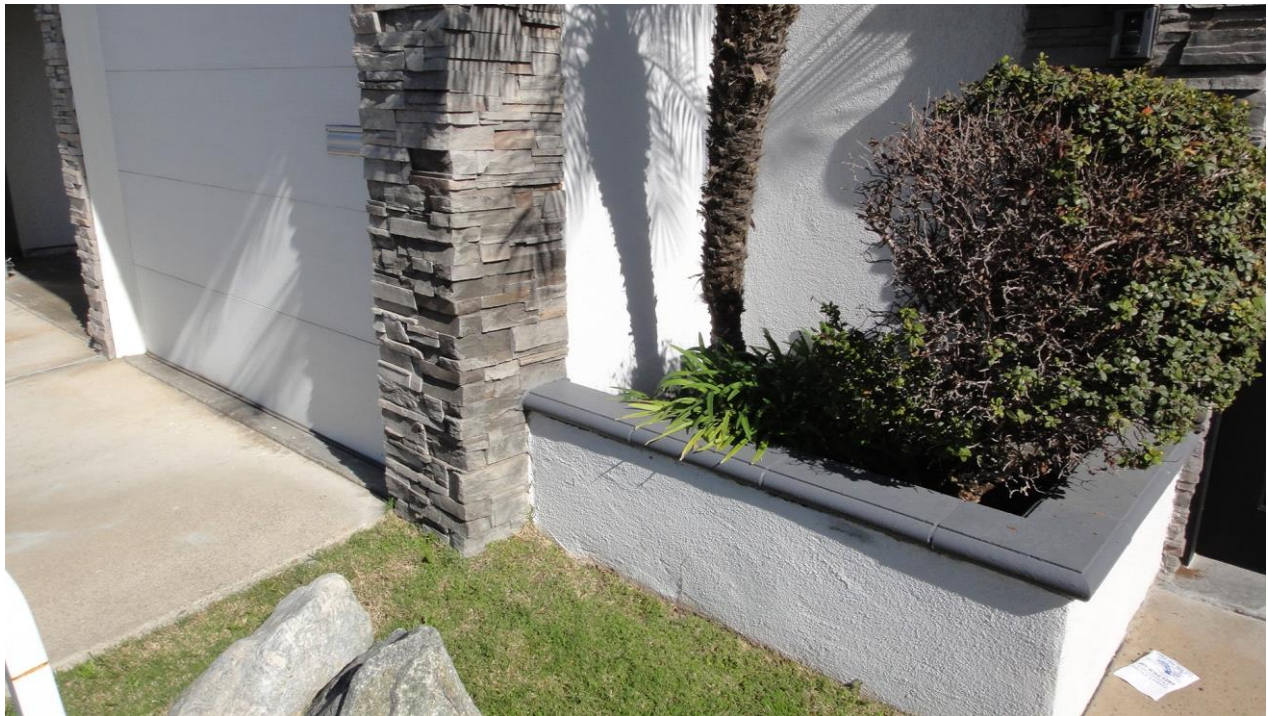
Photo 12: The raised planter at the front right corner of the garage. Water is intruding into the garage from the planter. DSC00083.JPG

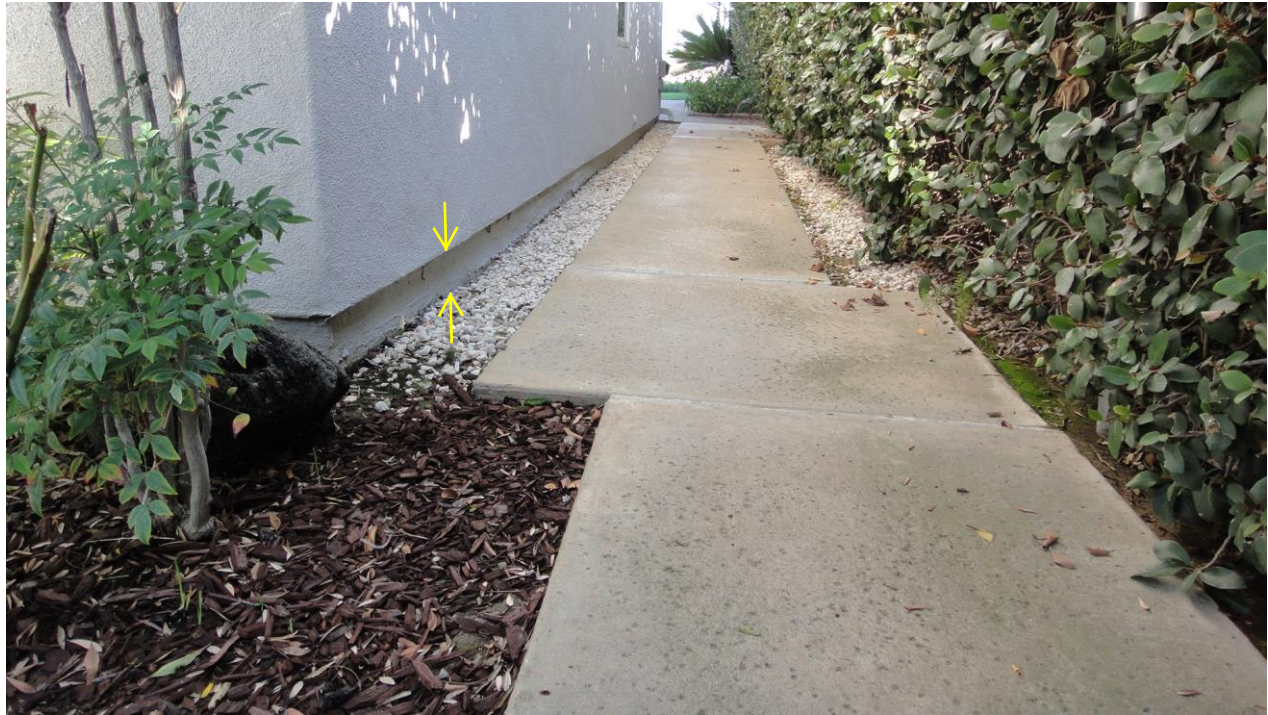
Photo 13: An overview of the right side yard. There is good clearance between the weep screed and the ground elevation. DSC00022.JPG

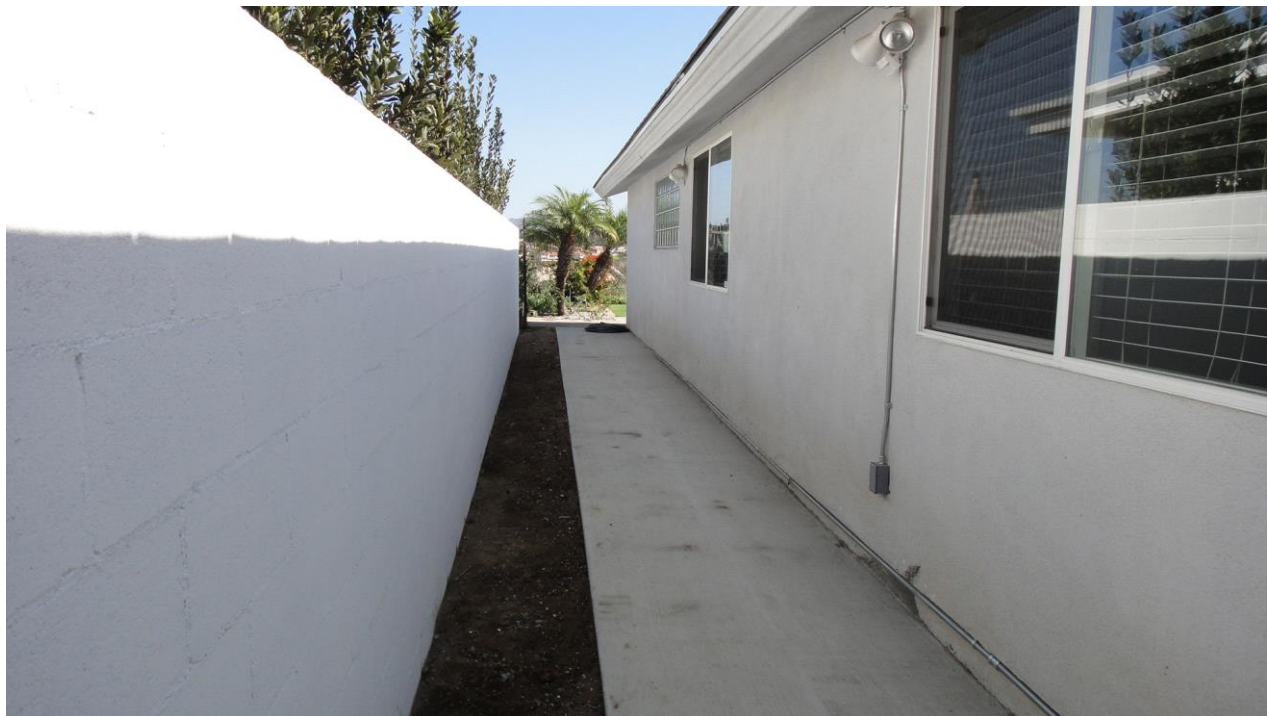
Photo 14: An overview of the left side yard. The side yard concrete is sloped to drain toward the street. DSC05200.JPG

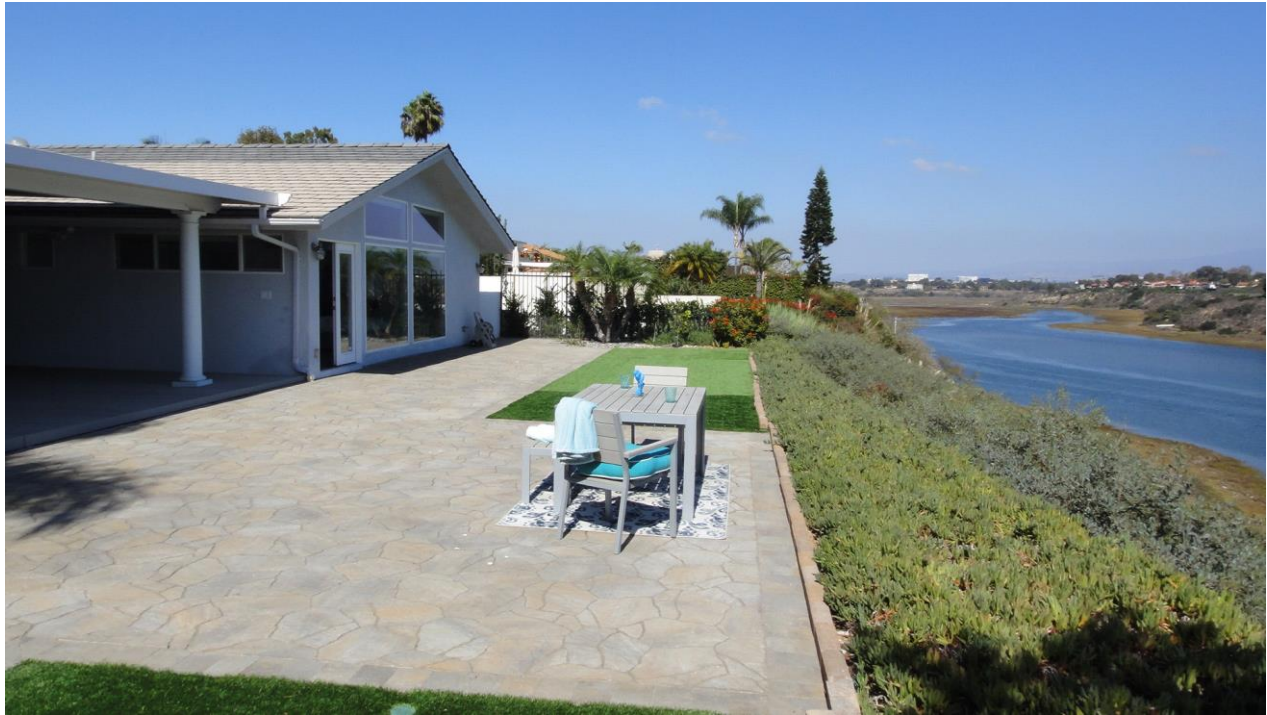
Photo 15: An overview of the rear yard and the adjacent steep bluff descending to Newport Bay.

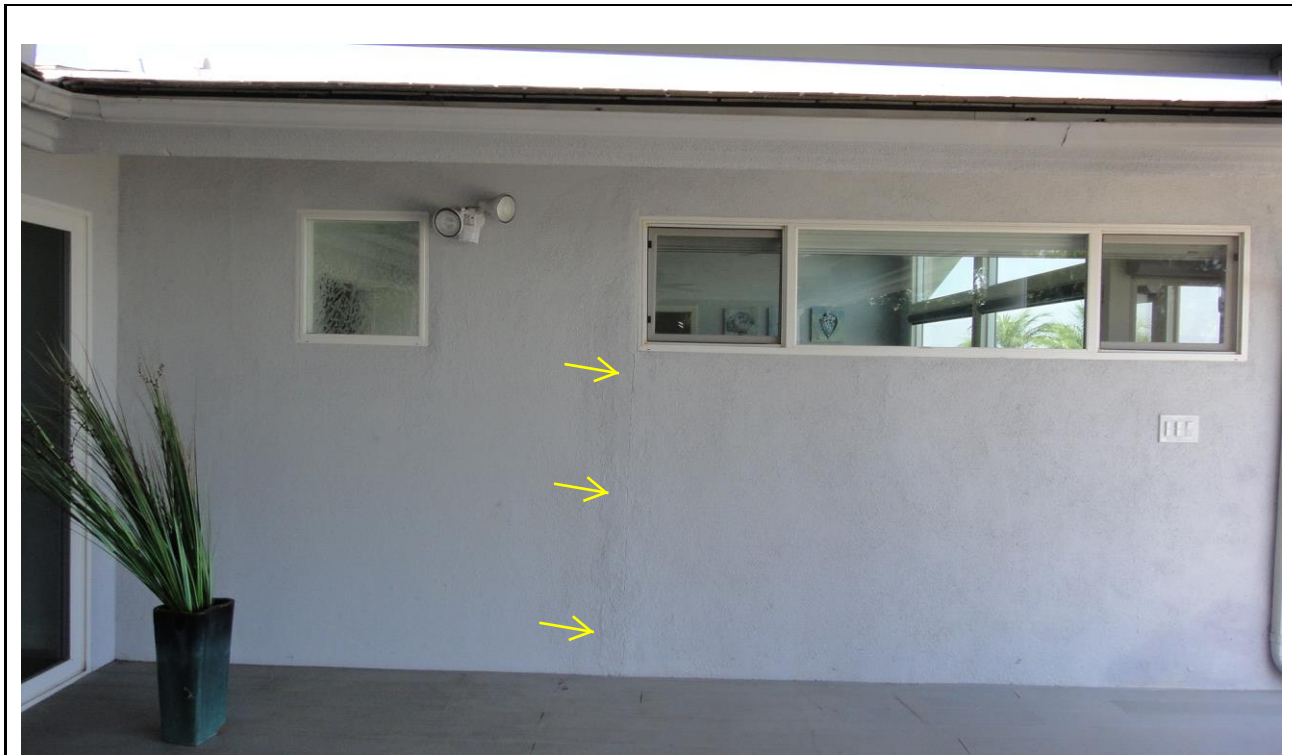
Photo 17: A view of the exterior wall of the master bedroom. There is stucco cracking where a sliding glass door used to be (see Photo 5). DSC00031.JPG

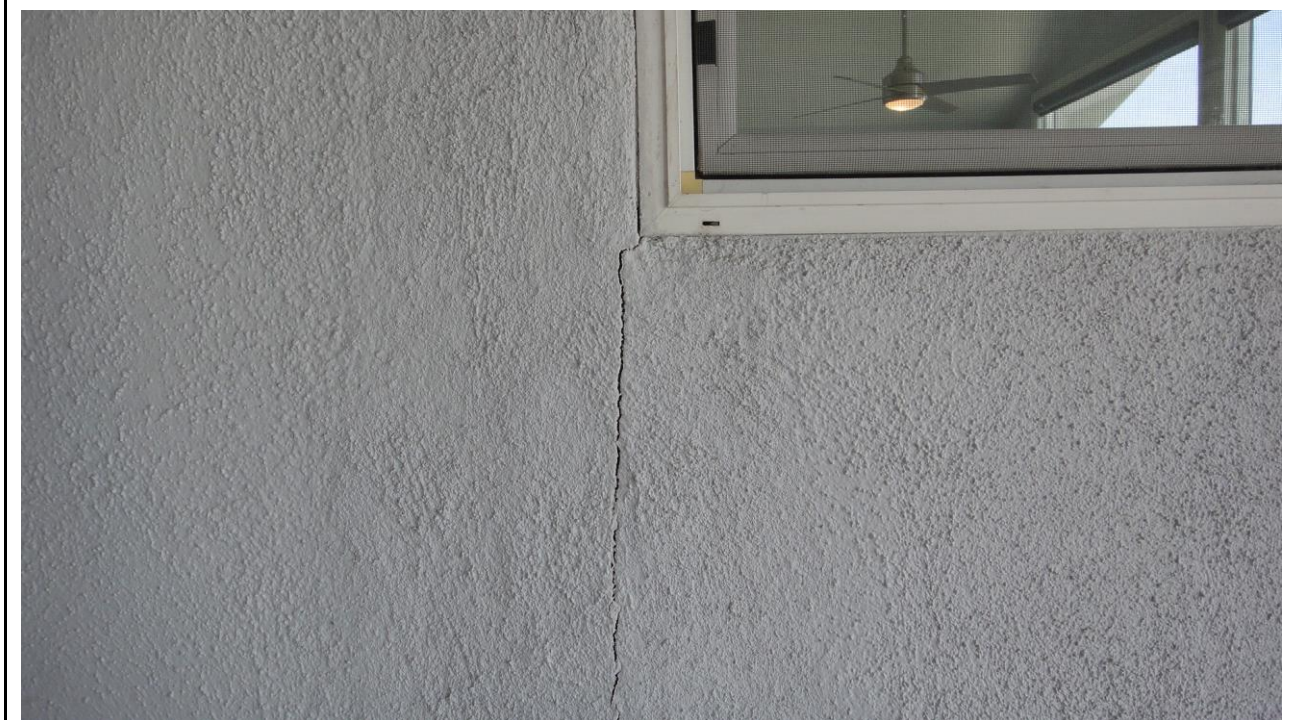
Photo 18: A closer view of the stucco cracking. DSC00055.JPG

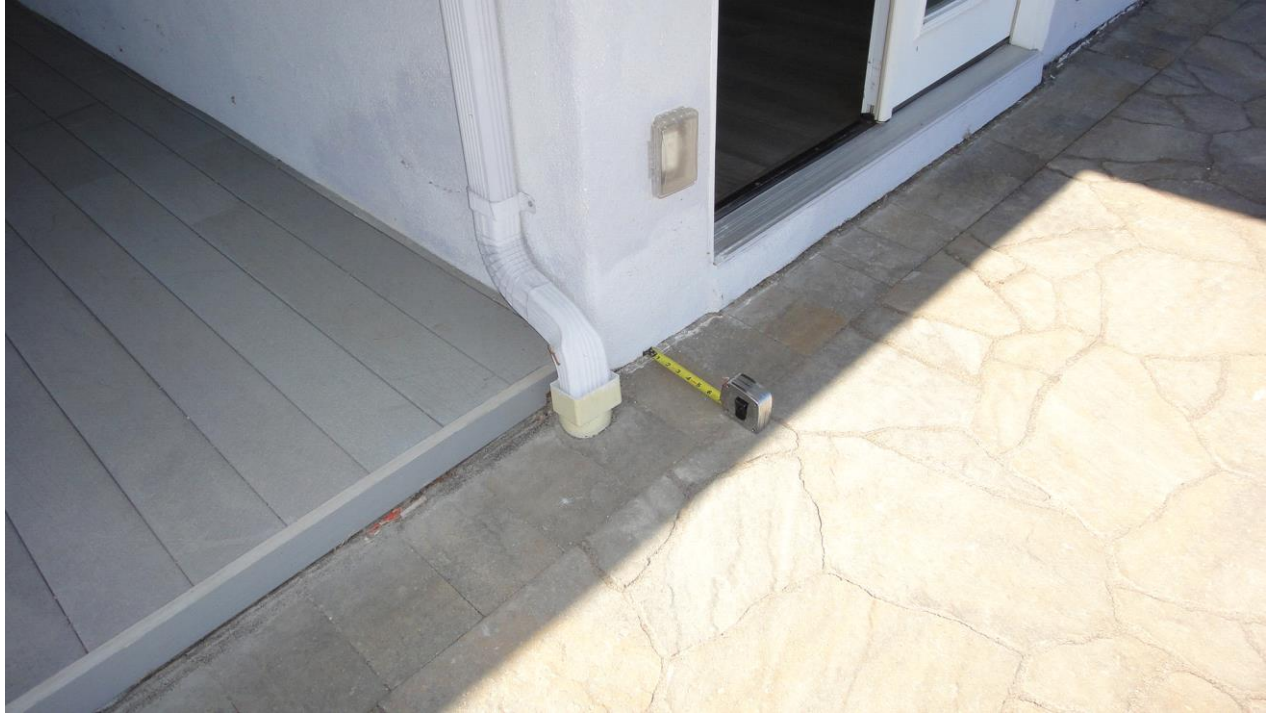
- The rear decorative concrete pavers were installed just over a year ago and have developed cracks and separations of about half an inch toward the rear bluff. The potential for additional slopeward movement should have been considered in the design of the new patio.

Photo 19: A view of the patio where it meets the rear of the residence. The patio has moved toward the bluff.

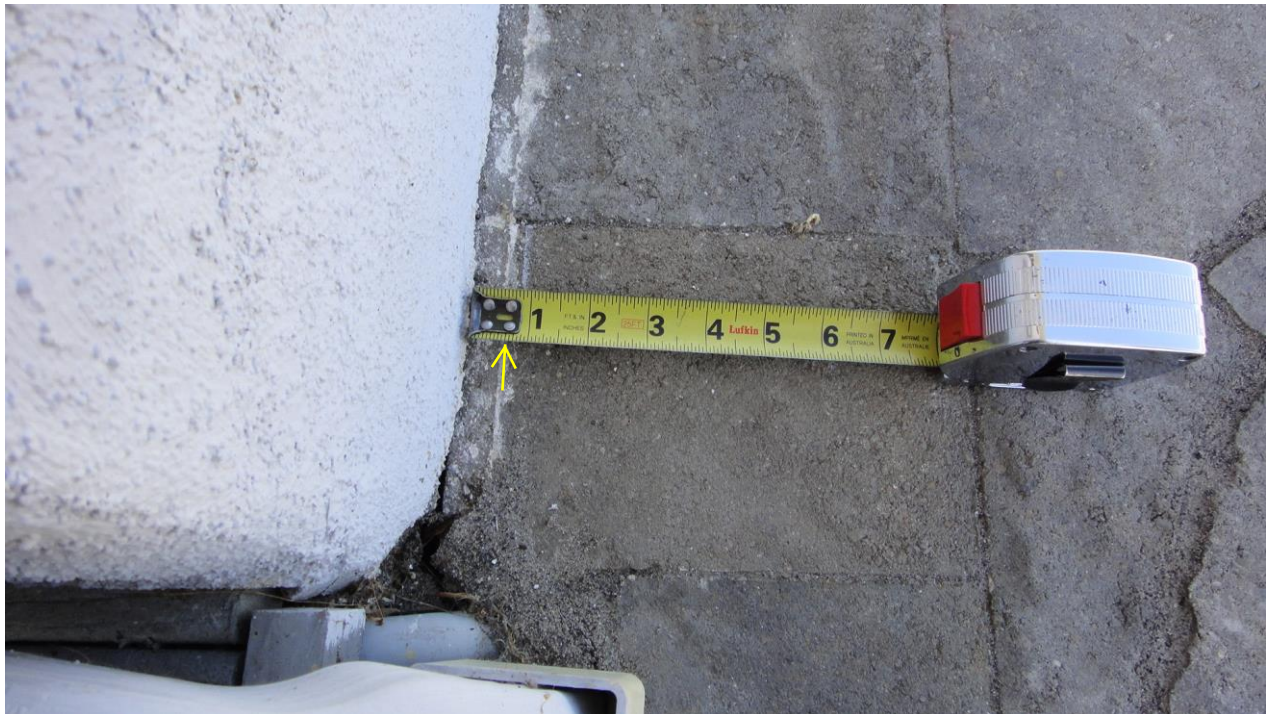
- Movement toward the bluff was also observed at the right side of the patio (Photos 23, 24). It appears that the entire patio has shifted laterally toward the bluff by up to half an inch (see Photo 20) in a little over a year.
- Although there are rain gutters and downspouts for the rear portion of the house and some area drains in the rear yard, drainage conditions should be improved. Rain gutters and downspouts should also be installed along the front and sides of the house to collect and discharge roof runoff water away from the foundation soils. Further, additional drains should be installed to minimize the flow of water toward the bluff.

Photo 20: A closer view of patio movement toward the bluff, measuring about 1/2 of an inch.

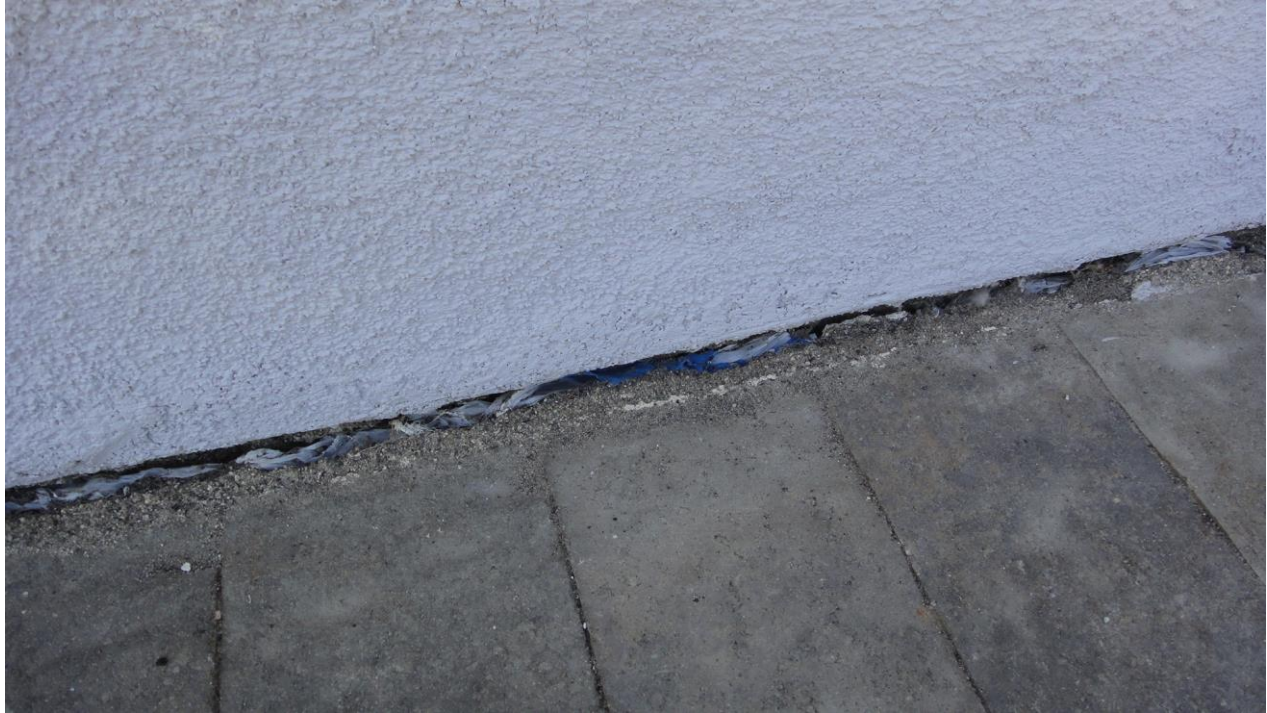
Photo 21: Another location of patio movement toward the bluff.

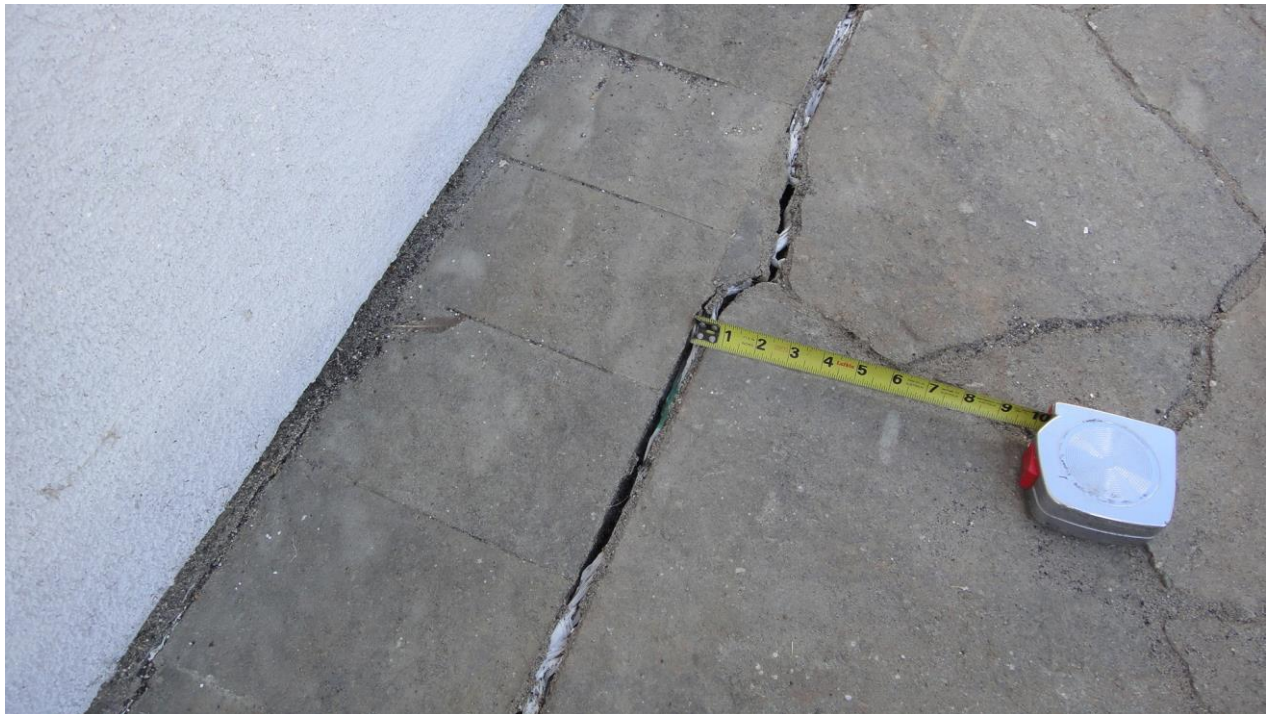
Photo 22: Another patio separation at the rear of the residence. This separation is also indicative of movement toward the bluff.

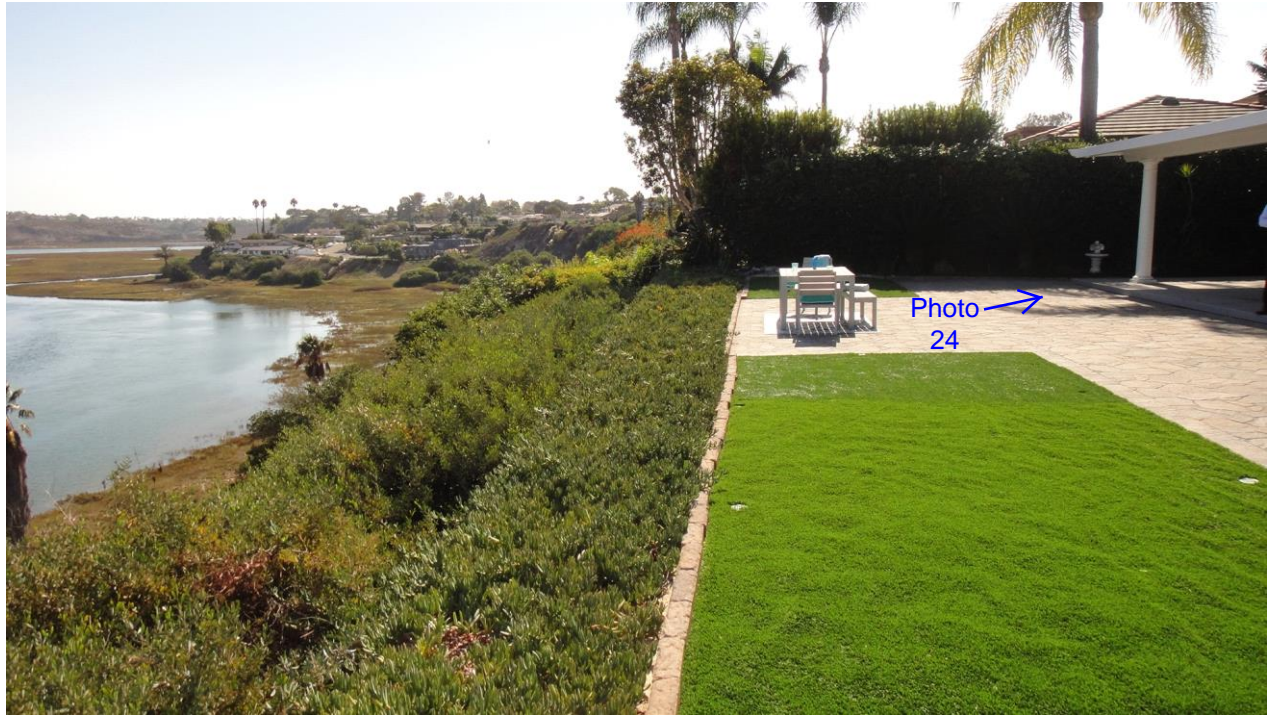
Photo 23: An overview of the right side of the rear yard. Note the steep bluff directly behind the property.

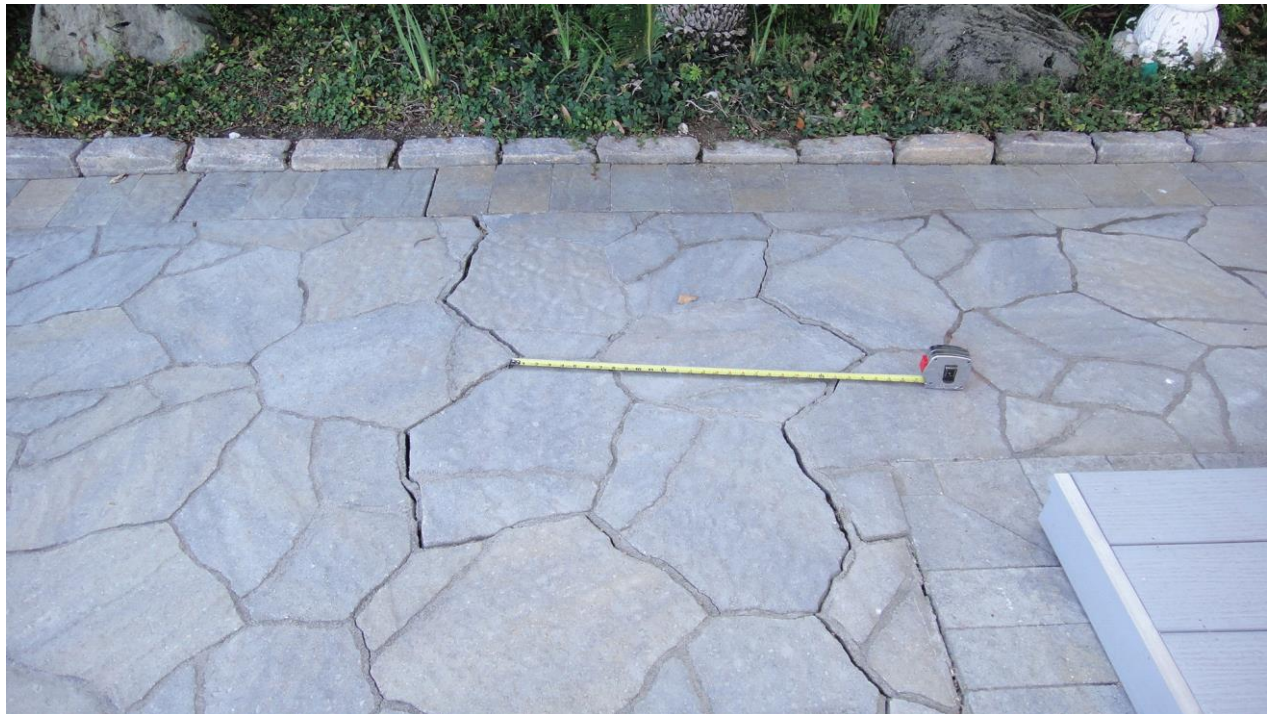
Photo 24: Patio separations at the right side of the patio. These separations also indicate movement toward the bluff.

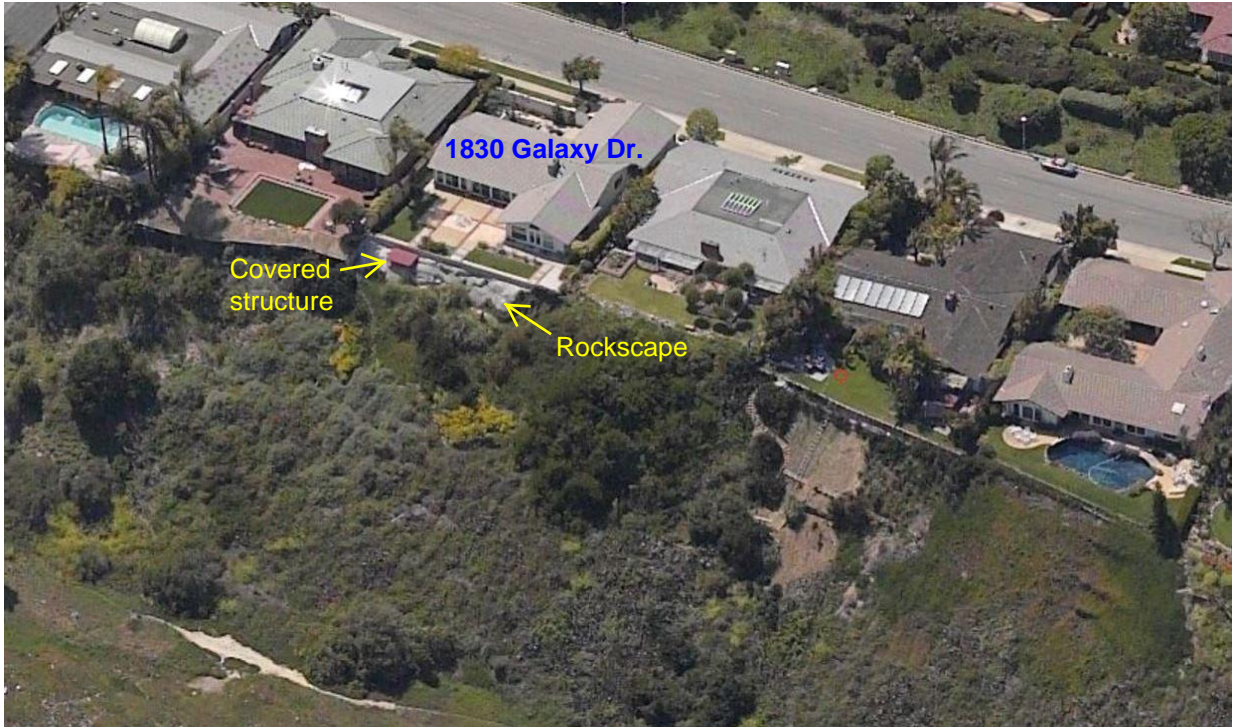
- An aerial photo from April 27, 2003 shows heavy vegetation growing on the bluff behind the subject property (Photo 25). Rockscape and a covered structure were built along the top of the bluff.
- An aerial photo from June 22, 2005 (after heavy winter rains) shows a large slope failure of the bluff behind several homes on Galaxy Drive (Photo 26).

Photo 25: An aerial photo from April 27, 2003. There is heavy vegetation covering the bluff. Note the rockscape and covered structure at the top of the bluff behind the property.

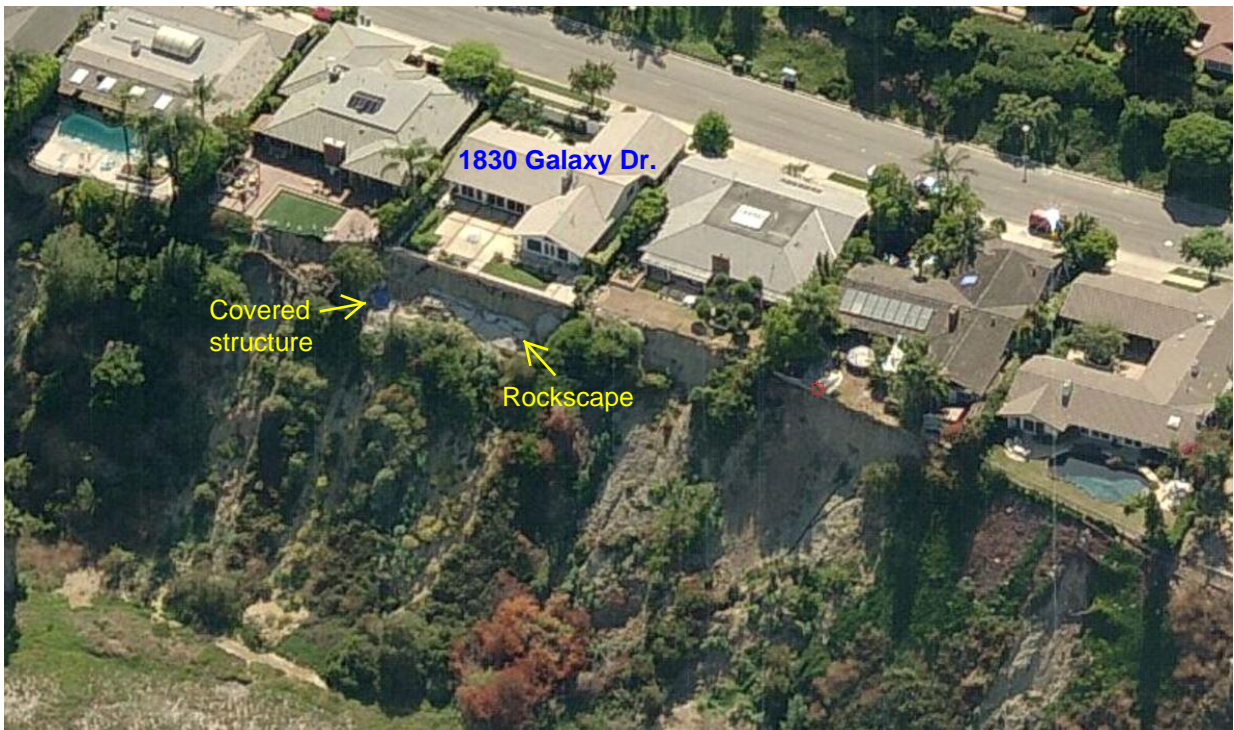
Review of historical aerial photos indicates that the bluff behind the property and adjacent lots experienced a large slope failure in the winter of 2004/2005 following heavy rains (see Photo 26). Even though the bluff was highly vegetated prior the slope failure (see Photo 25), the heavy rains were able to saturate the sandy soil and induce the slope failure. We understand that retaining walls were built as part of the slope repair. However, no permits or details of the repairs were found at the City of Newport Beach.

- The steep bluff behind the property and adjacent lots experienced a large slope failure in the winter of 2004/2005 following heavy rains. We understand that retaining walls were built as part of the slope repair; however, the details of the repairs are not known. The bluff area, in general, is susceptible to landsliding under adverse conditions, such as periods of intense rainfall or moderate to high-intensity earthquakes.

Photo 26: An aerial photo from June 22, 2005, following heavy winter rains. A large slope failure has occurred on the bluff behind several homes. Note that the rockscape and covered structure have fallen down the bluff.
