4842 Rockbluff Dr, Rolling Hills Estates, CA 90274
Inspection prepared for: Mike Eardley
Real Estate Agent: Cameron Stearns -

Date of Inspection: 8/17/2020 Time: 10:00 AM Size: 1865
Weather: Clear, warm, dry
Order ID: 215396

Sewer Camera Inspection

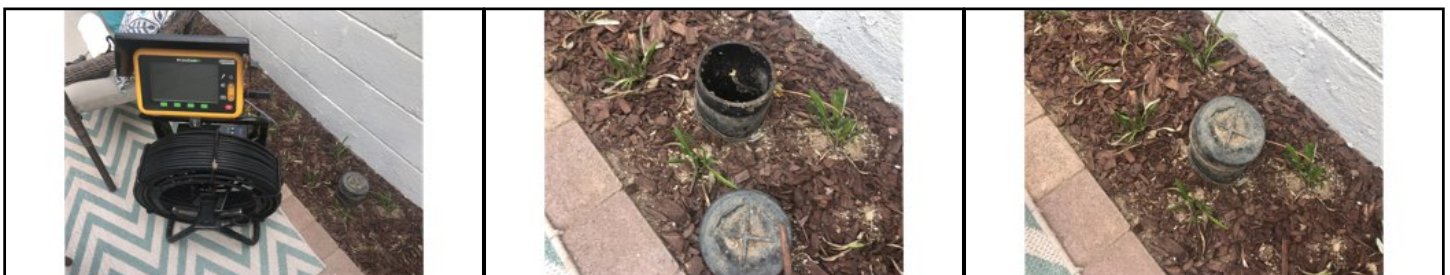
Clean out and equipment used for inspection.

Clean out cap removed.

Clean out.

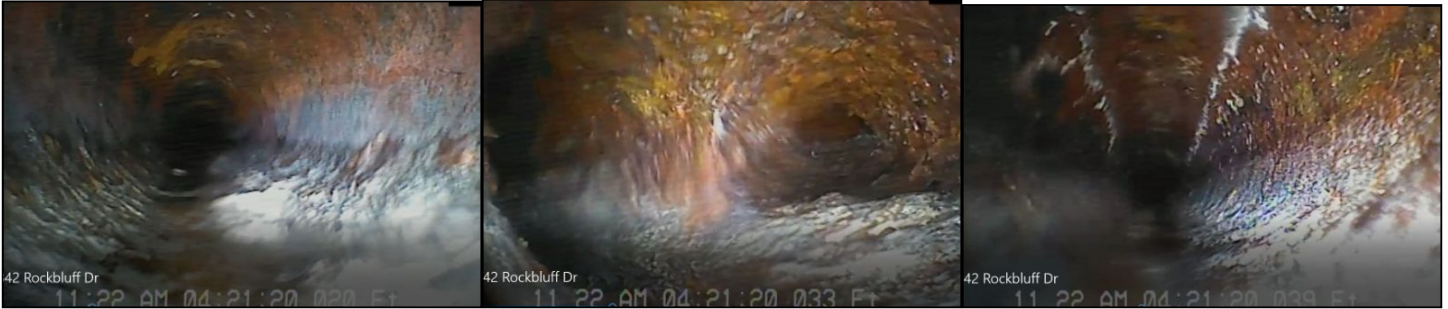
Sewer line sludge observed - cleaning recommended

Condition of sewer line at 20 feet. Condition of sewer line at 33 feet. Condition of sewer line at 39 feet.

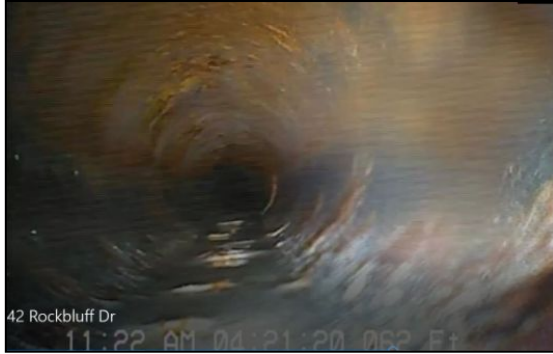
The sewer camera was unable to reach the main city connection due to issues with the piping design or layout of the sewer line, further evaluation is recommended by a licensed plumber

Final distanced reached at 62 feet.

We recommend that you consult with a licensed plumber for further evaluation, cleaning and any repairs needed

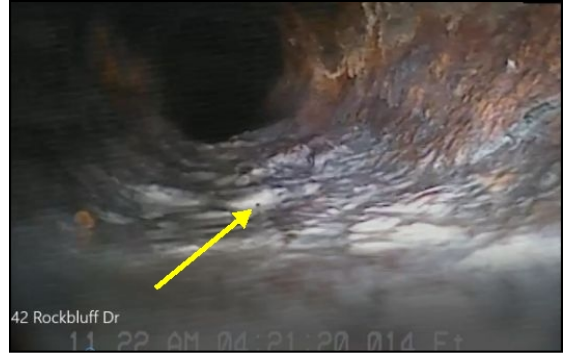
Sewage present at 14 feet.
