Cornerstone Inspection, Inc

Property Inspection Report

1274 Bond Street, San Luis Obispo, CA 93405
Inspection prepared for: Chris Nielsen.
Real Estate Agent: -

Date of Inspection: 4/10/2018 Time: 9:00 AM
Age of Home: 1939 Size: 900
Order ID: 3355

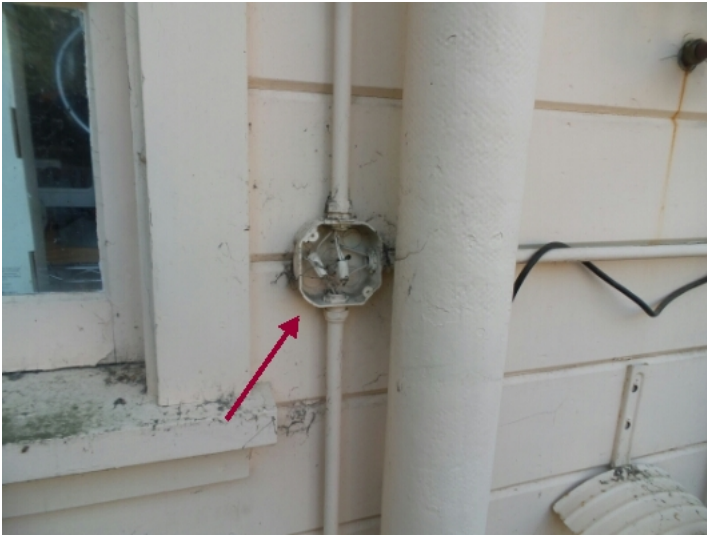
There is one or more open junction boxes that should be sealed.

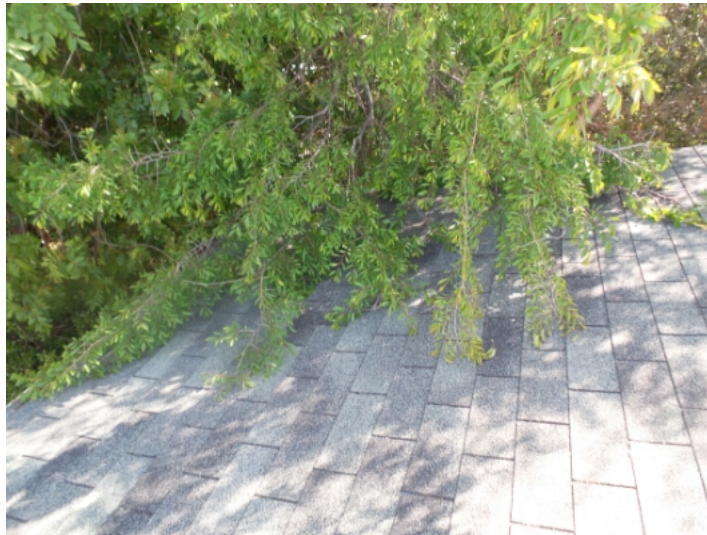
10.2. There are tree limbs overgrowing the residence that should be trimmed or monitored, to insure that they do not impact of damage the roof or its components.

There are tree limbs overgrowing the residence that should be trimmed or monitored, to insure that they do not impact of damage the roof or its components.

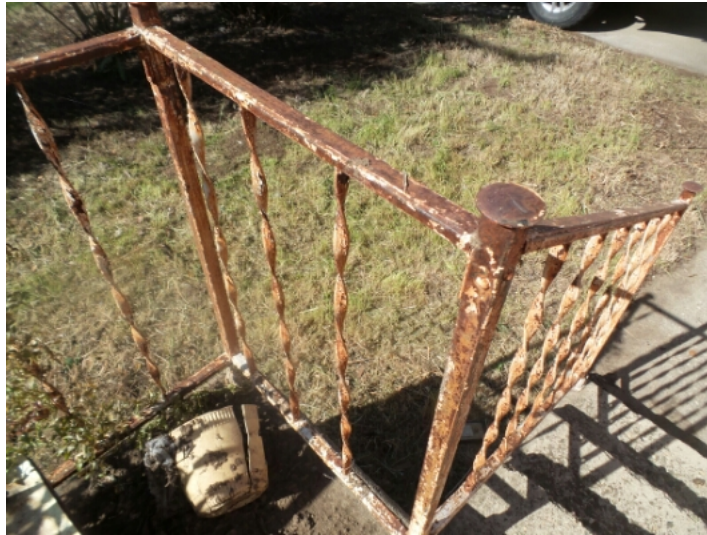
11.1. Sections of the guardrail need maintenance type service such as sealing, staining and or painting.

Sections of the guardrail need maintenance type service such as sealing, staining and or painting.

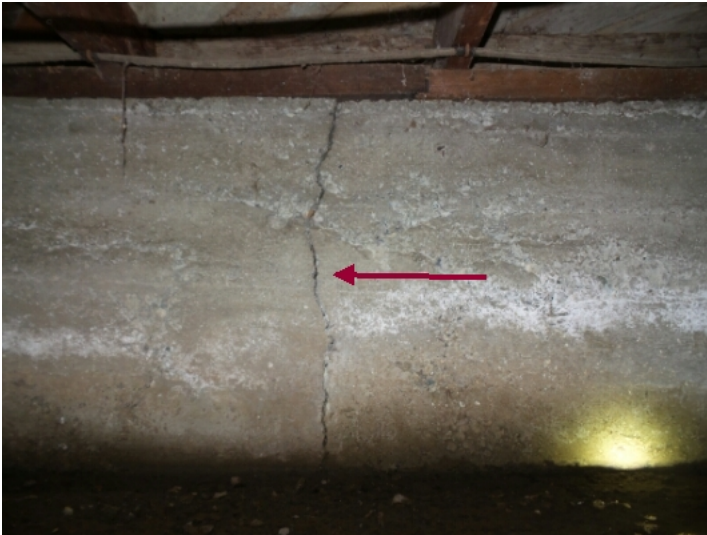
1.8. There are atypical cracks in the foundation walls that should be evaluated by a specialist.

There are atypical cracks in the foundation walls that should be evaluated by a specialist.

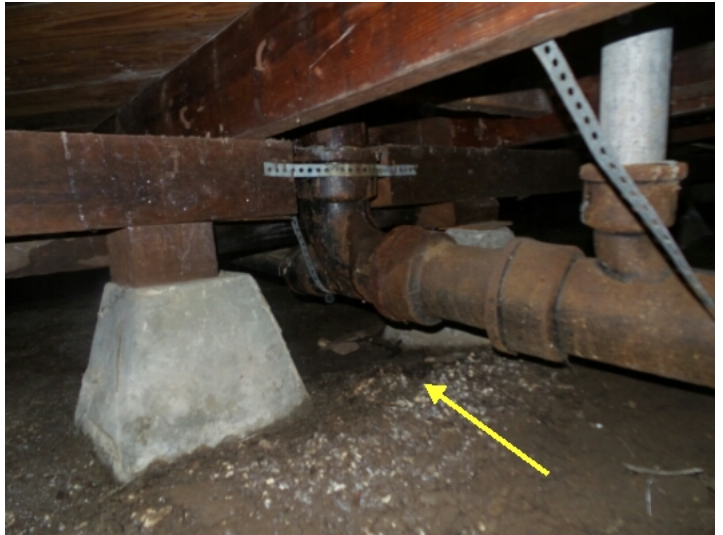
1.9. There is a leak beneath the hallway bathroom which should be repaired

There is a leak beneath the hallway bathroom which should be repaired

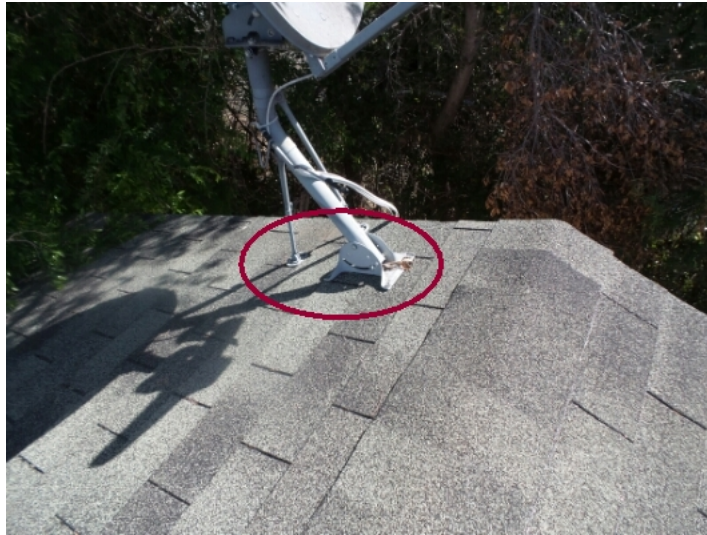
2.5. There is a satellite dish that has been installed on the roof without flashing and will need to be sealed regularly to prevent moisture from entering during rains.

There is a satellite dish that has been installed on the roof without flashing and will need to be sealed regularly to prevent moisture from entering during rains.

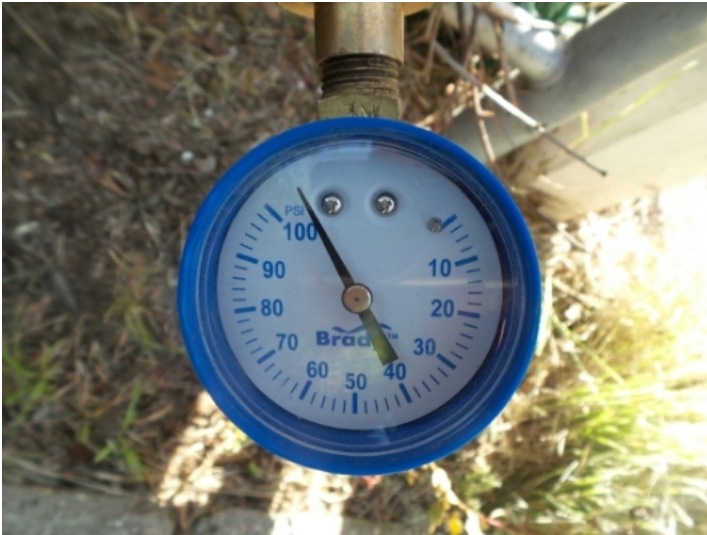
The pressure inside the residence exceeds 80psi, which is too strong and will stress components of the system, and a regulator should be installed. Most regulators come factory pre-set at 60psi.

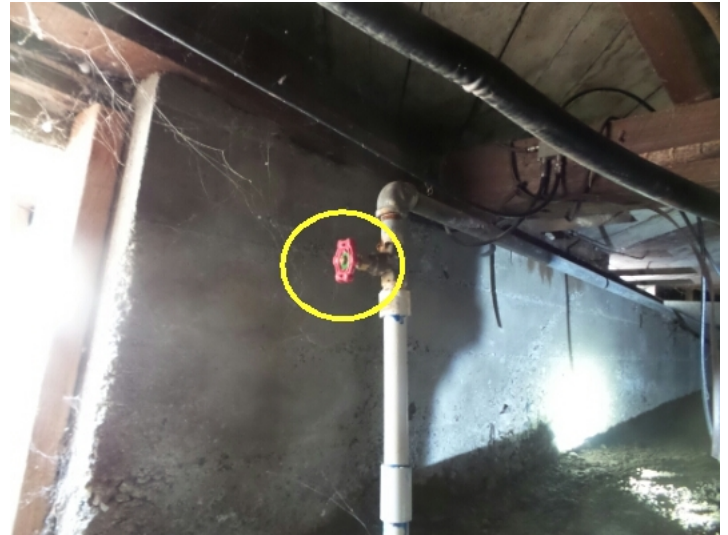
The main water shut-off valve is located inside the crawlspace opening.

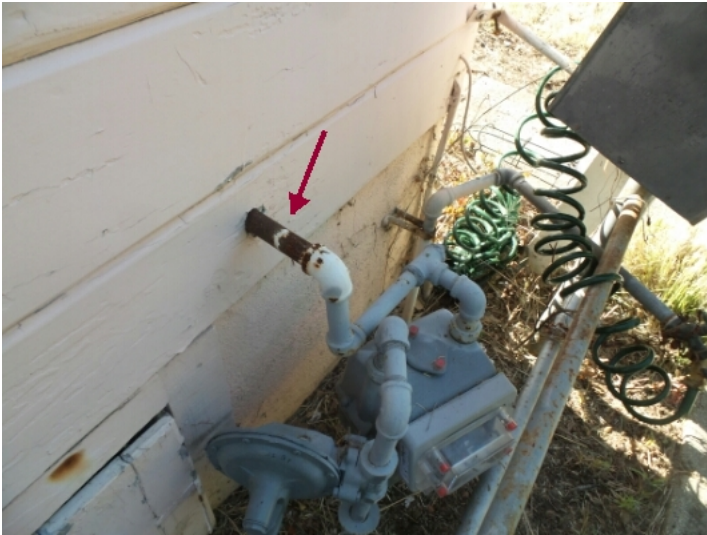
2.3. Some of the gas lines at the meter are rusted and should be painted to prevent further corrosion.

Some of the gas lines at the meter are rusted and should be painted to prevent further corrosion.

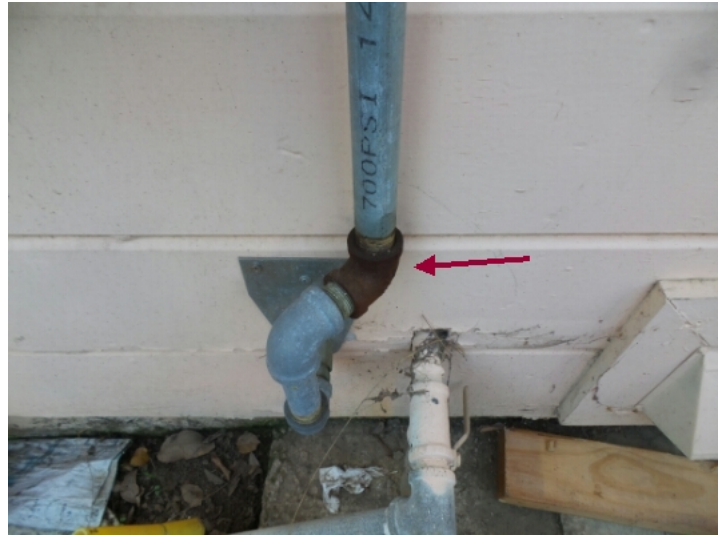
Rusted gas lines

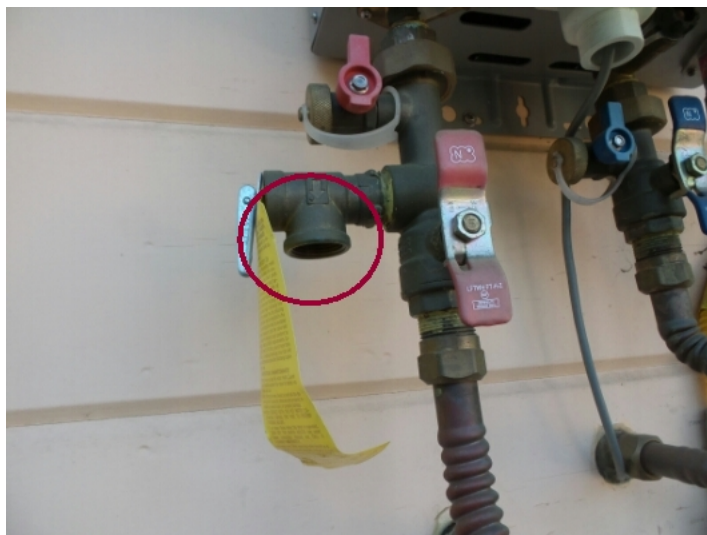
4.8. The pressure relief valve on the water heater does not have a discharge pipe. One should be installed that terminates to the exterior approximately 6 inches above grade.

The pressure relief valve on the water heater does not have a discharge pipe. One should be installed that terminates to the exterior approximately 6 inches above grade.

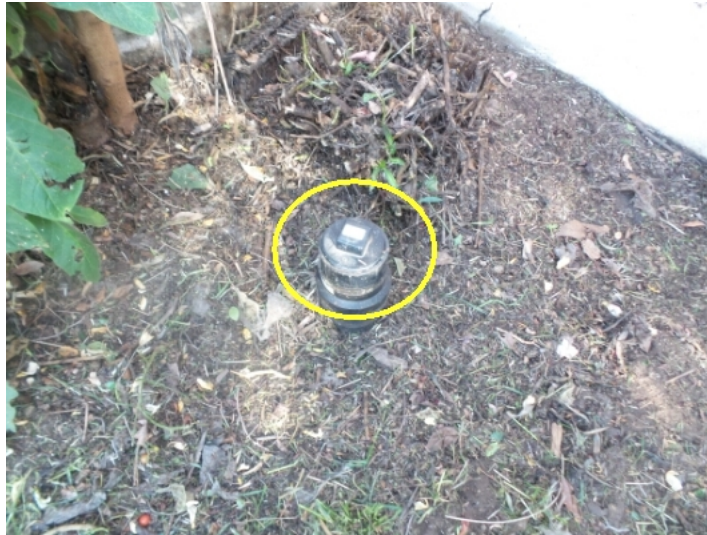
5.3. A cleanout has been added to the waste system, which could confirm chronic blockages. Ask the sellers about this, or you may wish to arrange to have the waste pipes video-scanned to confirm their condition.

A cleanout has been added to the waste system, which could confirm chronic blockages. Ask the sellers about this, or you may wish to arrange to have the waste pipes video-scanned to confirm their condition.

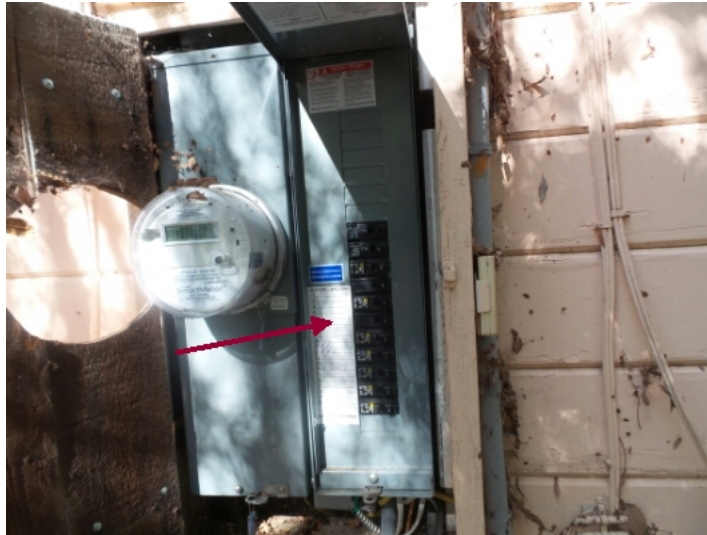
The residence is served by a 125 amp main electrical panel, located at the right side of the home or unit.

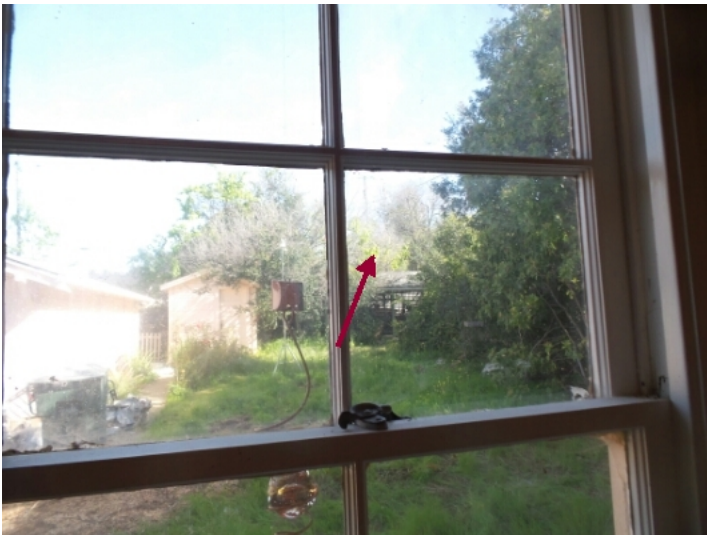
A window pane is cracked or broken and should be replaced.

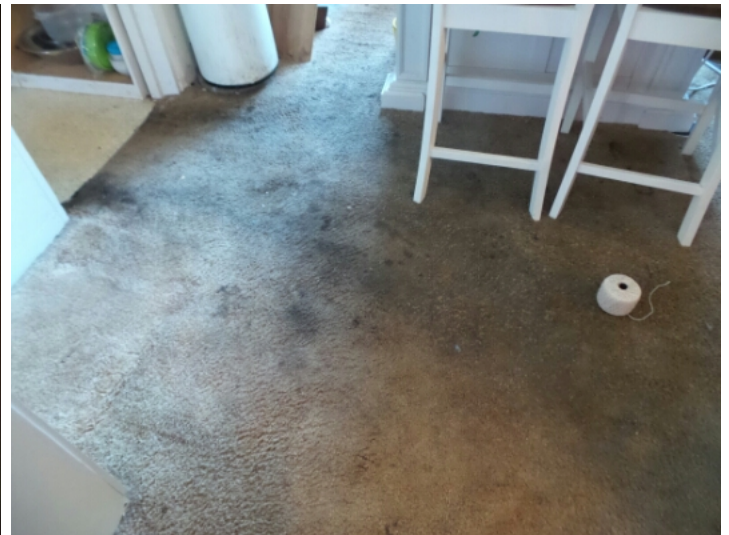
The floor is worn or cosmetically damaged, which you should view for yourself.

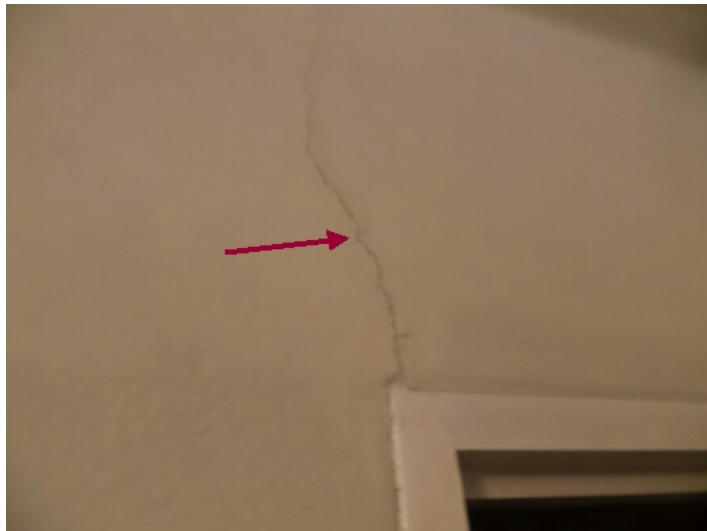
- 1.7. The bedroom walls have cosmetic damage, such as typical cracks above the doors or windows, or seam separations that you should view for yourself.

The bedroom walls have cosmetic damage, such as typical cracks above the doors or windows, or seam separations that you should view for yourself.

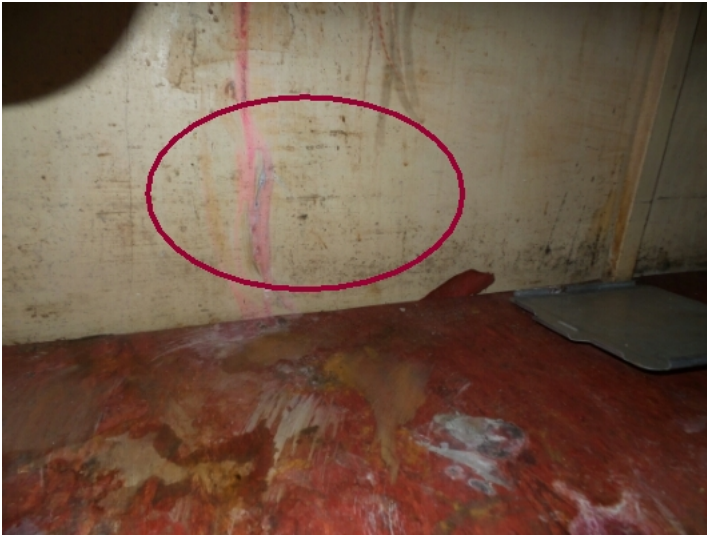
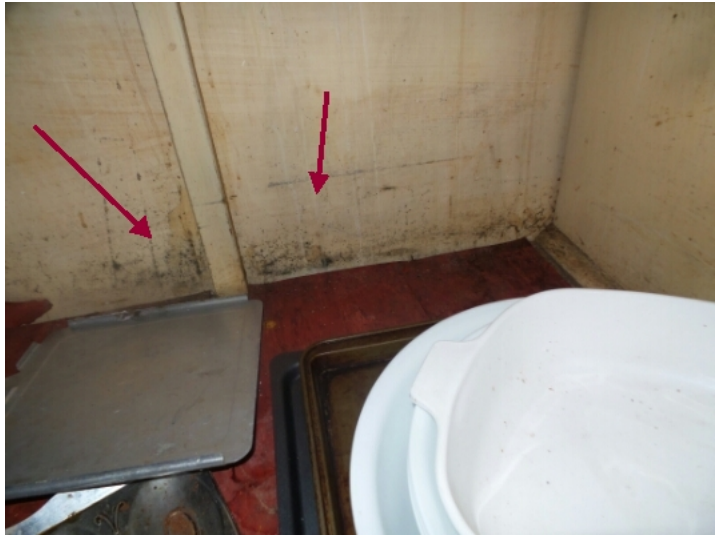
There is a mold-like substance in the sink cabinet that should be evaluated by a specialist. All molds flourish in a damp environment and many are commonplace, but some are toxic and pose a health risk.

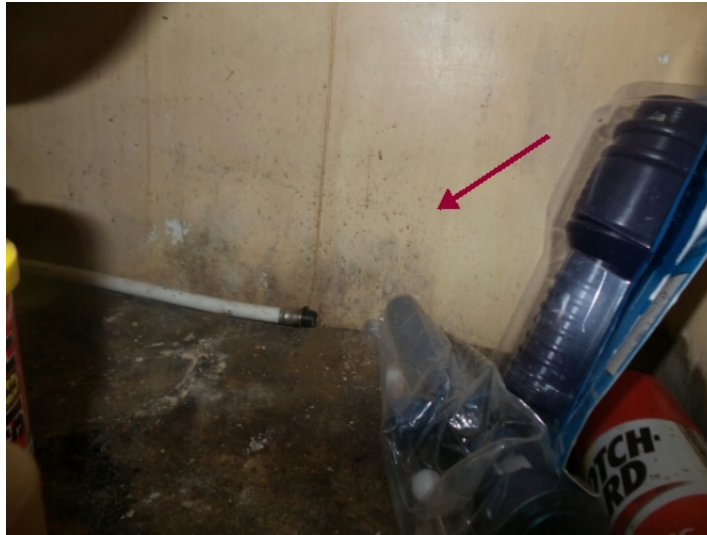
There is mold or mildew within the sink cabinet that should be evaluated and treated by the appropriate specialist. All molds flourish in a damp environment and many are commonplace, but some are toxic and pose a health risk.

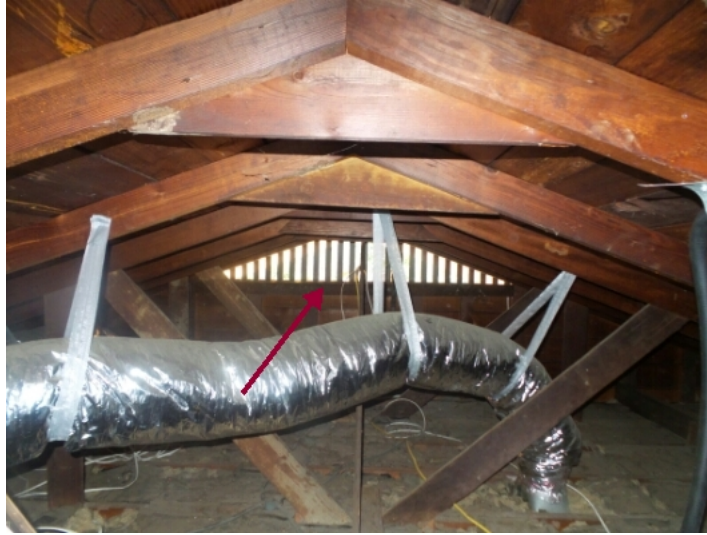
1.9. Some of the ventilation port screens are damaged or missing, which will allow rodents or other pests to enter and contaminate the area.

Some of the ventilation port screens are damaged or missing, which will allow rodents or other pests to enter and contaminate the area.
