# WOOD DESTROYING PESTS AND ORGANISMS INSPECTION REPORT

#: 20201343

| BUILDING NO.<br><b>25215</b> | STREET<br><b>WESTON</b> | CITY<br><b>TORRANCE</b> | ZIP<br><b>90505</b> | Date of Inspection<br><b>11/23/2020</b> | NUMBER OF PAGES<br><b>1 of 6</b> |

| GENERAL DESCRIPTION:<br>This is a one story, stucco, single family residence. It has a detached garage. It has a composition shingle roof and was vacant at the time of inspection. | Inspection Tag Posted:<br><b>Garage.</b> |

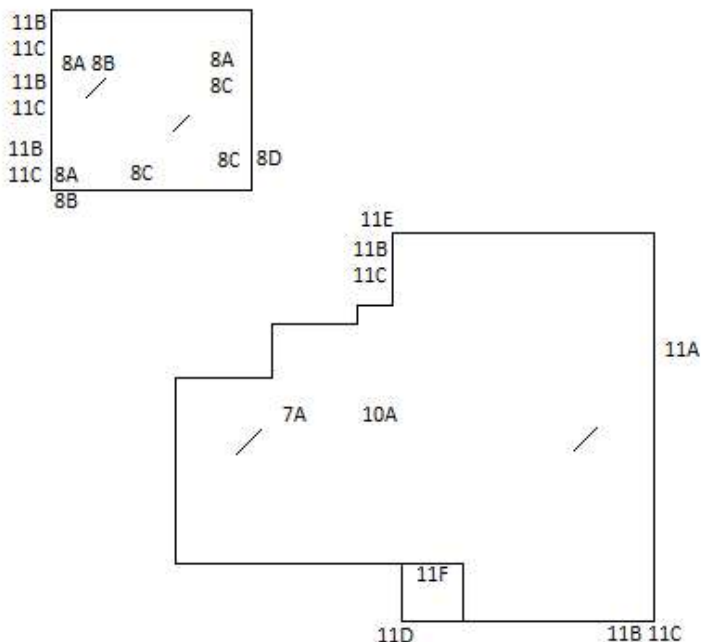
DRYWOOD TERMITE DAMAGE as indicated by 7A on diagram. The damage was noted in or near: RAFTER.

Evidence of DRYWOOD TERMITES as indicated by 8A on the diagram. Evidence noted in or near: DOOR JAMBS, RAFTERS, EAVES.

DRYWOOD TERMITE DAMAGE as indicated by 8B on diagram. The damage was noted in or near: DOOR JAMBS, RAFTERS, EAVES.

Drywood termite pellets as indicated by 8C on the diagram.

FUNGUS DAMAGE indicated by 8D on diagram. The FUNGUS DAMAGE was noted in or near: SIDE DOOR.

FUNGUS DAMAGE indicated by 10A on diagram. The FUNGUS DAMAGE was noted in or near: FALSE BOTTOM OF KITCHEN SINK.

FUNGUS DAMAGE indicated by 11A on diagram. The FUNGUS DAMAGE was noted in or near: RAFTER.

Evidence of DRYWOOD TERMITES as indicated by 11B on the diagram. Evidence noted in or near: FASCIA.

DRYWOOD TERMITE DAMAGE as indicated by 11C on diagram. The damage was noted in or near: FASCIA.

FUNGUS DAMAGE indicated by 11D on diagram. The FUNGUS DAMAGE was noted in or near: POST 4x4x8.

FUNGUS DAMAGE indicated by 11E on diagram. The FUNGUS DAMAGE was noted in or near: DOOR JAMB, TRIM.

FINDING:
DRYWOOD TERMITE DAMAGE as indicated by 11F on diagram. The damage was noted in or near: DOOR JAMB.

Cut off termite damage and repair with appropriate wood filler.

Recommendation: Further inspect areas to determine activity/inactivity of infestation and make further recommendations and costs if any.

Remove and replace damaged wood as necessary with today's available widths and grades.

Remove or cover pellets in visible and accessible areas. NOTE: It is common for additional pellets to sift down over a period of time due to normal household vibrations. This estimate is to cover the pellets one time only.

RECOMMENDATION: 11E
Remove and replace damaged wood as necessary with today's available widths and grades.

RECOMMENDATION: 11F
Remove and replace damaged wood as necessary with today's available widths and grades.
