WOOD DESTROYING PESTS AND ORGANISMS INSPECTION REPORT

Building No 6620	Street Atascadero Ave.	City Atascadero	Zip 93422	Date of Inspection 3-29-18	Number of Pages 4
---------------------	---------------------------	--------------------	--------------	-------------------------------	----------------------

REPORT # MD2519

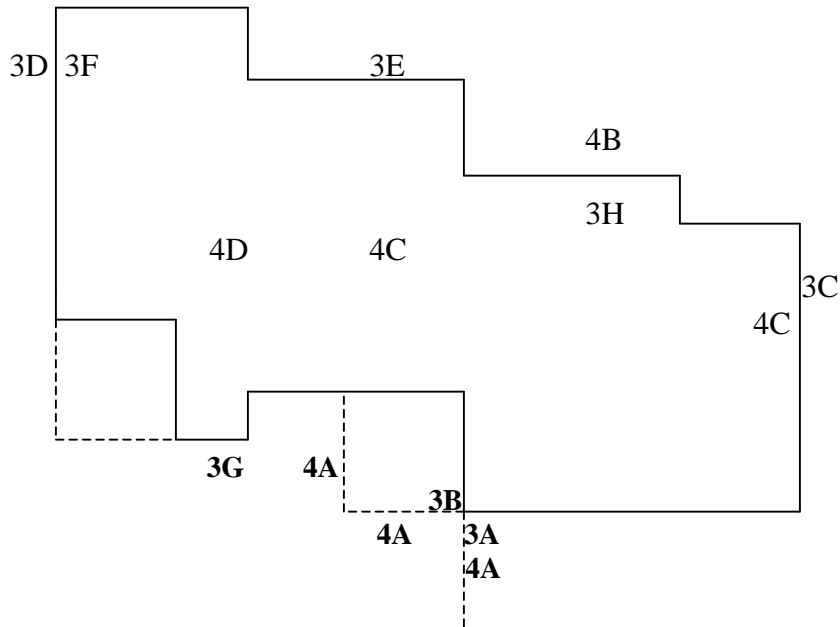
Diagram not to scale

| FINDING # 3A | Fungus damage was found at the fascia boards. |
| FINDING # 3B | Fungus damage was found at the pergola framing. |
| FINDING # 3C | Fungus damage was found at the window trim. |
| FINDING # 3D | Fungus damage was found at the exterior door. |
| FINDING # 3E | Fungus damage was found at the subarea vent. |
| FINDING # 3F | Fungus damage was found at the substructure framing. |
| FINDING # 3G | Fungus damage was found at the substructure access. |

FINDING # 3H Fungus damage was found at the door jamb.
RECOMMENDATION Make necessary repairs to damaged jamb.

FINDING # 4A Earth to wood contact was found at the pergola framing.

FINDING # 4B Moisture damage was found at the door.

FINDING # 4C Moisture stains were found in the garage and attic.

FINDING # 4D Cellulose debris were found in the substructure.

| RECOMMENDATION | Make necessary repairs to damaged fascia boards. |
| RECOMMENDATION | Make necessary repairs to pergola framing. |
| RECOMMENDATION | Remove and replace damaged window trim. |
| RECOMMENDATION | Repair / replace door as necessary. |
| RECOMMENDATION | Make necessary repairs to vent. |
| RECOMMENDATION | Make necessary repairs to damaged wood members. |

RECOMMENDATION Eliminate earth to wood contact as necessary.

RECOMMENDATION Repair / replace door as necessary.

RECOMMENDATION Stains were dry at the time of inspection. All parties and interests satisfy themselves as to the condition of the roof prior to the close of escrow

RECOMMENDATION Remove cellulose debris from the substructure.
