Building Inspection Report

5023 Golden Arrow Dr., Rancho Palos Verdes, CA

Inspection Date:
4/20/21 9:00am

Prepared By:
Beachside Property Inspection, LLC
5318 E. 2nd St., #707
Long Beach, CA, 90803
ph. (562) 433-2288

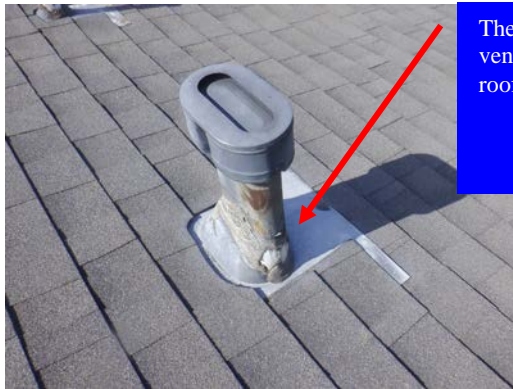
The water heater exhaust vent pipe is sealed to the rooftop flashing cone...

28. **Improve:** Proper rooftop jack flashing assemblies for gas appliance exhaust vent pipes should be provided storm collars. Here, the water heater exhaust vent pipe roof flashing cone is sealed to the vent pipe and is missing a storm collar; suggest improving as needed.

- **Improve:** Proper rooftop jack flashing assemblies for gas appliance exhaust vent pipes should be provided storm collars. Here, the water heater exhaust vent pipe roof flashing cone is sealed to the vent pipe and is missing a storm collar; suggest improving as needed.

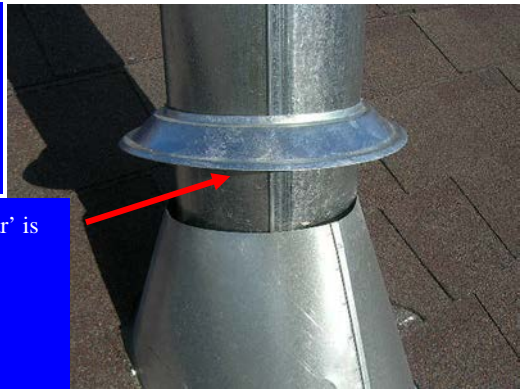
...where a 'storm collar' is needed (sample photo)

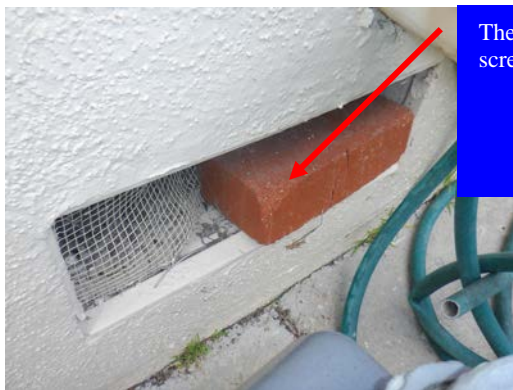
The garage wall vent screen is damaged

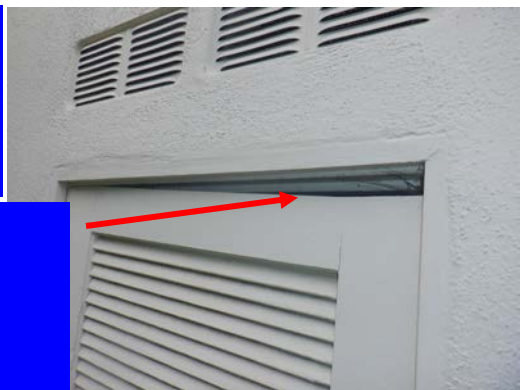
The forced air heating unit's closet door is sagging...

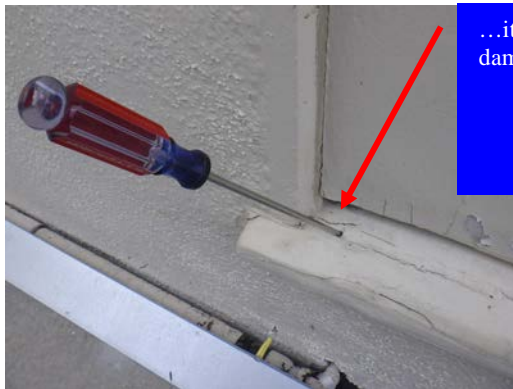
...its door sill is damaged...

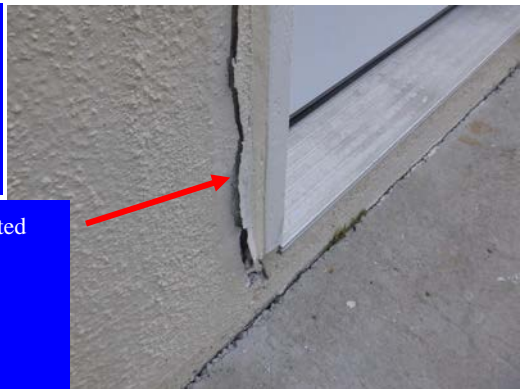
...damage was also noted at the garage exterior service door trim...

- **Improve:** Some of the home's exterior wood elements/features shows deterioration/damage/weathering that will require (in various degrees) replacement, repair, and paint (front entry support column, street facing siding, garage exterior service door stucco trim, forced air heater closet door, etc. Suggest a review of the pest report for the condition of this and all wood.

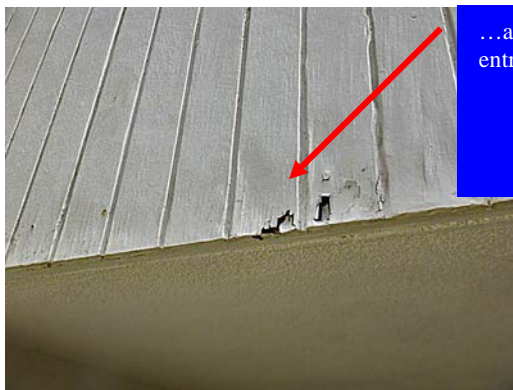
...at the siding above the entry stoop...

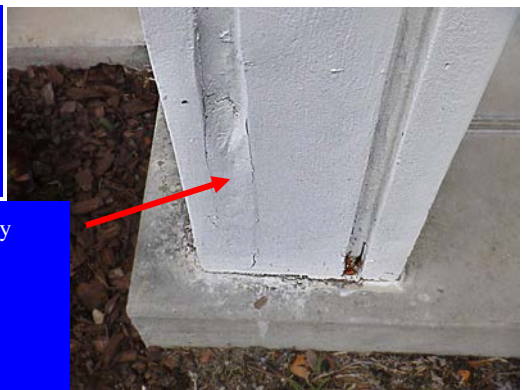
...as well as at the entry stoop support column

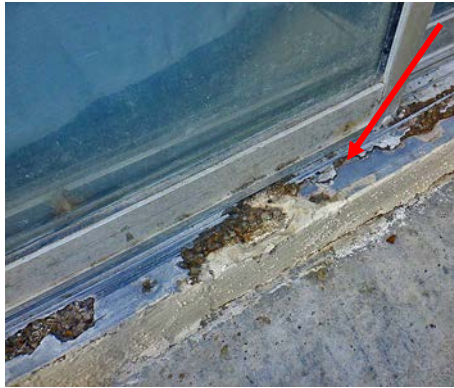
- **Major Improve:** The sliding glass door is very difficult to operate and it lower track shows extensive corrosion that will require its replacement by a licensed contractor.

The sliding glass door is very difficult to operate and its track has nearly fully corroded away

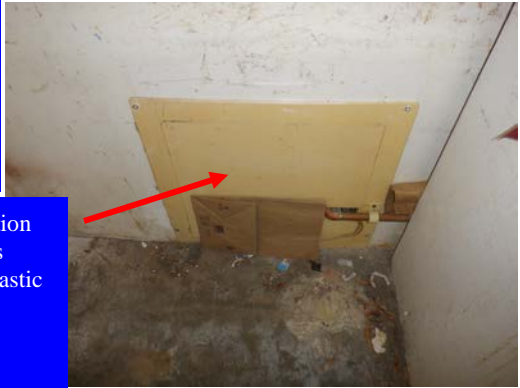
The garage fire-separation from the living space is compromised by the plastic access hatch at the rear wall...

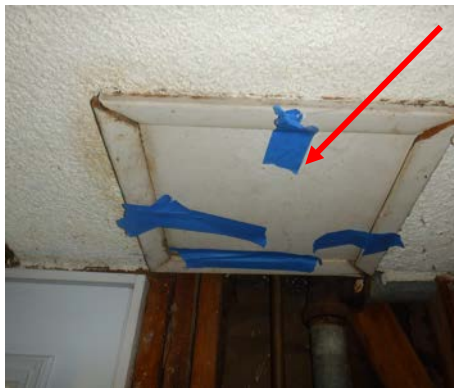
...and the improper ceiling access hatch

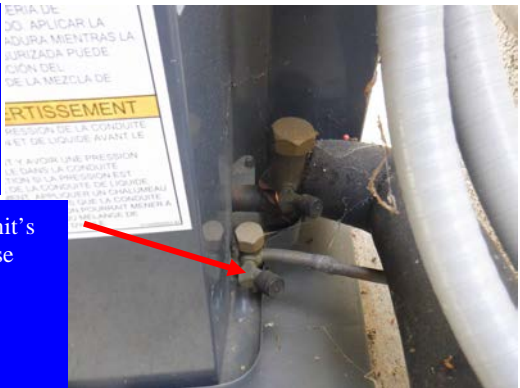
The air conditioning unit's refrigerant line ports use standard caps...

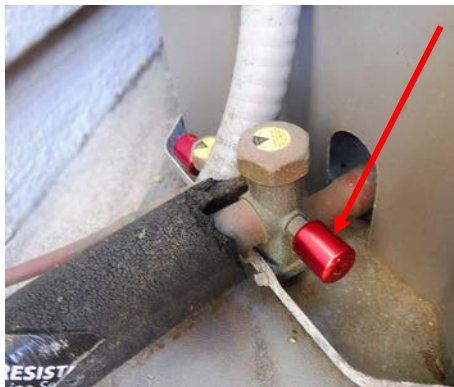
...where tamper-proof caps are needed (sample photo)

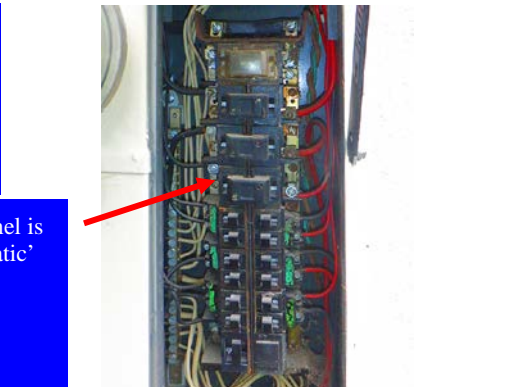
- **Major Improve/Safety Issue:** The "Pushmatic" main electrical service panel is an older component with known reliability issues that features a problematic breaker design long abandoned. The main breakers feature optical 'ON/OFF' windows where internal geared toggles rock back and forth alternately displaying 'ON' or 'OFF' icons that can jam the breaker from tripping. As well, these breakers do not display a tripped circuit condition (only that the breaker is 'on' or 'off'). Further, these toggles will bind in mid-rotation and display a confusing 'N/O' icon where one cannot determine the status of the circuit, or worse, indicate 'OFF' when the breaker is on. The performance/reliability of these older units is considered to be fully depreciated that requires it be *immediately replaced* by a licensed electrical contractor.

The main electrical panel is a troublesome 'Pushmatic' unit

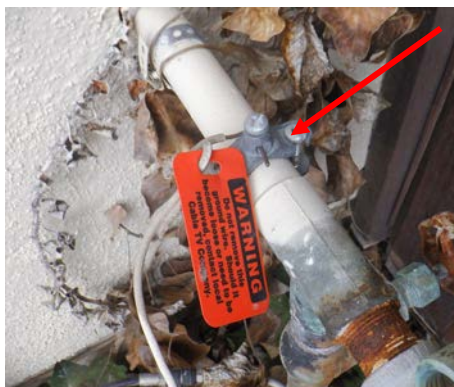
A low voltage system is grounded to the water supply piping...

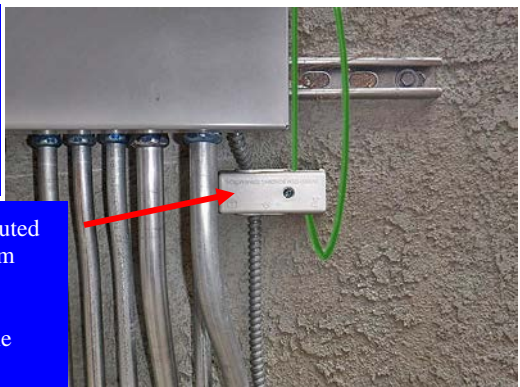
...when it should be routed to an added 'Intersystem Bonding Terminal' adjacent to the main electrical panel (sample photo)

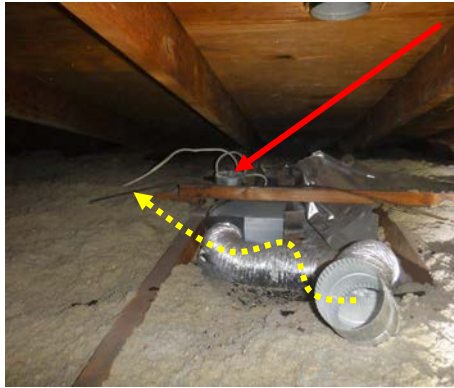
- **Safety Issue:** Open electrical junction box noted at the master bath attic presents fire hazards as all visible wiring connections must be enclosed within *covered junction boxes*; suggest conforming installation.

The master bath exhaust fan is discharging to the attic and is adjacent to an open electrical box

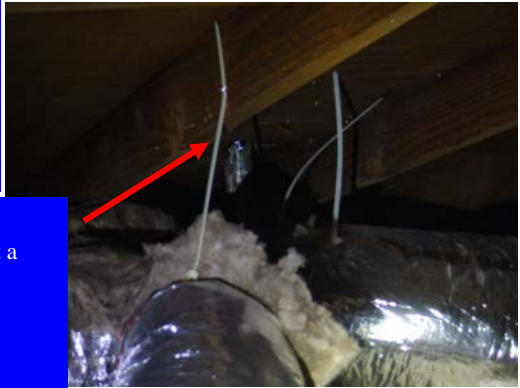
The HVAC ducting is supported by zip ties at a few attic areas

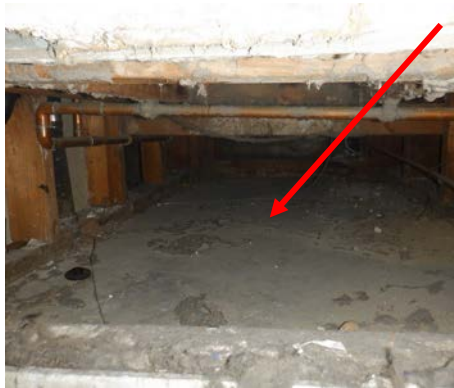
The HVAC system's return air chamber is filthy and this area communicates with the framing cavity below the clothes dryer...

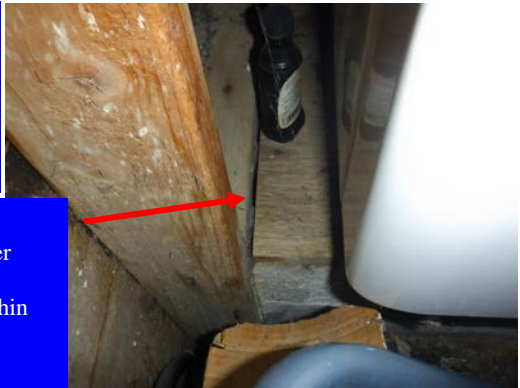
...that has a gap at the plywood deck perimeter where fan suction will draw garage fumes within the system and home

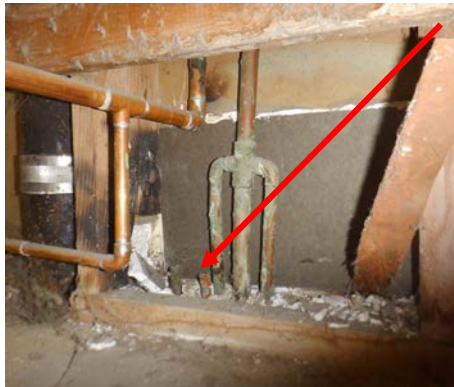
Inspection of the return air chamber also revealed abandoned copper water supply piping embedded within the slab

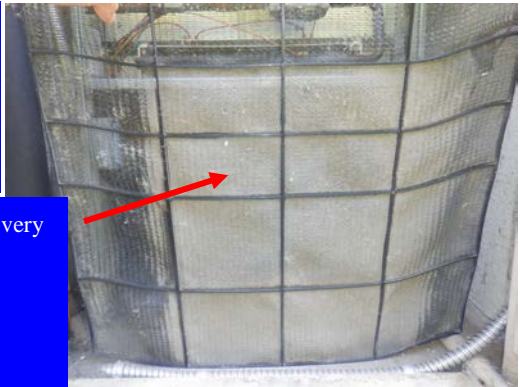
The HVAC air filter is very dirty...

33. **Improve:** The HVAC system's dirty air filter should be replaced.
34. **Improve:** The master bathroom ceiling exhaust fan vents directly into the attic space (allowing moisture into a confined area and compromising the fire-rating of the living space). The fan must be provided with a flexible/rigid metal duct terminating at an exterior vent; suggest improvements.
35. **Improve:** Wood deterioration and leaning sections noted at the backyard fencing and E-side yard fencing requires immediate repairs.

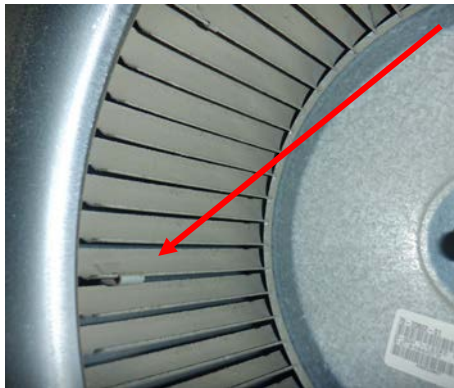
...as are the fan blades

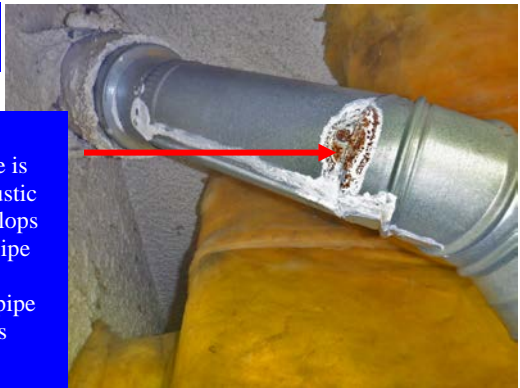
21. **Improve/Safety Issue:** The forced air heating unit's exhaust vent pipe shows extensive condensation corrosion damage that requires immediate attention. The forced air heating unit exhaust assembly utilizes the older transite vent pipe which is not prohibited. Forced air heating units with electronic ignition must use an all metal exhaust pipe assembly and may not incorporate the older transite exhaust pipes (of a ceramic/asbestos material) with the exhaust system. Interconnecting these different vent materials creates a highly acidic condensation from within the transite vent pipe which runs down the metal pipe, corroding it and compromising the integrity of the exhaust system and/or adjacent heating components; suggest immediate repairs by a licensed heating/cooling contractor.

The forced air heater's metal exhaust vent pipe is corroded due to the caustic condensation that develops where this new metal pipe passes into the older ceramic/asbestos vent pipe that served the previous heater

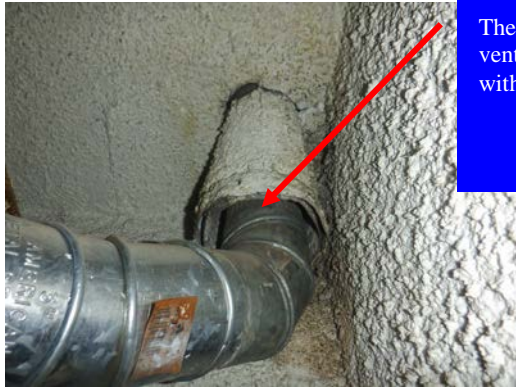
The water heater exhaust vent connector fits poorly within the vent pipe...

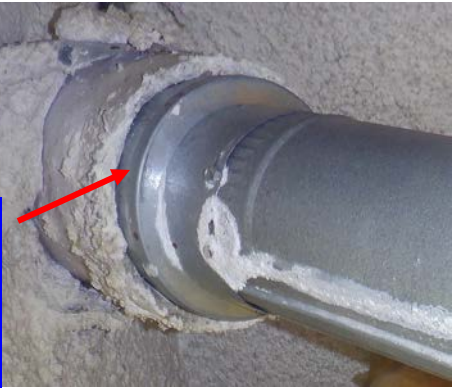
...where a 'vent increaser' fitting is needed (sample photo)

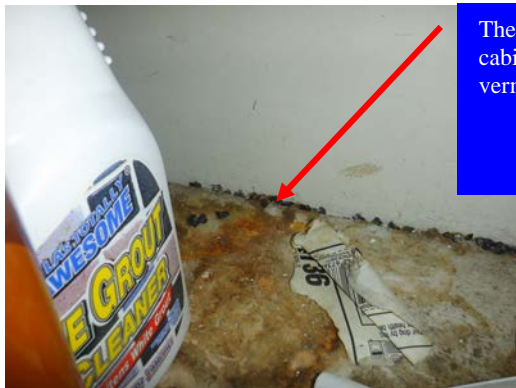
- **Improve/Safety Issue:** Vermin activity noted at the laundry area upper cabinet (droppings, urine stains/odor, etc.) requires remediation and prevention of all harborage by a "Branch II" pest control specialist prior to the close of escrow or contingency period.

The laundry area overhead cabinet shows signs of vermin haborage

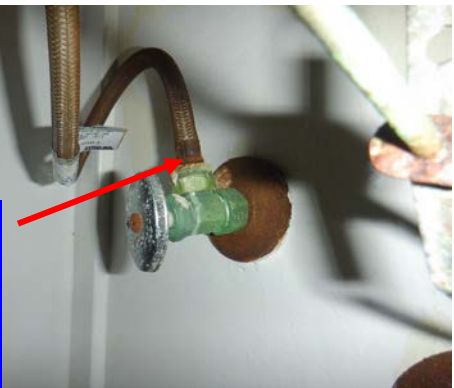
A few of the water supply connectors within the sink cabinets show corrosion

26. **Improve:** A few of the flexible water supply connectors within the sink cabinets show corrosion and should be replaced suggest repairs by a licensed electrical contractor.

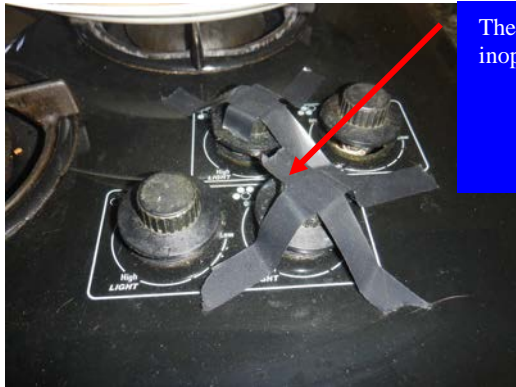
The gas range has a few inoperative burners...

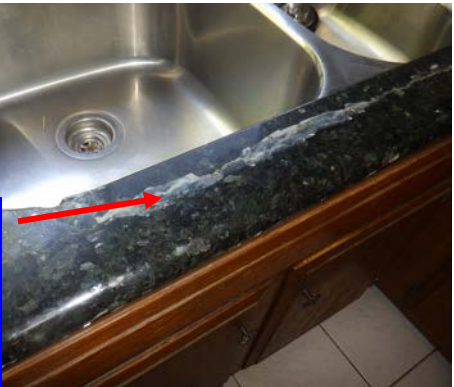
4. **Major Improve:** The kitchen's granite countertop has cracked along the length of the sink front that is poorly 'repaired' with caulking. Proper repairs may be possible (by replacing that section) but another crack at the rear of the sink deck suggests the wood 'rough-top' is compromised; suggest further assessment and repairs/replacement as needed by a licensed specialist.

...while the sink area countertop shows extensive damage...

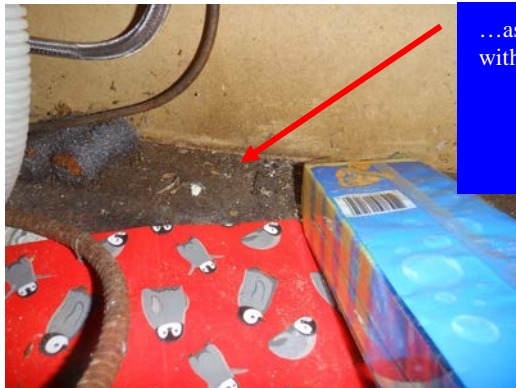
3. **Major Improve/Safety Issue:** The kitchen sink cabinet exhibits damage, repairs and stains consistent with past water exposure that may have created conditions where hibernating organics exist at inaccessible areas. Areas of past moisture intrusion or current leakage often create conditions that are favorable for the growth of many fungus-like organisms (bacteria, mold, mildew, fungus and many other types of growth) that comprise indoor air quality. Damaged/stained materials should be replaced and/or the stained areas covered with an approved brush/roller application of mold encapsulating/neutralizing paint/surface treatment by licensed specialists following established protocols to assure organics do not 'kick-off' if re-wetted. Inspection for and identification of these conditions is beyond the scope of the CREIA Standards of Practice and would require consultation with an environmental specialist or licensed/Certified Industrial Hygienist.

...as well as water damage within the cabinet

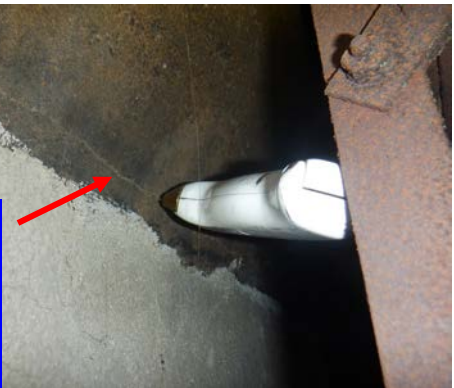
- **Major Improve/Safety Issue:** The home has a pre-cast concrete fireplace & chimney that requires further inspection prior to operation as many of these units have suffered damage during installation that prevents their safe operation such as noted here where the insulation plate above the firebox opening has developed a horizontal crack. Suggest immediate further review by a licensed chimney specialist familiar with this specific system. Further information is available at: <http://www.fireassociates.org/media/pre-cast.pdf>

The pre-cast concrete fireplace has developed a horizontal crack across the 'insulation plate'
