Home Inspection ERC

Inspection Date: 6/27/2017

Transferee / Property Information: Harry Mckinley
48 Via Divertirse
San Clemente, CA 92673

Worldwide ERC® Relocation Property Assessment

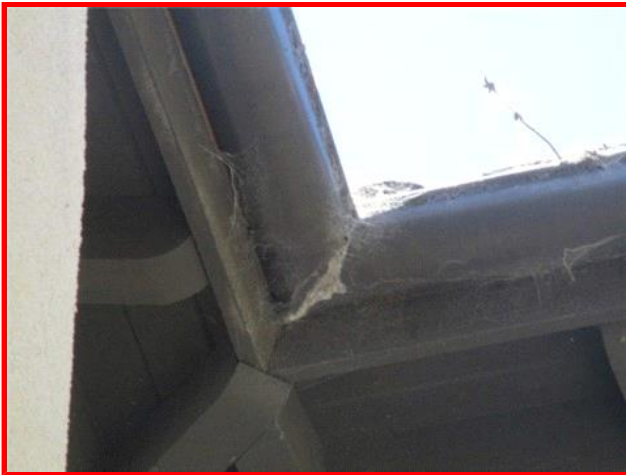
Leak at Atrium Gutter

Section	Remarks
Roof	<p>Roof Type #1 Remarks: Further evaluation is recommended. The roof could not be walked / fully assessed due to height. Contact a roofer to evaluate the condition of the roof system.</p> <p>Gutters Problem: The gutter at the corner of the atrium leaks. Corrective Action: Contractor to repair / replace the leaking gutter.</p>
Exterior Surfaces	<p>Type #1 Condition Remarks: The stucco was not assessed - See separate report.</p> <p>Trim Remarks: See Above Type #1 Comments.</p>
Garage / Carports	<p>Door Operation Problem: A drop down stopper is improperly installed at the fire door. Corrective Action: Contractor to repair / correct the fire-rated garage door.</p>
Electrical	<p>Branch Circuits Problem: An improper plug expander and extension cord wiring were observed in the garage. Corrective Action: Electrician to repair / certify the electrical system.</p> <p>Smoke Detector Problem: A smoke detector is missing at the master suite and the smoke detectors are not the required 10-year battery units. Corrective Action: Contractor to install a smoke detector at the master suite and replace the smoke detectors.</p>

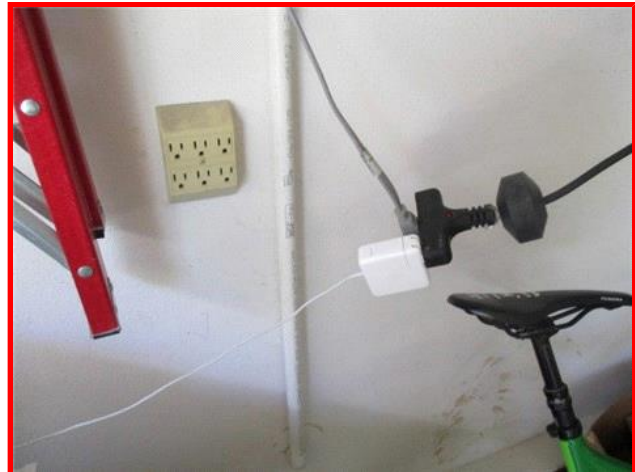
Improper Expander & Extension Cord in Garage

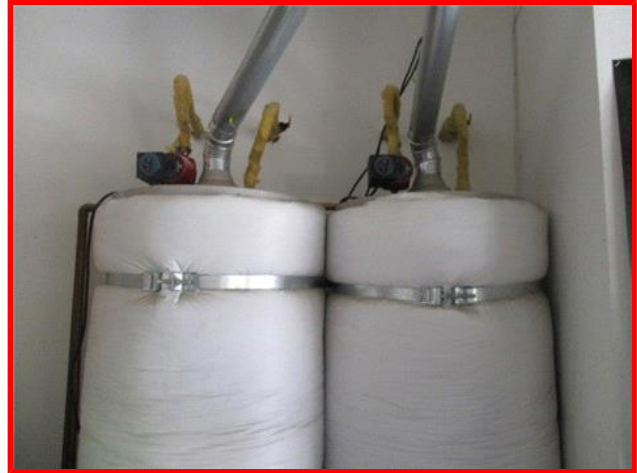
Water Heaters - Improper Seismic Strap Installation

Section	Remarks
Heating Systems	Carbon Monoxide Detector Problem: Carbon monoxide (CO) detectors are required but missing in the home. Corrective Action: Contractor to install CO detectors in the home as required by the state.
Plumbing	Heat Exchanger Remarks: The heat exchanger was not assessed. This part of the unit cannot be assessed without disassembly of the unit.
Fireplace	Water Heater Problem: The seismic straps at both water heaters are improperly installed over the insulation blanket (required to be installed directly on the water heater). Corrective Action: Plumber to repair / replace the seismic straps.
Additional Comments	Water Heater #2 Problem: See Above Water Heater Comments. Corrective Action: See Above Water Heater Comments.
Additional Comments	Flue Remarks: Please Note: Only visual portions of the flue were assessed due to design.
Additional Comments	Other Remarks: The sprinkler was not assessed - See separate report. Also, the fountain and solar equipment were not assessed (beyond the scope of an ERC assessment).

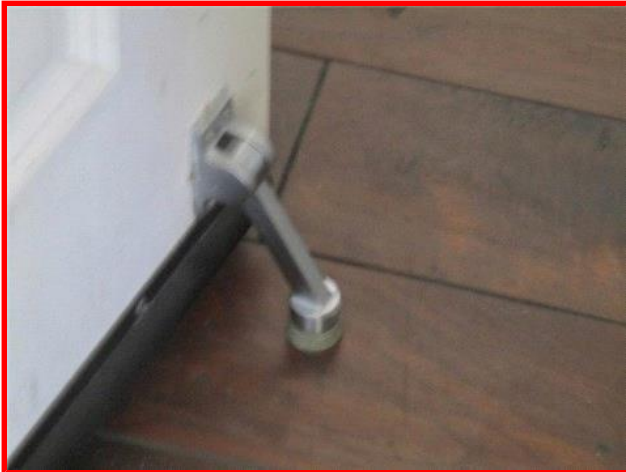
Improper Drop Down Stopper at Garage Door

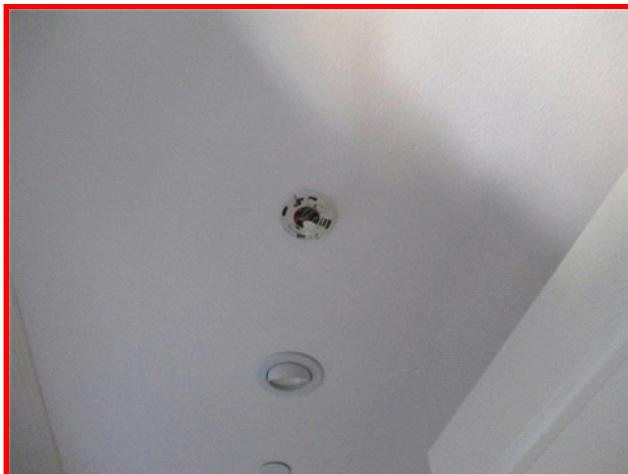
Missing Smoke Detector at Master Suite
