INSPECT BY L.A.
P.O. Box 33273
Granada Hills, CA. 91394
(818) 434-5988 Fax (000) 000-0000

Report #: JC060818096-096

Subject Property:

18645 Hatteras St.#181
Tarzana, Ca. 91356

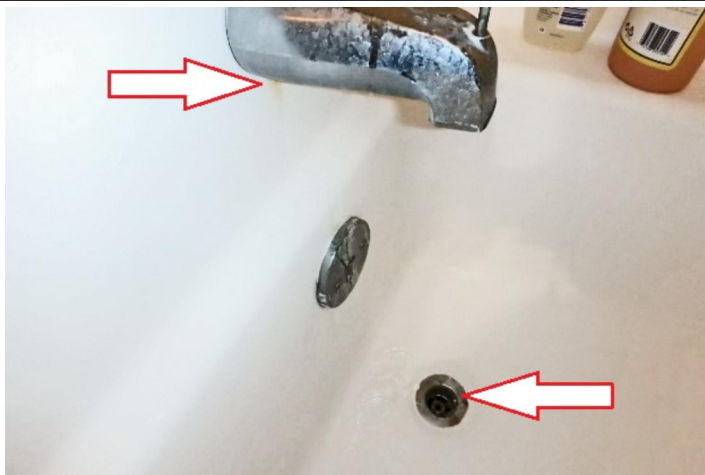
Item # 75

Drain stopper is missing at the tub in the main bathroom. * The faucet spout leaks at the shower wall union in the main bathroom. * (2)

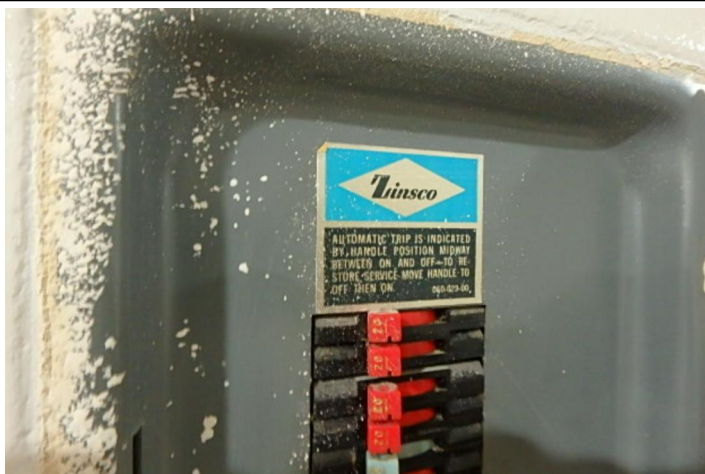
Item # 44

Comments: There are no visible defects in the main panel, however, please note that the "Zinsco" make and brand of breakers / panels are known to have performance failures as they get older. * (2) (4) (5)

There are no visible defects in the main panel, however, please note that the "Zinsco" make and brand of breakers / panels are known to have performance failures as they get older. * (2) (4) (5)

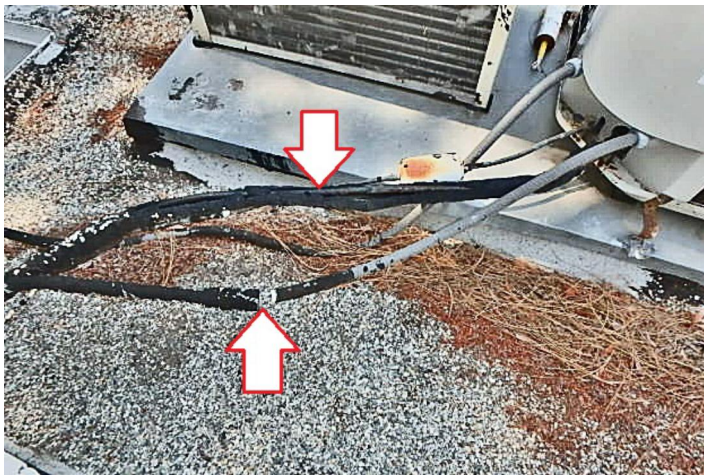
Item # 38a, 38c

Comments: Deteriorated and partly missing insulation was at the cooling system's refrigerant line. *

The power conduit line is disconnected at the cooling system. * (2)
(4) Deteriorated and partly missing insulation was at the cooling system's refrigerant line. *

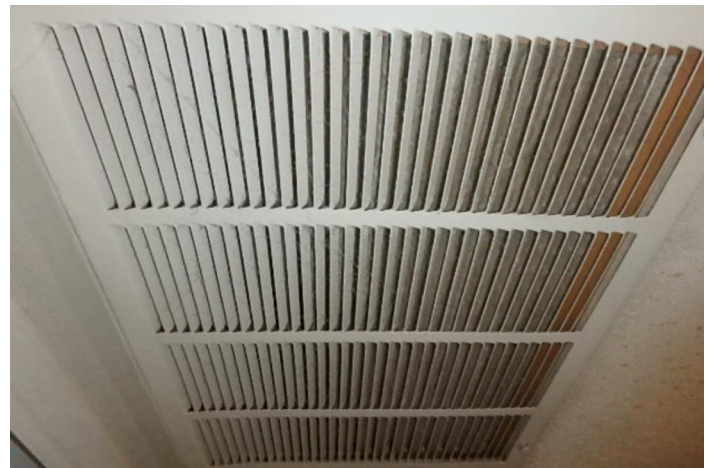
Item # 35

Comments: The air filter is dirty - recommend changing the filter. *

The air filter is dirty - recommend changing the filter. *

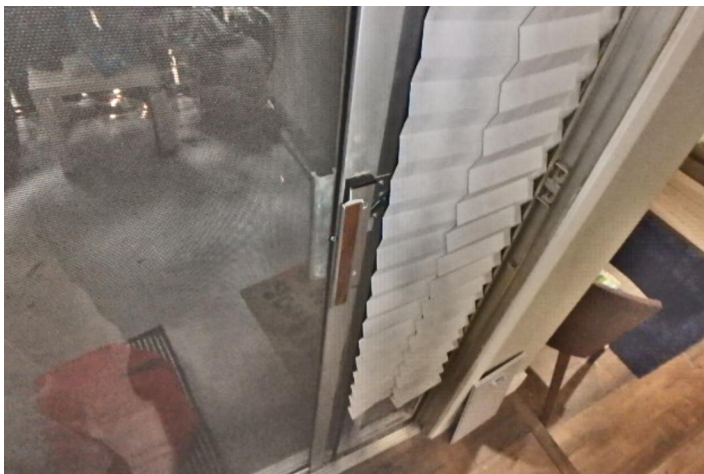
Item # 47

The latching hardware is not operational at the main bedroom sliding glass door to the patio. *

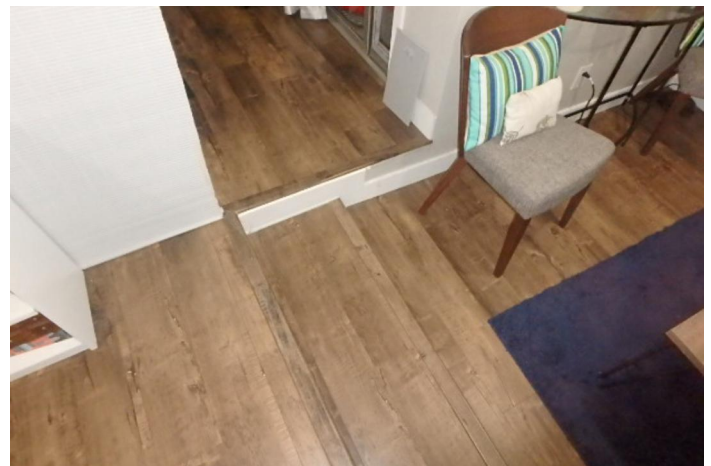
Item # 51

Trip hazards were noted at the living room's sunken floor area. * (4)

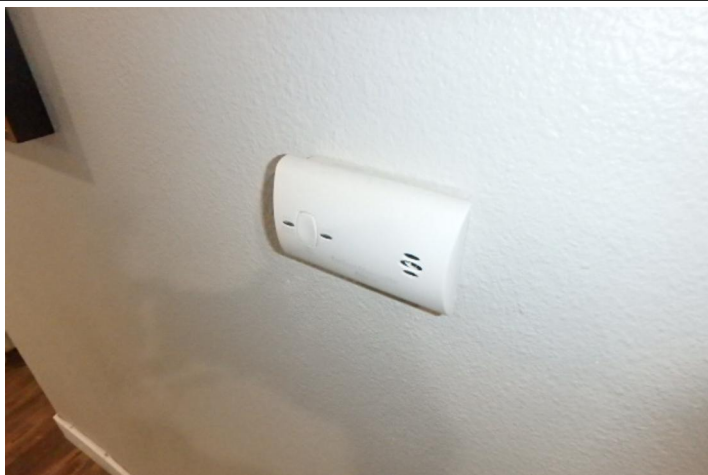
Item # 54

The Carbon Monoxide detector did not respond to test at the hallway.
* (4)

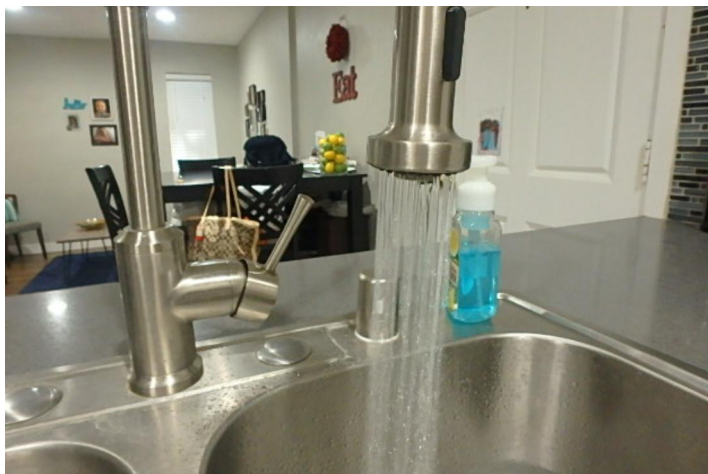
Item # 66

The kitchen sink spray wand is stuck in shower mode. *

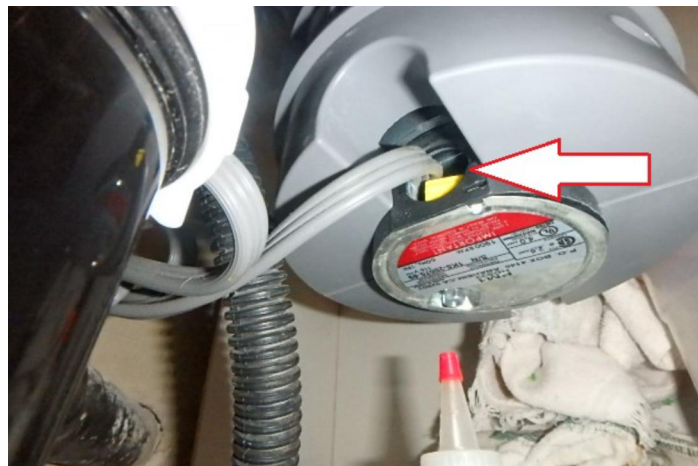
Item # 68

Wire clamp is missing at the disposal. * (4)
