INSPECT BY L.A.  
P.O. Box 33273  
Granada Hills, CA. 91394  
(818) 434-5988 Fax (000) 000-0000

Report #: JM080918134-134

Subject Property:

10926 Bluffside Dr.#34

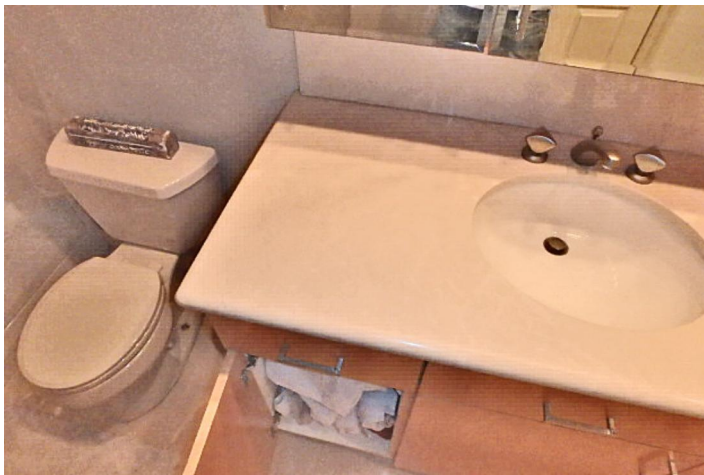
**Item # 72, 73**

The toilet tank is slightly loose in bathroom A. \* The faucet spout is loose / not secure in bathroom A. \*

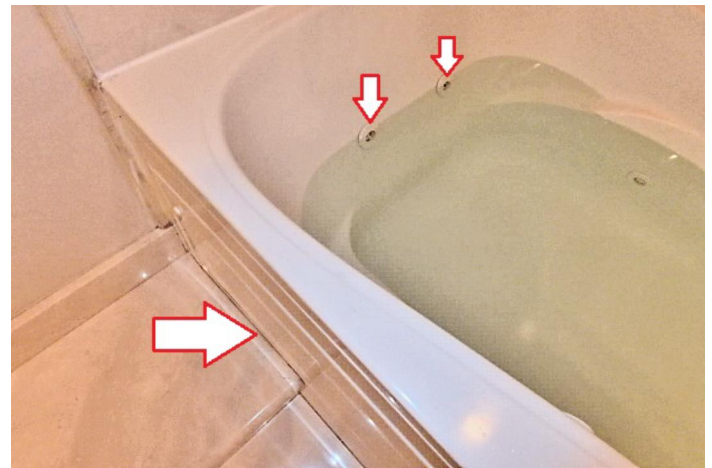
**Item # 75**

The left side hydro-massage jets are not functioning properly at the tub in bathroom A. \* (2) Minor additional grout and caulking is needed at the tub to bathroom floor union in bathroom A. \*

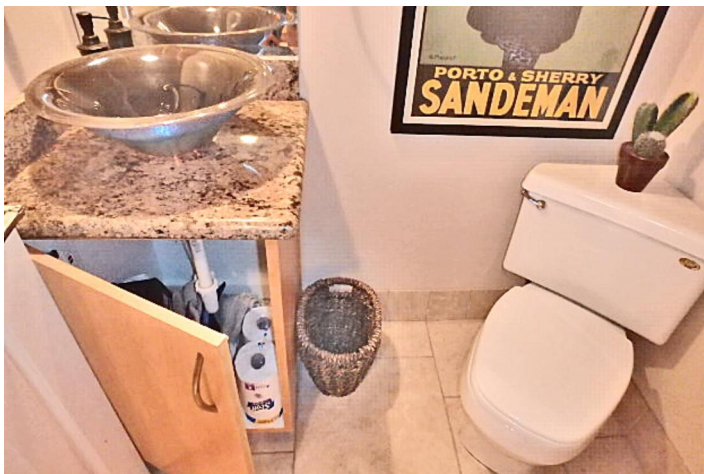
**Item # 72, 73**

The toilet tank is loose in bathroom B. (pictured) \* Makeshift plumbing work and patch and repair was noted to the drain lines under the sinks in bathrooms A and B. (also pictured) \* Hot and cold water is reversed at the sink faucet in bathroom B. \* (4) The sink drain stopper is missing in bathroom B. (also pictured) \*

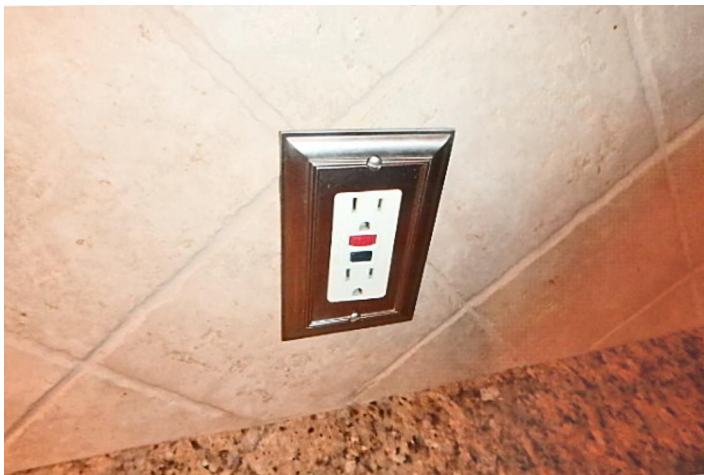
Item # 44

Loose / wobbly outlet was noted at the right side of the stove. \* (4)

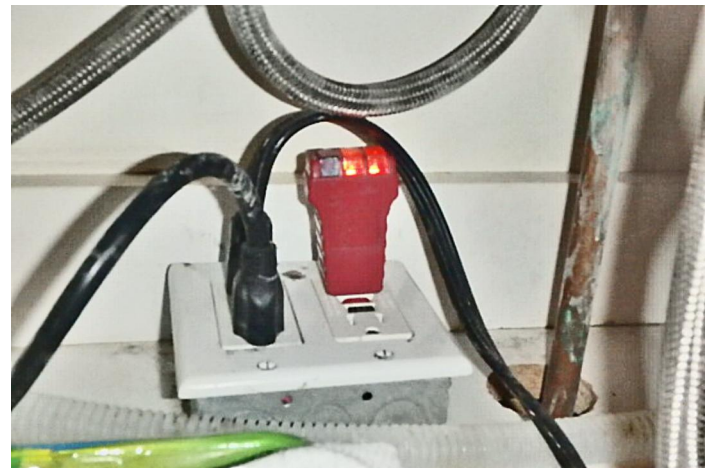
Item # 44

The GFCI outlet is grounded, however, did not trip when tested under the kitchen sink. \* (2) (4)

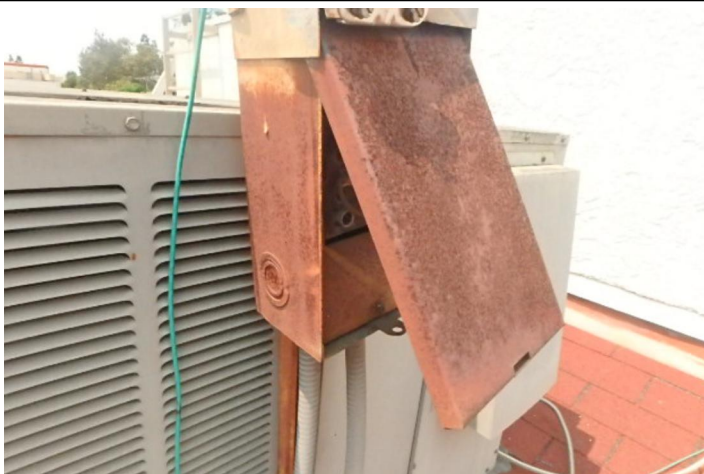
Item # 38, 38a

Comments: Power disconnect box is rusty at the A/C system. \*

The cooling system does not respond to normal controls. \* (2)  
Power disconnect box is rusty at the A/C system. (pictured) \*

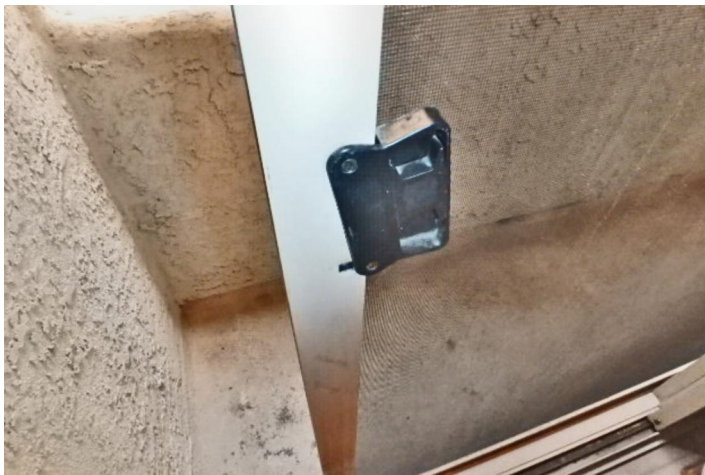
Item # 47

The sliding screen door to the rear deck has a loose latch-handle. \*

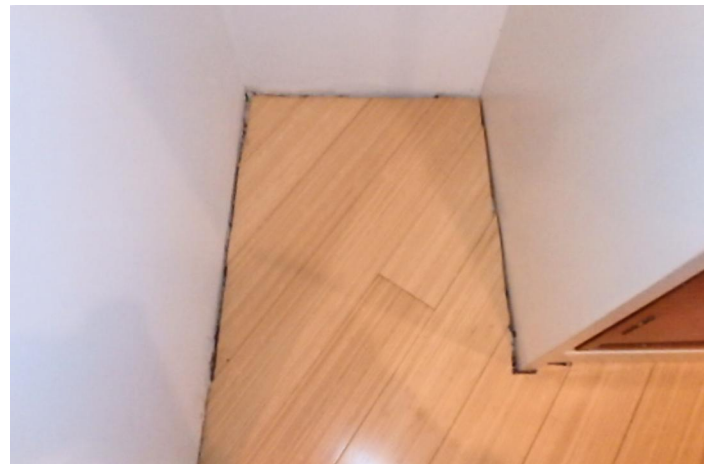
Item # 51

Trip hazard was noted to the floor at bathroom A to the laundry area floor. \* (4) Minor missing base board was noted to floor inside the main bedroom walk-in closet. (pictured) \*

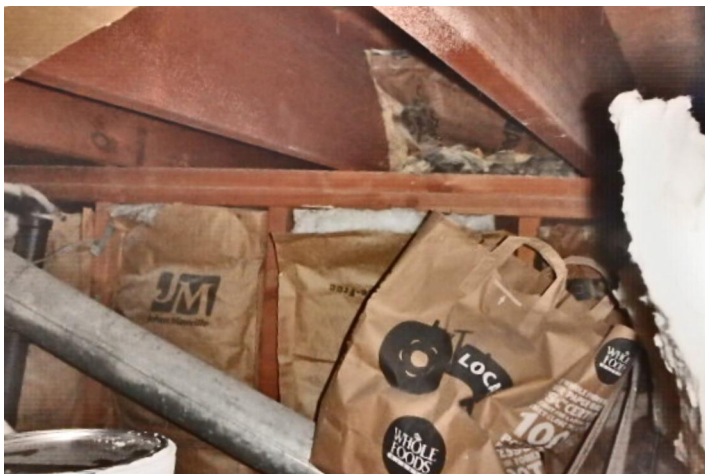
Item # 49, 50

Missing wall cover / exposed framing (pictured) and hole openings to the wall was noted inside the laundry area storage area. \* Missing ceiling cover / exposed framing was noted inside the laundry area storage area. (also pictured) \*

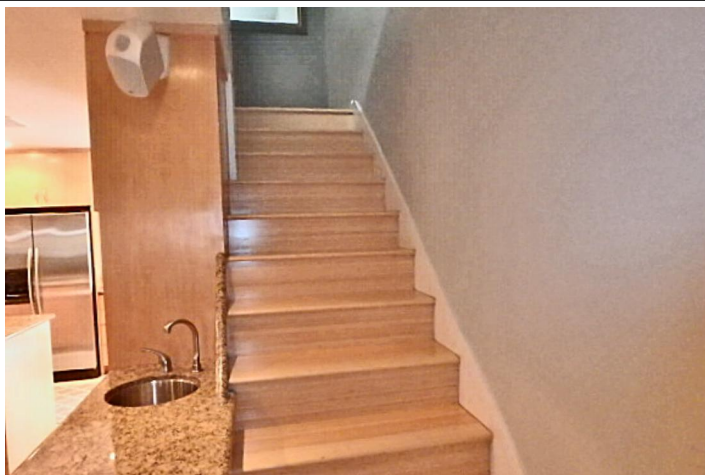
Item # 53b

The interior stairs has missing grab-rail \* (2) (4)

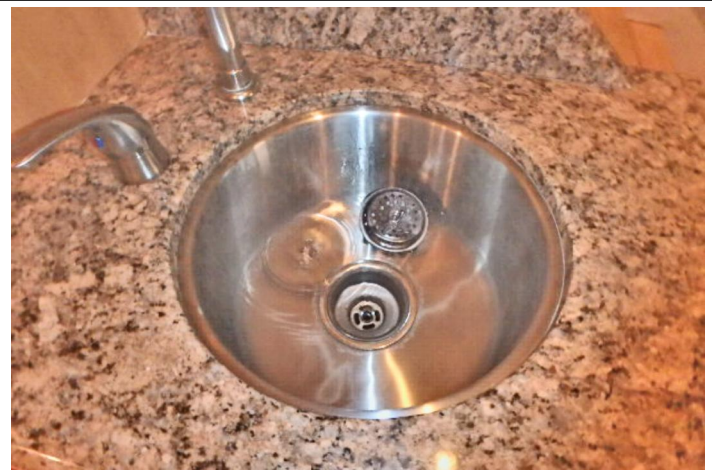
Item # 53c

The wet bar sink is slow draining. \*

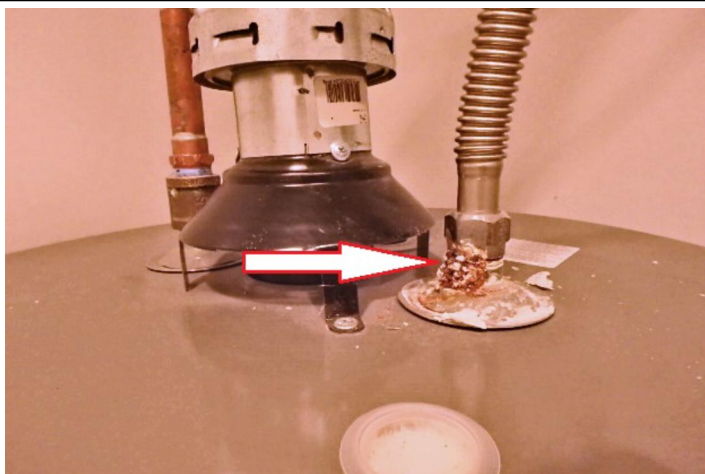
Item # 27

Comments: Signs of major corrosion was noted to the supply line at the water heater. \* (2)

Signs of major corrosion was noted to the supply line at the water heater. \* (2)

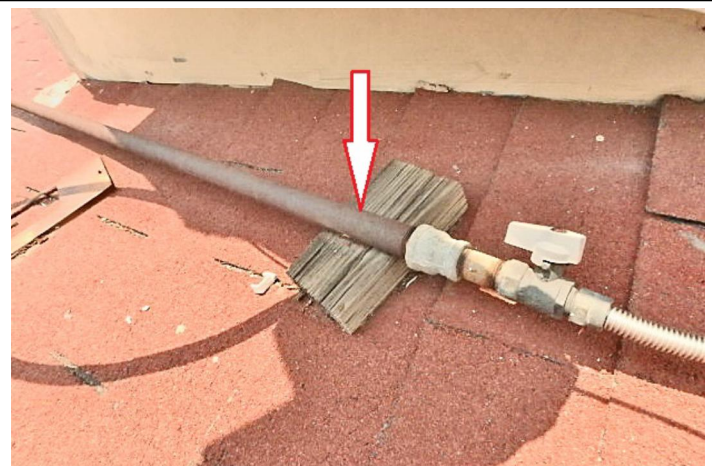
Item # 26

Comments: The gas line is not properly secure at the heating system / roof. \* (2) (4) Moderate to slightly heavy corrosion was noted to the gas line at the heating system / roof. \*

The gas line is not properly secure at the heating system / roof. \* (2) (4) Moderate to slightly heavy corrosion was noted to the gas line at the heating system / roof. \*
