INSPECT BY L.A.
P.O. Box 33273
Granada Hills, CA. 91394
(818) 434-5988 Fax (000) 000-0000

Report #: EN11219169-169

20470 Nashville St.

Chatsworth, Ca. 91311

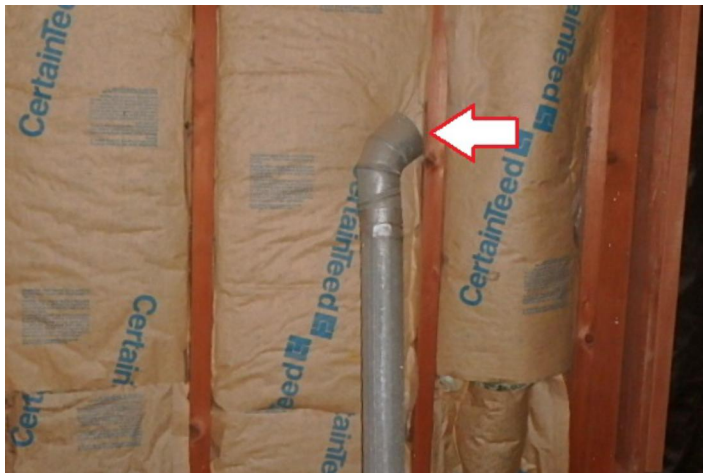
Item # 74

The ceiling exhaust fan duct terminates into the attic at bathroom D.
*

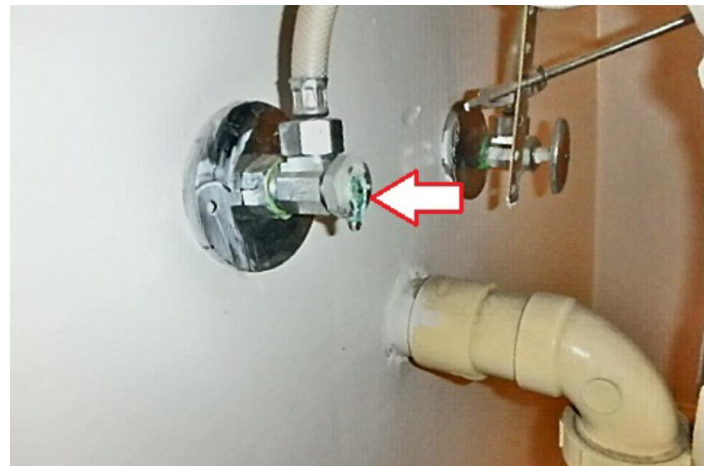
Item # 73

The left and right sink drain stoppers are not operational in bathroom A. * The left and right sink drain stoppers are missing in bathroom B. * The hot water supply valve has missing handle and is leaking under the sink in bathroom C. (pictured) * (2) Sink is slow draining and its drain stopper is defective in bathroom D. *

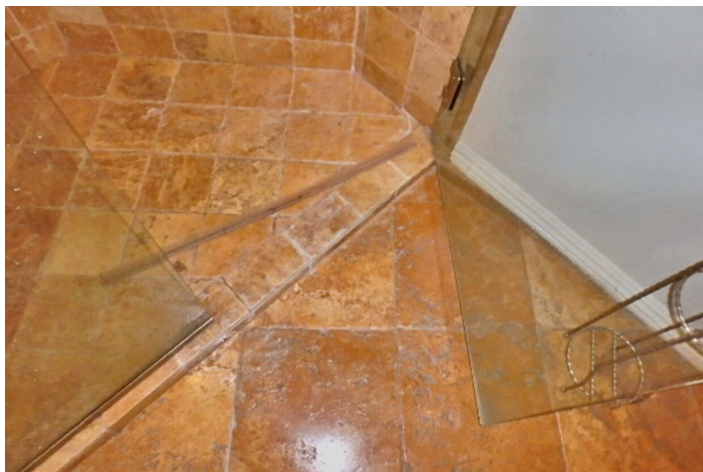
Item # 76

Hot and cold water is reversed at the shower in bathroom D. * (4)
The shower enclosure door has detached bottom seal in bathroom D. (pictured) * (4)

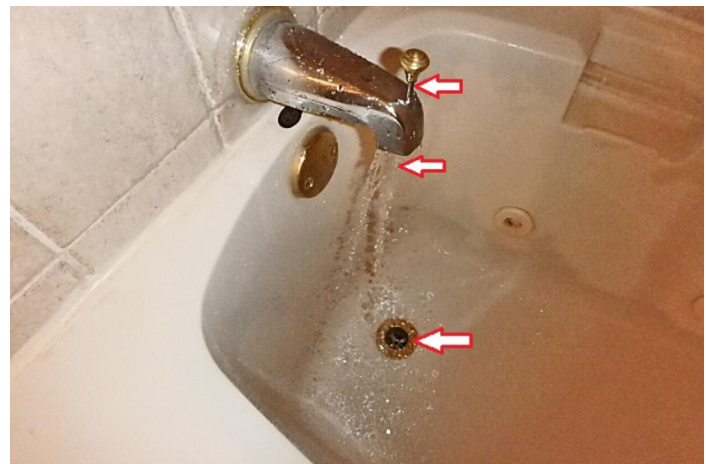
Item # 75, 76

The drain stopper is worn, not functional in bathroom A and is missing in bathroom B (pictured) - unable to fill the tubs to test the hydro-massage systems in bathrooms A and B. * (2) The shower diverter needs adjustment at bathroom B. (also pictured) *

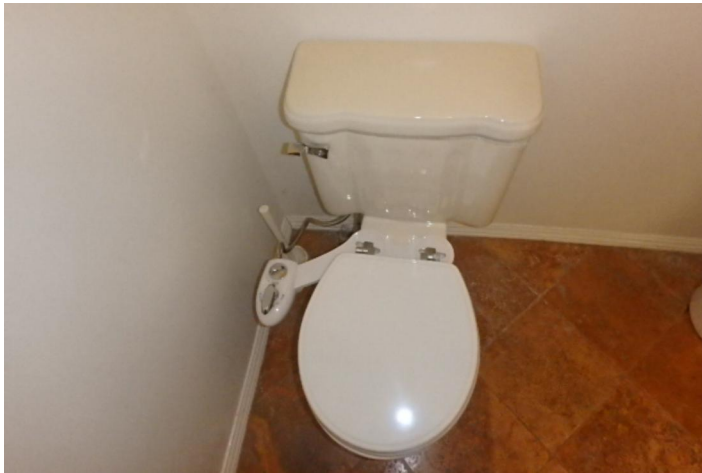
Item # 72

The toilet is slightly loose to floor in bathroom A. * The flushing lever is not secure at the toilet in bathroom B. * The toilet is loose to floor and has loose tank in bathroom C. (pictured) * The toilet tank is loose in bathroom D. *

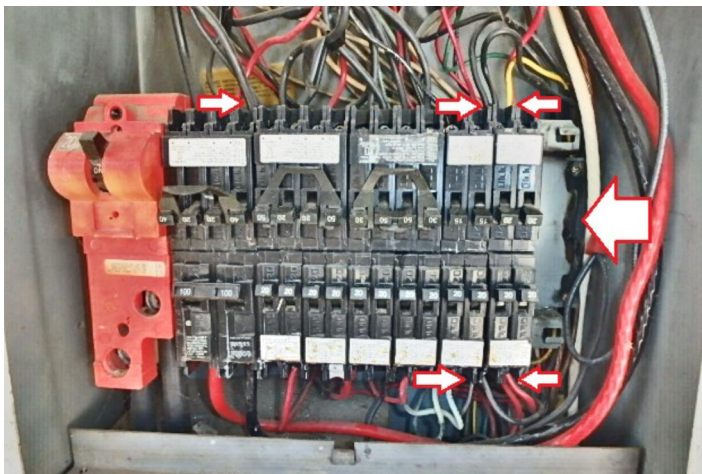
Item # 43

Two wires connected to breaker / double tap was noted to multiple breakers in the main panel. * (2) (4) Blackened surfaces show signs of past or possible current overheating in the main panel. * (2) (4)

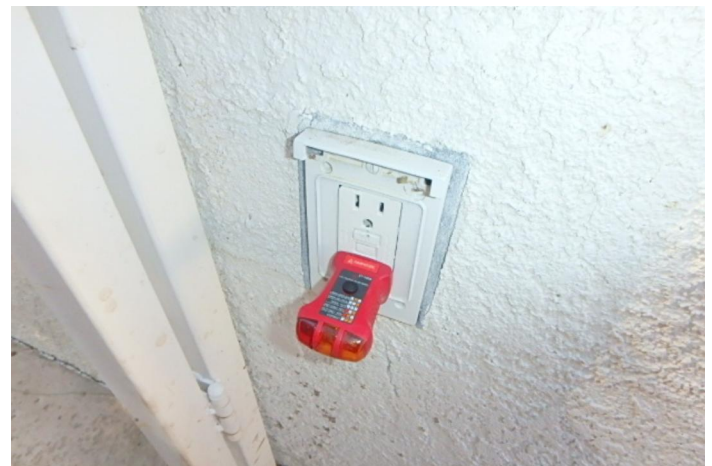
Item # 44

A junction box has a loose cover secured with duct tape at the front-yard. * (4) Outlet has no power and missing cover at left side exterior wall. (pictured) * (2) (4) Switches has damaged cover at the left backyard. * (4)

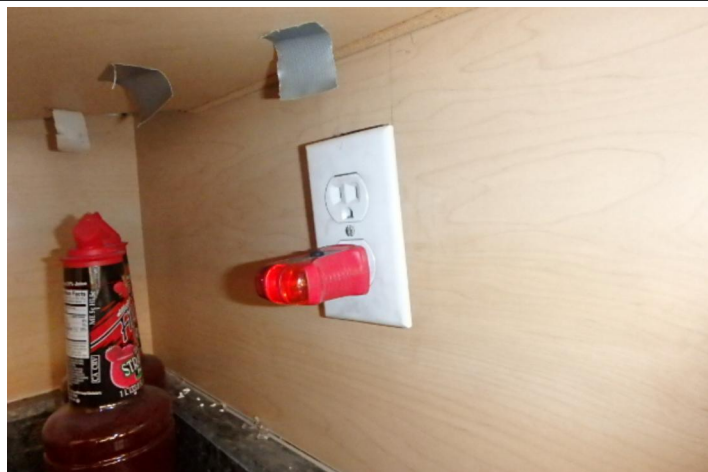
Item # 44

Reverse polarity was noted to outlets at various locations. * (2) (4)
Three-prong outlet is ungrounded and loose to wall at the wet bar counter, upper loft area bedroom 1 closet. (pictured) * (2) (4)
Outlet and switch have missing cover plates in the upper rear attic. * (4)

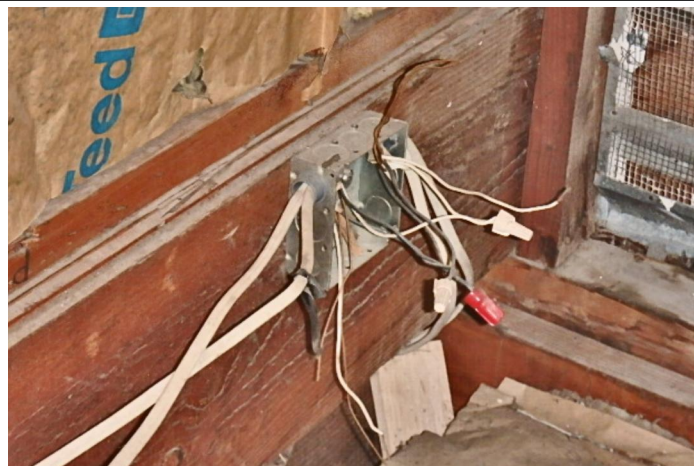
Item # 44

Junction boxes with missing covers and uncapped wires were noted in the lower attic. (pictured) * (4) Outlets have missing cover plates at various locations. * (4) Loose outlet and GFCI outlet with damaged receptacle was noted at the right side kitchen counter. * (4)

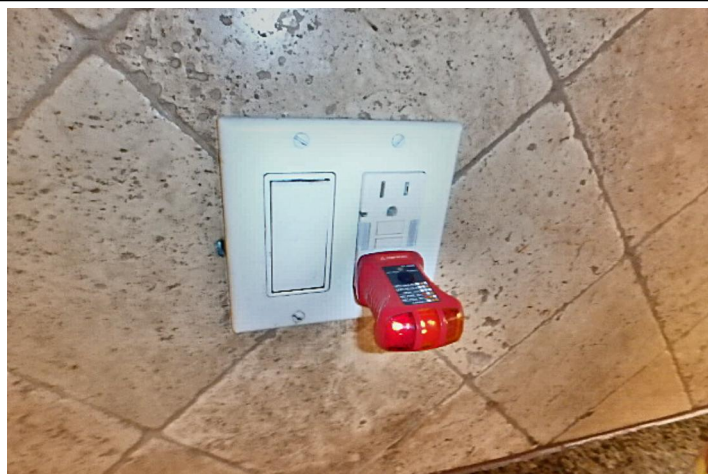
Item # 44

GFCI outlet has reverse polarity / not operational at the kitchen sink. (pictured) * (2) (4) Switches and outlets have cracked cover plates at a few locations. * (4) Loose / wobbly outlets were noted at a few locations. * (4)

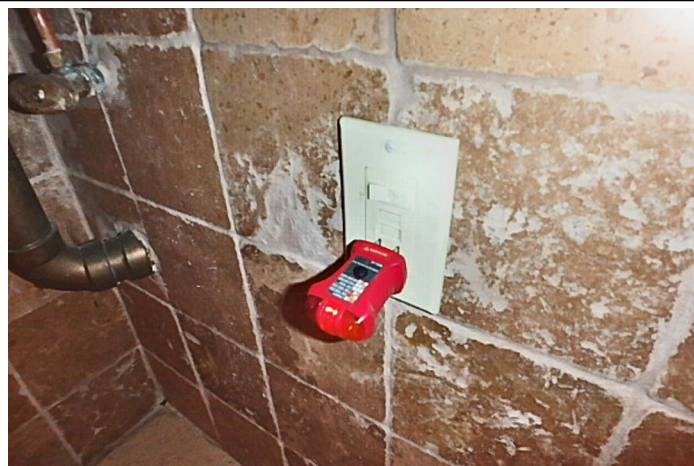
Item # 44

GFCI outlet is ungrounded / not operational at bathroom D. (pictured) * (2) (4) The ceiling light is too low in bathroom C. * (4) Recommend installing GFCI safety outlets at the applicable wet areas. *

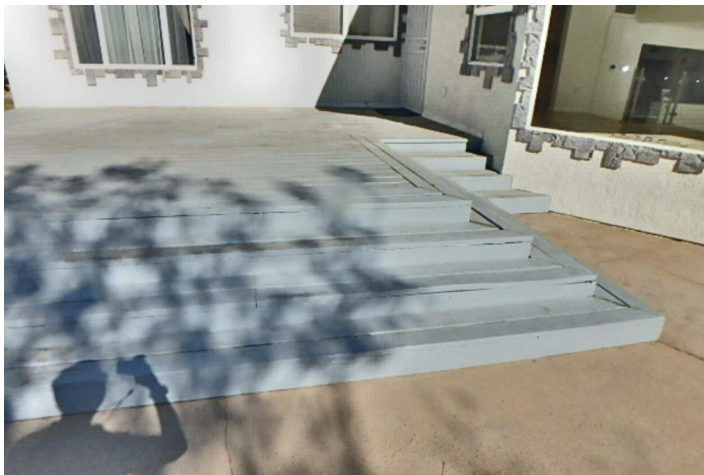
Item # 8

Comments: Railings are missing at the right rear side exterior stairs at the wood deck. * (2) (4) Earth to wood contact was noted under the exterior stairs at the rear wood deck. * (3)

Railings are missing at the right rear side exterior stairs at the wood deck. (pictured) * (2) (4) Earth to wood contact was noted under the exterior stairs at the rear wood deck. * (3)

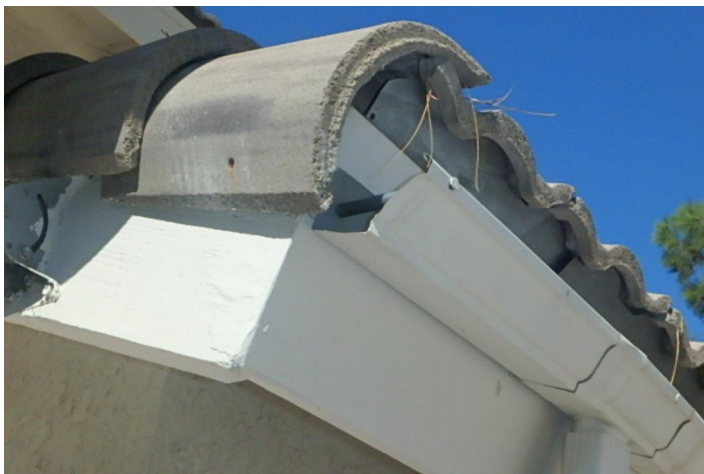
Item # 14

Comments: The gutter is open ended at the left side garage. * Moderate debris was noted in the gutters at few locations - recommend regular cleaning of existing gutters and down spouts. * Recommend additional gutters and down spouts for proper drainage. *

The gutter is open ended at the left side garage. (pictured) *
Moderate debris was noted in the gutters at few locations -
recommend regular cleaning of existing gutters and down spouts. *
Recommend additional gutters and down spouts for proper drainage.
*

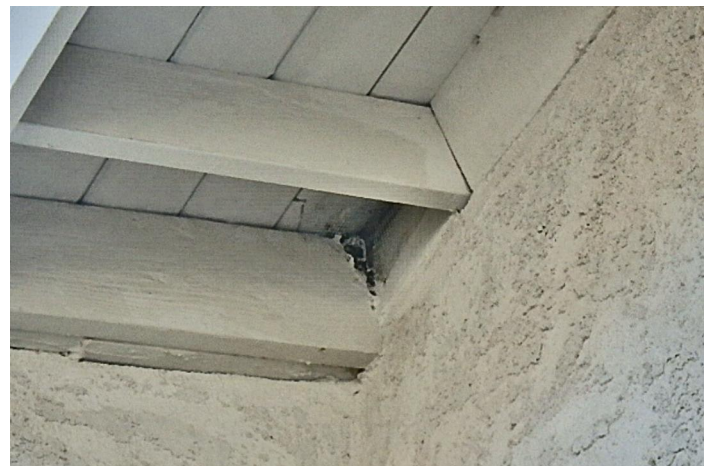
Item # 10

Comments: Opening was noted to the upper left side trim / eaves. *

Opening was noted to the upper left side trim / eaves. *

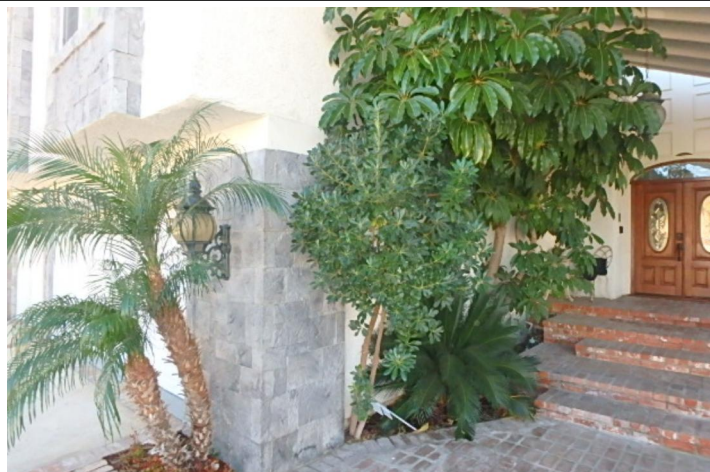
Item # 15

Comments: Plants and tree are in contact with the structure at the left side garage - these have to be regularly trimmed away or removed to prevent damage to the structure. * Sub-surface drain has damaged missing cover at the rear sidewalk. *

Plants and tree are in contact with the structure at the left side garage (pictured) - these have to be regularly trimmed away or removed to prevent damage to the structure. * Sub-surface drain has damaged missing cover at the rear sidewalk. *

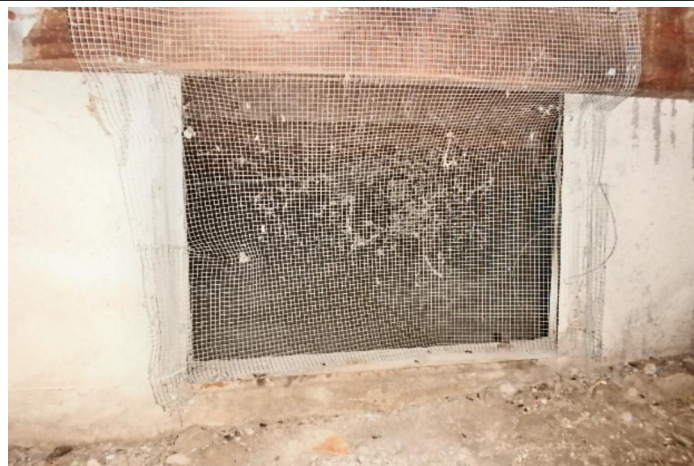
Item # 17a

Comments: A proper cover door is missing at the crawlspace access - permanently screwed-in mesh screen is not a proper cover. *
 Visibility and accessibility was limited in the crawlspace due to heat and cooling air ducts and waste lines. * Rodent droppings / evidence of rodent presence was noted in the crawlspace. *

A proper cover door is missing at the crawlspace access - permanently screwed-in mesh screen is not a proper cover. (pictured)
* Visibility and accessibility was limited in the crawlspace due to heat and cooling air ducts and waste lines. * Rodent droppings / evidence of rodent presence was noted in the crawlspace. *

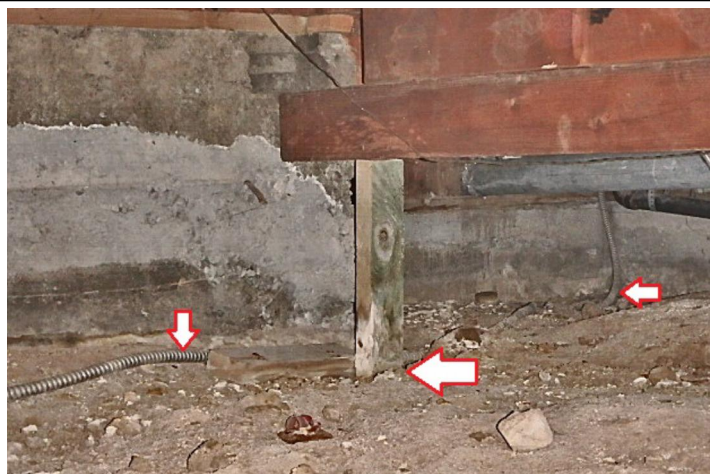
Item # 17b & Item # 44

Comments: Earth to wood contact was noted in the front side crawlspace under the foyer. * (3)

Earth to wood contact (pictured) was noted in the front side crawlspace under the foyer. * (3) A conduit line (also pictured) is not properly elevated / is touching the soil in the front side crawl space. * (2) (4)

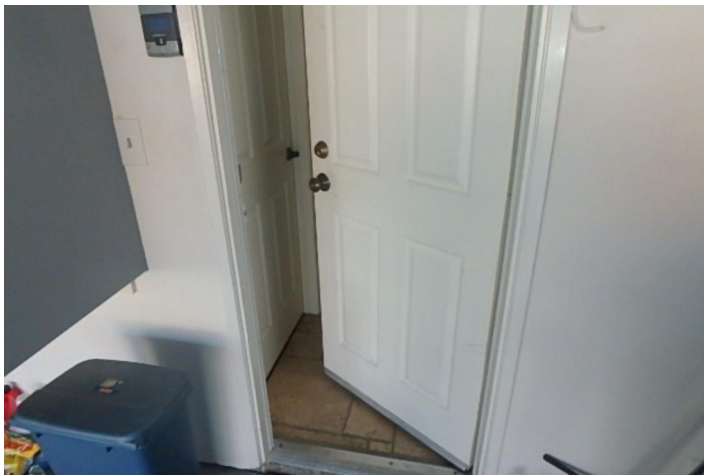
Item # 60

The garage fire door to interior is hollow core / not fire rated and has missing self-closer. * (2) (4)

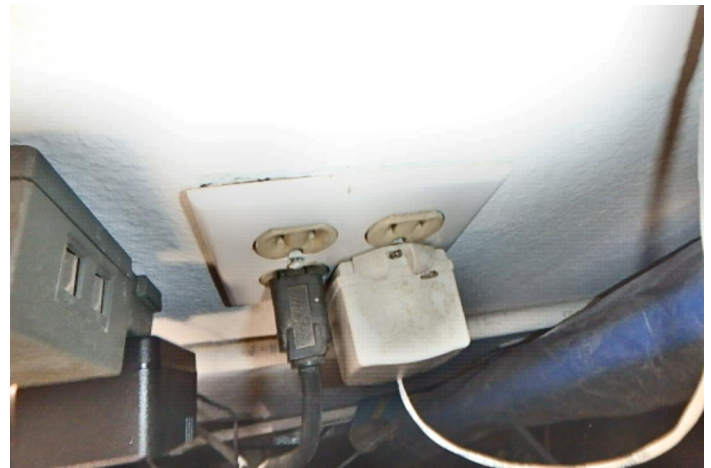
Item # 65

Loose / not properly secure outlet was noted at the garage. * (2) (4)

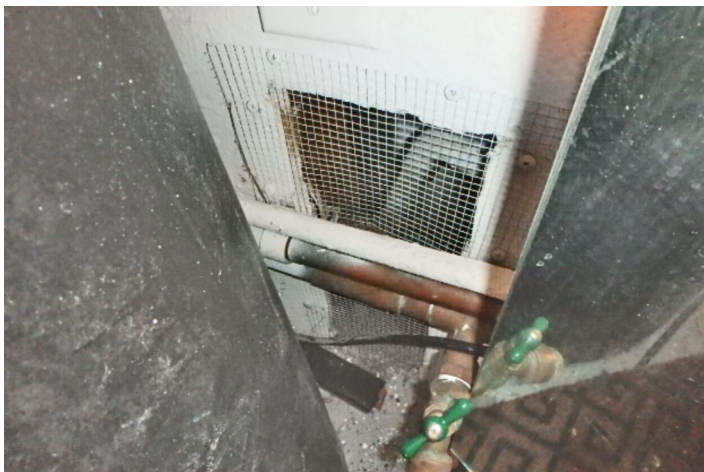
Item # 58

Hole openings / missing wall covers were noted to the garage fire wall - recommend properly sealing the hole openings at all the applicable locations. * (4)

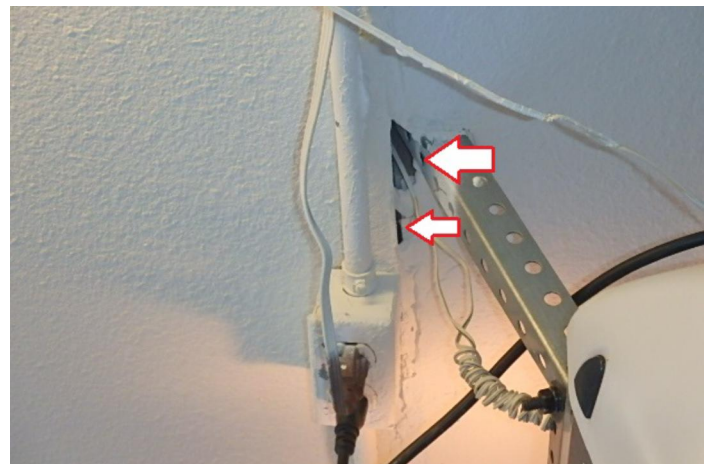
Item # 58

Recommend properly sealing the openings at the left side garage fire ceiling. * (4)

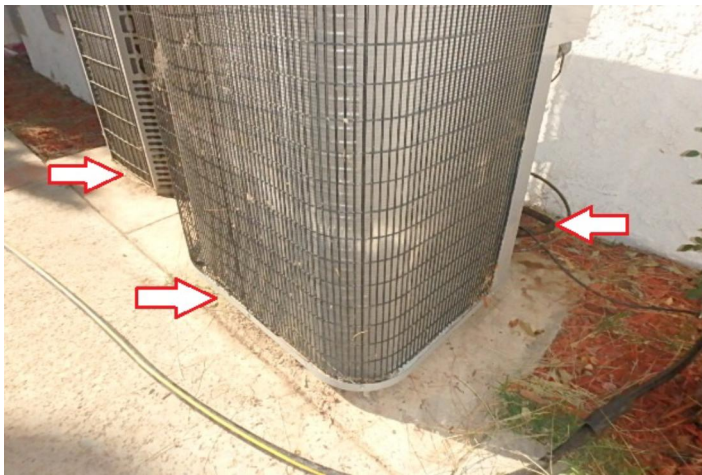
Item # 38, 38c

Cooling systems were operational at the time of the inspection, however, proper platforms or bottom pads is not provided under units A, B and C. * (2) (5) (units B and C pictured) The insulation on cooling system C refrigerant line is missing. (also pictured right) *

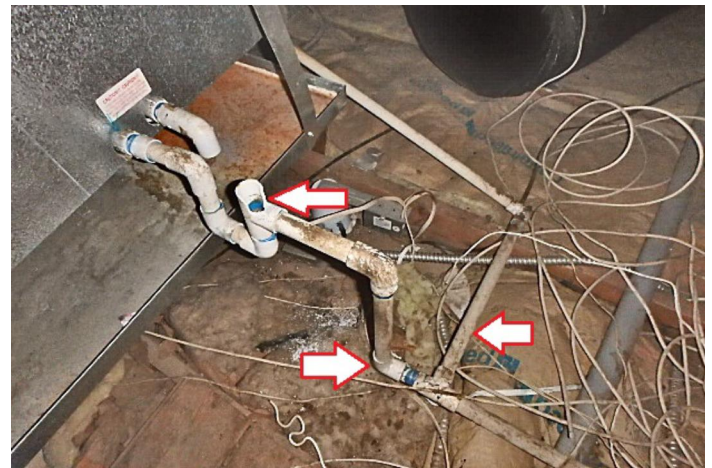
Item # 38b

Cooling systems A and C (pictured) primary and secondary condensate lines are joined together; which is not typical method of installation. * (2) (5) Damage was noted to the condensate line at system C. (also pictured) * (2) Moisture stain is visible on the attic floors which may indicate a possible current or past leak from systems B and C condensate lines - further monitoring is recommended. *

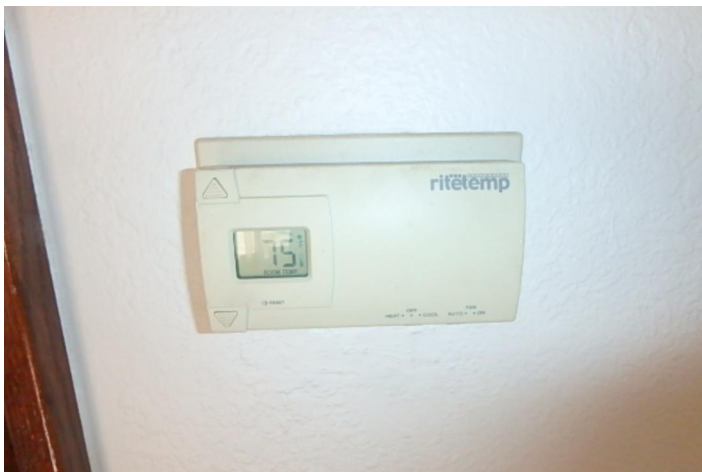
Item # 43

System A's thermostat control is operational, however is loose. *

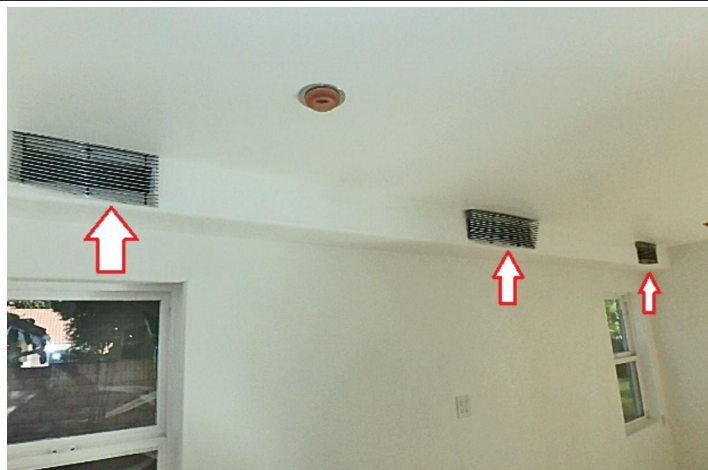
Item # 33

Low air volume was noted to the distribution system at the family room and the upper entertainment area. * (2) Improper covers were noted to the heat and cooling registers at the lower entertainment area. (pictured) *

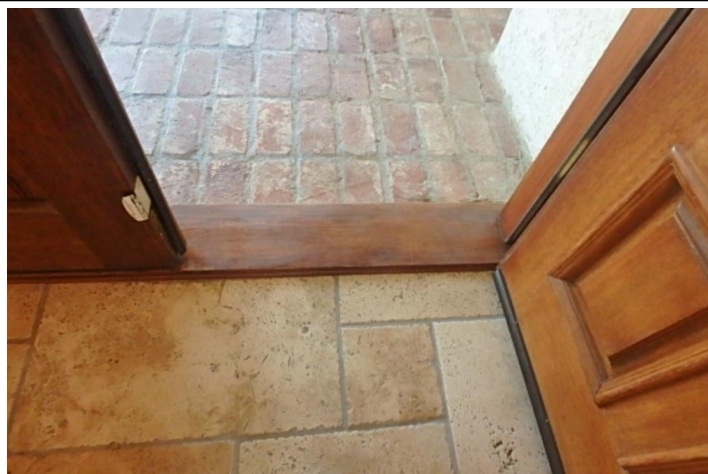
Item # 51

Trip hazard was noted to floor at the main entry doorway. (pictured) * (4) Other step-up or step-down at the lower floors are potential trip hazards. * (4)

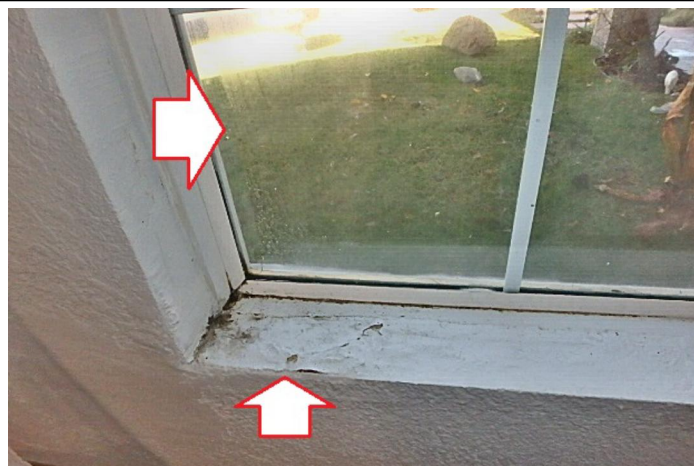
Item # 48

Signs of possible moisture damage on the bottom sill shows possible moisture intrusion to the window at the living room. (pictured) * Foggy surface between the glass show signs of possible failed to the double pane windows at living room (also pictured) and bedroom 4. *

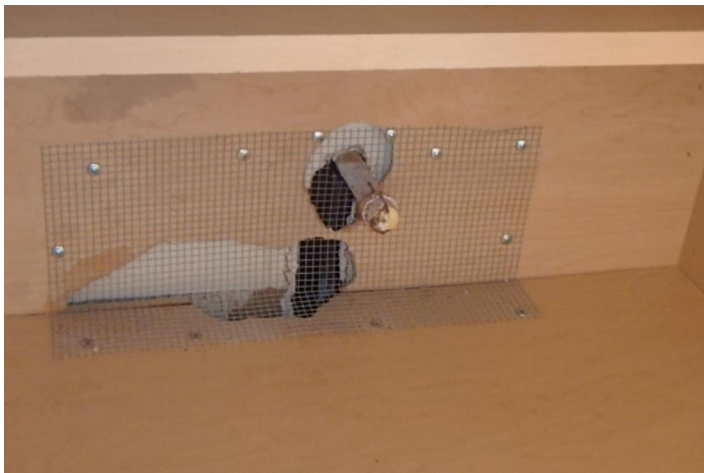
Item # 49

Hole opening was noted to the wall at under the kitchen cook top counter. *

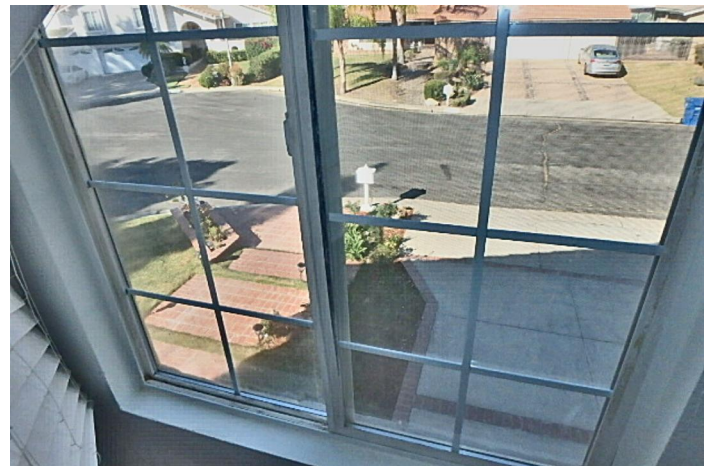
Item # 48

The window does not latch and its glass pane has a bent frame at bedroom 4. (pictured) * (4) Full size windows have no tempered / safety glass insignia at the the upper and lower family rooms. * (4) (5)

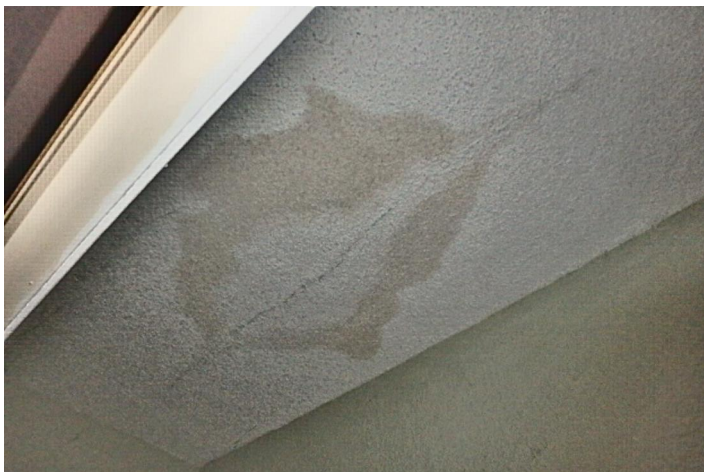
Item # 50

Moisture stain along with patch and repair on a crack was noted to the ceiling inside bedroom 5 closet. *

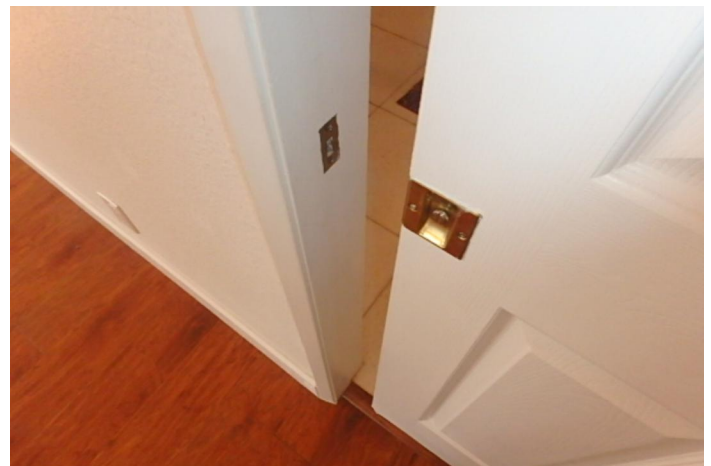
Item # 46

Door does not latch at the upper hallway closet. * Pocket door has missing handle at bedroom 1 walk-in closet. * The pocket door does not latch at bathroom A entry. (pictured) *

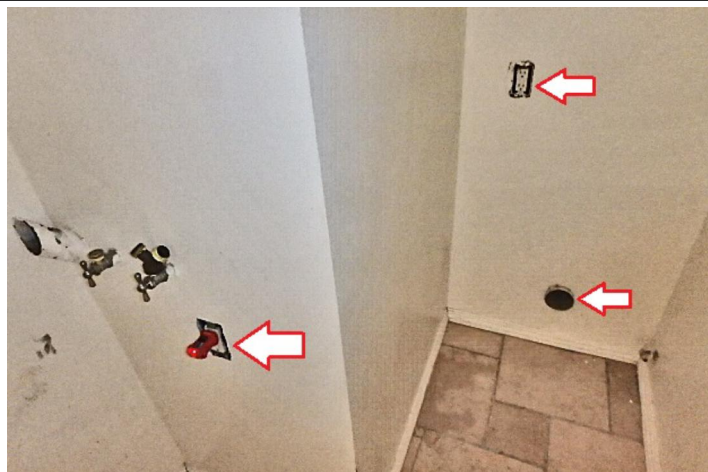
Item # 55

Reverse polarity (both outlets pictured) along with missing cover plates was noted to the outlets at the laundry room. * (2) (4) The dryer vent pipe (also pictured) is filled with lint - blockage of the pipe may cause the gas dryer to malfunction and may result in a fire. * (2) (4)

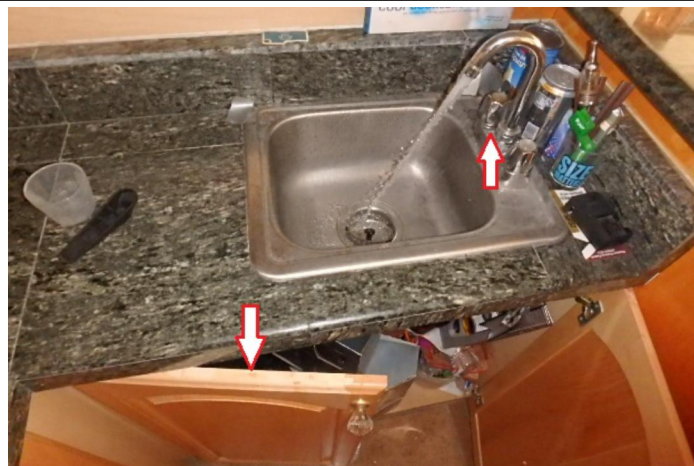
Item # 53c

The hot water handle leaks at the wet bar sink faucet. * (2) The cabinet door rubs to the counter bottom of the wet bar sink. *

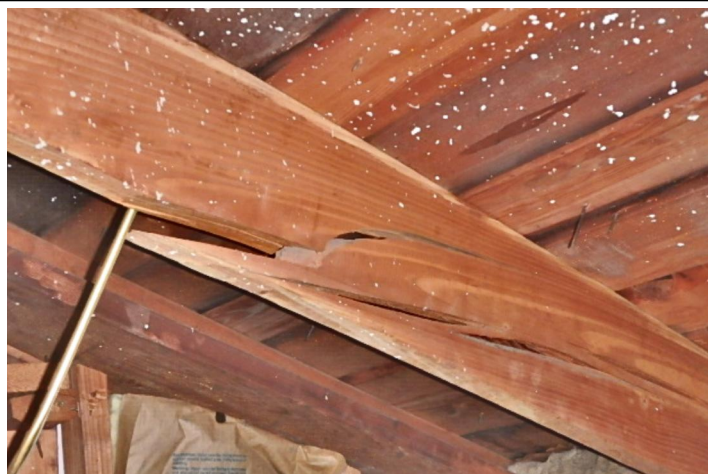
Item # 56, 56a

Moderate stains were noted in the lower and upper front attics. (pictured) * Rodent droppings and traps / evidence of possible rodent presence was noted in the lower and upper front attics. * Damage / popped roof board was noted in the upper front attic. * (2) Cracked rafter was noted in the upper front attic. (also pictured) * (2) Recommend installing screen to the turbine vent at the rear upper attic. *

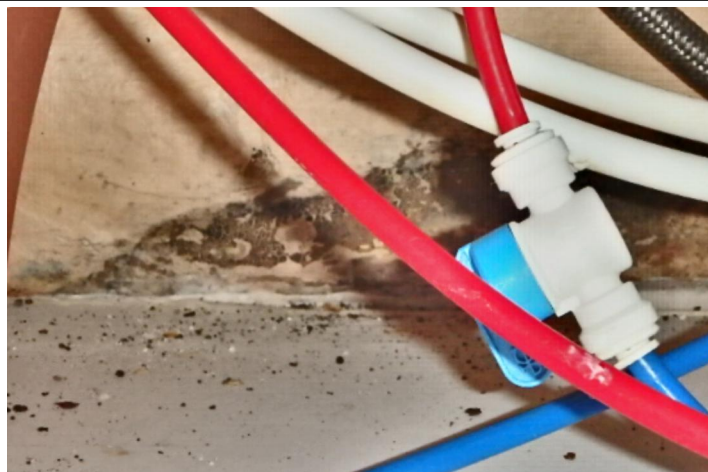
Item # 66

Moderate moisture damage and moisture stains was noted under the kitchen sink. * Mold-like substance was noted under the kitchen sink. * (4)

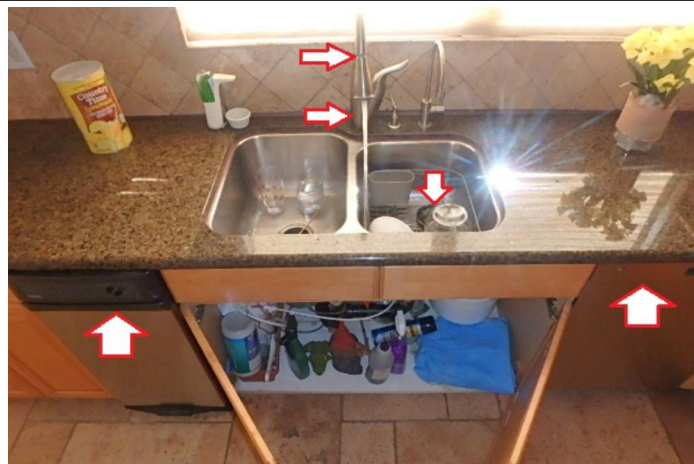
Item # 66, 68, 70, 71

The right kitchen sink is slow draining. * The kitchen sink spray wand leaks at the hose connection. * Kitchen sink faucet is slightly loose. * Disposal is operational, however, it vibrates and is noisy along with signs of corrosion within. * Dishwasher is operational, however, is not secure to the cabinetry. * The trash compactor is not operational. * (2)

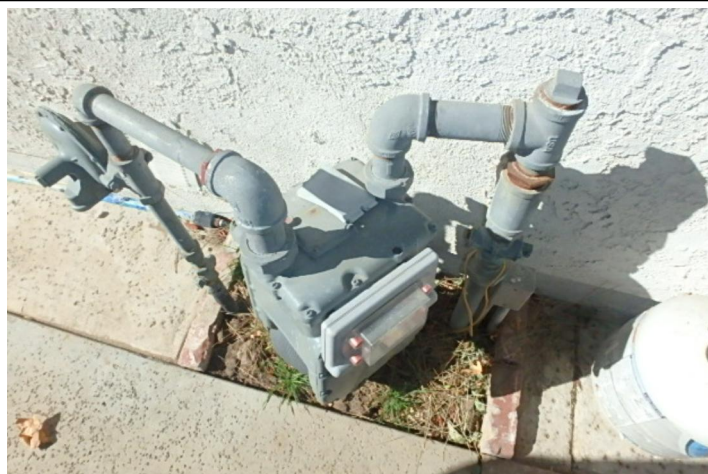
Item # 26

Automatic seismic shutoff valve is missing at the gas meter. * (2) (4)

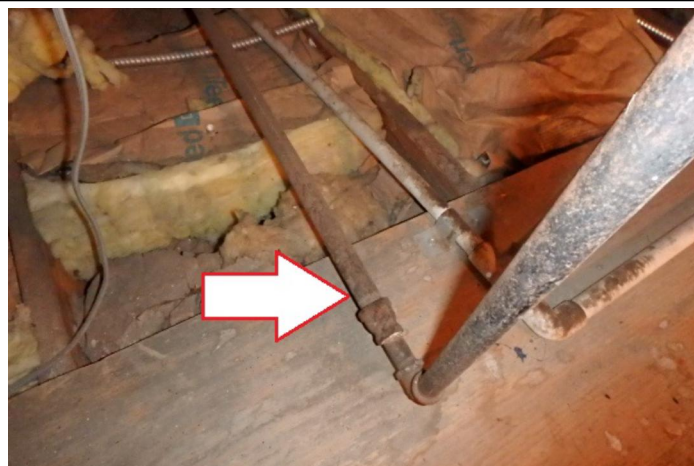
Item # 26

Gas line is not properly secure at the A heating system in the lower attic. (pictured) * (2) (4) Recommend upgrading the gas shut off valve at the pool-spa heater to a newer dial-type shut off. *

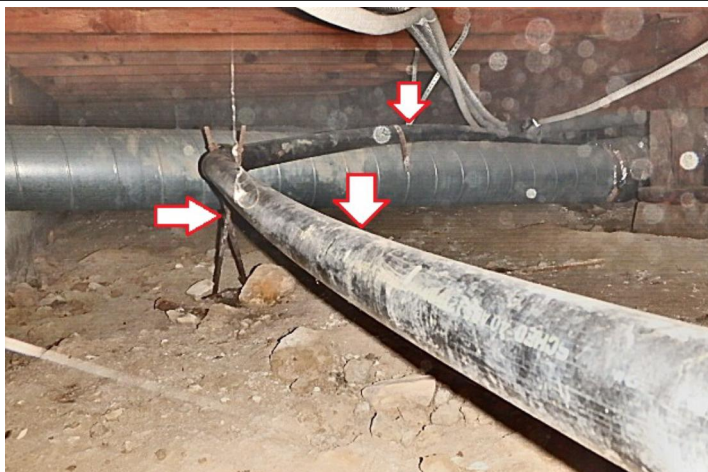
Item # 25

Improper support along with inadequate fall / improper slope was noted to the waste line under the kitchen in the crawlspace. (pictured)

* (2) Improper support was noted to the waste line under bathroom D in the crawlspace. * (2)

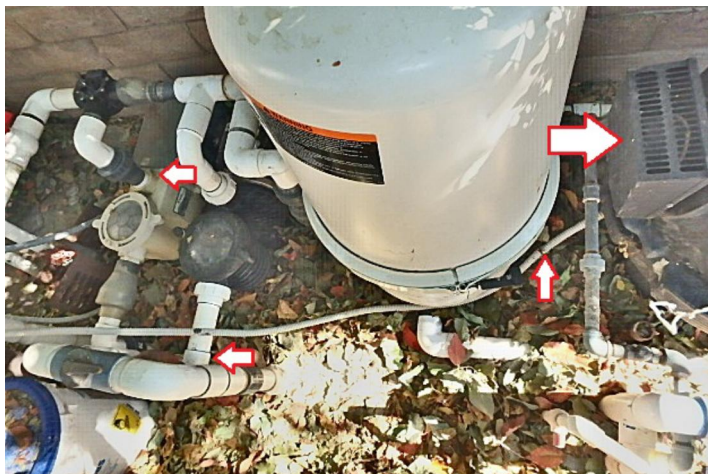
Item # 78, 80, 82

The pool-spa heater does not respond to normal controls, and has no body ground wire. * (2) (4) Debris was noted in the pool/spa heater the vent. * There is no body bond ground wires attached to the water fall and circulation pumps. * (2) (4) Leaks were noted to the waterfall pump and to the pump piping. * (2) The conduit line to the pool-spa heater has damage. * (2) (4)

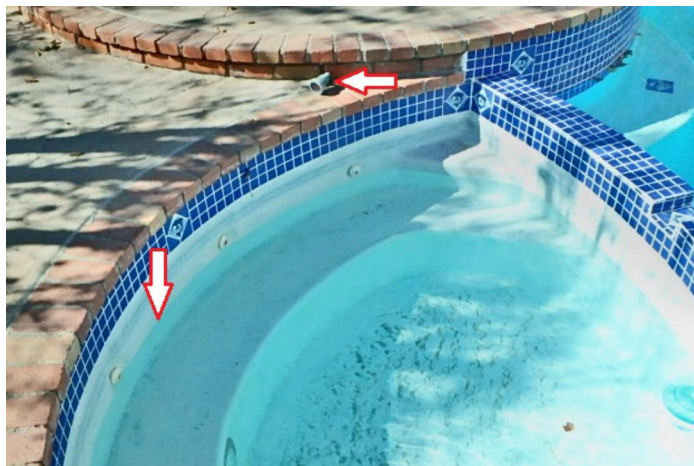
Item # 81, 82a

The air bubbler to the spa is operational, however, was not properly tested due to the low water table in the spa. (pictured) * (2) Unable to determine the operation of the pool and spa lights. * (2) Recommend asking the seller as to the serviceability of the pool and spa lights. * The surface light at the spa deck is loose / not secure. (also pictured) * (2) (4)

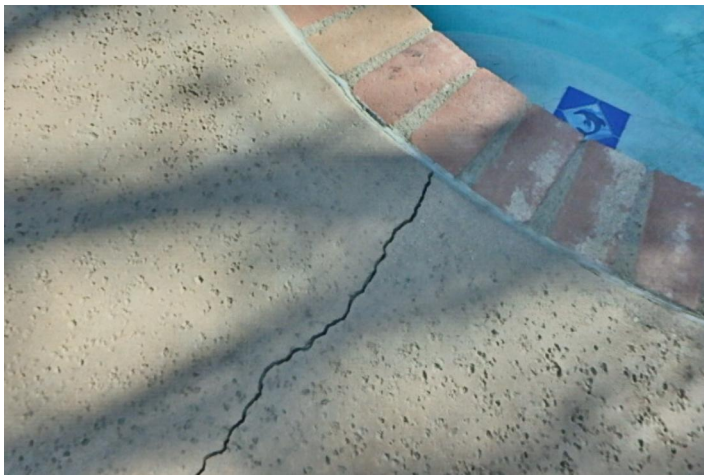
Item # 83

Copping is needed on the moderate cracks the right pool deck. (pictured) * (2) Signs of moderate / typical wear was noted to the pool and spa bottom surfaces. * Unable to test the spring-loaded right side gate leading the pool-spa area - gate is locked. * (4) Recommend fencing around the pool-spa area. * (4) (5)

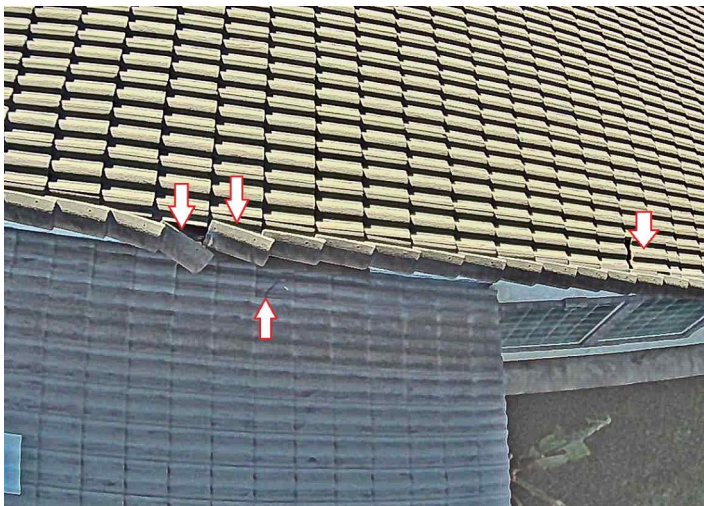
Item # 19

Comments: The main roofs are generally serviceable with a few loose roof tiles noted at the right upper front section, and a cracked roof tile noted at the right lower section of the main roof. * Typical maintenance is recommended. *

The main roofs are generally serviceable with a few loose roof tiles noted at the right upper front section, and a cracked roof tile noted at the right lower section of the main roof. * Typical maintenance is recommended. *

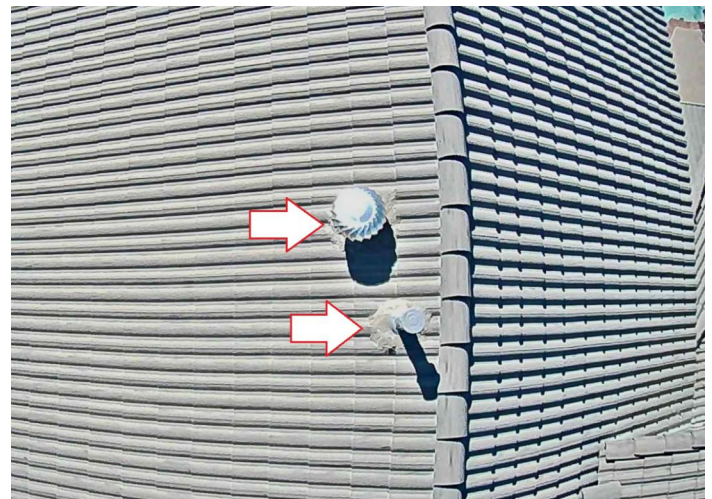
Item # 22

The exposed flashings were generally serviceable, however, improper no visible flashing was noted to a roof vent and vent pipe at the upper rear section of the main roof. * (2)
